# Buildings north of Hill Farm, Taylors Lane, Higham, Kent.

## Structural Inspection Report

Reference: 23-0255

Date: 12<sup>th</sup> July 2023

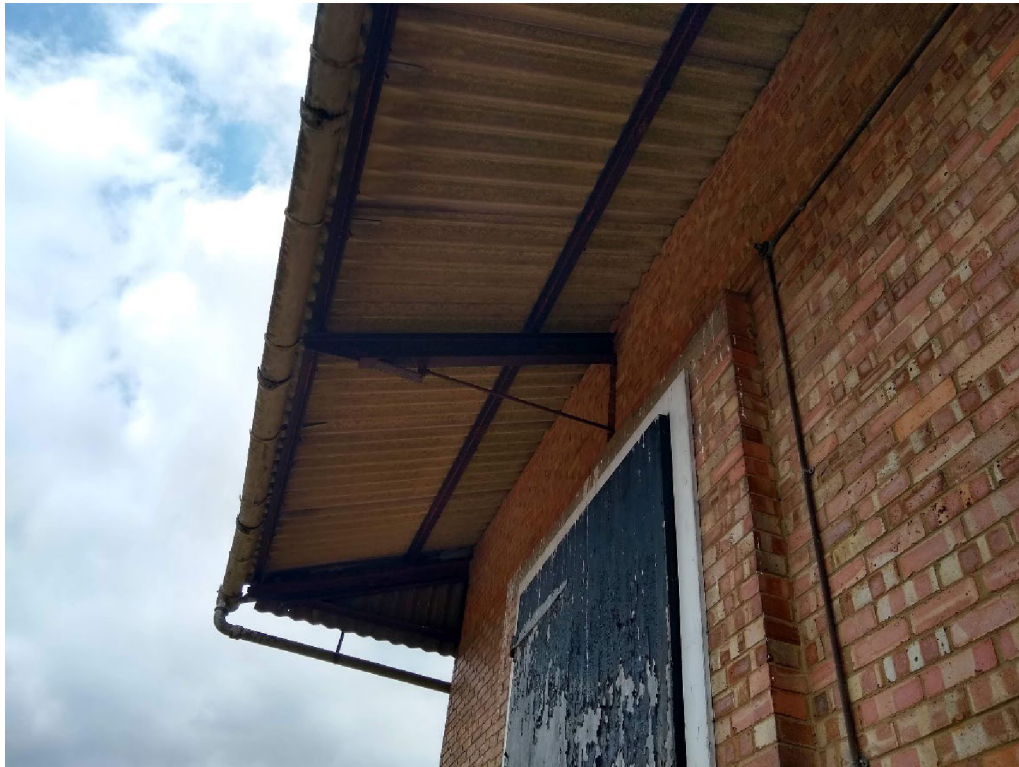
**Photo 7 – Building B – canopy overhang.**

To the southern elevation, the roof cantilevers over the wall to form a canopy to the cold store doors.

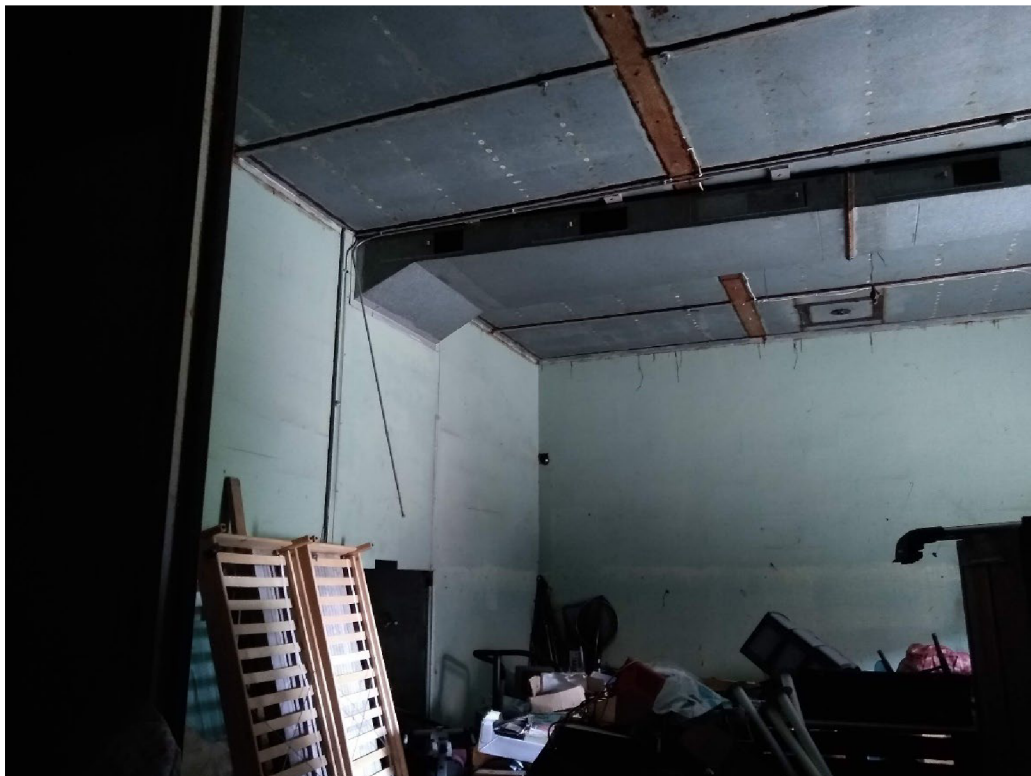
**Photo 8 – Building B - internal.**

Internally the building used to be divided into two cold stores, but a large opening was formed in the dividing wall with associated steel beams and columns installed.

The building appears to be showing no signs of structural issues.

The floor slab is concrete and is in a good condition and could possibly be retained  
If it can comply with building regulations.

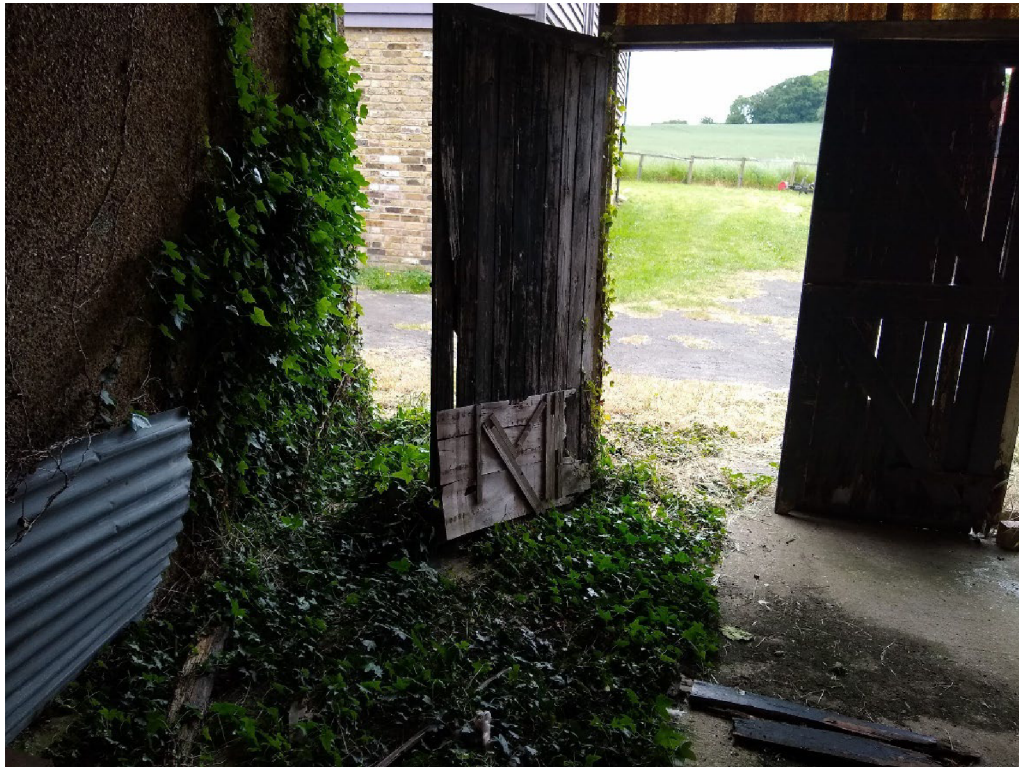
**Photo 9 – Building C – internal view of south wall.**

To the south elevation, there is a double timber door, either side of which used to be a timber stud wall on a dwarf brick wall. Unfortunately, poor maintenance has meant the studwork is missing and the dwarf wall has partially collapsed. However, this wall is not structural and does not support the roof.

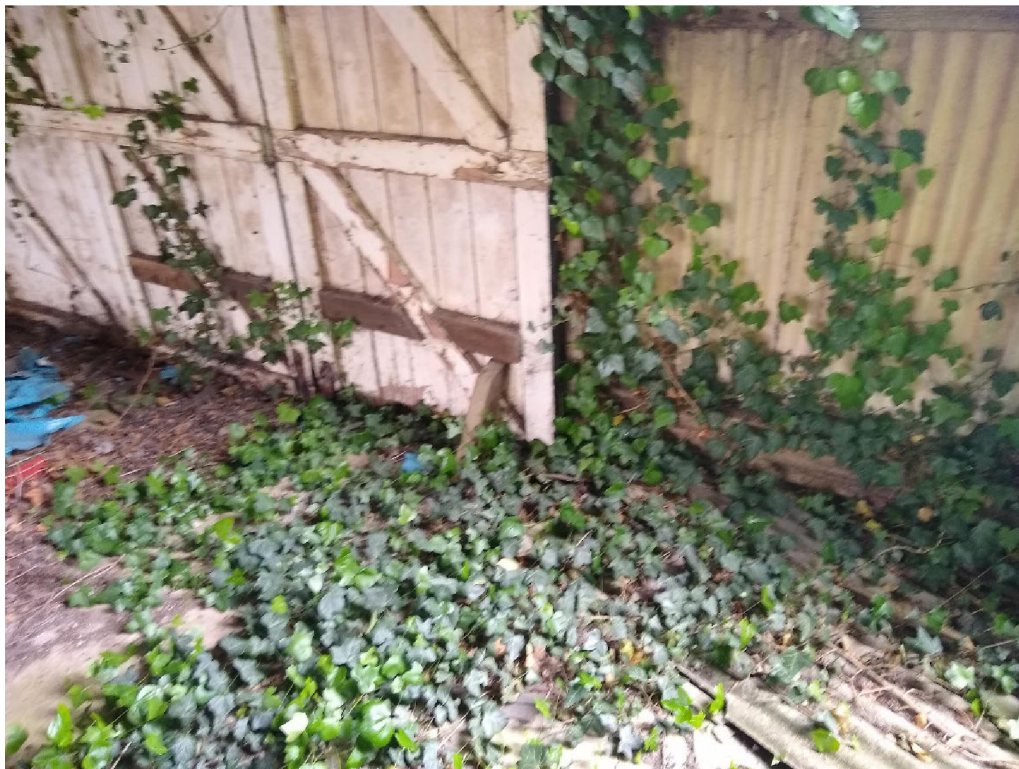
**Photo 10 – Building C – sliding door to north wall.**

To the north elevation, the wall consists mainly of a large timber sliding door, with timber posts and beams supporting the roof timbers above and clad in metal sheeting. The wall is covered in vegetation and this will need to be carefully removed. It would appear that one of the corner posts to this wall is missing and some localized strengthening works will be required.

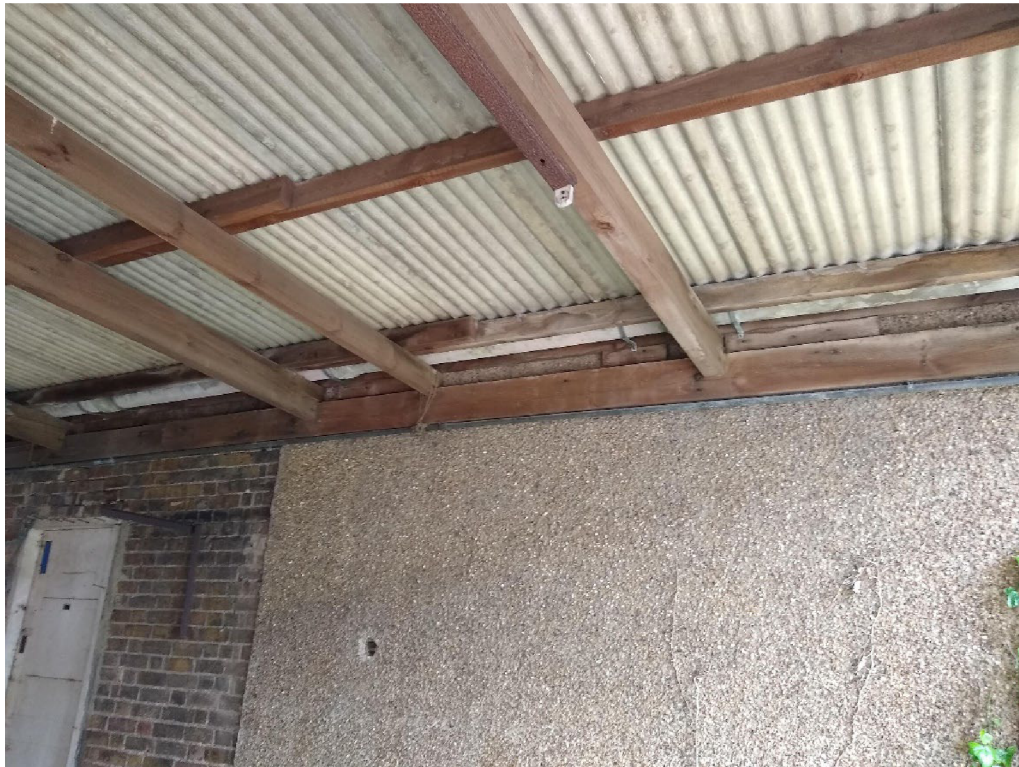
**Photo 11 – Building C – roof.**

Where the roof abuts building A and forms a valley, poor maintenance over the years has meant that some of the roof timbers are suffering from rot and will need strengthening.

At present the roof timbers will be capable of taking the existing roof covering with added roof insulation after some localized strengthening has been carried out.
