**Ref: 3962/22**

**PROPOSED REDEVELOPMENT AT  
UNIT K6, LOWER ROAD, NORTHFLEET,  
KENT DA11 9BL.**

**PHASE I GEO ENVIRONMENTAL DESK STUDY  
AND PRELIMINARY RISK ASSESSMENT**

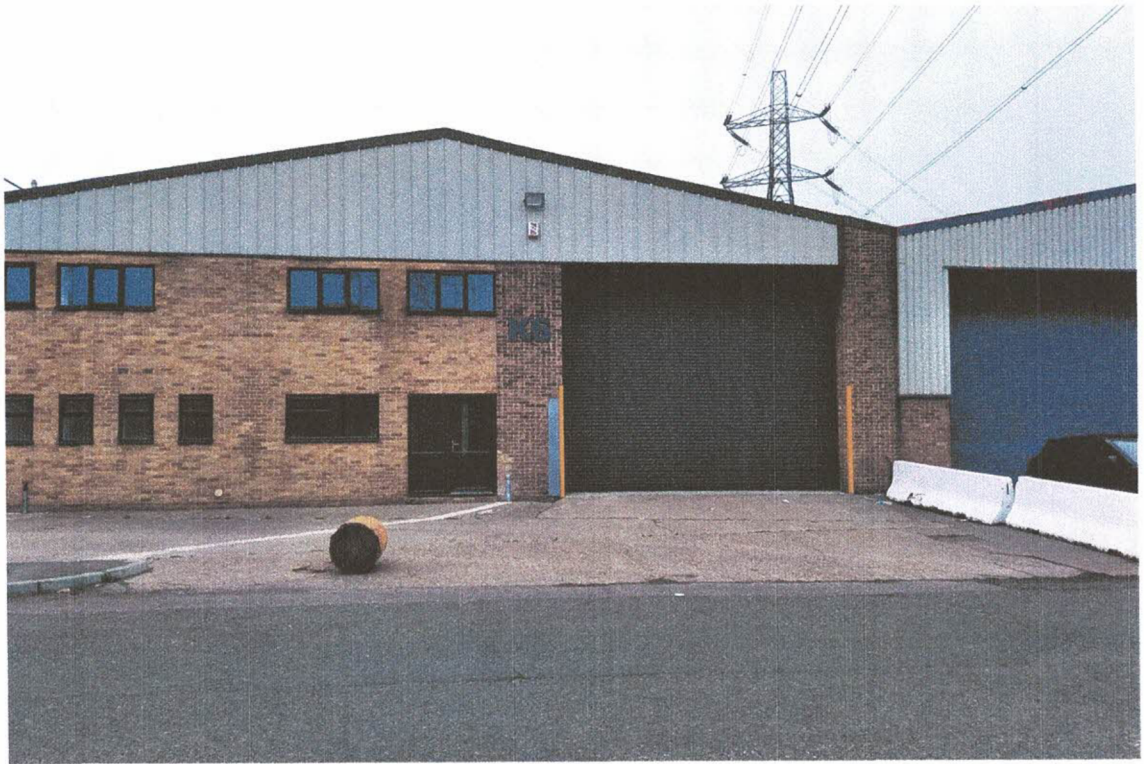
**Plate 1**

- 7.3 The site comprised a vacant unit of brick and steel construction contained within a larger rectangular block of similar commercial premises (Plate 1). The east section of the unit supported two-storey office accommodation, with a roll-over commercial vehicle entry point to the west. Access into the building was unavailable.

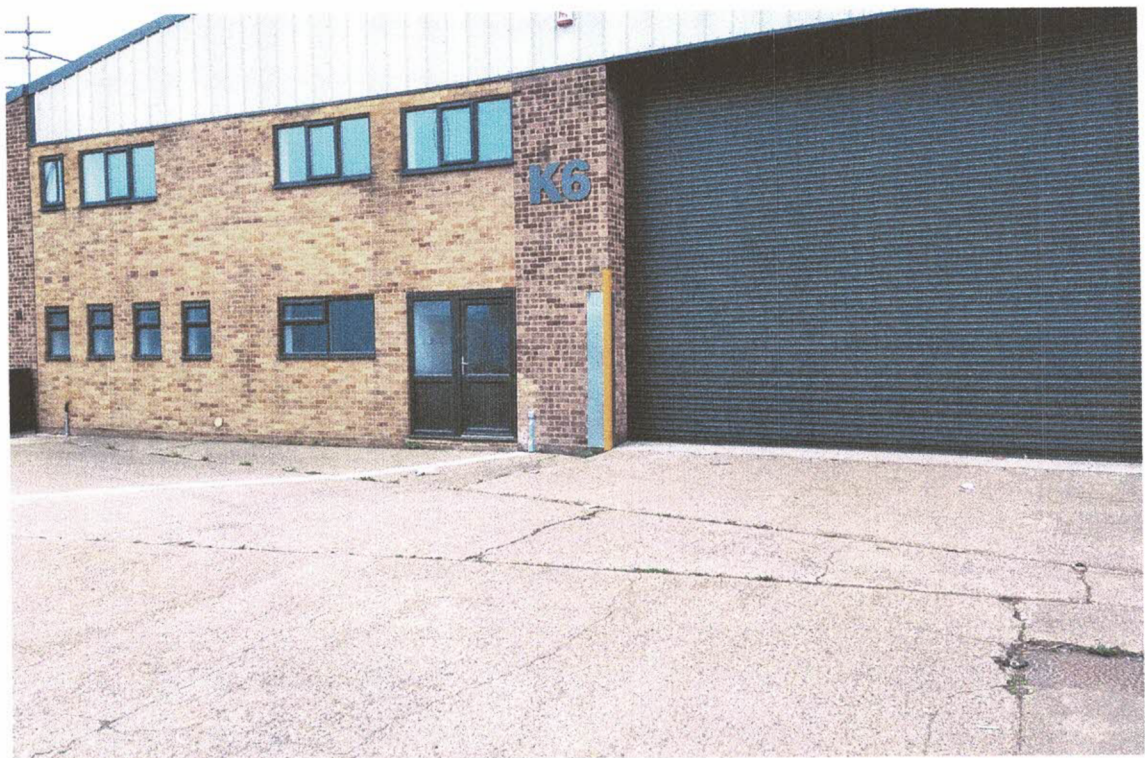
**Plate 2**

- 7.4 Concrete surfacing of an unstained appearance was present at the front of the building, adjacent to the estate road (Plate 2). A trailer was parked on the roadside to the front of the building.

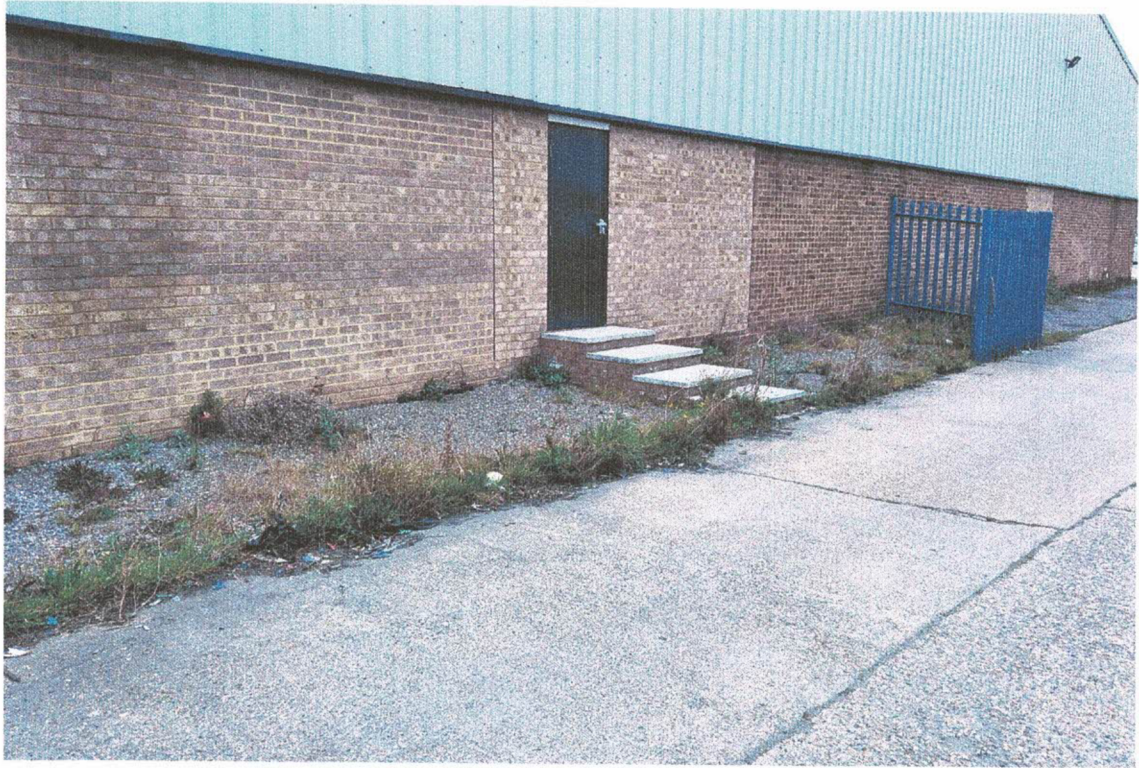
**Plate 3**

- 7.6 Access to the rear of the site was gained via a concrete road which led from the end of the estate road around the east end of the main block and alongside the rear of the units. The rear elevations of the units were of brick construction under a steel roof. A single door accessed via a short flight of steps was present on the rear elevation of the subject unit (Plate 3). Compact granular surfacing approximately 2m in width with patches of emergent weeds formed the ground surface between the concrete road and the rear elevation of the unit.

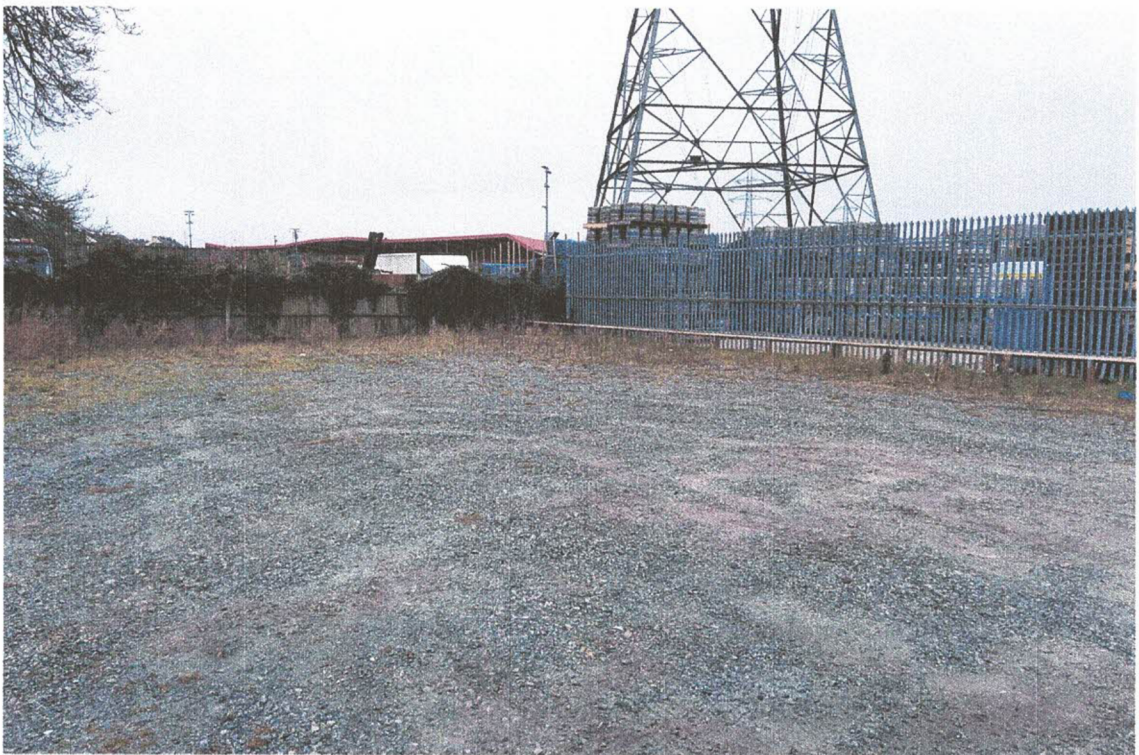
**Plate 4**

- 7.7 The rear section of the site comprised a vacant, roughly square area of compact granular surfacing located on the south side of the concrete road and enclosed on its east and west sides by steel railings. A panelled timber fence formed the south boundary of the site (Plate 4 to Plate 6). The southeast corner of the site contained a mature Oak tree.

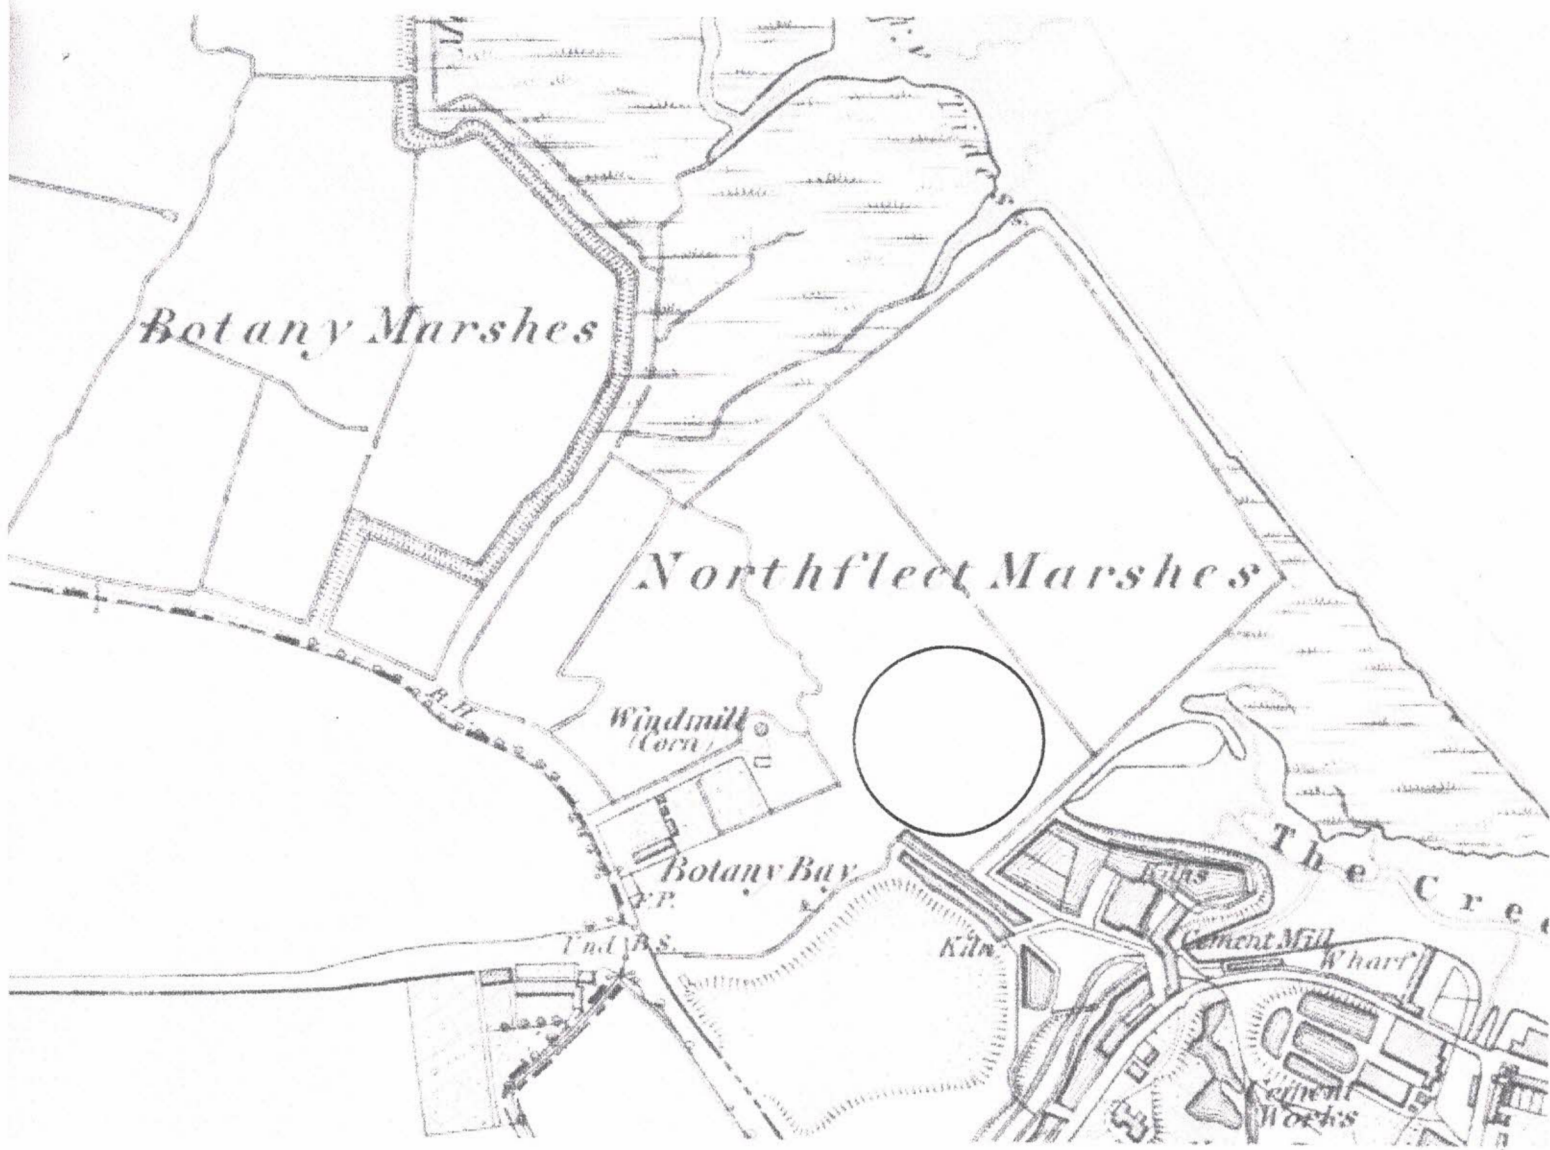
**Unit K6 Lower Road, Northfleet.**  
**OS map scale 1:2500 1869.**

- 5.1 A search has been undertaken of historical Ordnance Survey Maps obtained from the Kent County Council Archives and Landmark websites. The following maps have been examined for the presence of potential on and off-site contamination, extracts of which are contained in Appendix A:
- 5.2 OS map scale 1:2500 1869:  
**On site:** The site comprises undeveloped land located within an area of estuarine

marshes. A drainage ditch passes roughly west to east across the site, discharging into a meandering surface watercourse to the north.

**Off site:** A corn windmill and an associated building are located adjacent to the northwest corner of the site. An additional surface watercourse is present within 10m to the northwest. Kilns are denoted within 100m to the south and southeast, a quarry also being in evidence within 100m to the southwest. Cement Works are located within 200m to the southeast of the site.

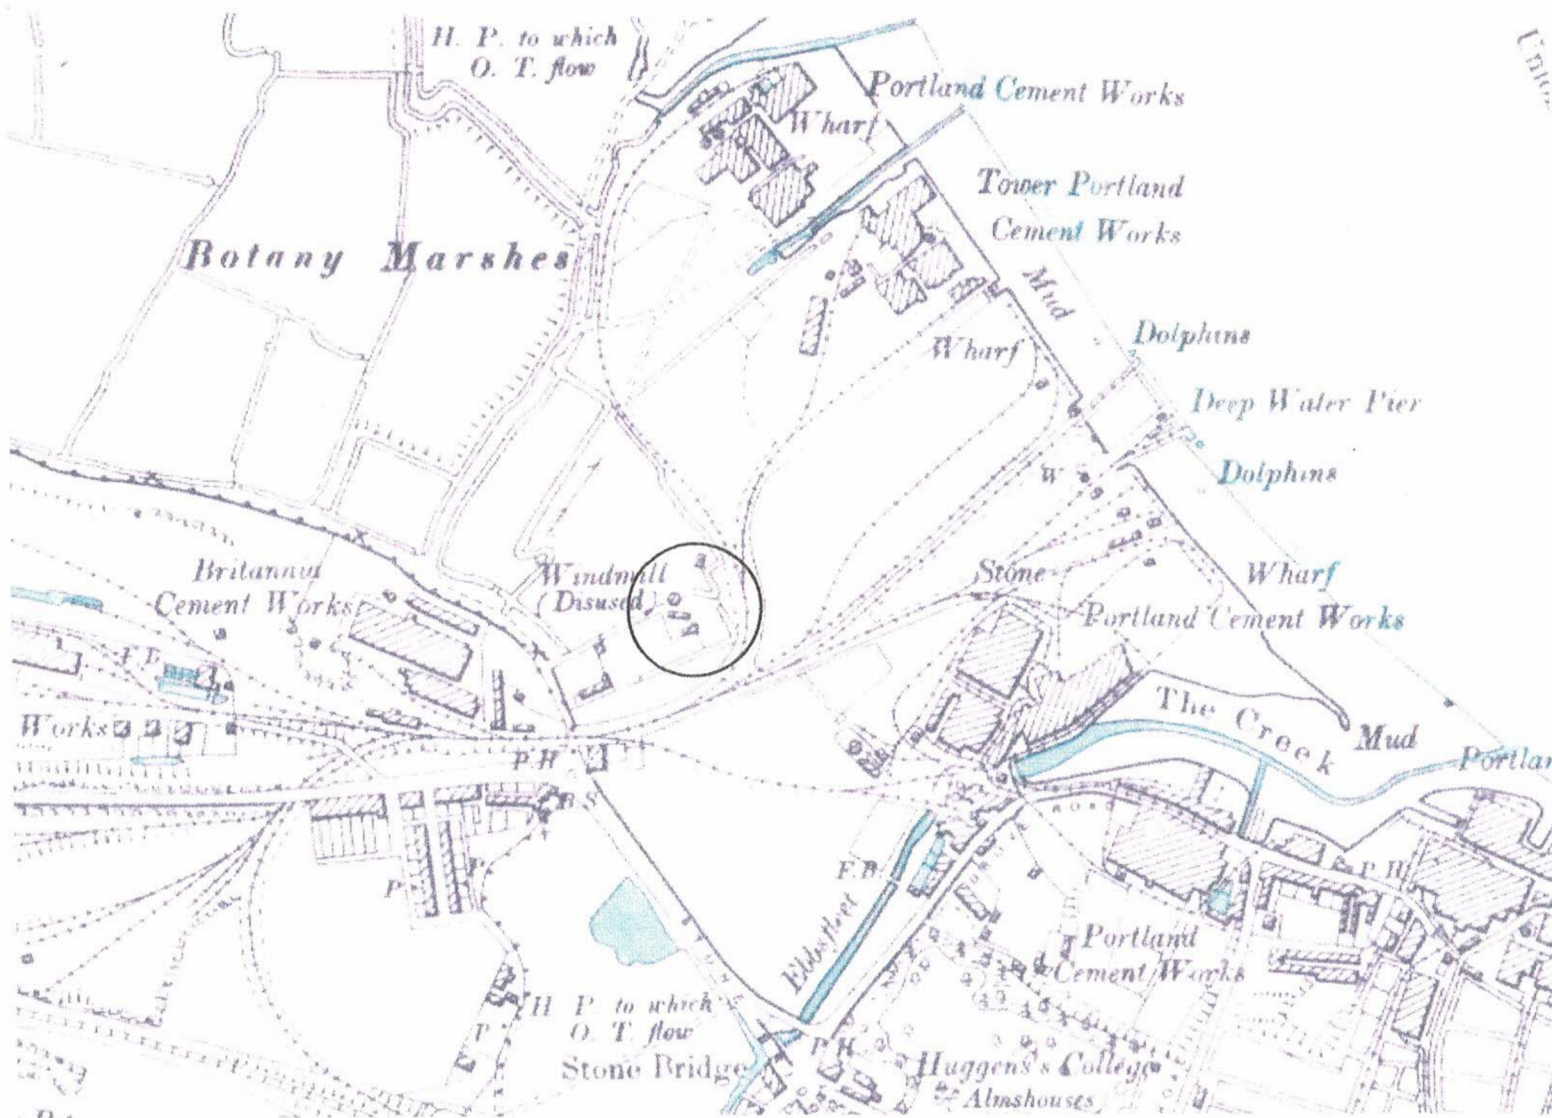
Unit K6 Lower Road, Northfleet.  
OS map scale 1:2500 1898.

**On site:** Tramways have been installed within the local area and appear to cross the southeast corner of the site.

**Off site:** An additional building has been constructed next to the windmill, though the windmill is now disused. Additional cement works and associated tramways have been installed within 200m to the west of the site and within 400m to the northeast, a quarry associated with the former cement works being located within 250m to the west. A flooded quarry is in evidence within 200m to the southwest. Wharfs have been installed alongside the estuary to the northeast. The quarry to the south is no longer denoted.

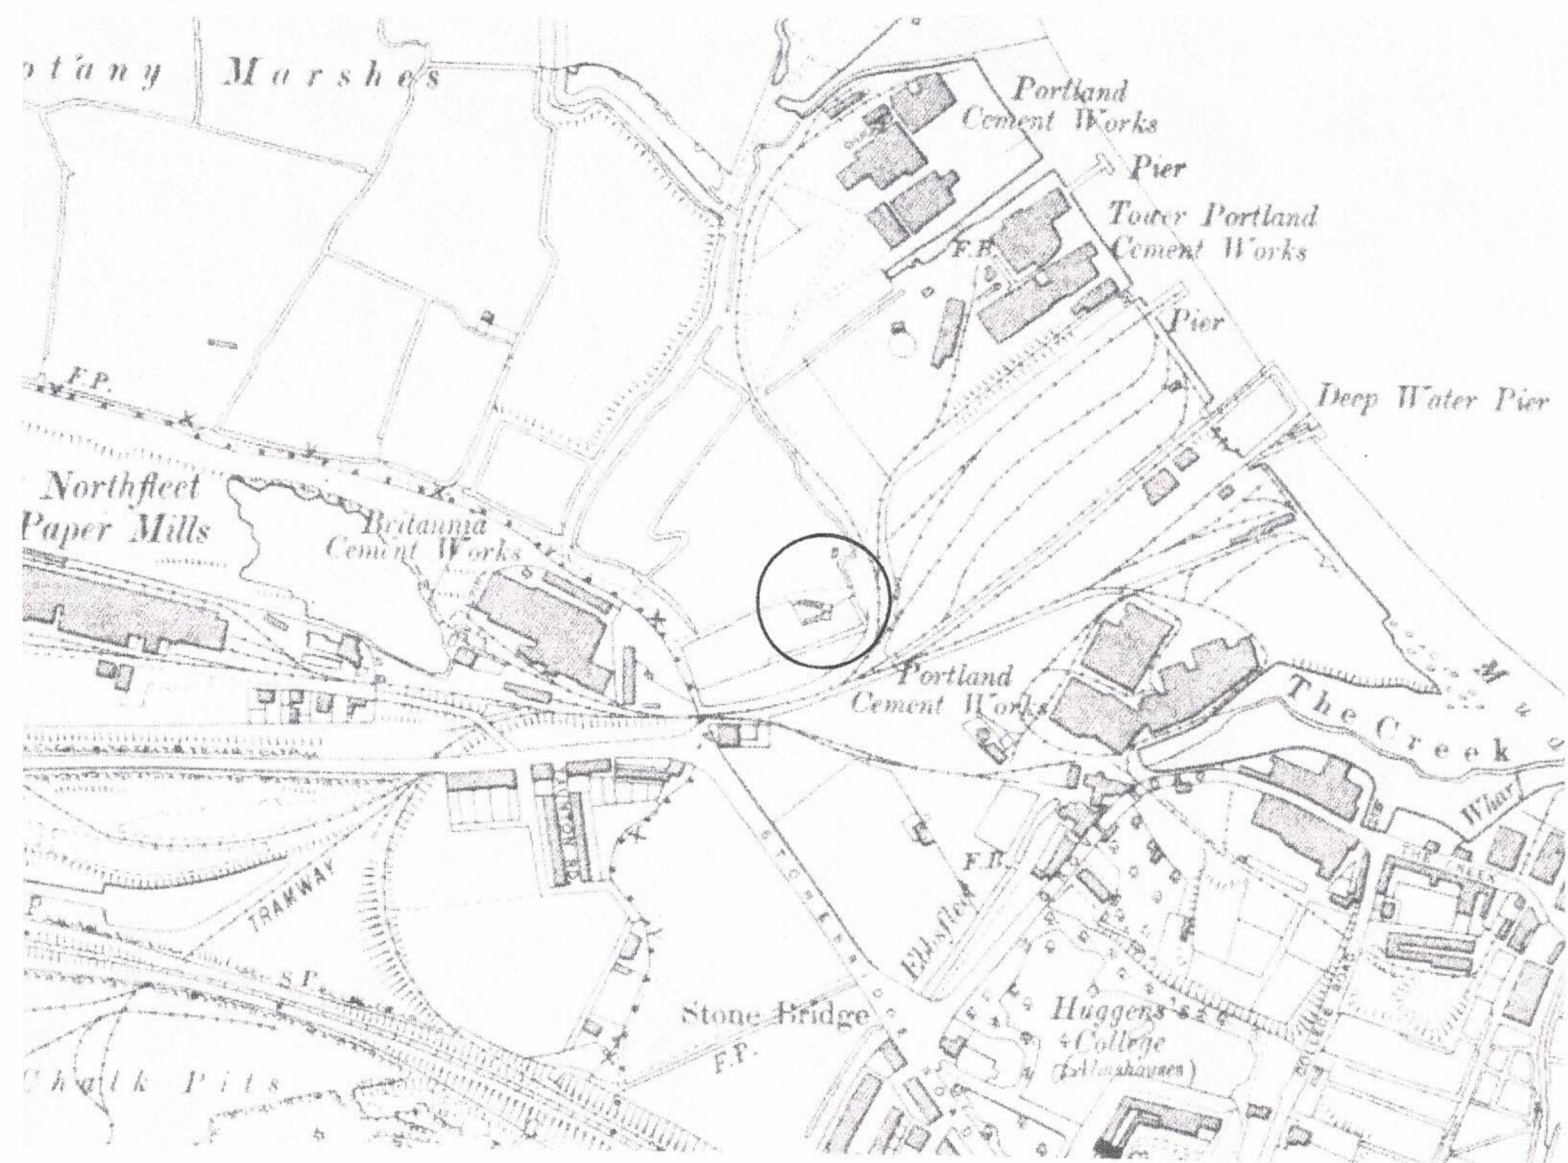
**OS map scale 1:2500 1910.**

**On site:** No significant change.

**Off site:** The windmill has been demolished, though the pair of adjacent buildings remain. The flooded quarry to the southwest has been infilled. Northfleet Paper Mills have been established within 300m to the west of the site.

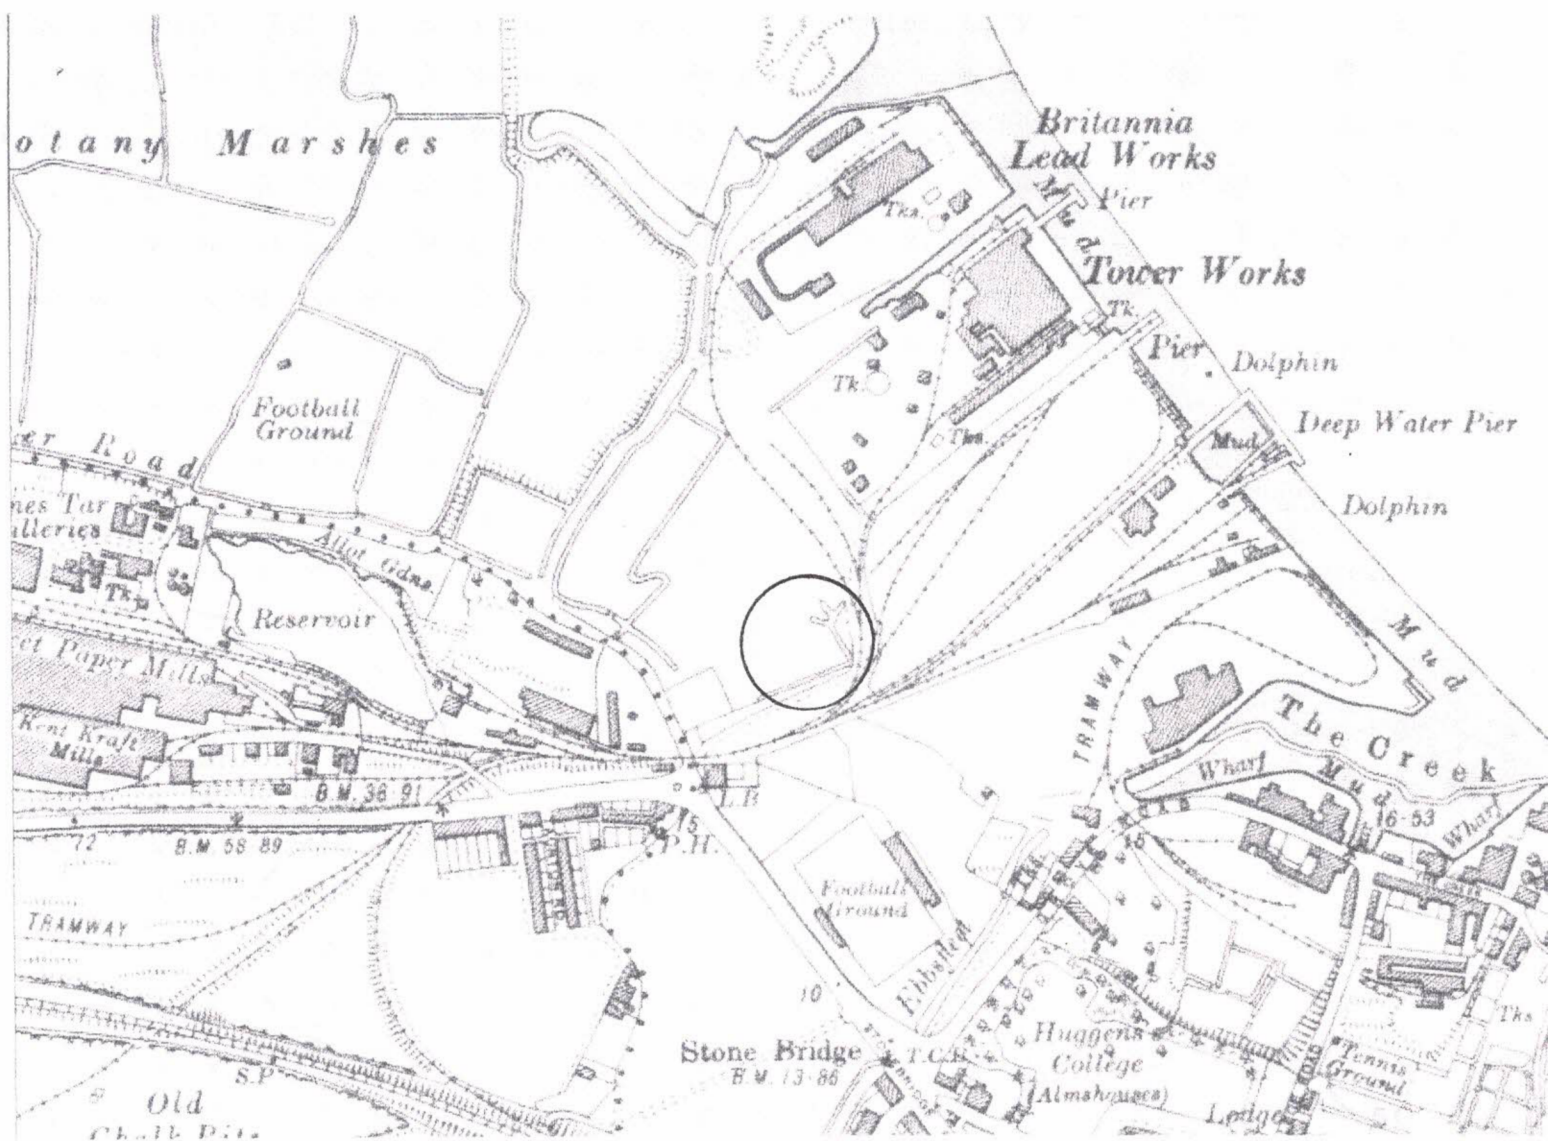
Unit K6 Lower Road, Northfleet.  
OS map scale 1:2500 1934.

**On site:** No significant change.

**Off site:** The quarry to the west is now referred to as a reservoir. The Britannia Lead Works are denoted within 400m to the northeast of the site.

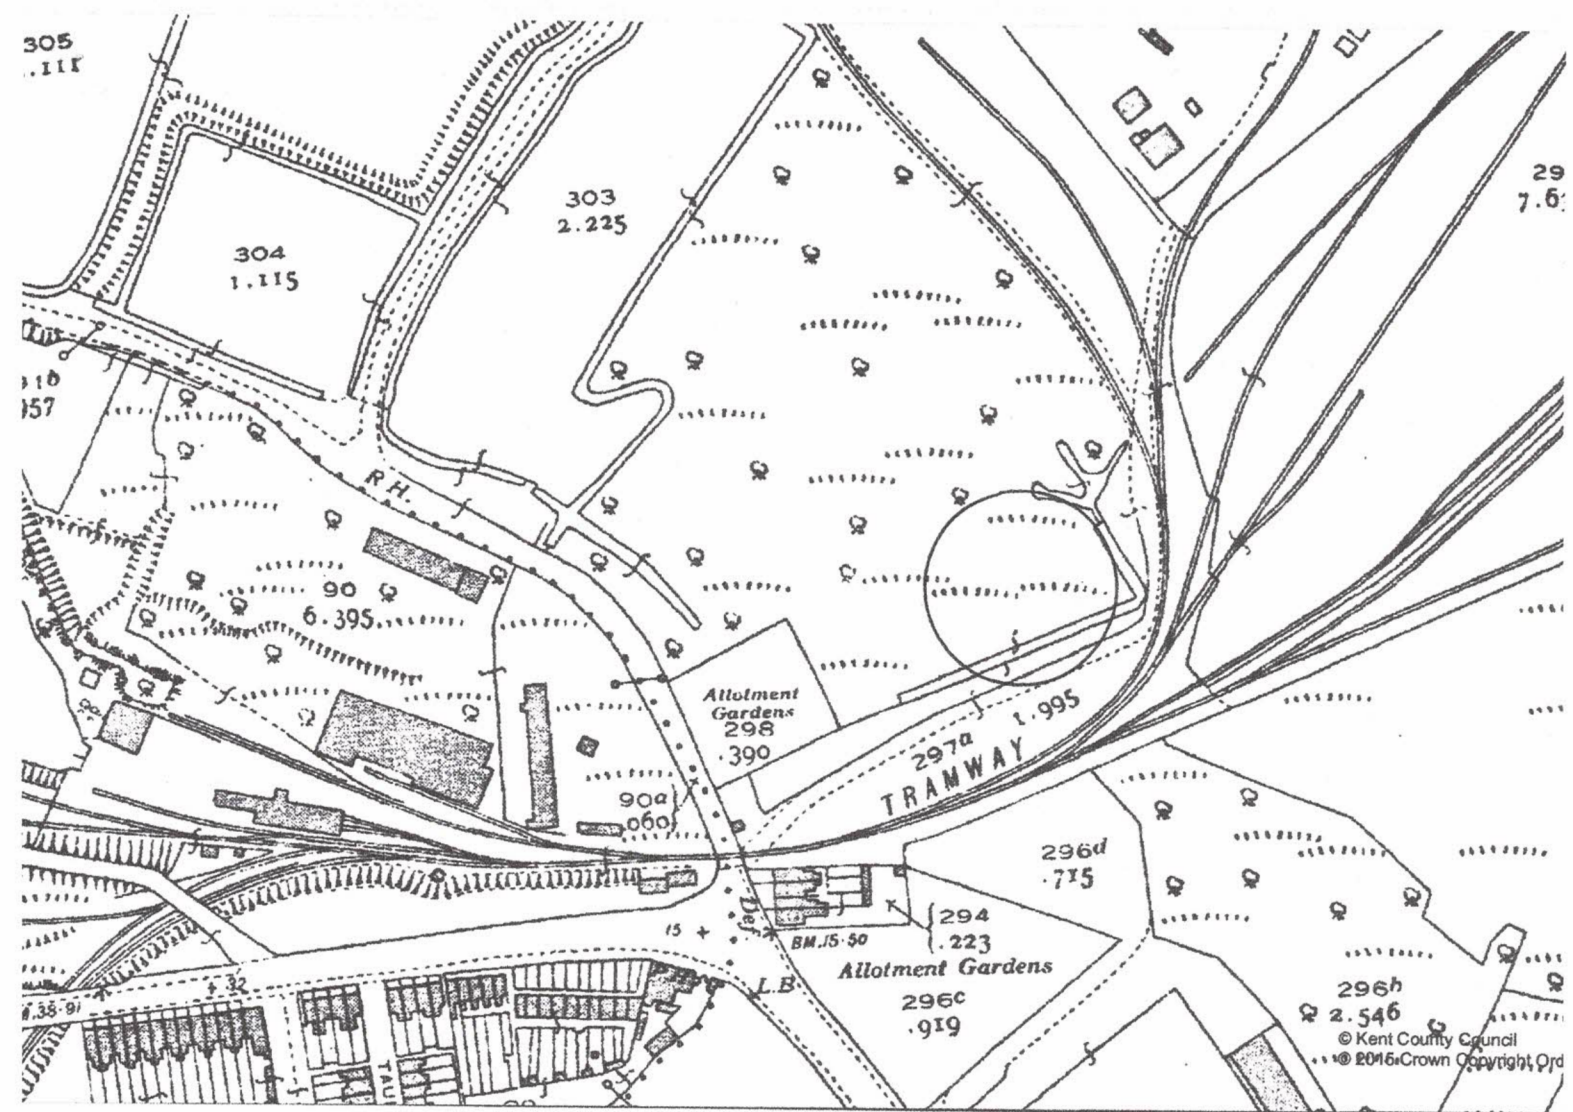
**Unit K6 Lower Road, Northfleet.**  
**OS map scale 1:2500 1929-1952.**

**On site:** No significant change.

**Off site:** Allotment gardens are denoted within 25m to the west of the site.

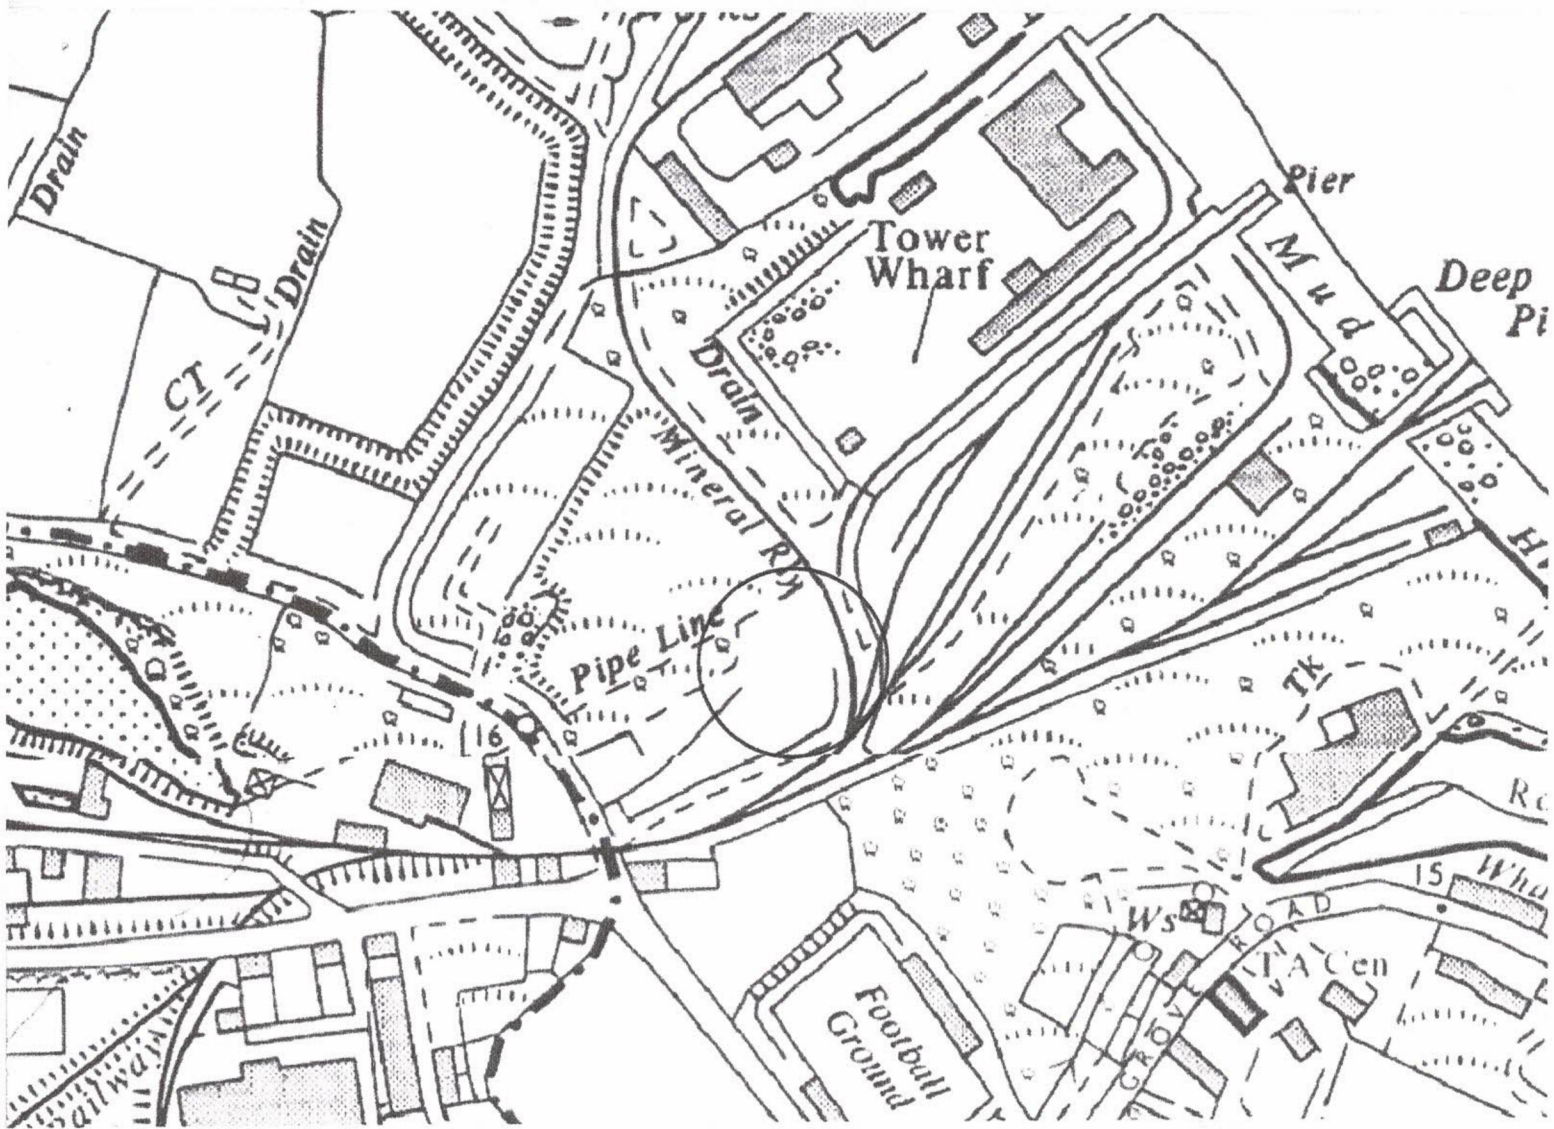
Unit K6 Lower Road, Northfleet.  
OS map scale 1:10560 1961-1962.

**On site:** The drainage ditch is no longer in evidence on the site.

**Off site:** A pipeline passing roughly southwest to northeast has been installed within 25m to the north of the site and a football ground has been constructed within 150m to the south.

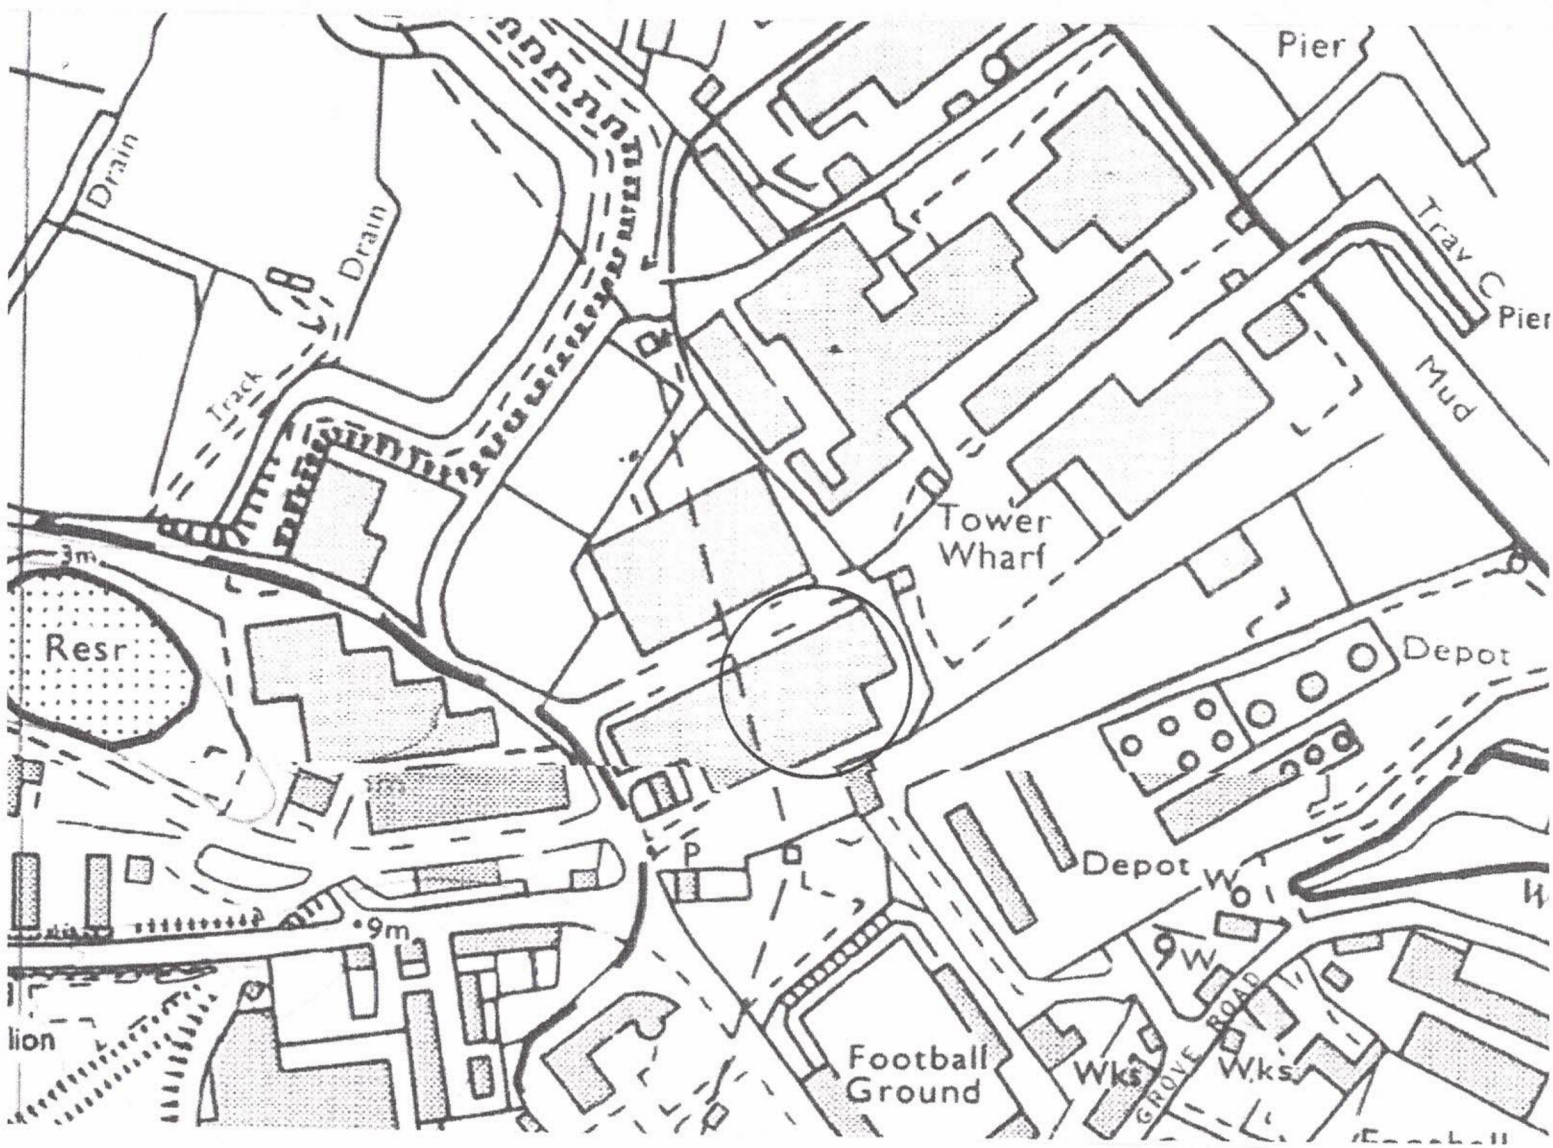
**Unit K6 Lower Road, Northfleet.**  
**OS map scale 1:10000 1991-1993.**

**On site:** A large building incorporating the existing unit is now present on the site, extending across the former allotments to the west.

**Off site:** The tramways have been removed and the surrounding area extensively developed with buildings of commercial appearance. Depots are denoted within 100m to the south and southeast. Works are also located within 200m to the southeast. The football ground remains to the south.
