Our Ref: PM/5291

**RE: NURSTEAD HALL, NURSTEAD LANE, LONGFIELD HILL**

The purpose of the visit was to inspect cracking over the boiler room external door opening as well as various cracks around the exterior of the property. We comment on each elevation as follows;

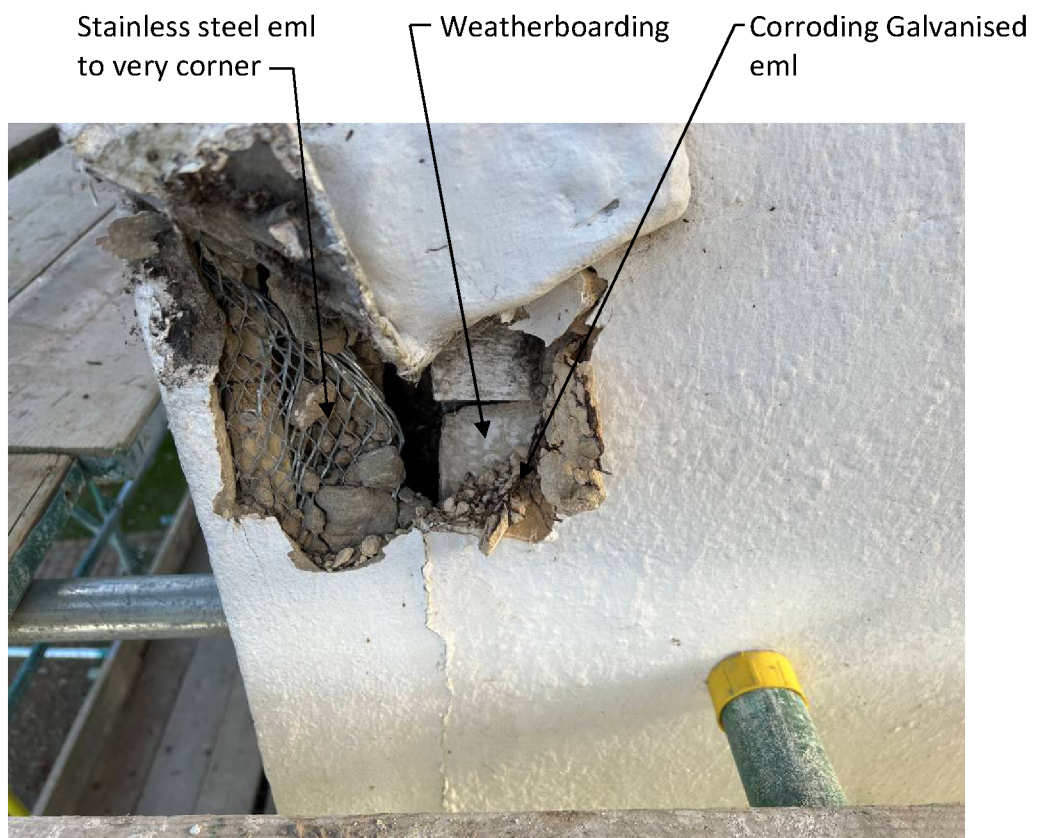
A vertical hairline crack is evident to the corner with the north elevation as well as hairline cracks elsewhere. A small inspection hole was formed which revealed timber weatherboarding directly beneath the external render finish (see plate 1 at the rear of this report). The render finish incorporated eml, which was generally found to be corroding except for the very corners where stainless steel was used. The weatherboarding was showing signs of decay.

Rendering on timber weatherboarding is extremely poor construction and will lead to numerous future problems including cracking, which is clearly evident in this case. We are therefore of the opinion that the render and weatherboarding should be removed and replaced with either new weatherboarding or re-rendered on a suitable render board.

Plate 1 – Opening up to West Elevation to Corner with South Elevation

Once the finishes are removed, an inspection should be made of the main oak framework behind to determine its condition and reinforced/strengthened as necessary.

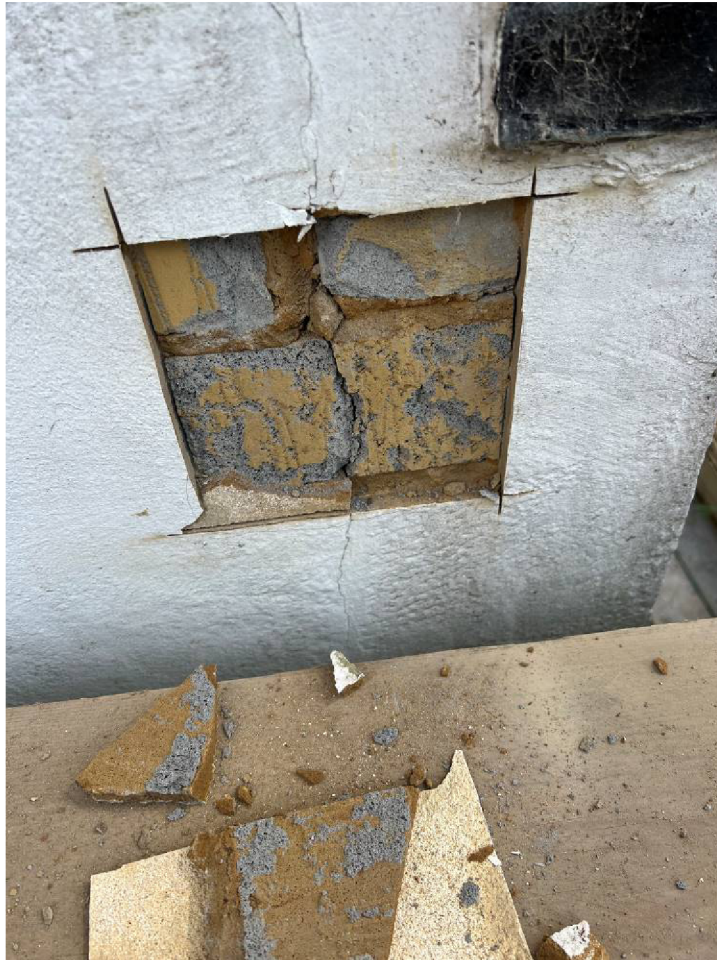
This extension also comprises a render finish which again shows various hairline cracks. A small inspection hole was formed which revealed lightweight thermalite type blocks directly beneath the render (see plate 2). These thermalite blocks offer a poor substrate to render to as they absorb a high amount of moisture from the render when it is being applied which often leads to cracking. These blocks are also very prone to thermal shrinkage that results in hairline vertical cracking through the blocks (and direct applied finishes).

Plate 2 – Cracking to Render and Through Thermalite Blocks

The vertical cracking would have caused the blocks to have lost some of their integrity, so we would recommend that the cracks are strengthened using heli-bars at 450mm vertical centres, extending 500mm beyond the cracks. However, due to the inherent poor quality of the blocks, it is very difficult to prevent future cracking from occurring elsewhere within the wall. As a result, we would recommend that, following installation of the heli-bars, the wall is battened and counter-battened to receive a render board and re-rendered to suit. Due to the eccentric load with this arrangement, the wall will need to be checked to see if adequate wall ties are present, with allowance being made for possible new remedial wall ties. Alternatively to the render finish, the wall may be able to be weatherboarded after the heli-bars are installed. In both cases, the render should be left in place as it enhances the integrity of the wall.

However, should the client accept these cracks and appreciate that ad-hoc future filling and painting will be required to these elevations, then the heli-bars and re-rendering works may not be strictly necessary at this stage to these more modern walls. Should this approach be taken, then the wall should be monitored for future movement.

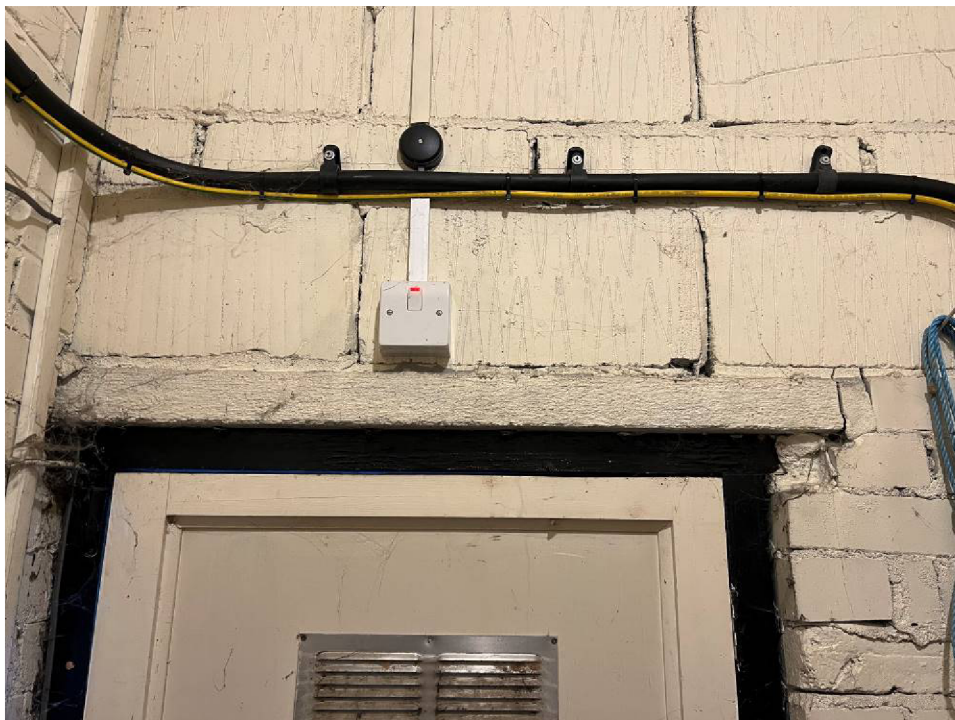
Cracking is evident above and around the boiler room door. The wall contains no finishes internally so the existing lintel and blockwork can be seen. A 65mm deep PC lintel is present, although this does not have sufficient bearings (see plate 3). Cracking is present over and to the side of the opening, and this is considered to be a combination of lintel deflection and thermal shrinkage of the blockwork.

Plate 3 – Poor Lintel Bearing to Boiler Room Door

We are therefore of the opinion that this lintel should be replaced with a more substantial concrete lintel with additional bearings and local strengthening at the bearing.
