CASCADES LEISURE CENTRE  
7313-FUR-XX-XX-RP-0001  
STRUCTURAL SURVEY  
NOVEMBER 2022

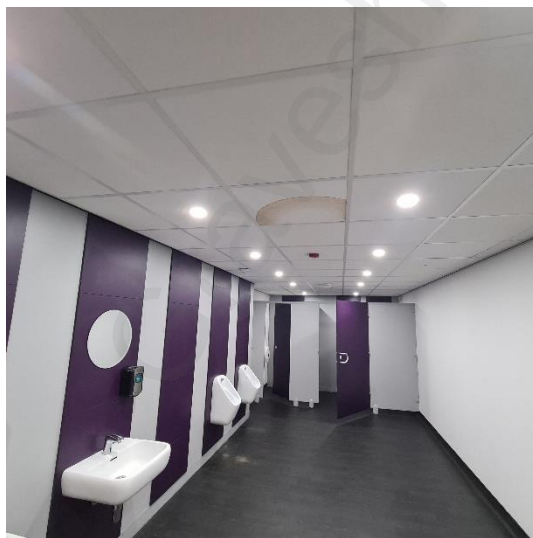
- 3.1.6 The nature and condition of the roof covering are unknown but there is evidence of historic water damage to ceilings and soffits which may have been caused by water ingress due to damaged or failed waterproofing on the flat roof.

Figure 14: Evidence of water damage to dry change ceiling

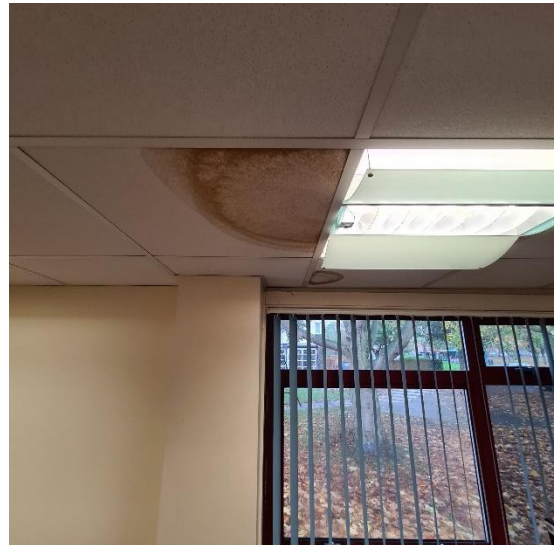
Figure 15: Evidence of water damage to office ceiling

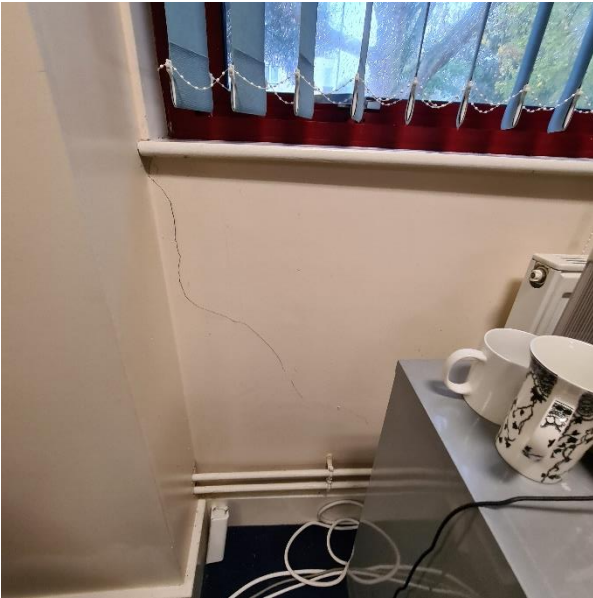
Figure 16: Cracking to internal plaster finish of office external wall

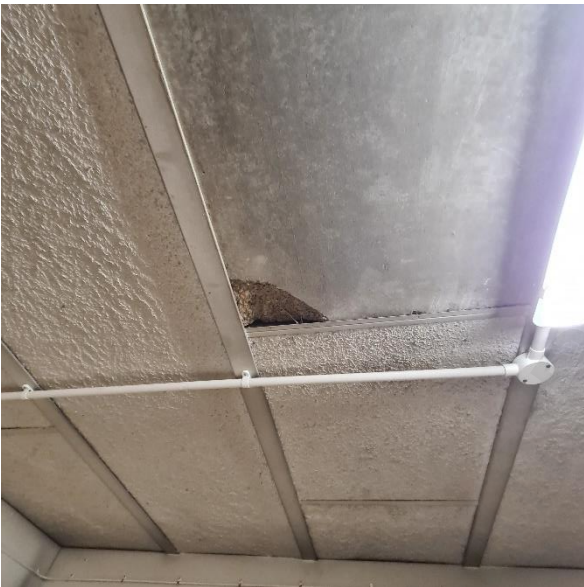
- 3.1.6 Some instances of localised damage were observed to the exposed rib and board soffit in the sports changing rooms. These include cracking and spalling of the soffit board, and rust staining to surface of ribs.

Figure 18: Damage to exposed wood fibre soffit to sports changing rooms (1)

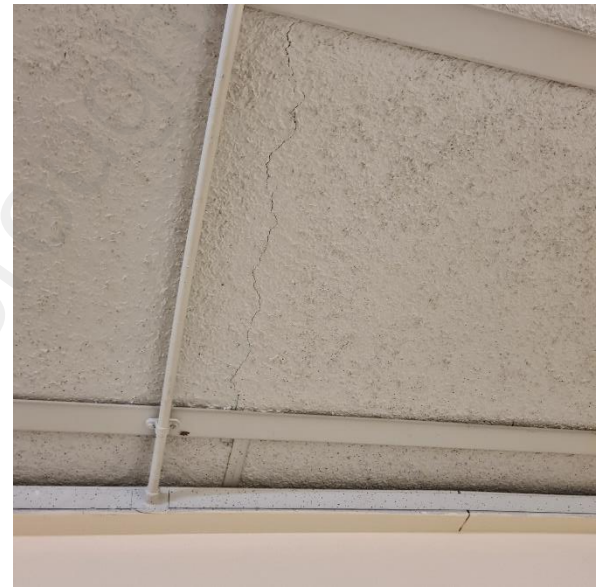
Figure 19: Damage to exposed wood fibre soffit to sports changing rooms (2)

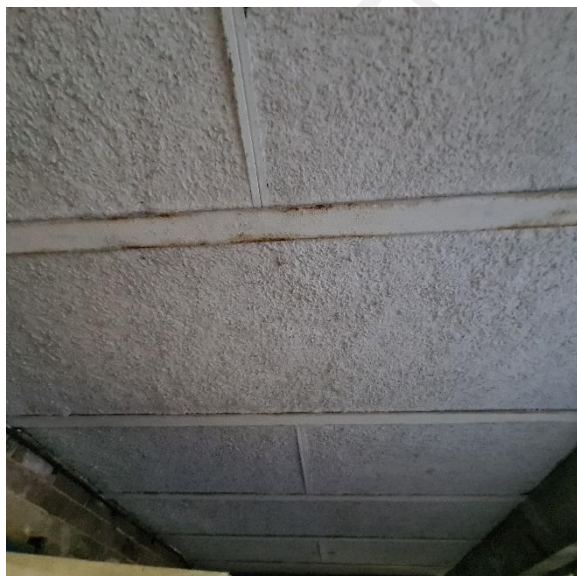
Figure 20: Corrosion to steel rib of sports changing room roof slab soffit

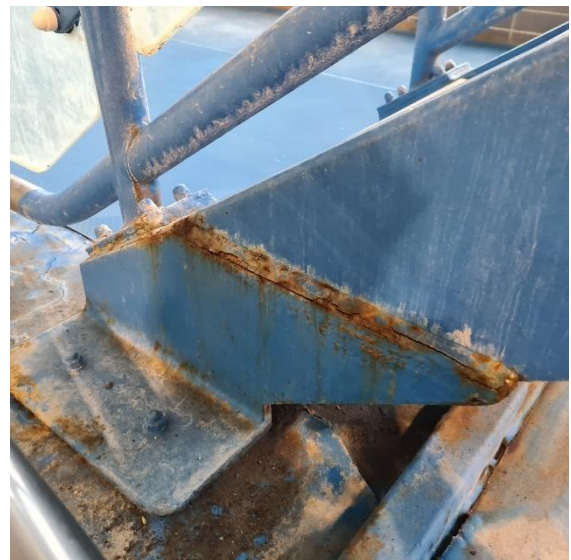
- 4.1.3 The observed structural defects are most notably the corrosion of steelwork and reinforced concrete in areas exposed to a highly corrosive pool environment. This includes the flume stair tower steelwork and reinforced concrete undercroft base slab which will require remediation for prolongation of serviceable design life.

Figure 45: Corroded flume tower steelwork (1)

- 4.2.2 Methodology for treatment and repair of corroded steelwork including flume stair tower steelwork is as follows;
- Mechanical cleaning of existing steelwork back to bare metal.

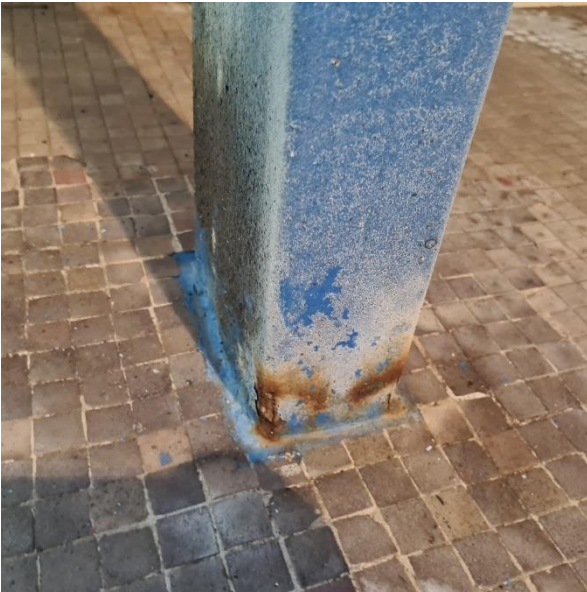
Figure 46: Corroded flume tower steelwork (2)

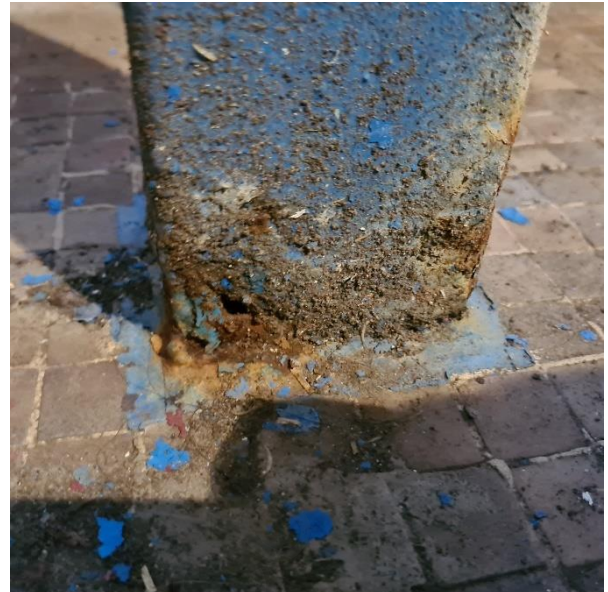
Figure 47: Corroded flume tower steelwork (3)

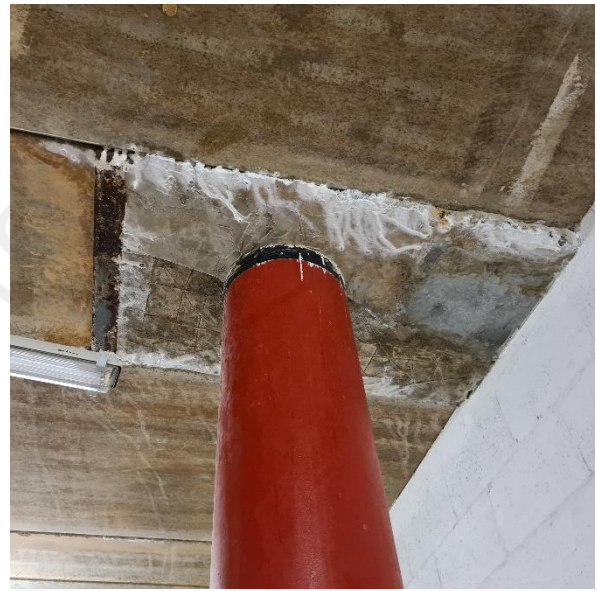
- 3.5.1(6) The pool store room, in which the exposed CHS column is located, comprises of a precast concrete capping slab supported by load-bearing concrete blockwork. Steel trimming and insitu concrete infill is present where the CHS column passes through the concrete capping slab. The infill concrete is in poor condition with extensive surface staining and the trimming steelwork has significant surface corrosion.

Figure 49: Corrosion to capping structure to pool store

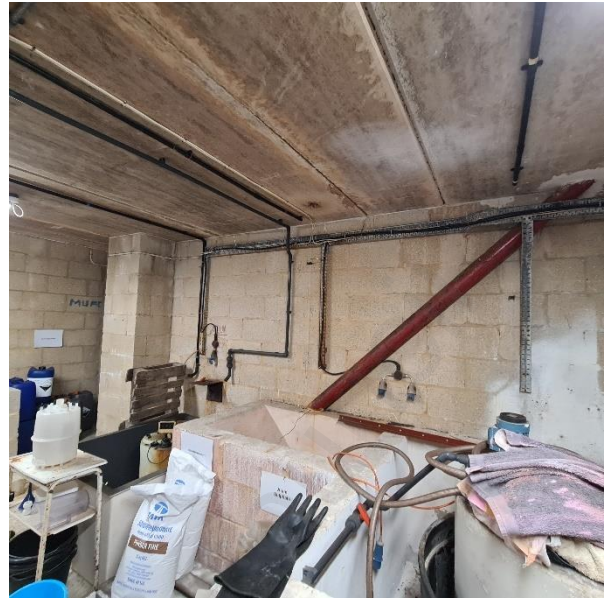
- 3.5.2(5) The exposed elements of the steel superstructure were typically observed to be in good condition with exception of some surface corrosion to structural steelwork, most notably the vertical bracing in the chemical store. It is noted that close inspection was not possible due to restricted access.

Figure 53: Corrosion to steel bracing in chemical store room

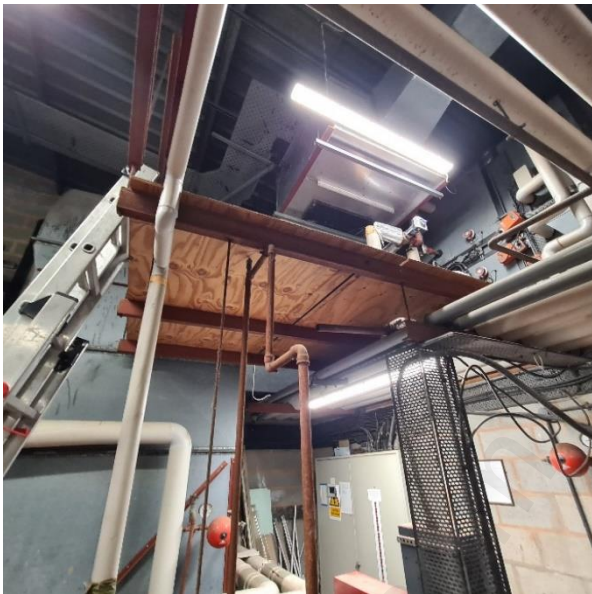
- 3.5.2(6) There are a variety of secondary structural elements within the plant room for support of plant, access platforms and cappings. Some of the secondary structural elements were found to be in poor condition with significant extensive surface corrosion, although these are outside of the scope of this survey.

Figure 54: Corroded secondary steelwork in pool plant room

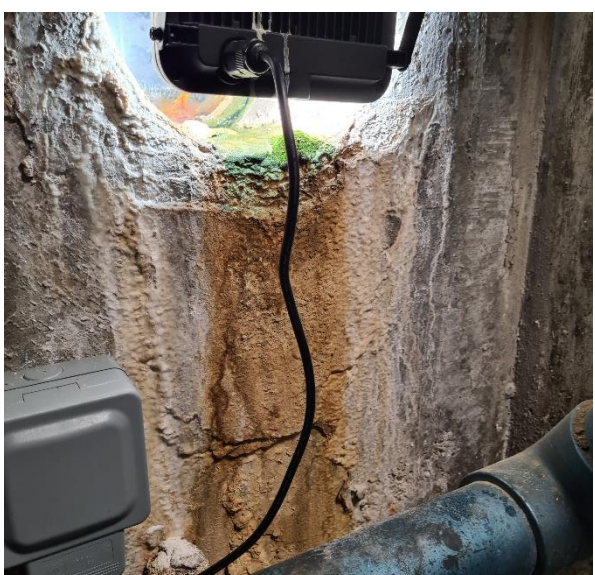
- 3.5.2(8) The undercroft provides access to the rear face of the pool tank wall which is constructed from reinforced concrete. The pool tank walls were found to be in sound condition but with some localised defects associated with poor workmanship and pool water ingress. Such defects were commonly observed in the vicinity of pool lights with evidence of historic pool water ingress and resulting degradation of concrete surface.

Figure 57: Damage to pool tank concrete due to water ingress through pool lights

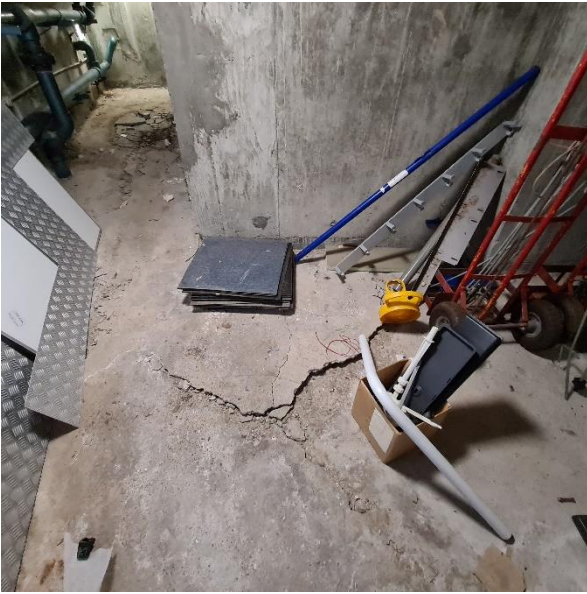
- 3.5.2(9) The undercroft base slab was found to be in very poor condition with extensive spalling and cracking of the concrete surface. Where exposed the steel reinforcement was found to be in very poor condition with severe corrosion and section loss. This is thought to have been caused by prolonged exposure to water and highly corrosive environment. During the inspection water ponding was observed adjacent to the pool tank wall beneath pool pumps/pipework. The cause of the water ingress is thought to be associated with faulty pipework.

Figure 58: Damaged undercroft concrete base slab (1)

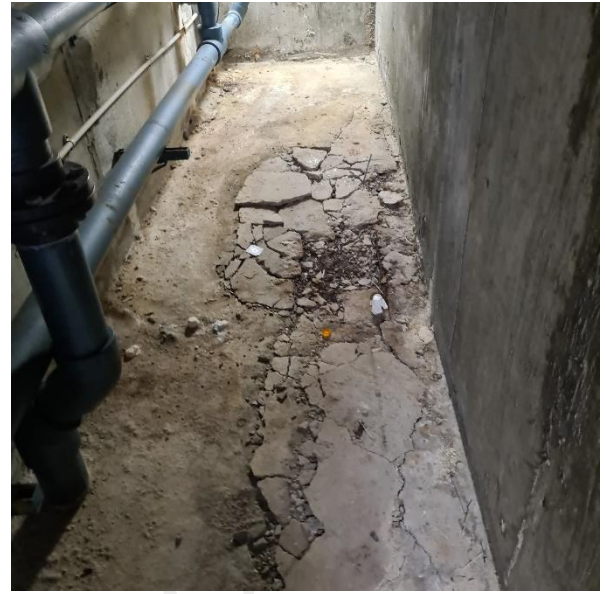
Figure 59: Damaged undercroft concrete base slab (2)

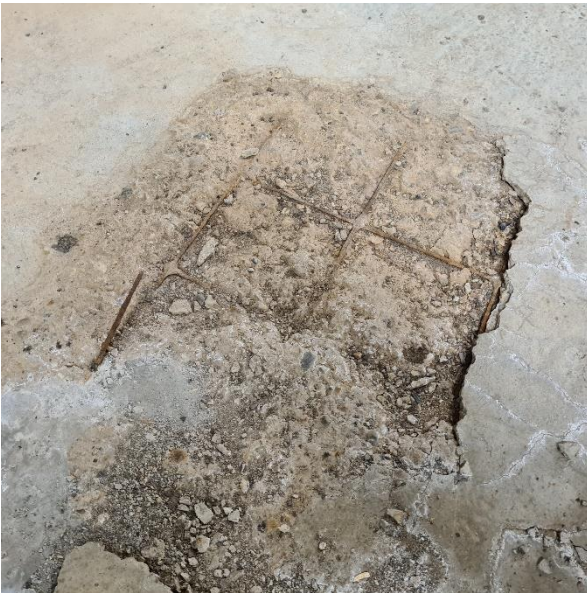
Figure 60: Damaged undercroft concrete base slab (3)

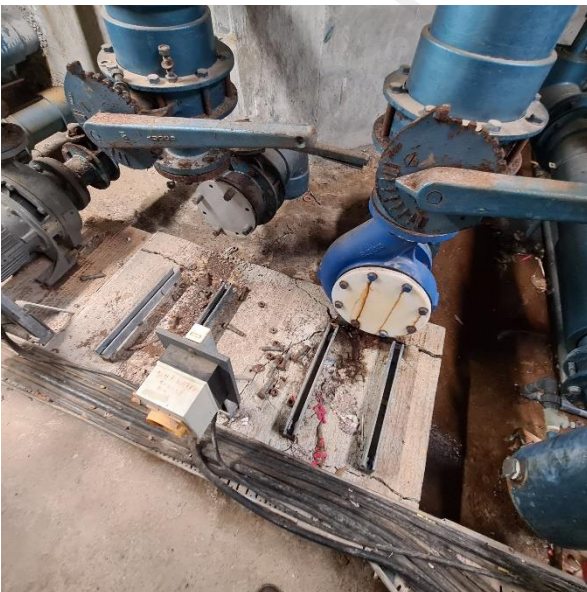
- 3.5.2(10) Concrete plinths for support of decommissioned plant were observed to be in very poor condition with extensive cracking thought to have been caused by corrosion of cast-in or encased steelwork.

Figure 62: Undercroft damaged concrete plinths

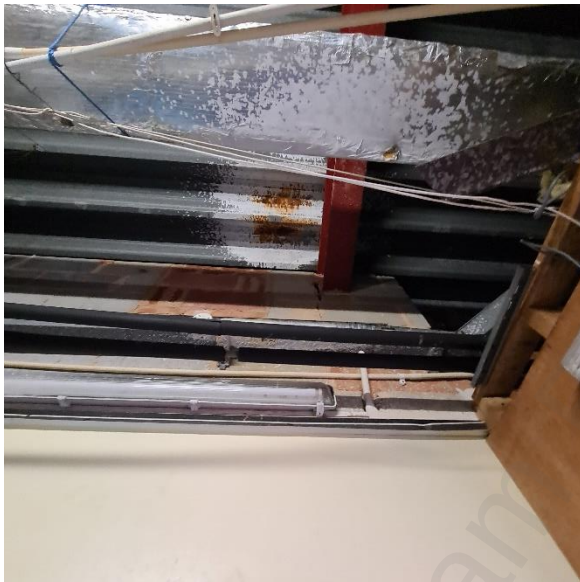
- 3.5.3(3) The inspected areas of roof structure were generally observed to be in good condition with exception of some localised corrosion to the roof deck in store rooms adjacent to the sauna at first floor level.

Figure 66: Corroded steelwork adjacent to first floor spa

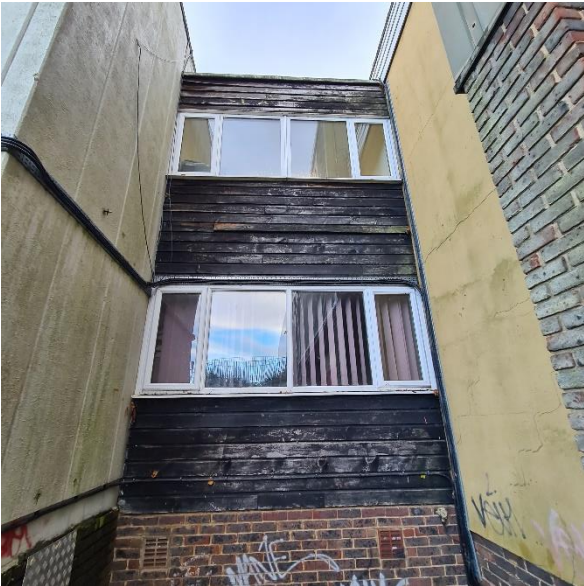
- 3.1.12 The external wall elevations of this block were largely inaccessible but external wall construction is thought to be cavity wall construction comprising of internal masonry and outer skin of rendered masonry with areas of timber panelling. The inspected areas of external elevations were found to be in poor condition with cracking to external render and loose timber panelling.

Figure 75: East elevation of squash courts with cracked render and damaged timber

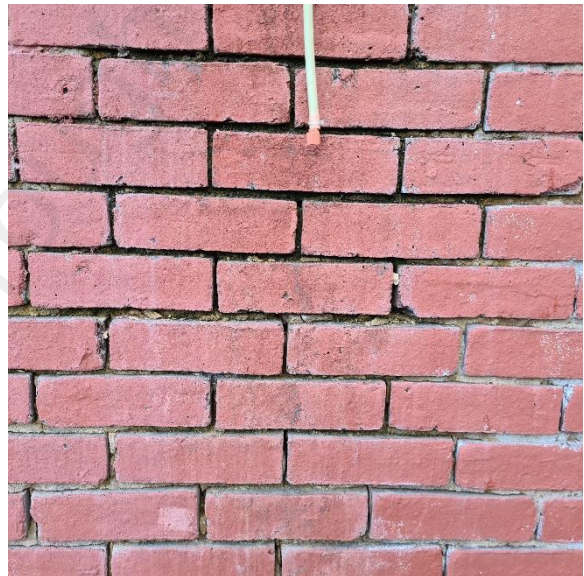
Figure 78: Mortar bed joint loss to squash court external brickwork (1)

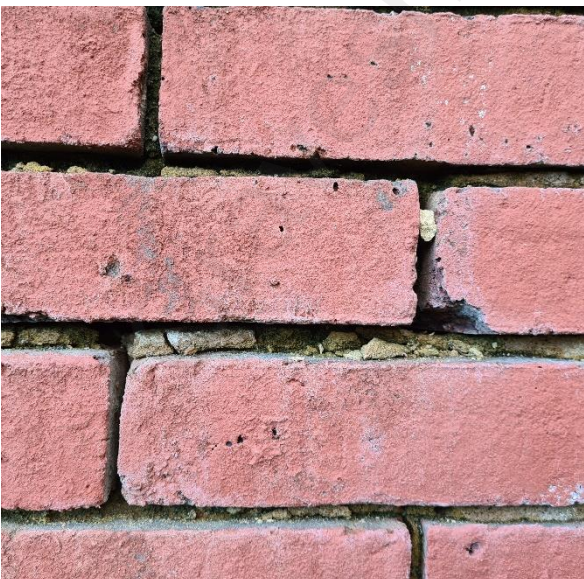
Figure 79: Mortar bed joint loss to squash court external brickwork (2)

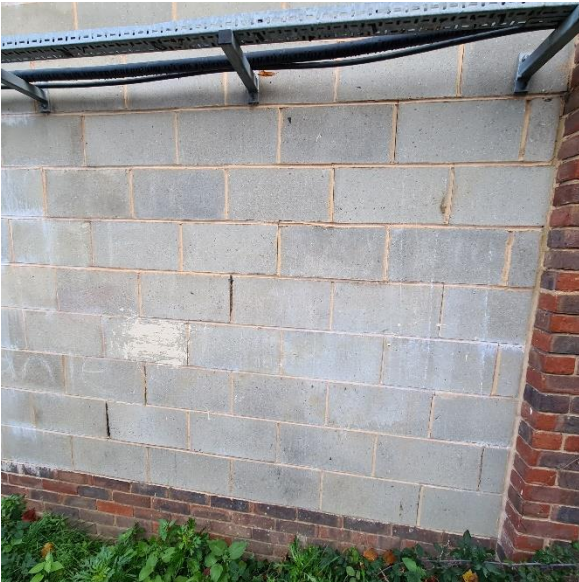
*Figure 81: Damaged blockwork to west elevation of pool hall and plant room*
