### **Refurbishment Survey (with MA only)**

The Old Forge  
Wrotham Road  
Meopham  
DA13 0JE

**KD Drainage and Asbestos Ltd**  
**Matts Hill Farm**  
**Matts Hill Road**  
**Hartlip**  
**Sittingbourne**  
**Kent**  
**ME9 7UY**

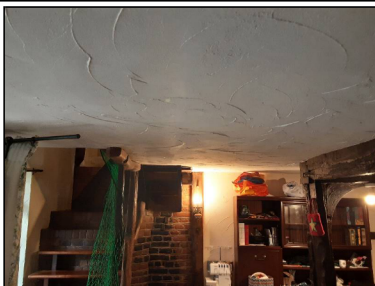
| | 27 Sep 2023 | Daniel Smith | Refurbishment Survey | Ground Floor | No Asbestos Detected |
| Surveyor comments | N/A | | | | |

| Recommended action | No further action required | | | | |

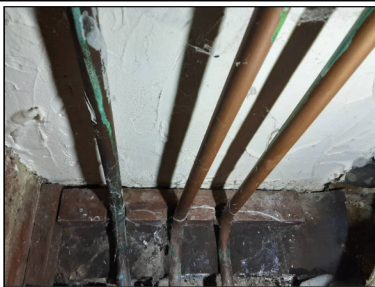
| | 27 Sep 2023 | Daniel Smith | Refurbishment Survey | Ground Floor | No Asbestos Detected |

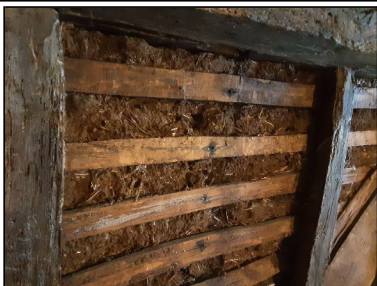
| | 27 Sep 2023 | Daniel Smith | Refurbishment Survey | Ground Floor | No Asbestos Detected |
| Surveyor comments | N/A | | | | |

| Recommended action | No further action required | | | | |

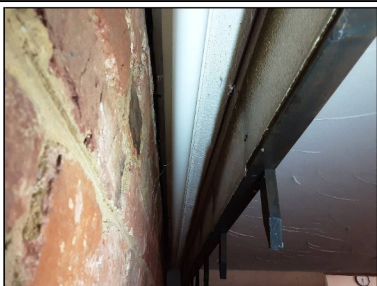
| | Survey Date: | Lead Surveyor | Survey Type | Floor | Analysis |
|---|---|---|---|---|---|
| | 27 Sep 2023 | Daniel Smith | Refurbishment Survey | Ground Floor | Chrysotile (1) |

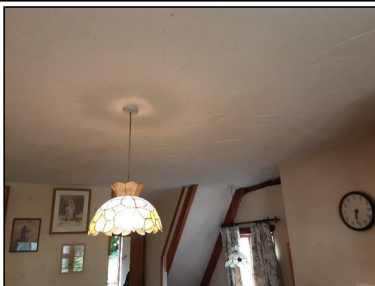
| | 27 Sep 2023 | Daniel Smith | Refurbishment Survey | Ground Floor | No Asbestos Detected |
| Surveyor comments | N/A | | | | |

| Recommended action | No further action required | | | | |

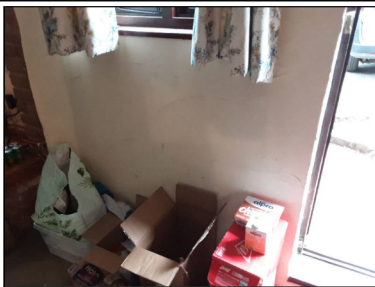
| | 27 Sep 2023 | Daniel Smith | Refurbishment Survey | Ground Floor | Chrysotile (1) |

| Surveyor comments | This textured coating is concealed throught the living room. | | | | |

| Recommended action | Removal | | | | |

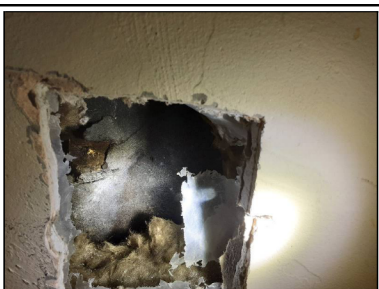
| | 27 Sep 2023 | Daniel Smith | Refurbishment Survey | Ground Floor | No Asbestos Detected |

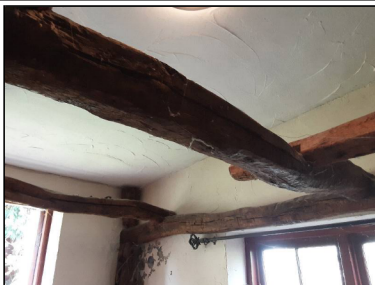
| | 27 Sep 2023 | Daniel Smith | Refurbishment Survey | Ground Floor | No Asbestos Detected |
| Surveyor comments | N/A | | | | |

| Recommended action | No further action required | | | | |

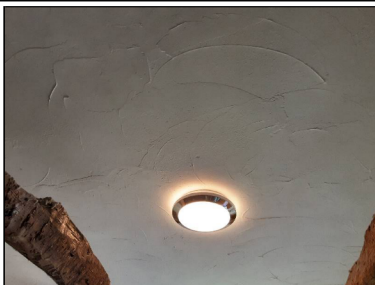
| | 27 Sep 2023 | Daniel Smith | Refurbishment Survey | Ground Floor | Chrysotile (1) |

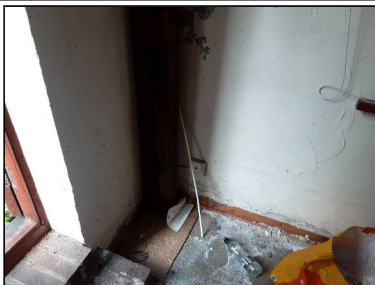
| | 27 Sep 2023 | Daniel Smith | Refurbishment Survey | Ground Floor | No Asbestos Detected |
| Surveyor comments | N/A | | | | |

| Recommended action | No further action required | | | | |

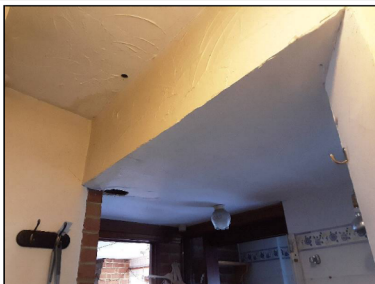
| | 27 Sep 2023 | Daniel Smith | Refurbishment Survey | Ground Floor | No Asbestos Detected |

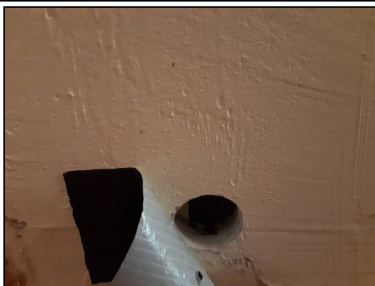
| | 27 Sep 2023 | Daniel Smith | Refurbishment Survey | Ground Floor | N/A |
| Surveyor comments | No suspect materials noted in area inspected | | | | |

| Recommended action | No further action required | | | | |

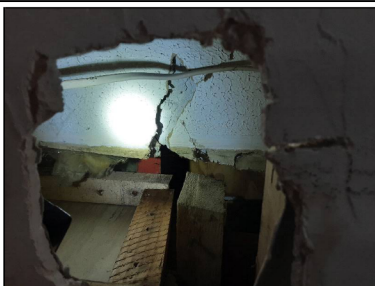
| | 27 Sep 2023 | Daniel Smith | Refurbishment Survey | Ground Floor | Chrysotile (1) |

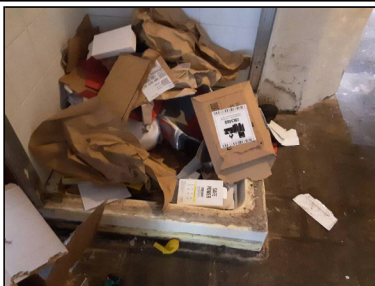
| | 27 Sep 2023 | Daniel Smith | Refurbishment Survey | Ground Floor | No Asbestos Detected |
| Surveyor comments | N/A | | | | |

| Recommended action | No further action required | | | | |

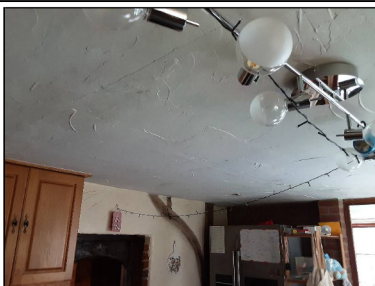
| | 27 Sep 2023 | Daniel Smith | Refurbishment Survey | Ground Floor | No Asbestos Detected |

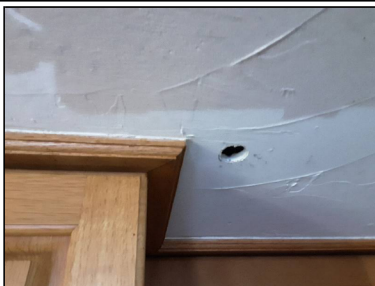
| | 27 Sep 2023 | Daniel Smith | Refurbishment Survey | Ground Floor | Chrysotile (1) |
| Surveyor comments | This textured coating is concealed through the living room. | | | | |

| Recommended action | Removal | | | | |

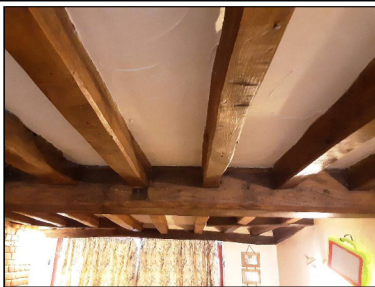
| | 27 Sep 2023 | Daniel Smith | Refurbishment Survey | Ground Floor | No Asbestos Detected |

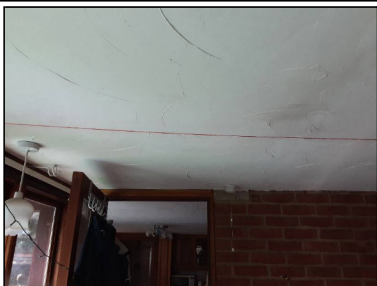
| | 27 Sep 2023 | Daniel Smith | Refurbishment Survey | Ground Floor | Chrysotile (1) |
| Surveyor comments | This textured coating is concealed throught the living room. | | | | |

| Recommended action | Removal | | | | |

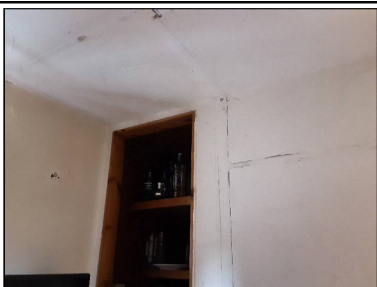
| | 27 Sep 2023 | Daniel Smith | Refurbishment Survey | 1st Floor | No Asbestos Detected |

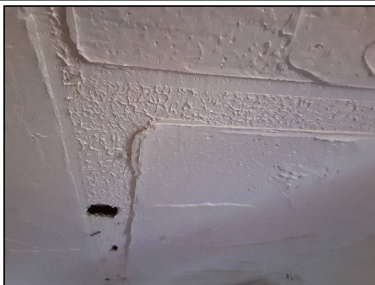
| | 27 Sep 2023 | Daniel Smith | Refurbishment Survey | 1st Floor | Chrysotile (1) |
| Surveyor comments | N/A | | | | |

| Recommended action | Removal | | | | |

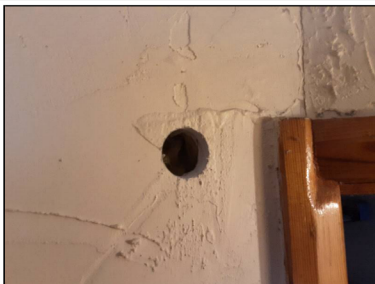
| | 27 Sep 2023 | Daniel Smith | Refurbishment Survey | 1st Floor | N/A |

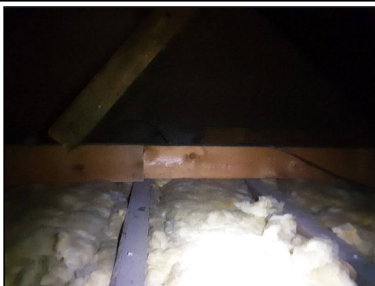
| | 27 Sep 2023 | Daniel Smith | Refurbishment Survey | Roof Void | N/A |
| Surveyor comments | No suspect materials noted | | | | |

| Recommended action | No further action required | | | | |

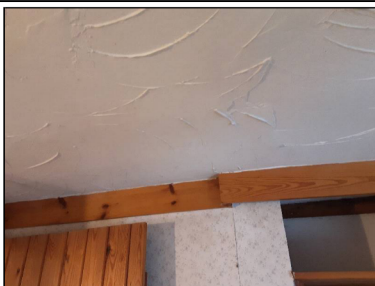
| | 27 Sep 2023 | Daniel Smith | Refurbishment Survey | 1st Floor | No Asbestos Detected |

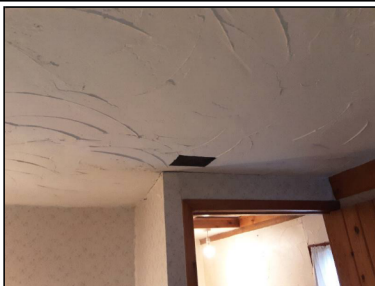
| | 27 Sep 2023 | Daniel Smith | Refurbishment Survey | 1st Floor | Chrysotile (1) |
| Surveyor comments | N/A | | | | |

| Recommended action | Removal | | | | |

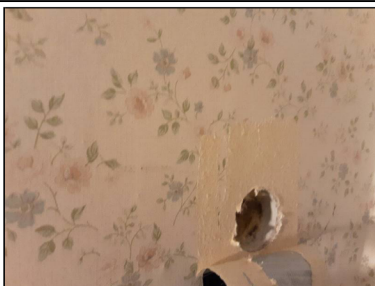
| | 27 Sep 2023 | Daniel Smith | Refurbishment Survey | 1st Floor | N/A |

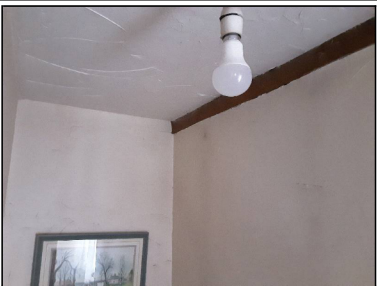
| | 27 Sep 2023 | Daniel Smith | Refurbishment Survey | 1st Floor | No Asbestos Detected |
| <b>Surveyor comments</b> | N/A | | | | |

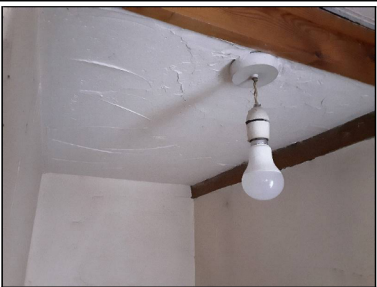
| | 27 Sep 2023 | Daniel Smith | Refurbishment Survey | 1st Floor | Chrysotile (1) |

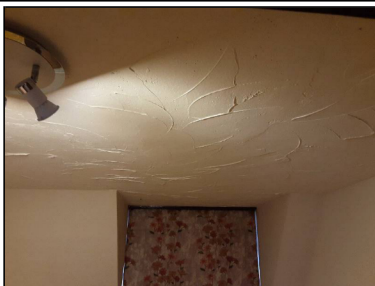
| | 27 Sep 2023 | Daniel Smith | Refurbishment Survey | 1st Floor | No Asbestos Detected |
| Surveyor comments | N/A | | | | |

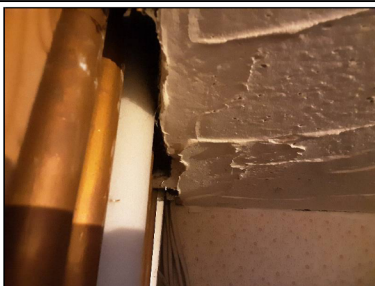
| | 27 Sep 2023 | Daniel Smith | Refurbishment Survey | 1st Floor | Chrysotile (1) |

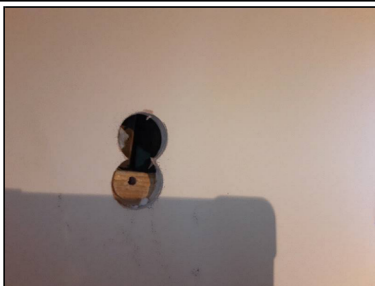
| | 27 Sep 2023 | Daniel Smith | Refurbishment Survey | 1st Floor | N/A |
| Surveyor comments | No suspect materials noted in area inspected | | | | |

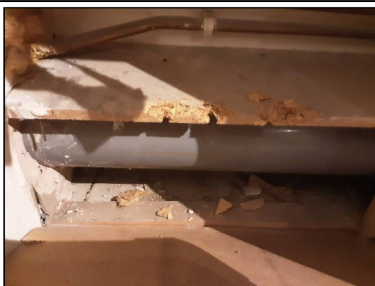
| | 27 Sep 2023 | Daniel Smith | Refurbishment Survey | 1st Floor | N/A |

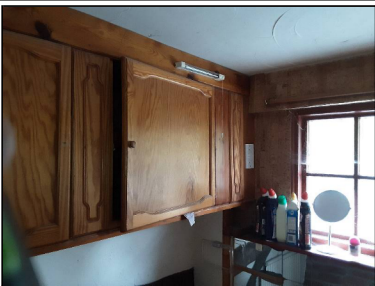
| | 27 Sep 2023 | Daniel Smith | Refurbishment Survey | 1st Floor | No Asbestos Detected |

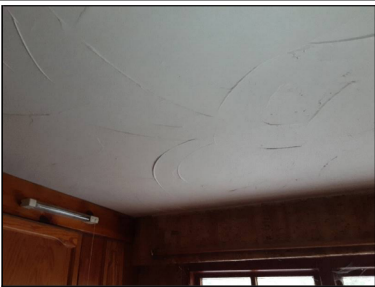
| | 27 Sep 2023 | Daniel Smith | Refurbishment Survey | 1st Floor | Chrysotile (1) |

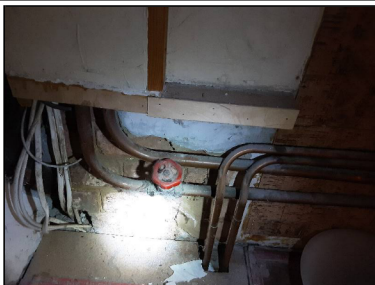
| | 27 Sep 2023 | Daniel Smith | Refurbishment Survey | 1st Floor | No Asbestos Detected |
| Surveyor comments | N/A | | | | |

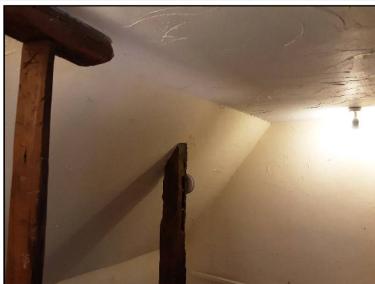
| | 27 Sep 2023 | Daniel Smith | Refurbishment Survey | 1st Floor | No Asbestos Detected |

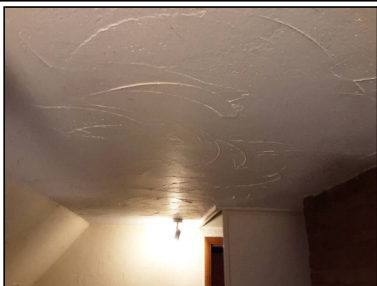
| | 27 Sep 2023 | Daniel Smith | Refurbishment Survey | 1st Floor | Chrysotile (1) |
| Surveyor comments | This textured coating is concealed throught the living room. | | | | |

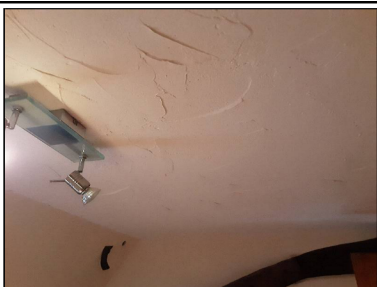
| | 27 Sep 2023 | Daniel Smith | Refurbishment Survey | 1st Floor | No Asbestos Detected |

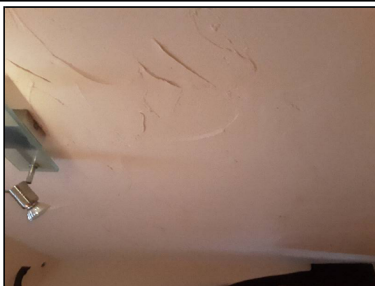
| | 27 Sep 2023 | Daniel Smith | Refurbishment Survey | 1st Floor | Chrysotile (1) |
| Surveyor comments | This textured coating is concealed throught the living room. | | | | |

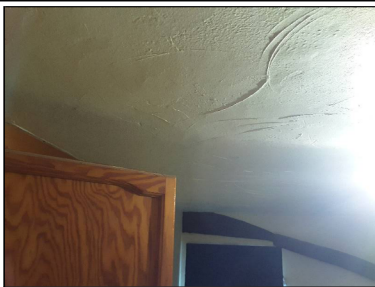
| | 27 Sep 2023 | Daniel Smith | Refurbishment Survey | 1st Floor | No Asbestos Detected |

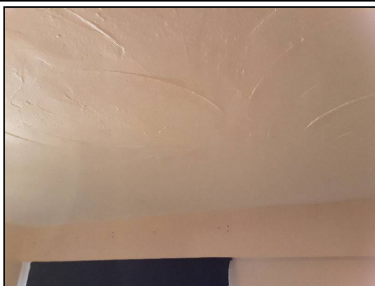
| | 27 Sep 2023 | Daniel Smith | Refurbishment Survey | 1st Floor | Chrysotile (1) |
| Surveyor comments | This textured coating is concealed throught the living room. | | | | |

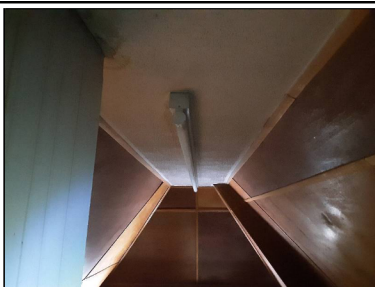
| | 27 Sep 2023 | Daniel Smith | Refurbishment Survey | Roof Void | Chrysotile (1) |

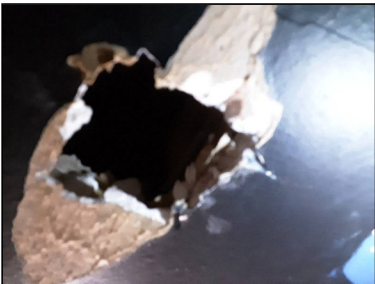
| | 27 Sep 2023 | Daniel Smith | Refurbishment Survey | Ground Floor | N/A |

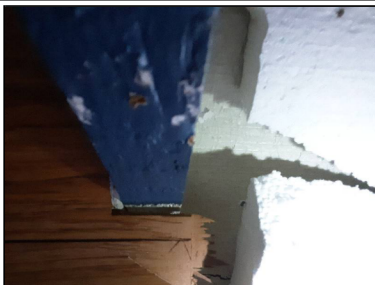
| | 27 Sep 2023 | Daniel Smith | Refurbishment Survey | 1st Floor | No Asbestos Detected |
| Surveyor comments | N/A | | | | |

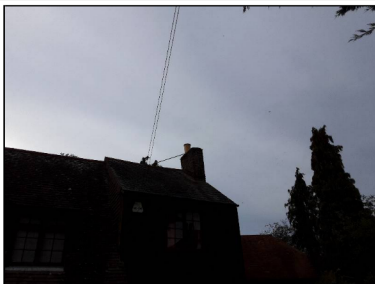
| | 27 Sep 2023 | Daniel Smith | Refurbishment Survey | External | No Asbestos Detected |

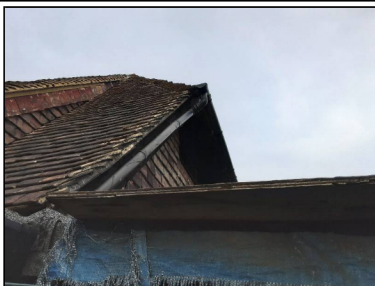
| | 27 Sep 2023 | Daniel Smith | Refurbishment Survey | External | Chrysotile (1) |
| Surveyor comments | N/A | | | | |

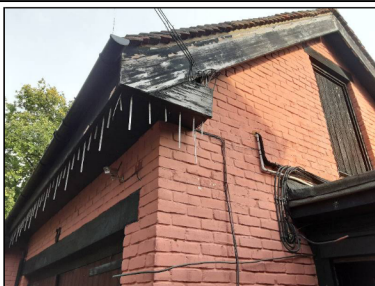
| | 27 Sep 2023 | Daniel Smith | Refurbishment Survey | External | Chrysotile + Amosite (2) |

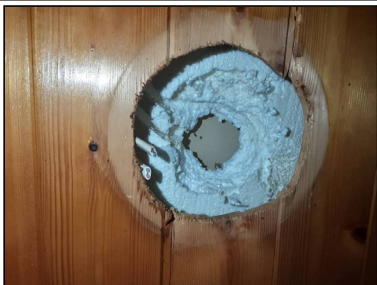
| | 27 Sep 2023 | Daniel Smith | Refurbishment Survey | Ground Floor | No Asbestos Detected |
