# Arboricultural Impact Assessment and Method Statement

Milton Place Car Park  
Gravesham  
Kent  
DA12 2PQ

**Date:** February 2025

**Reference:** TCTC-19152-B

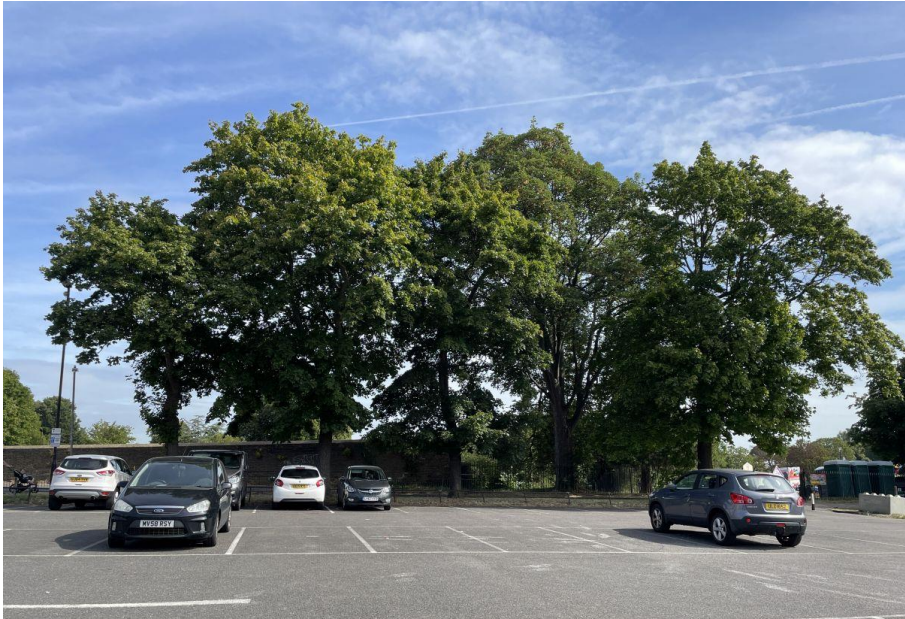
TC1. (14.08.24) looking north, T3-T7 retained along the northern boundary of the park

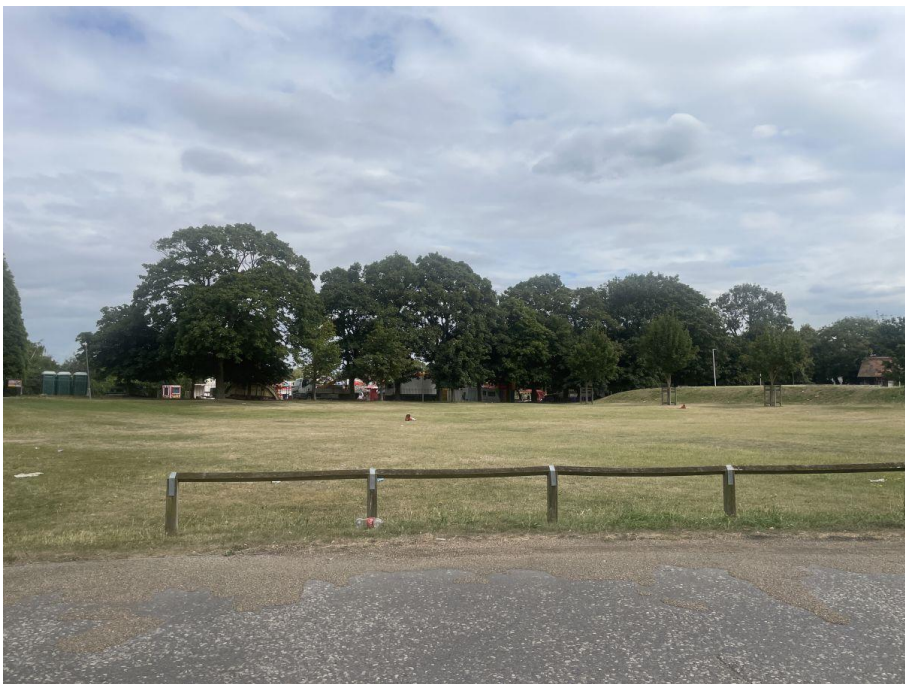
TC2. (14.08.24) looking northeast, T9-T34 retained along the northern boundary of the park

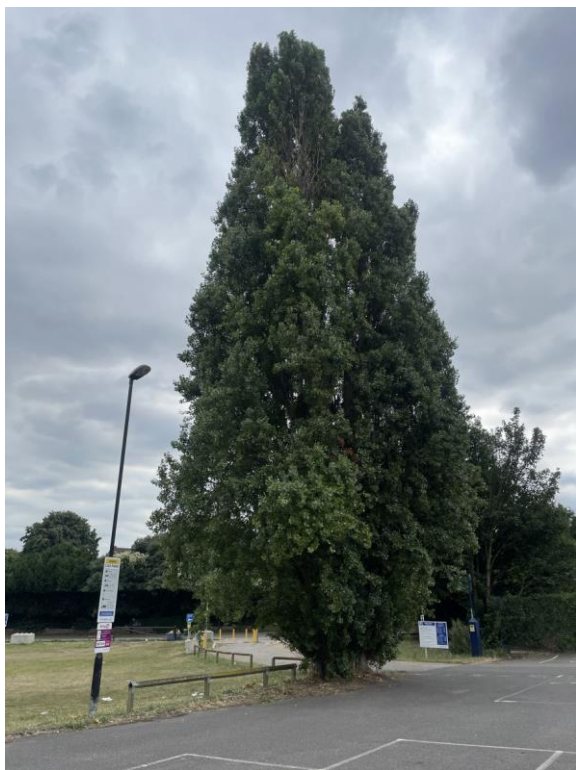
TC3. (14.08.24) – T41 Lombardy poplar to be removed

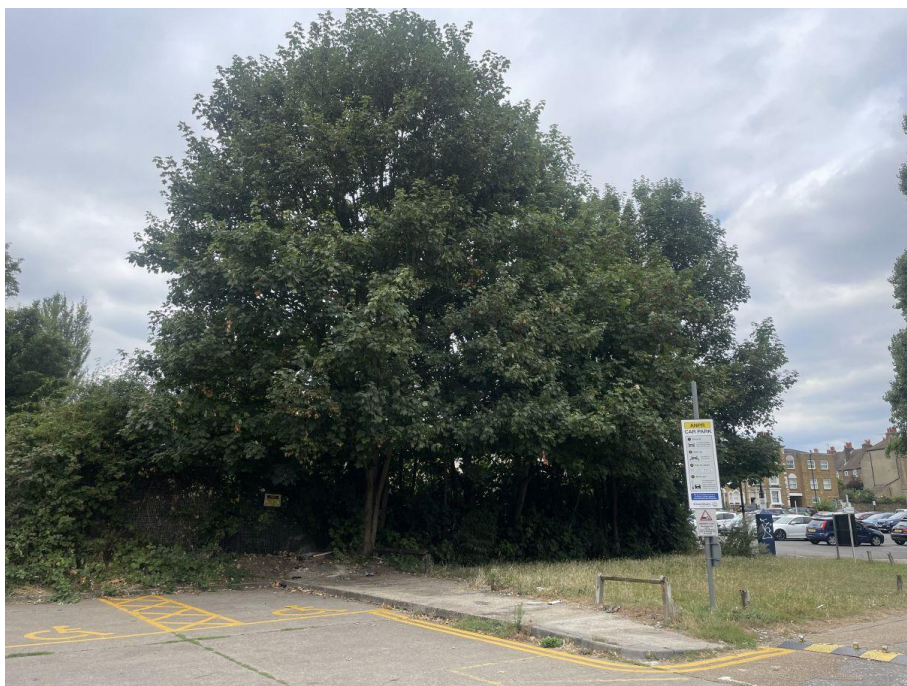
TC4 . (14.08.24) G42 (sycamores) looking west – to be removed

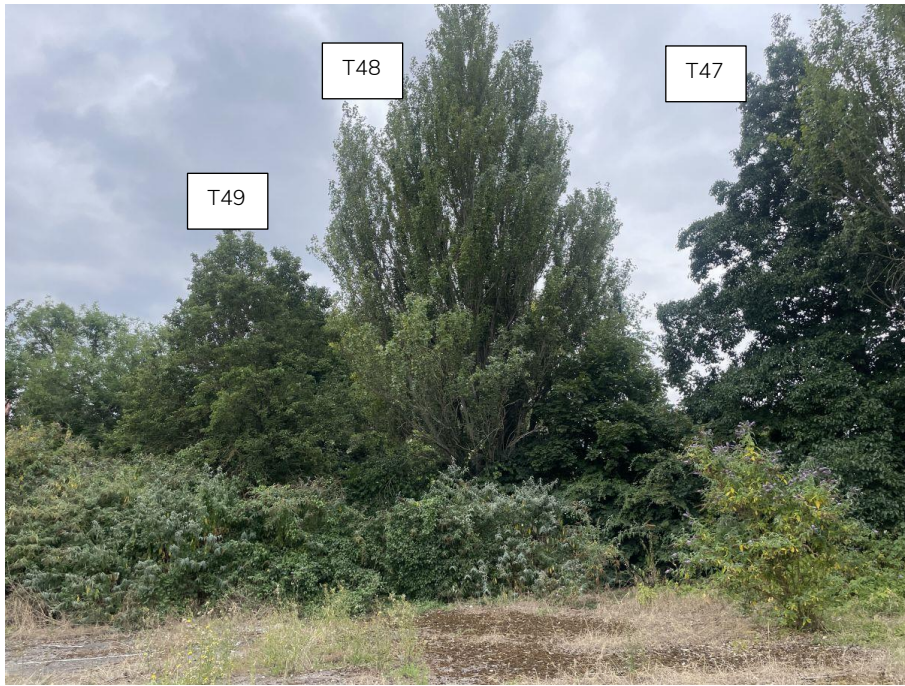
TC5. (14.08.24) T49, T48, T47 looking west, to be retained along western boundary

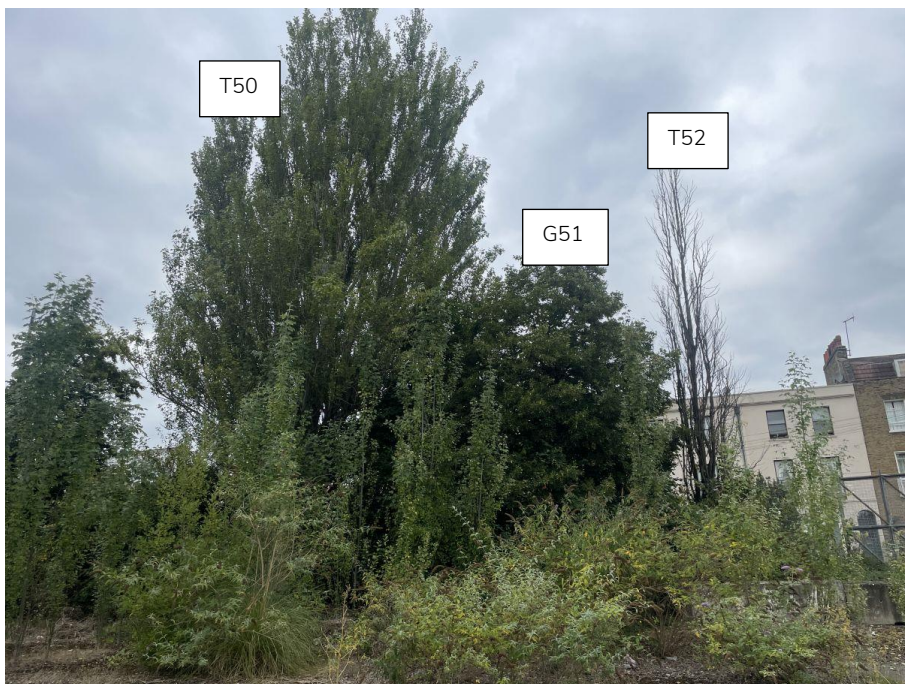
TC6. (14.08.24) looking west, T50, G51 and T52 to be removed

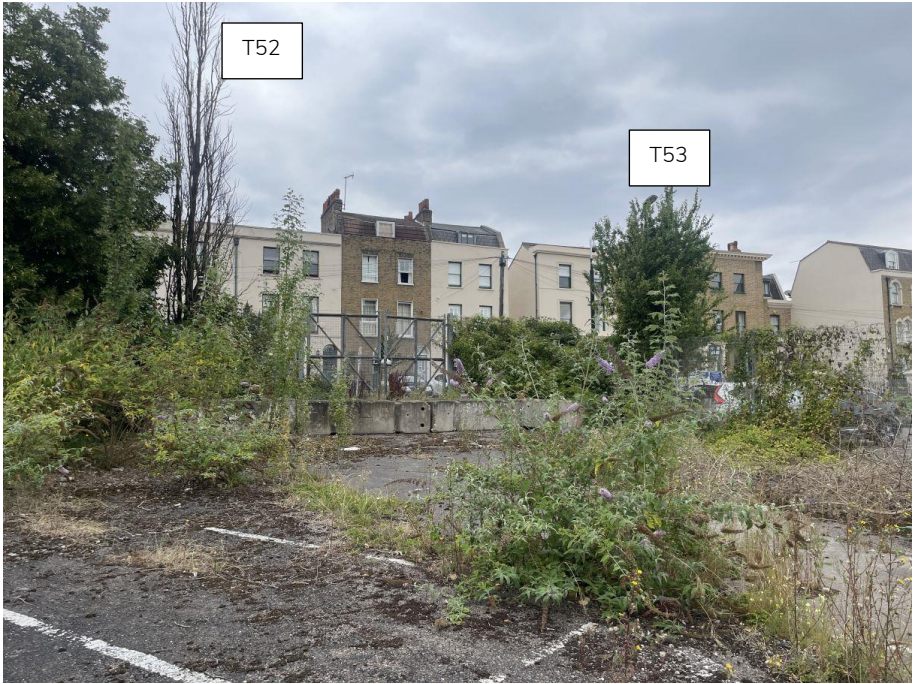
TC7. (14.08.24) looking west, T52 and T53 to be removed
