**Arboricultural Report and Tree Condition Survey  
for Proposed Residential Development  
at  
Land North of Chalk Road,  
Lower Higham,  
Kent.**

**Prepared for Richborough**

**Prepared by  
Peter Wilkins BA (Hons) CEnv MArborA MIEnvSc  
Our Ref 0425-100845  
August 2025**

## **Tree Condition Survey for Land North of Chalk Road, Lower Higham, Kent.**

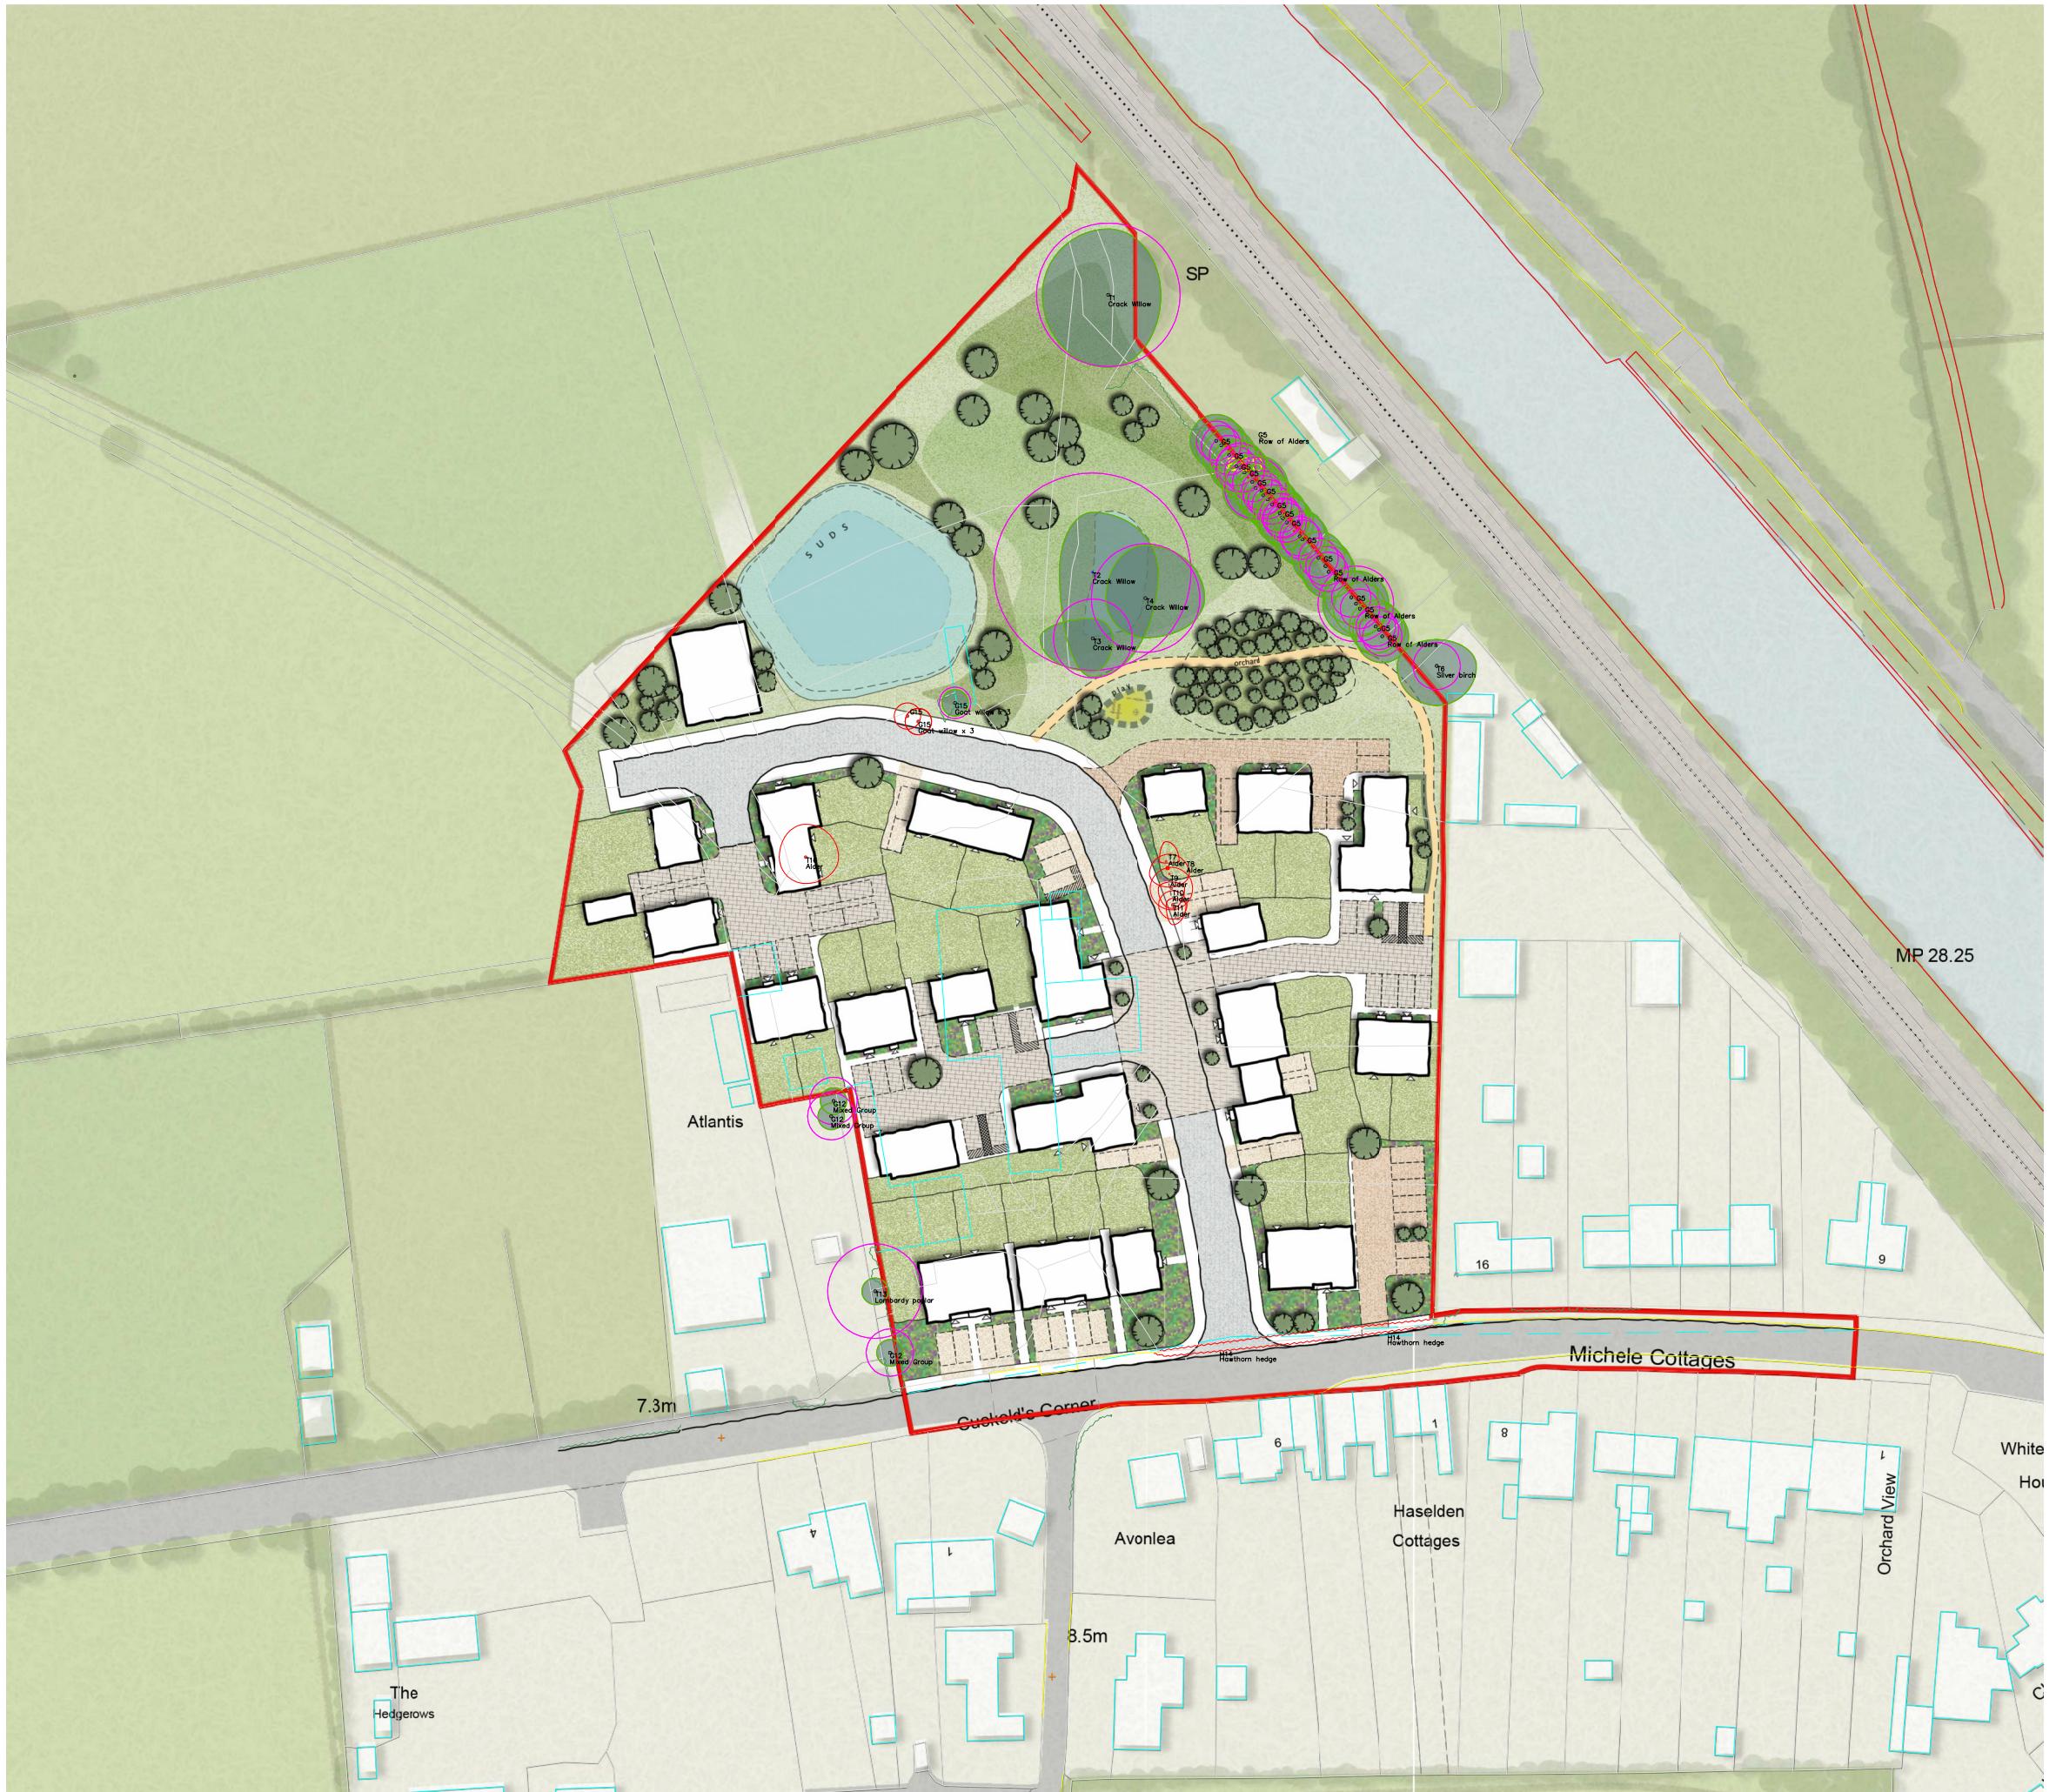
## **Tree Removals Plan**

5.3 The trees to be removed consist of a small linear group of dead and declining bramble covered alders T7-T11 to the east of the existing driveway and a poor quality, semi-mature alder T16 growing close to the corner of the concrete yard area and two small semi-mature goat willows G15. The removal of these trees will not impact on the amenity value or quality of the tree resource in the local area.

5.4 To allow for the proposed access and visibility splay the managed hawthorn hedge H14 to the front boundary eastern side of the existing site access is to be removed. The loss of this hedge is compensated within the proposed hedgerow planting on-site.
