Land East of Wrotham Road,  
Meopham

British Standards 5837:2012 Tree  
Survey: Arboricultural Impact  
Assessment, Method Statement and  
Tree Protection Plan

RSE\_9340\_R1\_V3\_ARB

September 2025

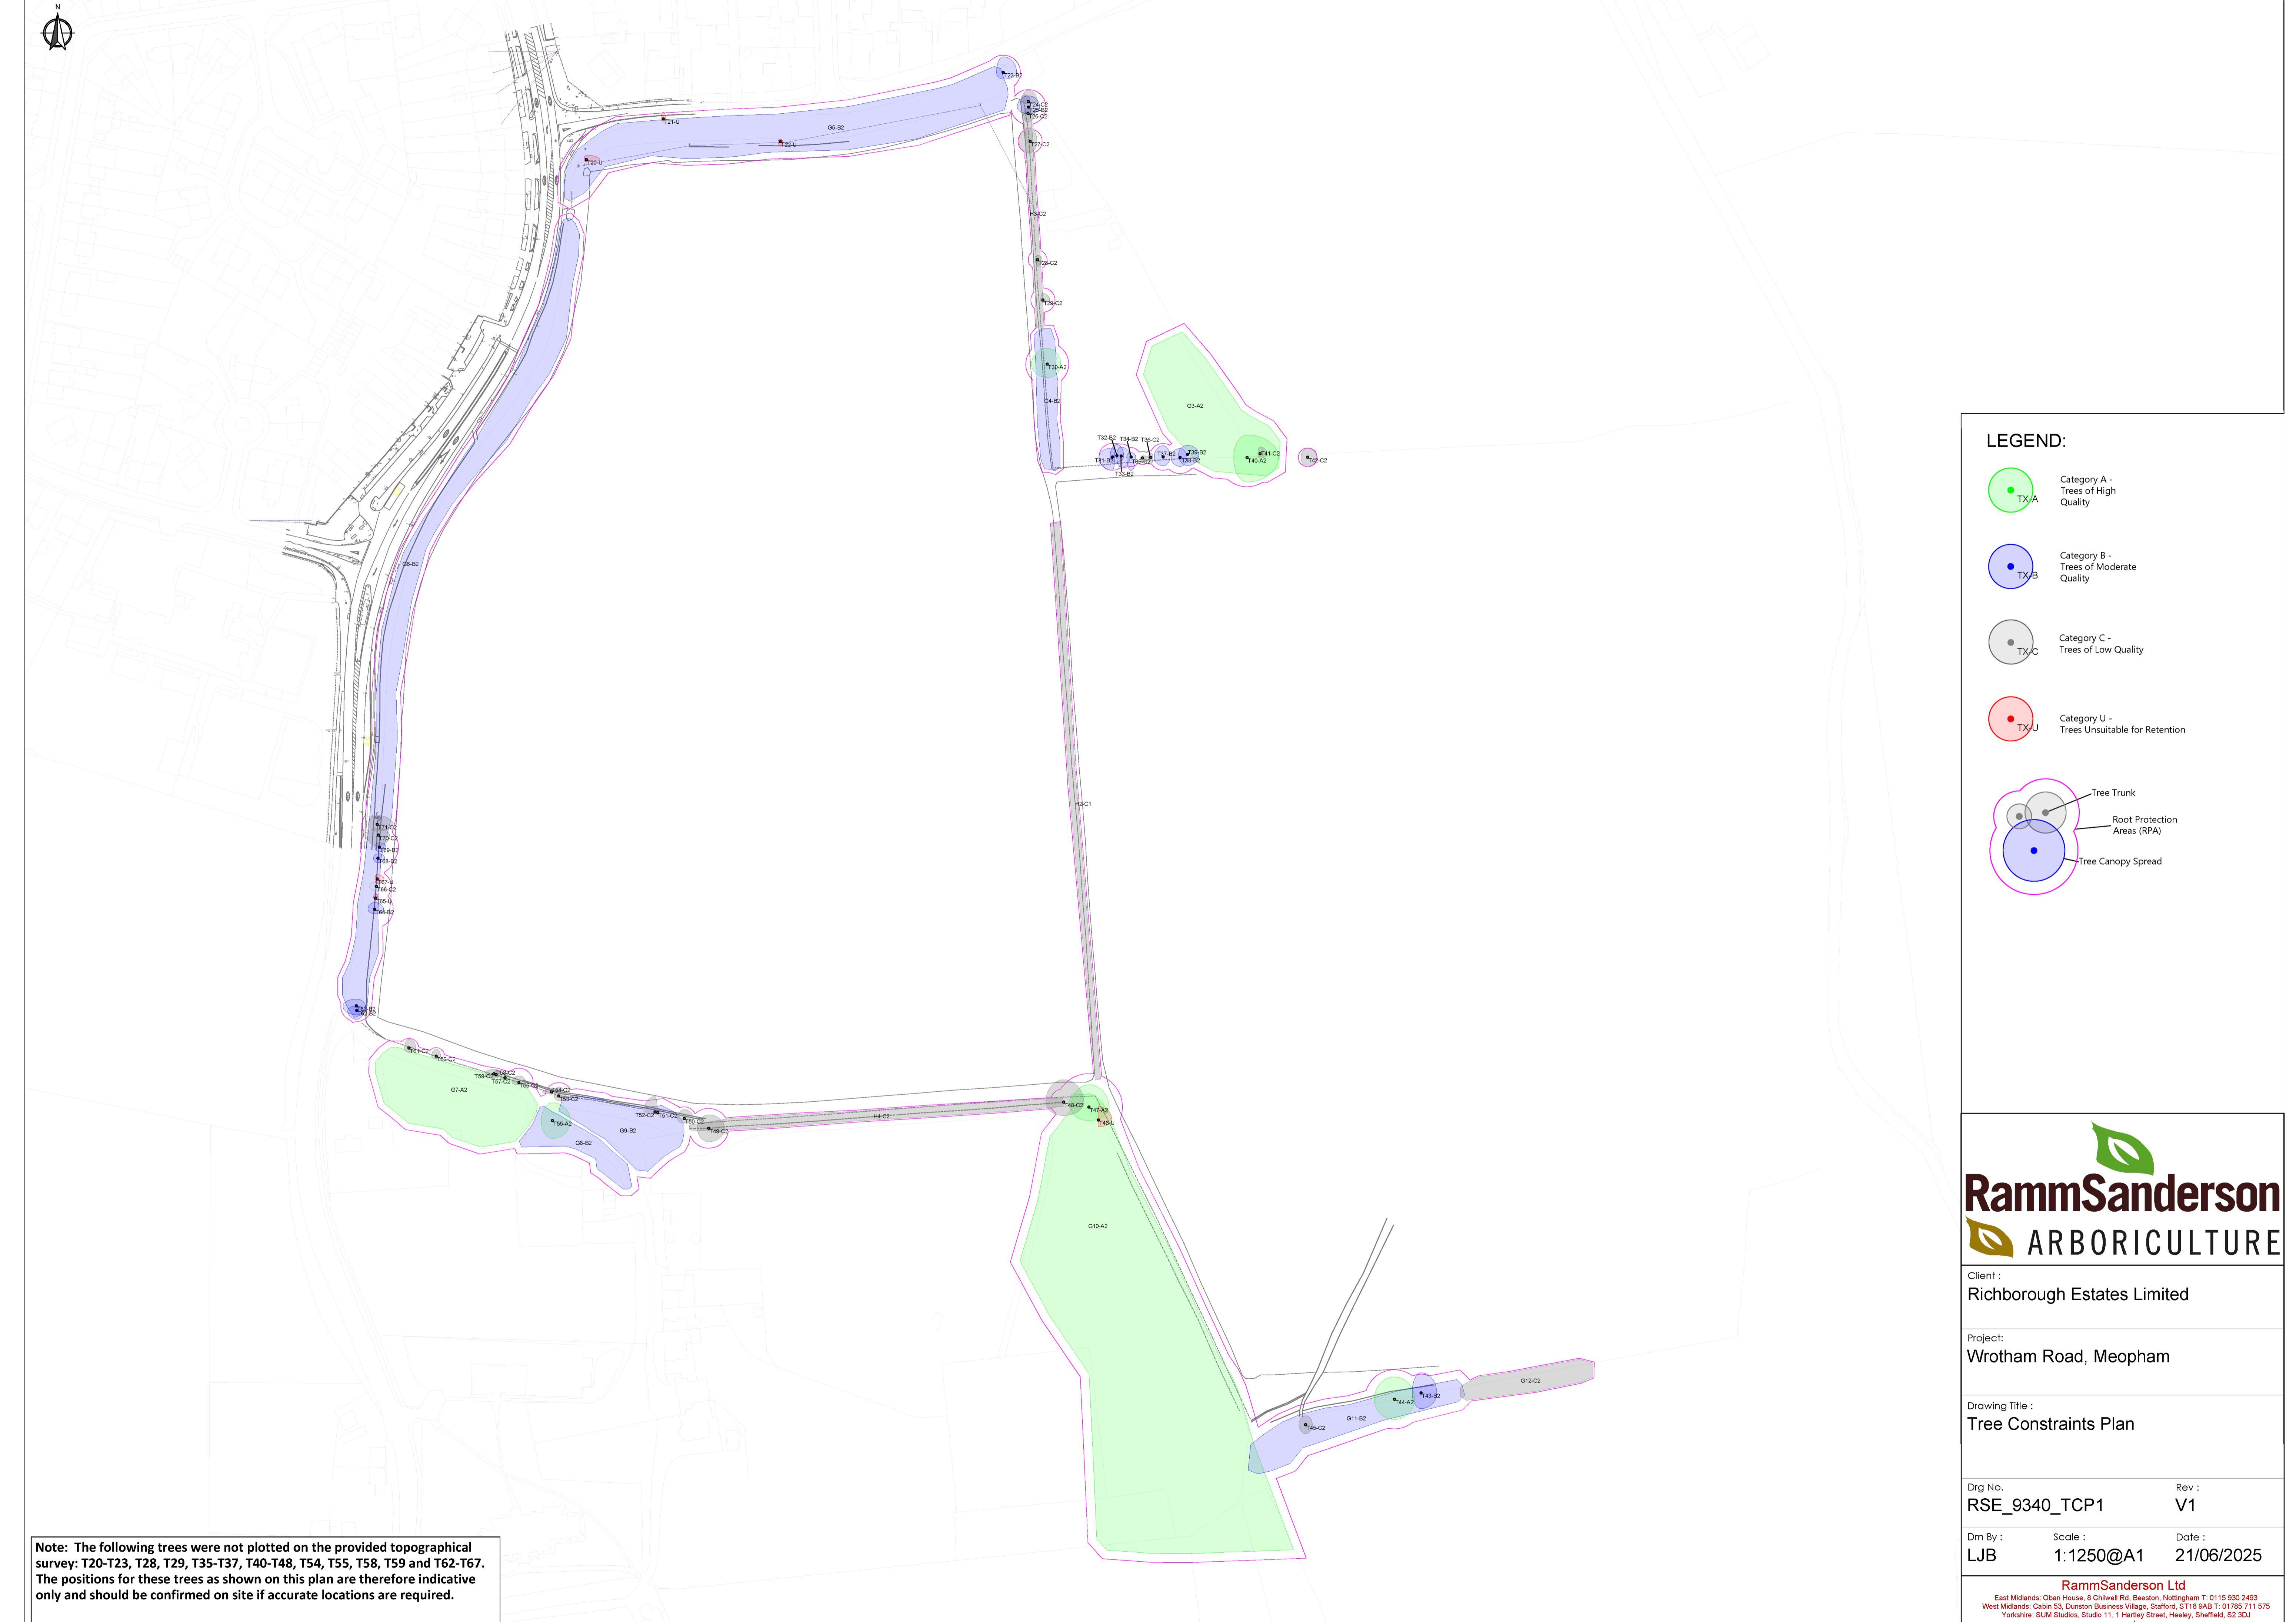
**Appendix C: Tree Constraints Plan – RSE\_9340\_TCP1\_V1**

- i Recommended Root Protection Areas (RPA) for all individual trees on or immediately adjacent to the survey area are detailed within the Tree Schedule (Appendix A) and illustrated on the Tree Constraints Plan (Appendix C).
