# Preliminary Ecological Appraisal and Roost Assessment

Kesson House, Northfleet, Kent, DA11 9HN

Atelier-SM Architects

25<sup>th</sup> March 2024

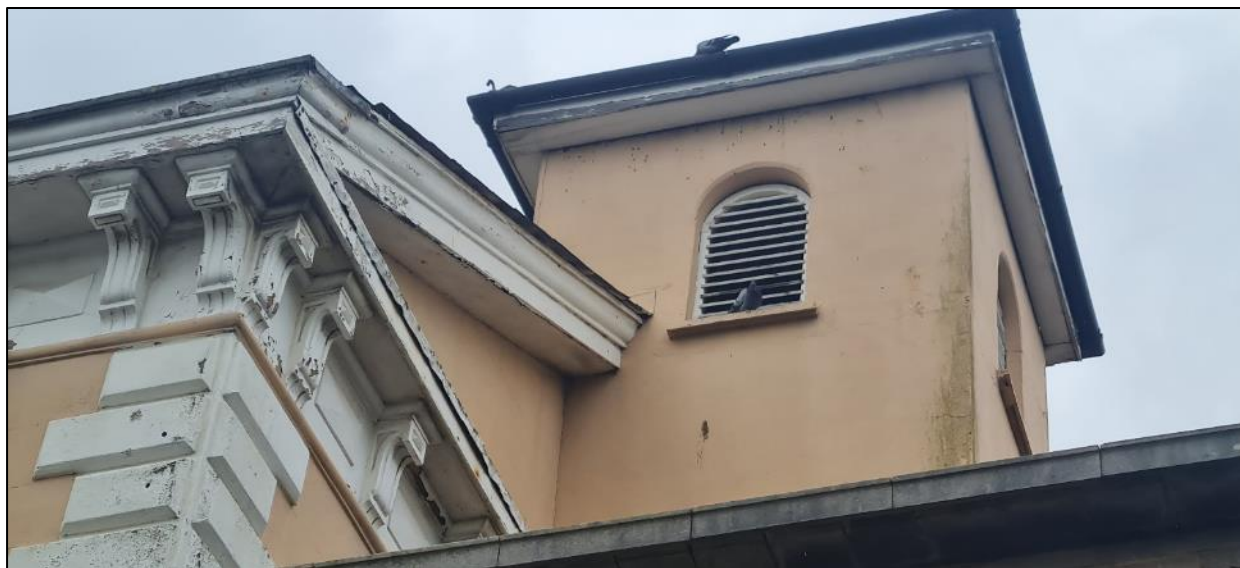
Photo 3: Looking south at the tower section of B1a, showing louvres and pigeons. A crevice on an overhanging section on the pediment can be seen on the left.

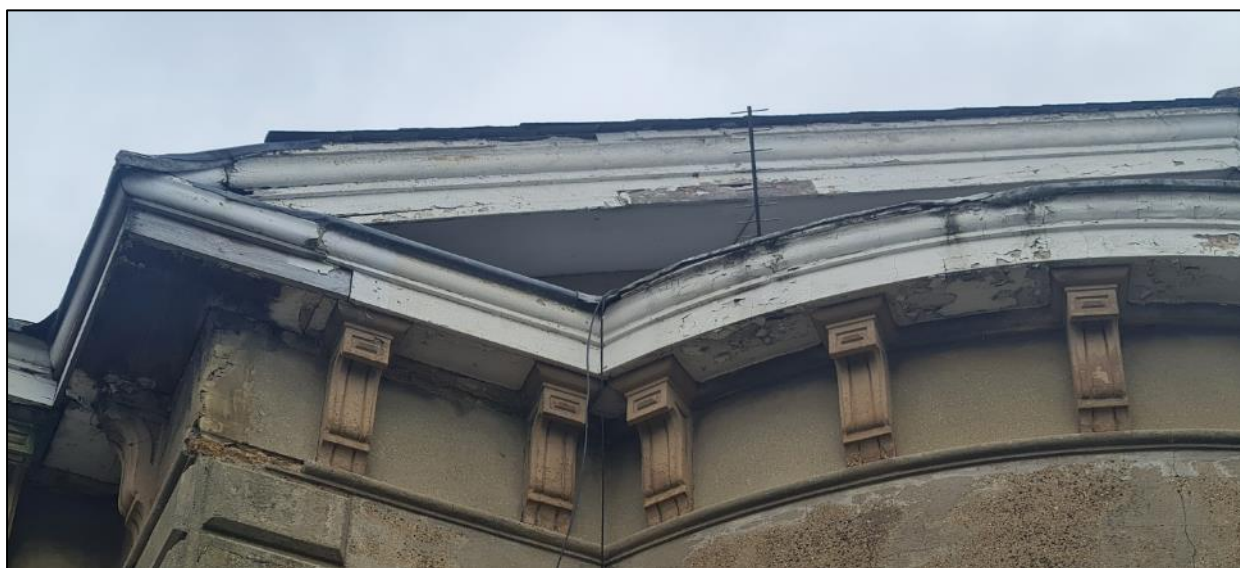
Photo 4: Looking north-east at the south-western elevation of B1a, showing another crevice near the top of the bay window element.

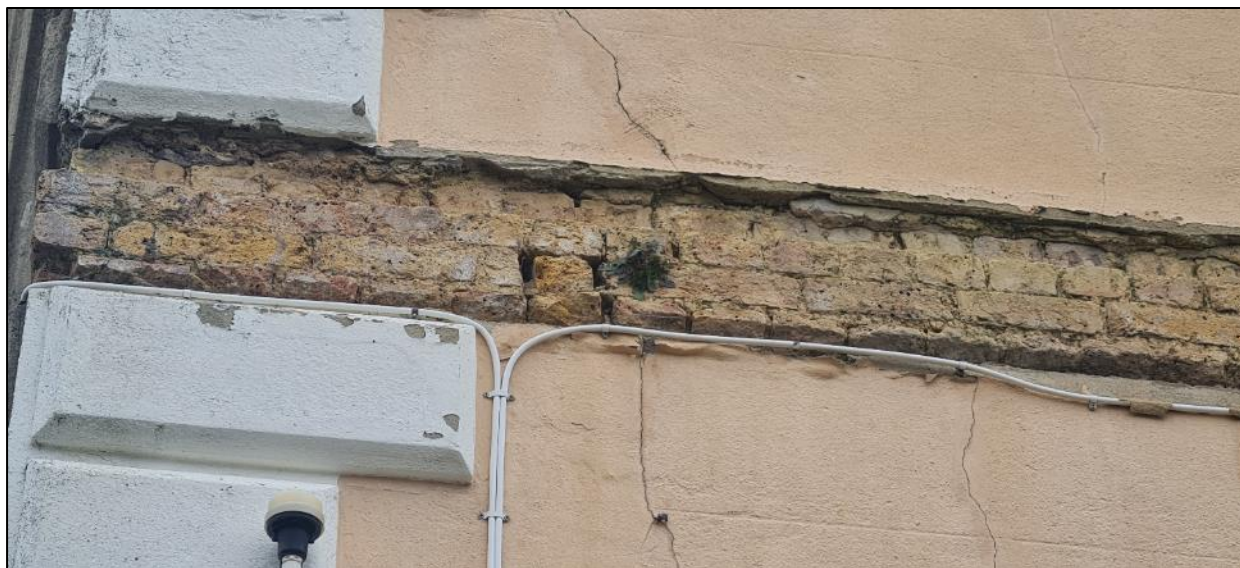
Photo 5: Crevices in brickwork on the south-eastern elevation of B1a.

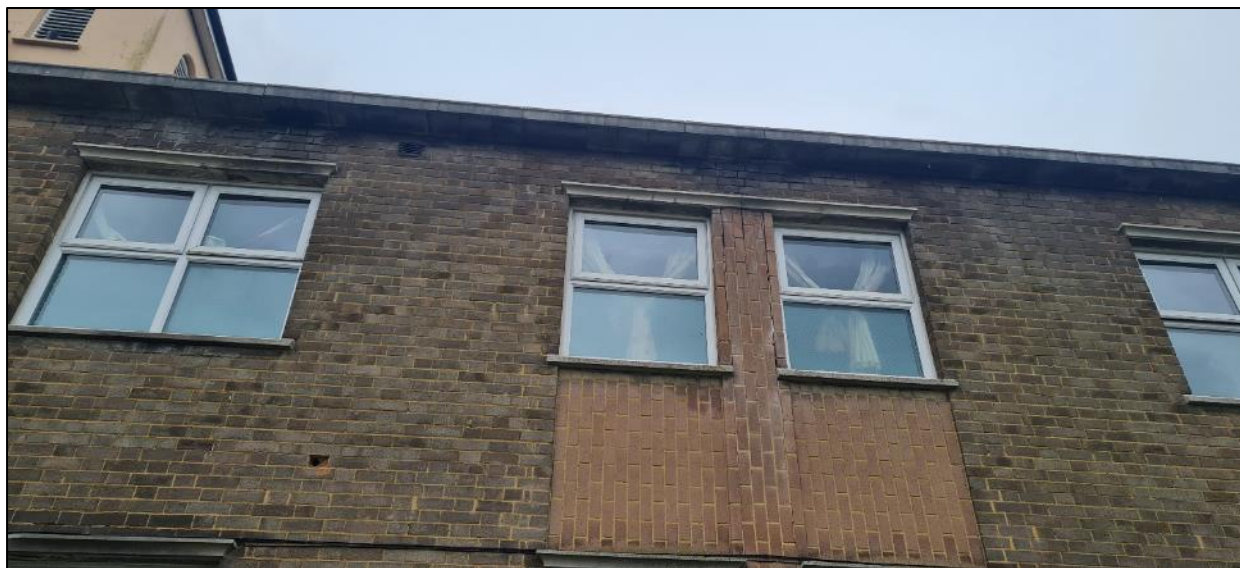
Photo 7: Holes and cracks in the north-eastern elevation of B1b.

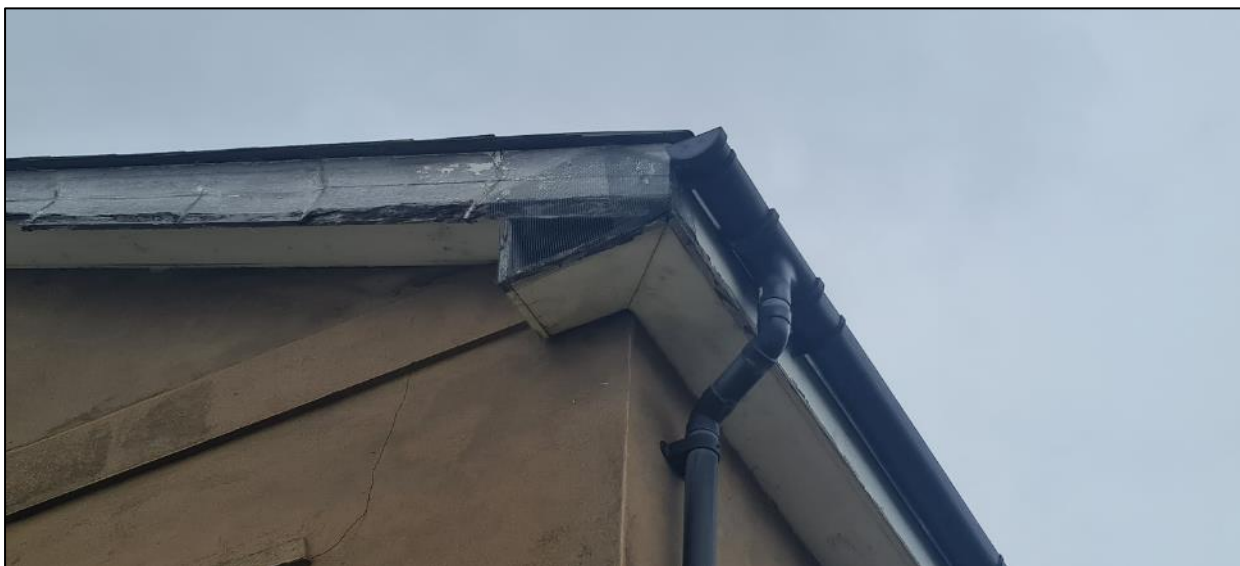
Photo 10: A gap in the soffit box on the south-eastern elevation of B1d, with a similar feature the other side.

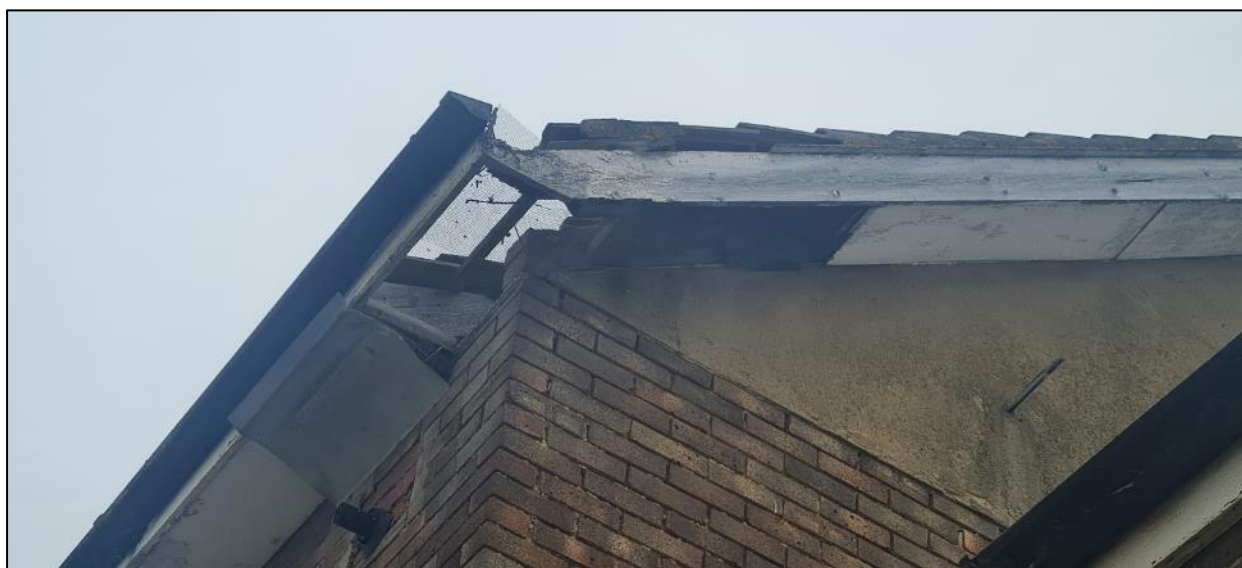
Photo 12: A soffit box hole in the south-eastern part of the gabled roof section of B1e.

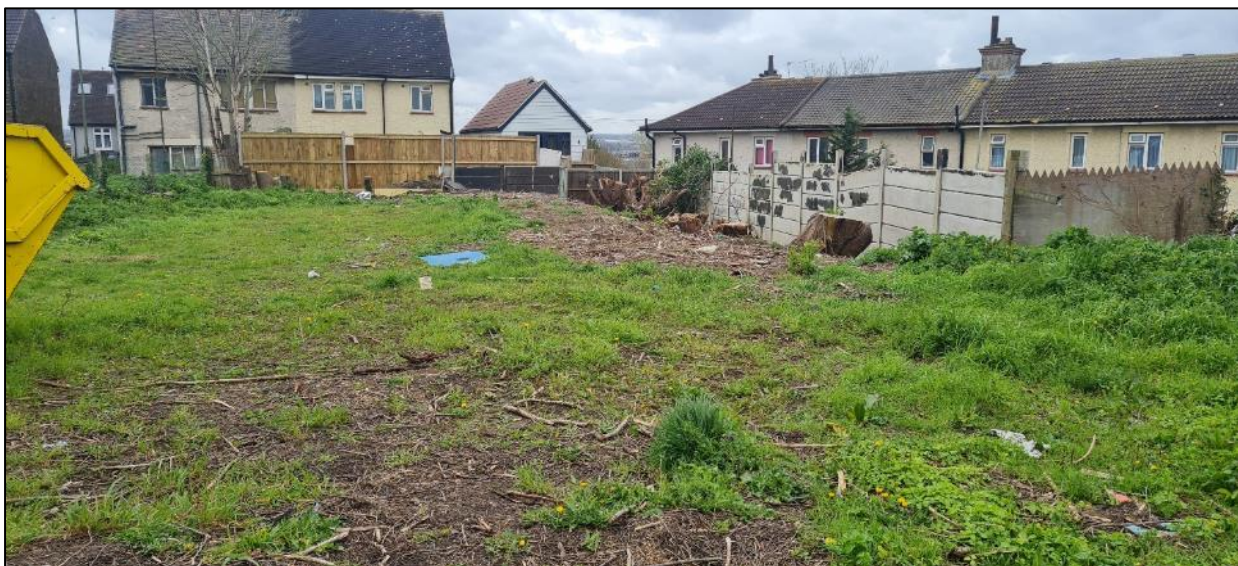
Photo 16: Looking south across the area of ruderal/ephemeral herb in the south of the site, with recent tree line felling.

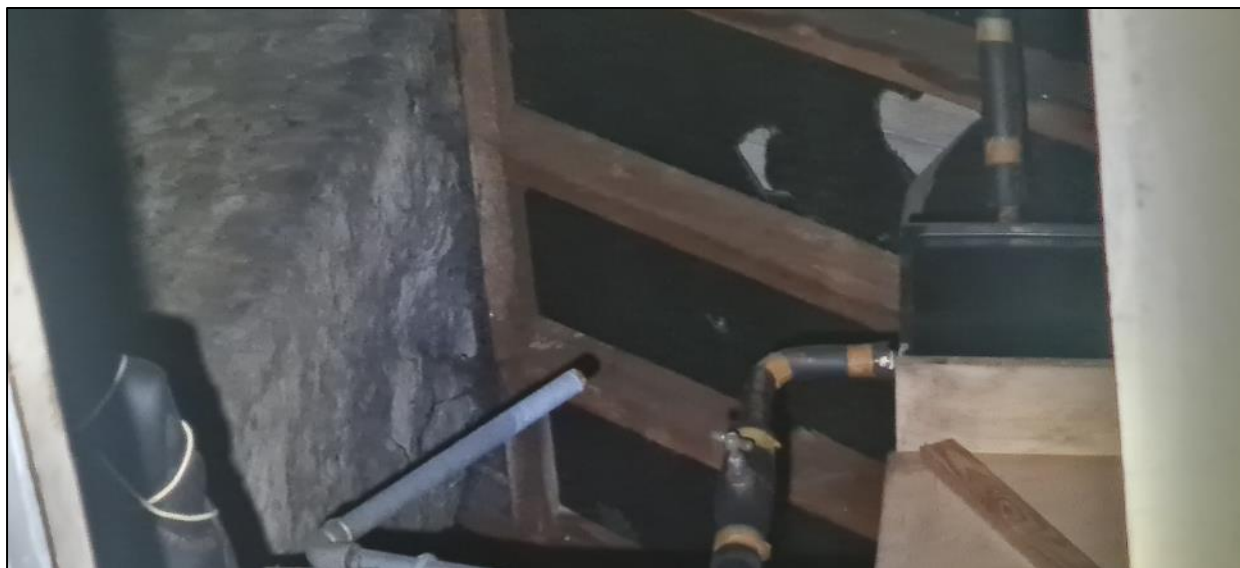
Photo 19: Looking at the loft lining of B1e.
