# **BS5837 Tree Survey Report & Arboricultural Impact Assessment**

**Site: Hopehill Scout Campsite, South Street, Wrotham Rd.,  
Meopham DA13 0QJ**

**Prepared for: Gravesend District Scout Council**

**Issued: 01.02.2024**

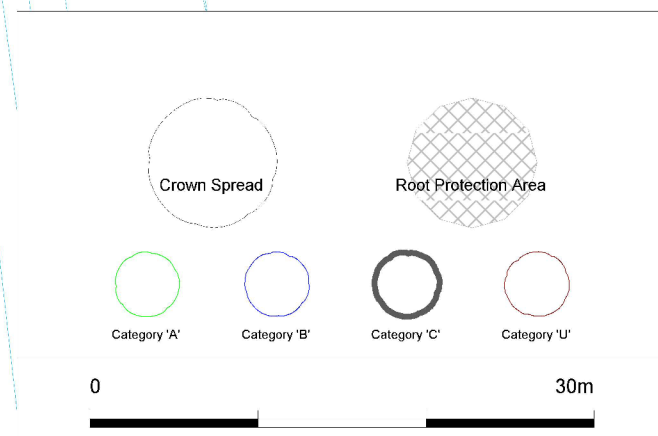
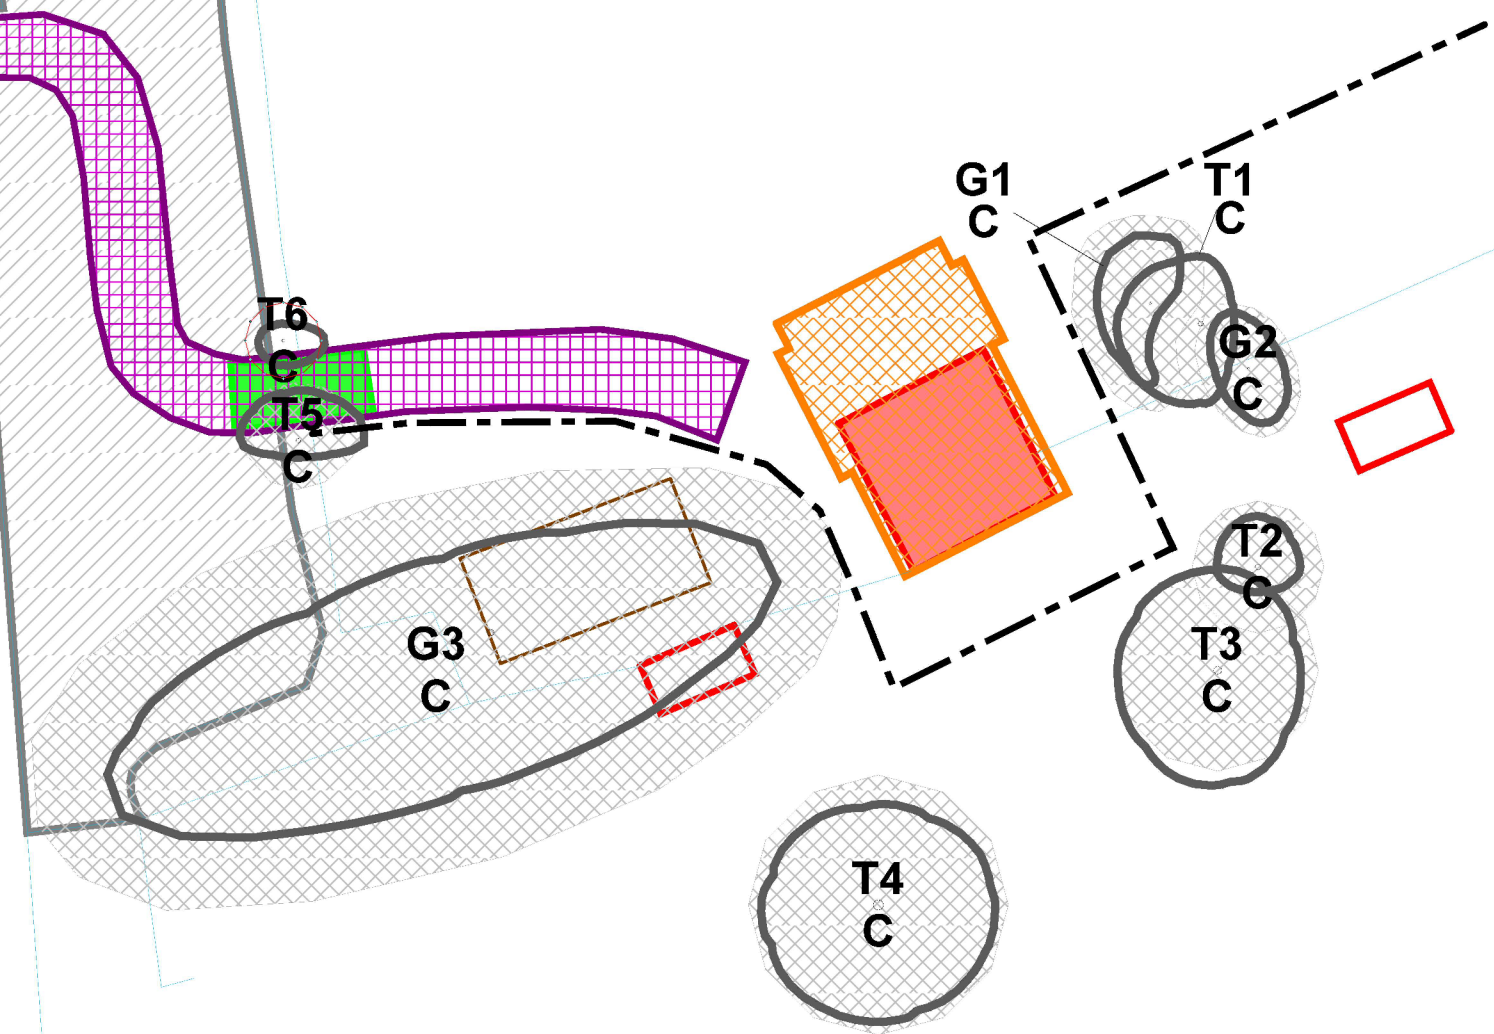
## Appendix C

**4.3 Incursions within the Root Protection Areas (RPAs) areas of retained trees:** the proposed refurbishment and extension will not require incursions into the RPAs of any retained trees. However, the access route for vehicles/machinery will cross the Root Protection Areas of trees T5 and T6.

Machinery requirements for the project have yet to be finalised, but due to the proximity of trees T5 and T6 to the vehicle gate, via which machinery will cross the field in order to access the construction area, the incursions are relatively substantial as a percentage of the total Root Protection Areas (approximately 50% for T5, and 30% for T6). However, approximately half of each of these incursion areas lies beneath the existing car park to the west, the surface of which is a cellular concrete material, in-filled with aggregate or similar, and is well-established. Roots to the west of these trees will therefore be accustomed to the soil compaction beneath the car park, and protected by the existing surfacing.

The vulnerable parts of these Root Protection Areas are those within the soil in the gateway, and immediately to the east, at the edge of the field. It is therefore important that temporary ground protection (as specified at Section 4.10, below, and marked in green on the Tree Protection Plan at **Appendix C**) is installed within these incursion areas in order to prevent mechanical damage to the soil surface, and minimise soil compaction. For the same reason, it is also advisable to carry out construction works at a time of year when the soil is likely to be dry/firm, if possible.

**4.10 Ground protection:** the area of the RPA marked for ground protection (shaded green on the Tree Protection Plan) must be covered with ground protection mats of a suitable load rating for the machinery required, with appropriate cushioning/load-bearing material incorporated in order to absorb the weight of vehicles/machinery and reduce soil compaction along the access route; this can then be removed following project completion. Any ground protection which both protects the soil surface from mechanical damage and spreads the weight of vehicles in order to minimise soil compaction will be suitable but, regardless of exact layout/design, must be specified with reference to the axle weight of the vehicles/machinery required for the project, once this is known.
