# Owletts Mansion & Outbuildings: Heritage Statement

PROPOSED LISTED BUILDING CONSENT

FOR CONSERVATION REPAIRS TO OWLETTS MANSION & OUTBUILDINGS TO THE EAST AT THE STREET, COBHAM, KENT

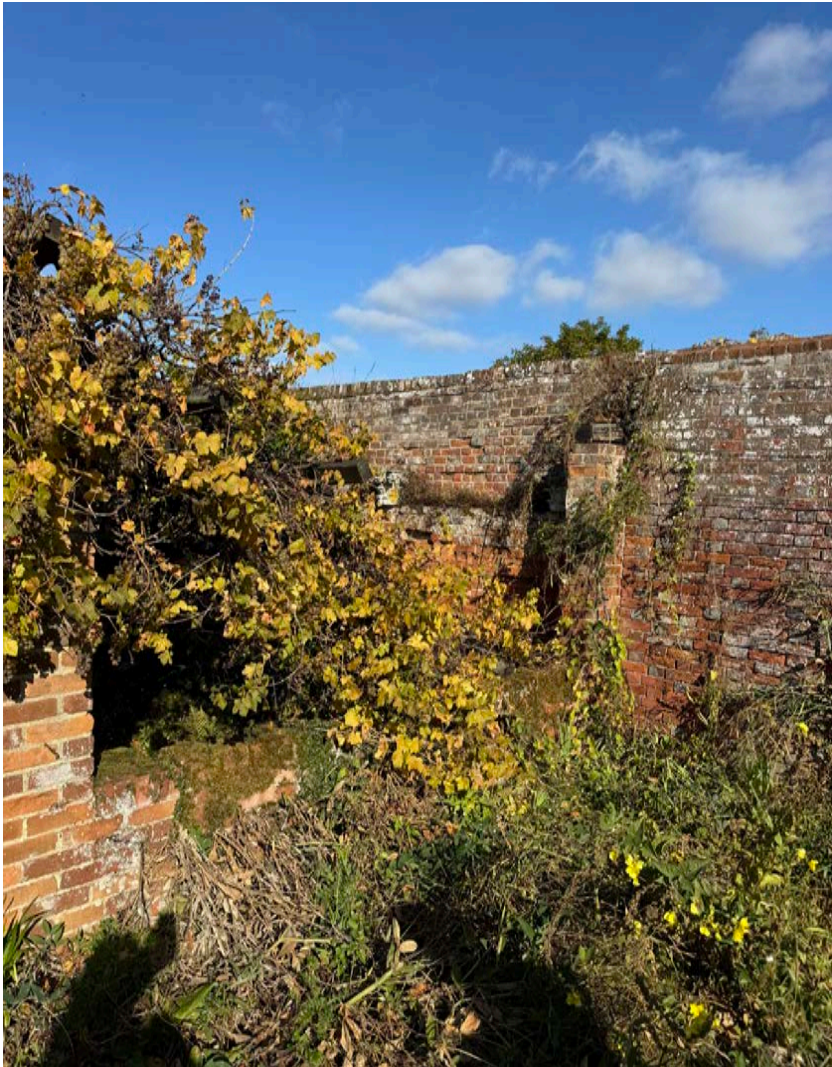
The loggia structure has experienced significant deterioration to the timber roof structure, primarily due to prolonged exposure to moisture and age-related decay. The existing primary timber beams are severely rotten and structurally compromised, resulting in partial collapse of the roof structure.

4. View of Loggia from south east end showing timber roof collapse and excessive vine growth

Structural repairs will be undertaken in accordance with the Structural Engineer’s report and drawings. The existing decayed timber beams will be replaced with six new 200 × 200mm D30 grade oak primary beams, improving structural stability while maintaining a traditional material appropriate to the structure.

In addition, seven timber slats positioned above the primary beams will be replaced with new 100mm × 75mm D30 oak members, matching the existing configuration and dimensions.

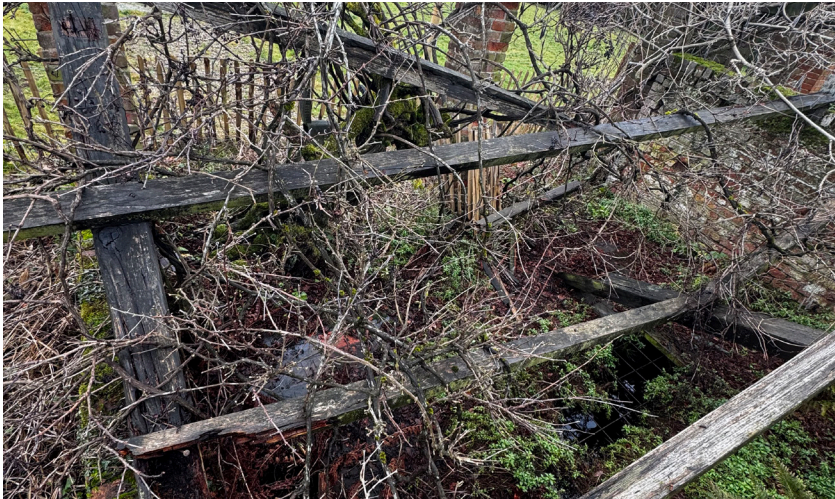
5. View of Loggia from above showing timber roof collapse

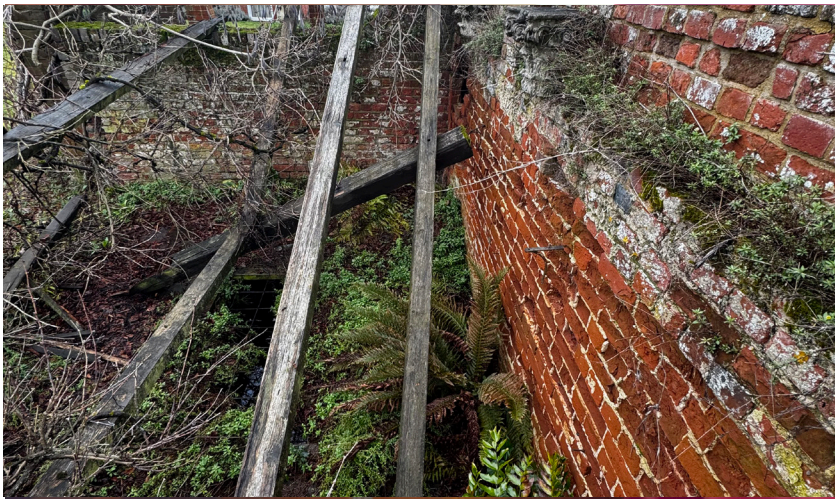
7. View of Loggia showing collapsed timber structure from above

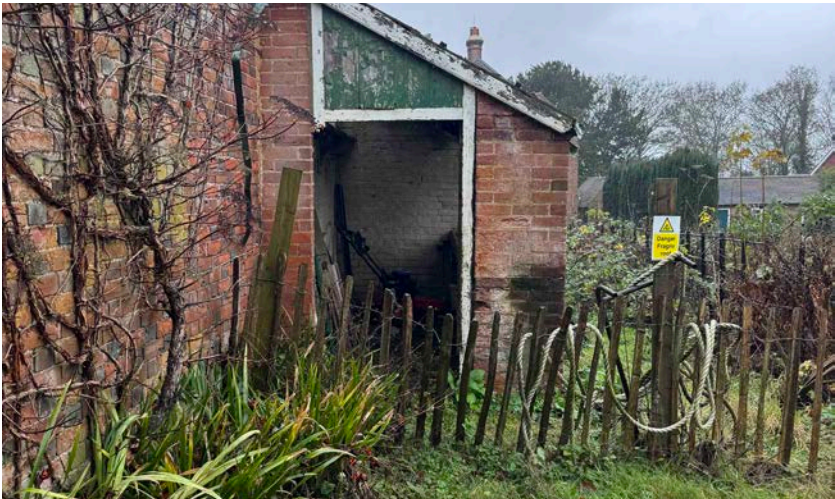
2. South-eastern entrance door to potting shed - timber door frame suffers rot

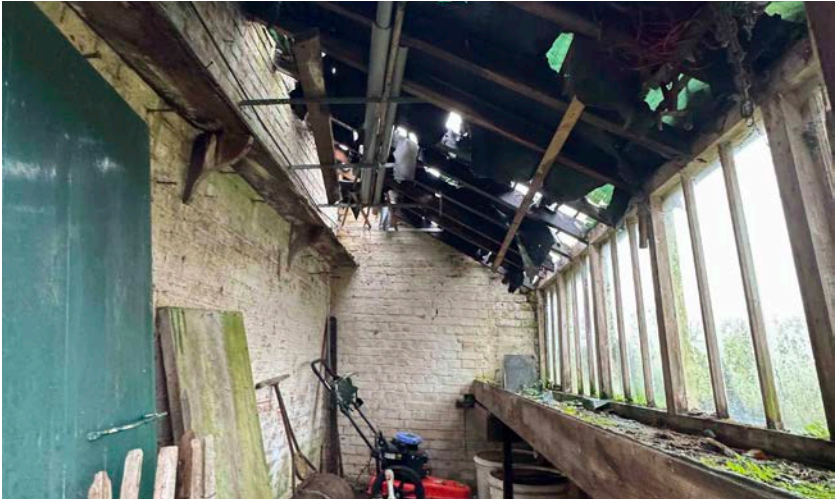
The potting shed roof structure has deteriorated due to prolonged exposure to moisture and age-related decay, resulting in significant deterioration of the existing timber rafters. The roof structure is no longer considered structurally reliable and requires replacement. The associated masonry has areas of missing and deteriorated mortar, which has allowed moisture penetration into the wall fabric.

3. Internal photo showing decayed timber structure and failing tarpaulin

The existing mono-pitch roof structure will be carefully dismantled and replaced, with the new structure replicating the original roof form, pitch and arrangement. New structural timbers will be installed to match the size and configuration of the original rafters, ensuring the visual and structural character of the building is maintained. Where possible, existing roof tiles will be retained and reused, preserving historic material fabric. Any additional tiles required will be sourced to match the originals. Areas of deteriorated mortar within the masonry will be carefully raked out and repointed using a lime mortar matched to the existing composition, based on samples taken from deep within the joints.

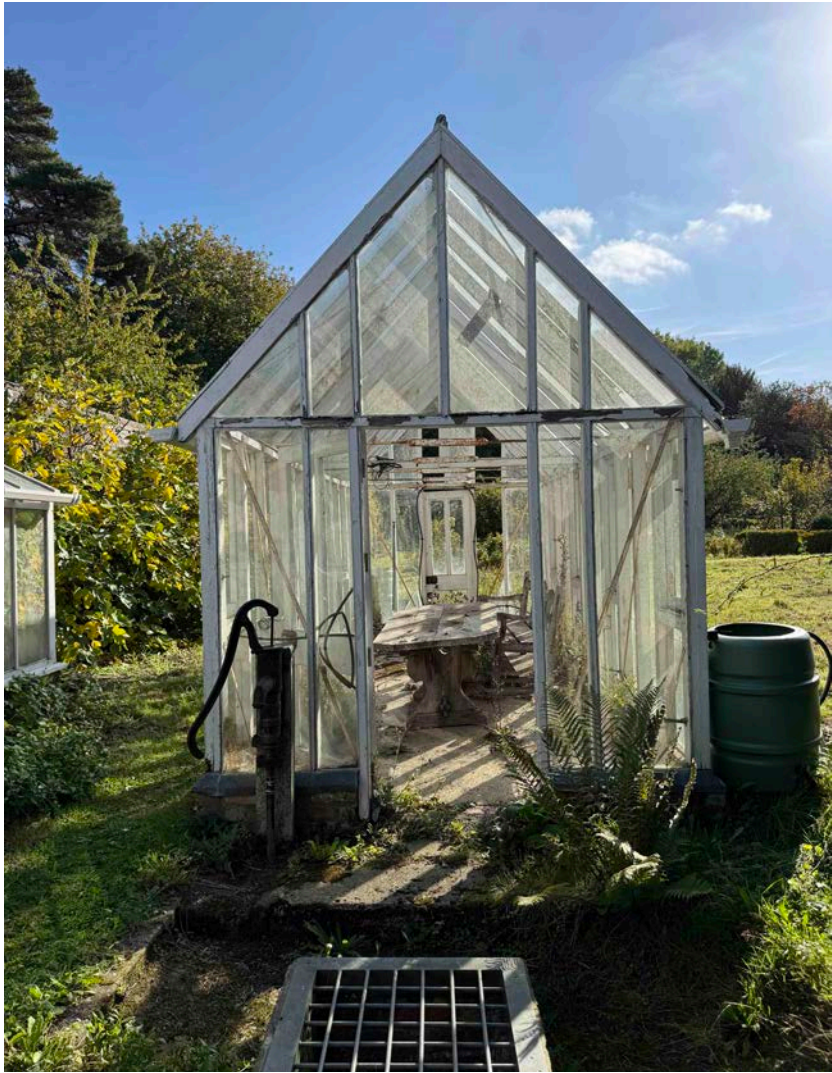
1. Front view of greenhouse

The existing greenhouse structure has experienced extensive decay to the timber framework, particularly at the base of the walls above the brick plinth and within elements of the roof structure adjacent to the guttering. This deterioration is primarily due to prolonged exposure to moisture and the close proximity of timber elements to ground level.

Due to the extent of decay, the timber structure is no longer capable of effective repair.

The existing greenhouse structure will be carefully dismantled and replaced, with the new structure designed to match the architectural character, proportions, window rhythm and overall height of the existing building.

The brick plinth will be raised by several courses, increasing the separation between ground level and the timber structure to improve durability and reduce the risk of future moisture-related decay.

A new plinth detail will incorporate a timber cill positioned above a DPC / leaded brickwork, creating an improved moisture barrier between masonry and timber.

The replacement structure will be constructed from durable timber such as Accoya, chosen for its resistance to decay and long-term performance. The timber framework will be painted white to match the appearance of the existing greenhouse.

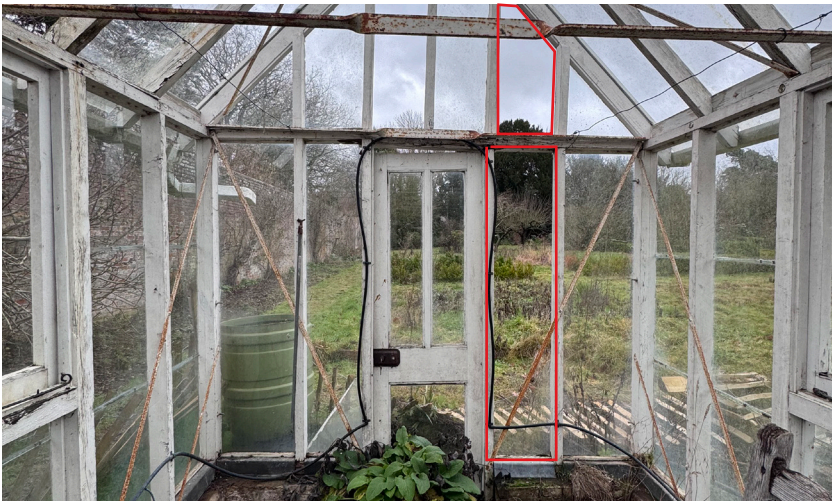
4. Internal view - showing broken glass panes highlighted in red

Glazing will be replaced with reinforced or shatter-resistant safety glazing to improve durability and ensure visitor safety.

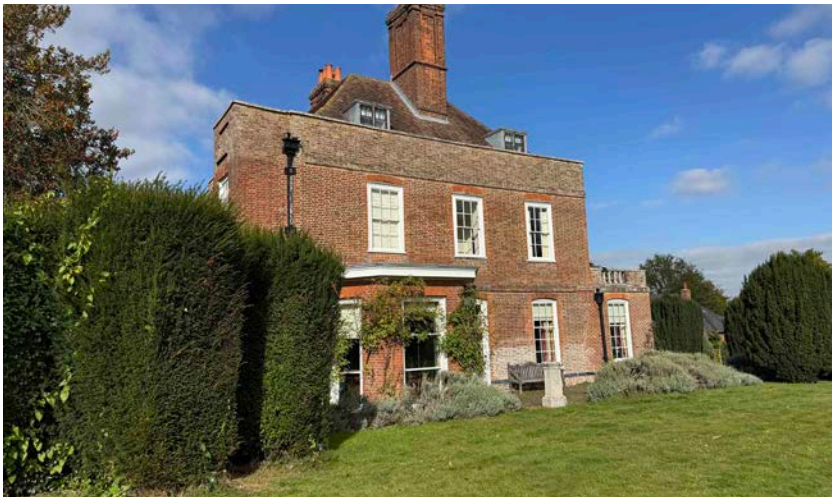
The existing gutter outlet through the roof parapet is currently undersized, restricting the efficient discharge of rainwater. This increases the risk of water overflow and moisture penetration into the adjacent masonry, potentially accelerating deterioration of the building fabric.

1. South-eastern elevation showing affected gutter outlet

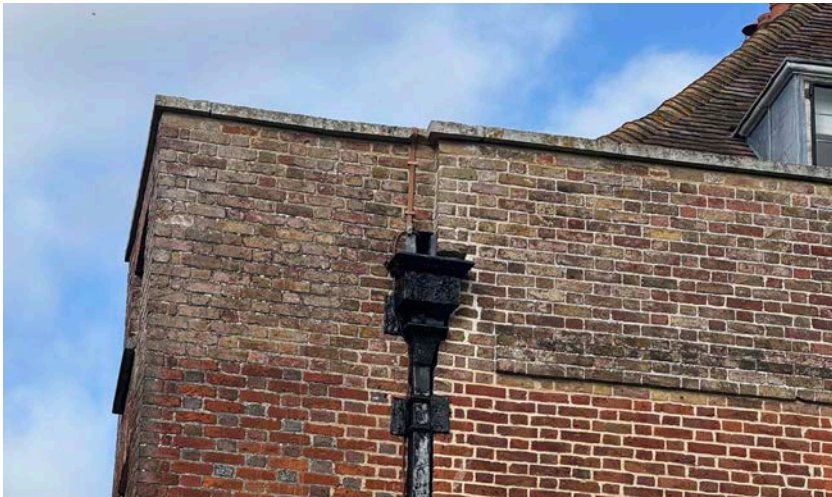
2. Close up of gutter outlet, hopper and downpipe
