NORTH WING, OWLETT'S

COBHAM, KENT

DESIGN &  
ACCESS  
STATEMENT  
INCLUDING  
HERITAGE  
IMPACT REPORT

MAY 2023

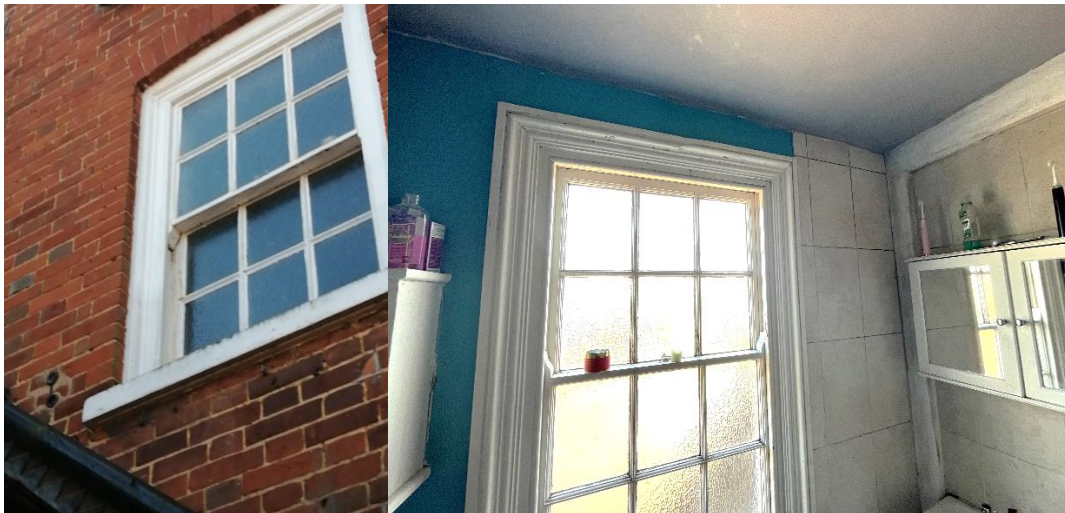
The bathroom is suffering from a severe case of damp, which has affected the walls and ceilings. These have been cleaned off, but the damp has penetrated into the surfaces, and this now requires redecoration. There is no extract fan in the room and only a sash window existing. Opening the window would help, but this is not an ideal remedy.

The proposal here is to install a wall mounted extractor, which will allow a constant air flow, especially whilst the showers and bath are being used. This will allow the condensation to escape. The proposal is to install a cast iron grille externally and locate it approx. 300mm away from the window reveal.

Some existing bricks will be removed, and this will be approximately 100mm diameter, at the depth of the wall.

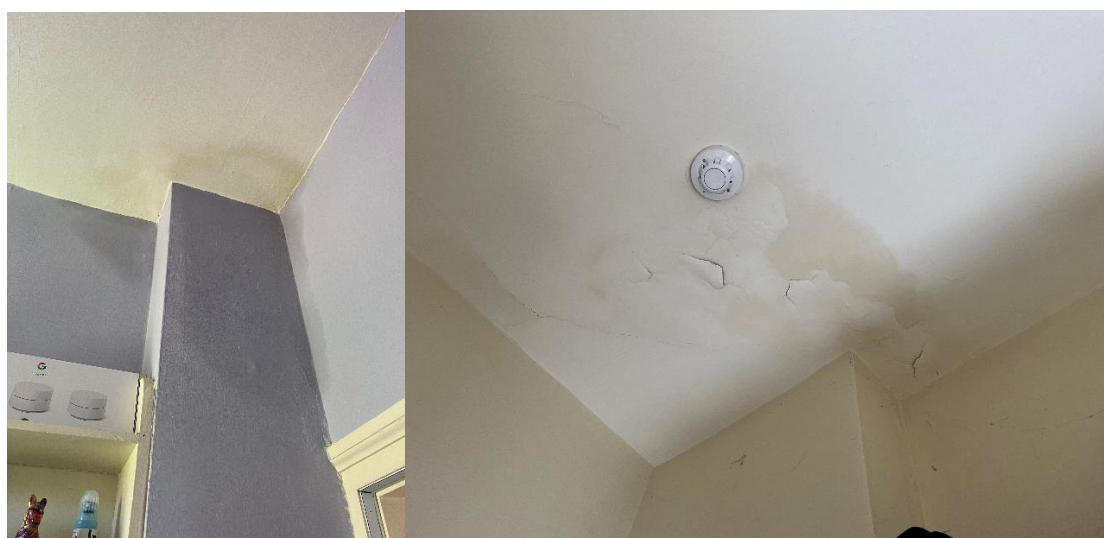
There is an apparent leak on the internal face of the chimney breast at second floor. This has affected both sides of the chimney breast and has made its way along the ceiling.

The proposal is to arrange for scaffolding over to reach all sides at flaunching level. This will enable us to have a closer view of the external chimney, to check the flaunching and brickwork. The proposal here is to remove the existing flaunching and pots. A Code 6 lead tray will be installed at flaunching level and NHL 3.5 lime constructed over to form new flaunching. Any cementitious mortar on the stack will be carefully removed by hand tools and replaced in NHL 2.5.

The flaunching will be removed, including any cement mortar to the stack. Some internal repairs and reinstatement to the ceiling will be planned here to remove the small sections of defective ceiling. Lime plaster will be applied over laths. Existing laths will be retained if these are in good order, otherwise we proposed to use oak riven laths.

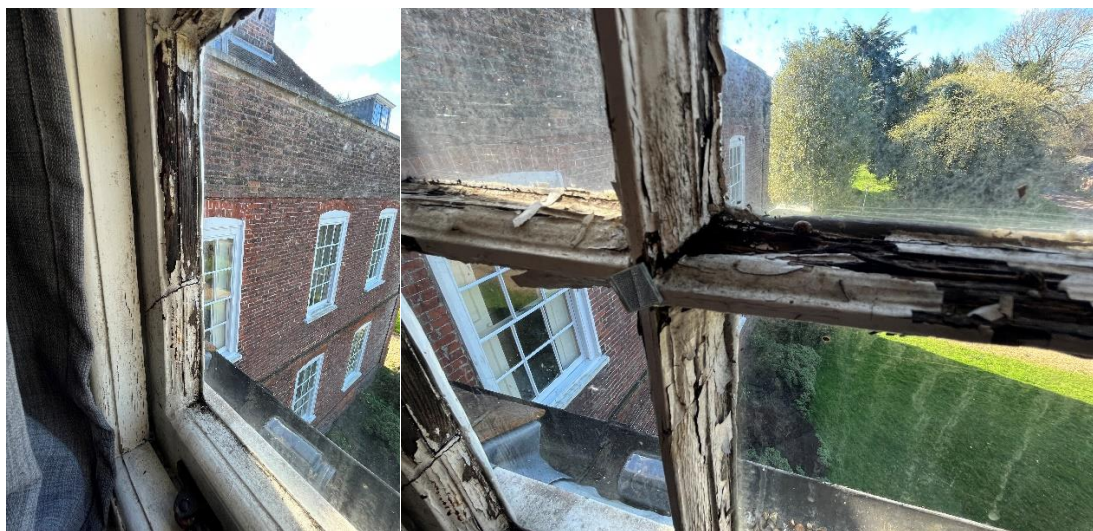
The existing timber casement window is suffering from a severe case of rot, which has primarily affected the left side opener (as you look at it from inside). The glazing bar and frame has no structural integrity to it, which is easy to crush between your fingers. There is evidence of a previous splice repair, which has now bowed, and this has displaced the frame, causing significant air and water ingress internally. The right side is less serious, but has defects, nonetheless.

Window – Medium – this could hold some original fabric, albeit from the 1877 extension. The drawing details to repairs and replacement. However, there are quite a few modern filler repairs and later timber scarf repairs, which have failed or are failing.

The proposal is to remove and fabricate a new opener on the left side, as the existing one is not repairable. This will be done to match the existing dimensions, style and glazing bar mouldings. The right side will be repaired using splice techniques in a workshop. All timber to match the existing, either in soft or hardwood (to be determined). The joinery will be primed and painted white to match existing.

The left side window will be removed and replaced. Some minor repairs will be made generally, which will include splice repairs. The existing paint will be removed and redecorated.
