Ref: 3822/20

**PROPOSED DEVELOPMENT ON
LAND AT OLD MANOR DRIVE,
GRAVESEND, KENT DA12 1NP.**

**PHASE I GEO ENVIRONMENTAL DESK STUDY
AND PRELIMINARY RISK ASSESSMENT**

November 2020

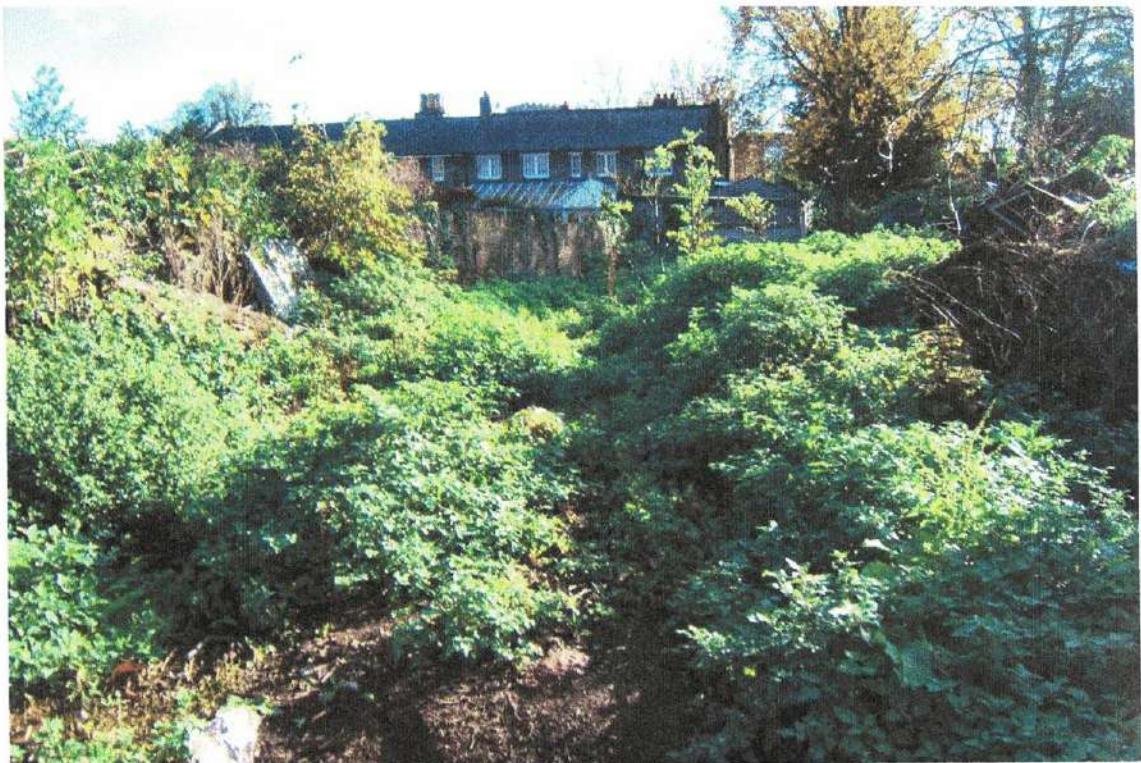
Plate 1

- 7.3 The site comprised an L-shaped area of land which appeared to have previously comprised two adjoining domestic gardens. The north section of the site consisted of rather uneven ground overgrown with emergent weeds and Elder saplings (Plate 1). A boundary wall approximately 1.5m in height passed along its north boundary and a panelled timber fence of similar height formed its south side, the gardens of neighbouring dwellings being present beyond the site boundaries.

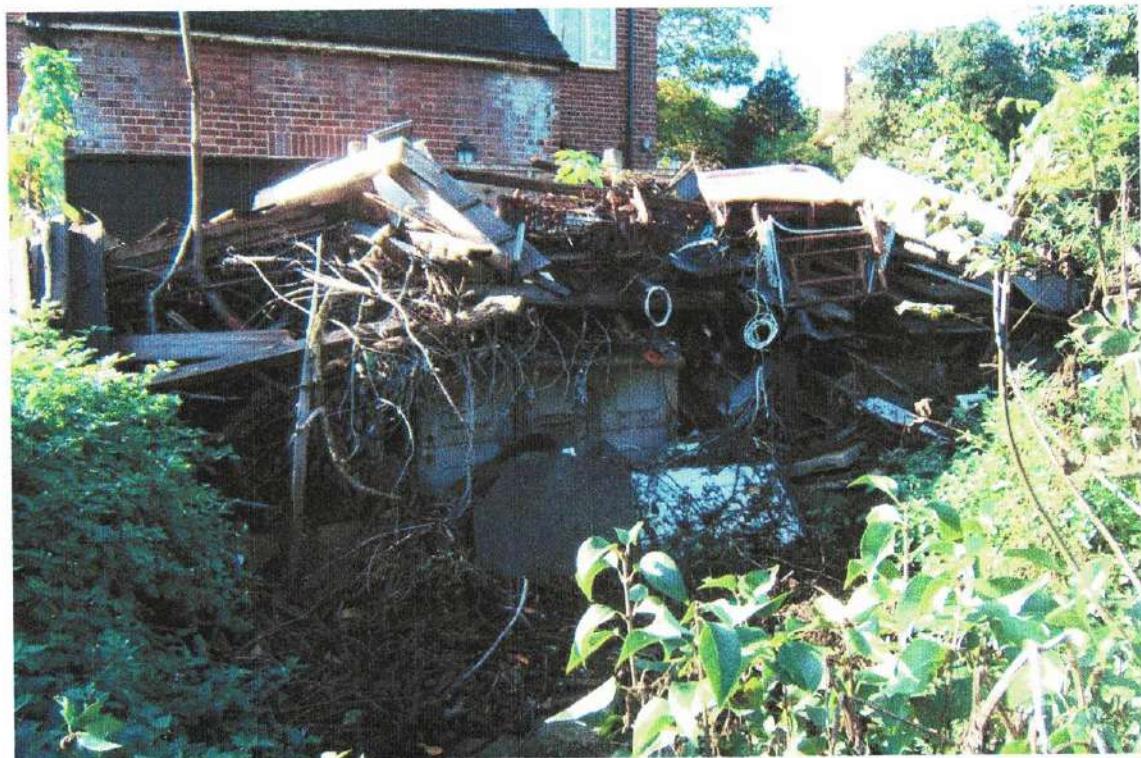
Plate 2

- 7.4 A heap of domestic rubbish and discarded timber was situated at the west end of the site, adjacent to the site entrance (Plate 2).
- 7.5 The north boundary of the site deviated around a block and timber shed under a corrugated steel roof which was situated within the garden of a neighbouring dwelling to the northeast corner of the site (Plate 3). A derelict, steel-framed

10.4 Based on the available information there is little evidence to suggest that the site has been impacted by either on or off-site activities. No significant pollutant linkages have been identified, therefore a Category 4 classification as proposed by DEFRA publication SP1010 (March 2014) is considered applicable (i.e. level of risk posed acceptably low). Further action is therefore considered unnecessary other than the appropriate removal and disposal of rubbish present near the site entrance.

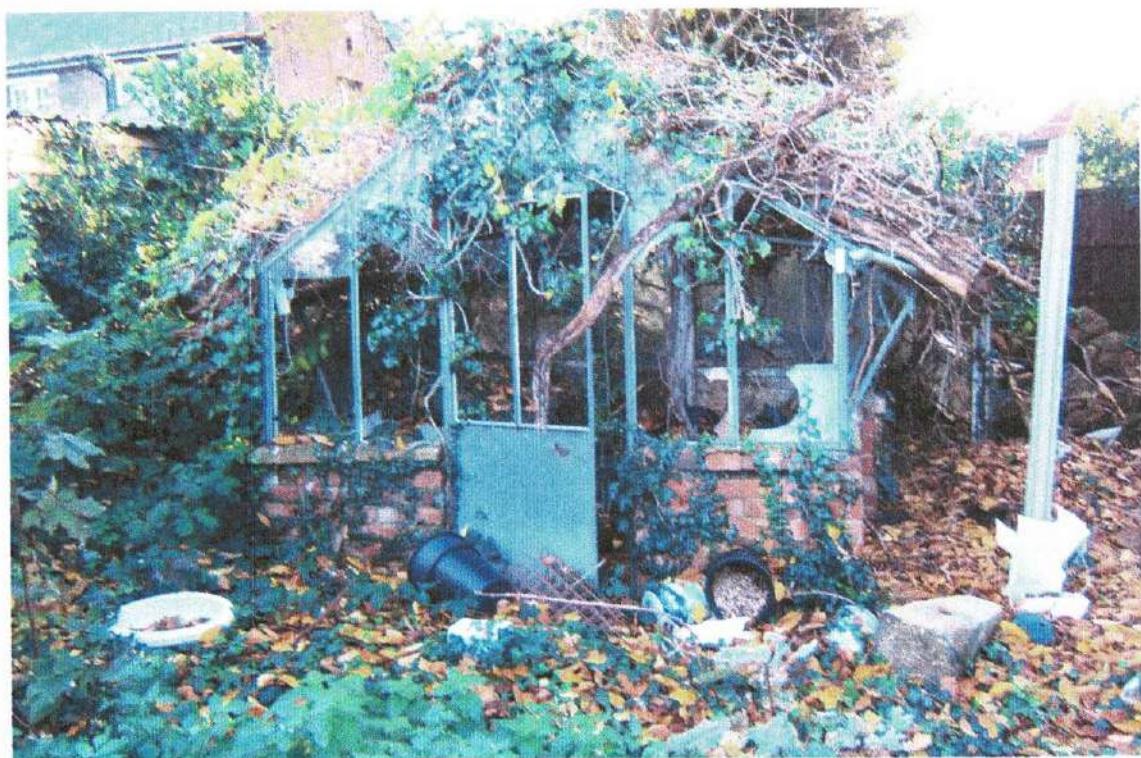
Plate 4

greenhouse set on brick walls was present within the site at its east end (Plate 4).

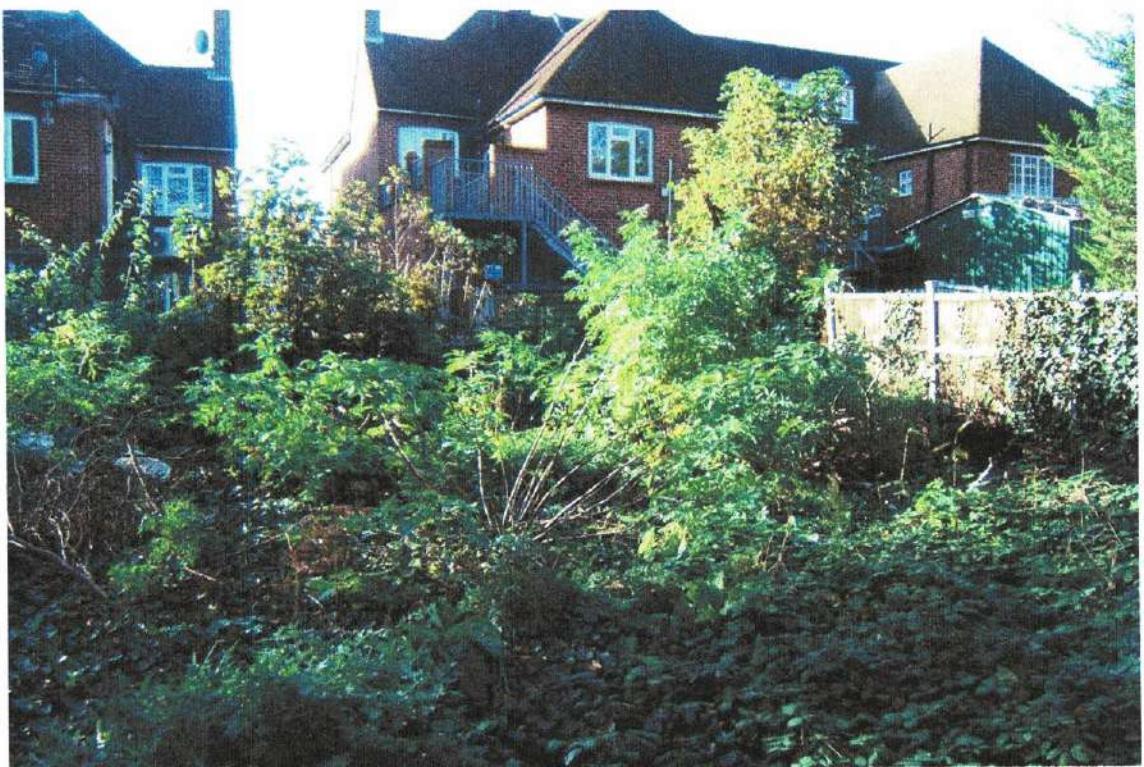
Plate 5

- 7.6 The site's south section comprised a relatively level area of former garden enclosed on its east and west sides by panelled timber fences and overgrown at its south end with Elder and Sycamore saplings (Plate 5). The site surface at the north end of the garden consisted mainly of exposed soil with mature Cherry and Yew trees being present in its northeast corner (Plate 6).

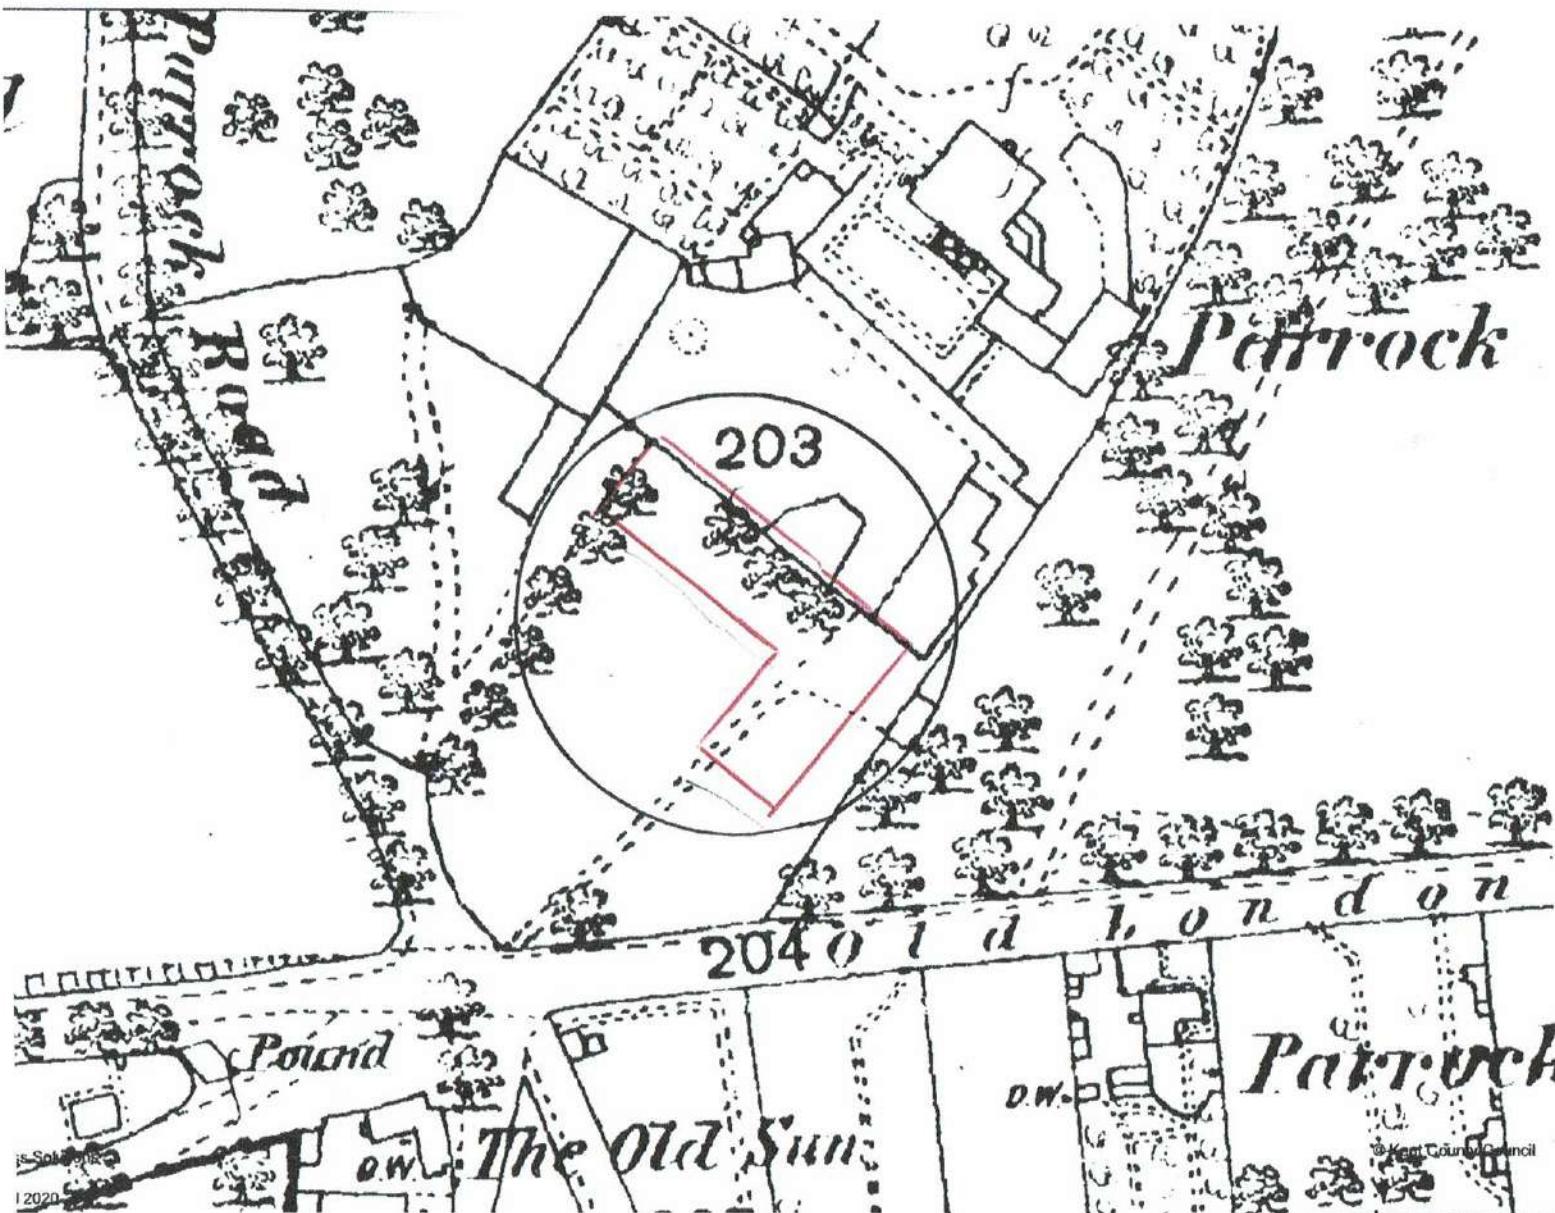
OS map scale 1:1250: 1871-1890.

5.2 OS map scale 1:1250 1871-1890:
On site: The site comprises vacant land located within the grounds of Parrock Manor.
Off site: The surrounding area comprises mainly undeveloped land with scattered dwellings, intersected by Parrock Road to the west and Old London Road to the south. A pond is in evidence alongside the site's north boundary and a rectangular building is located adjacent to its northeast corner. An additional building is present within 50m to the northwest.

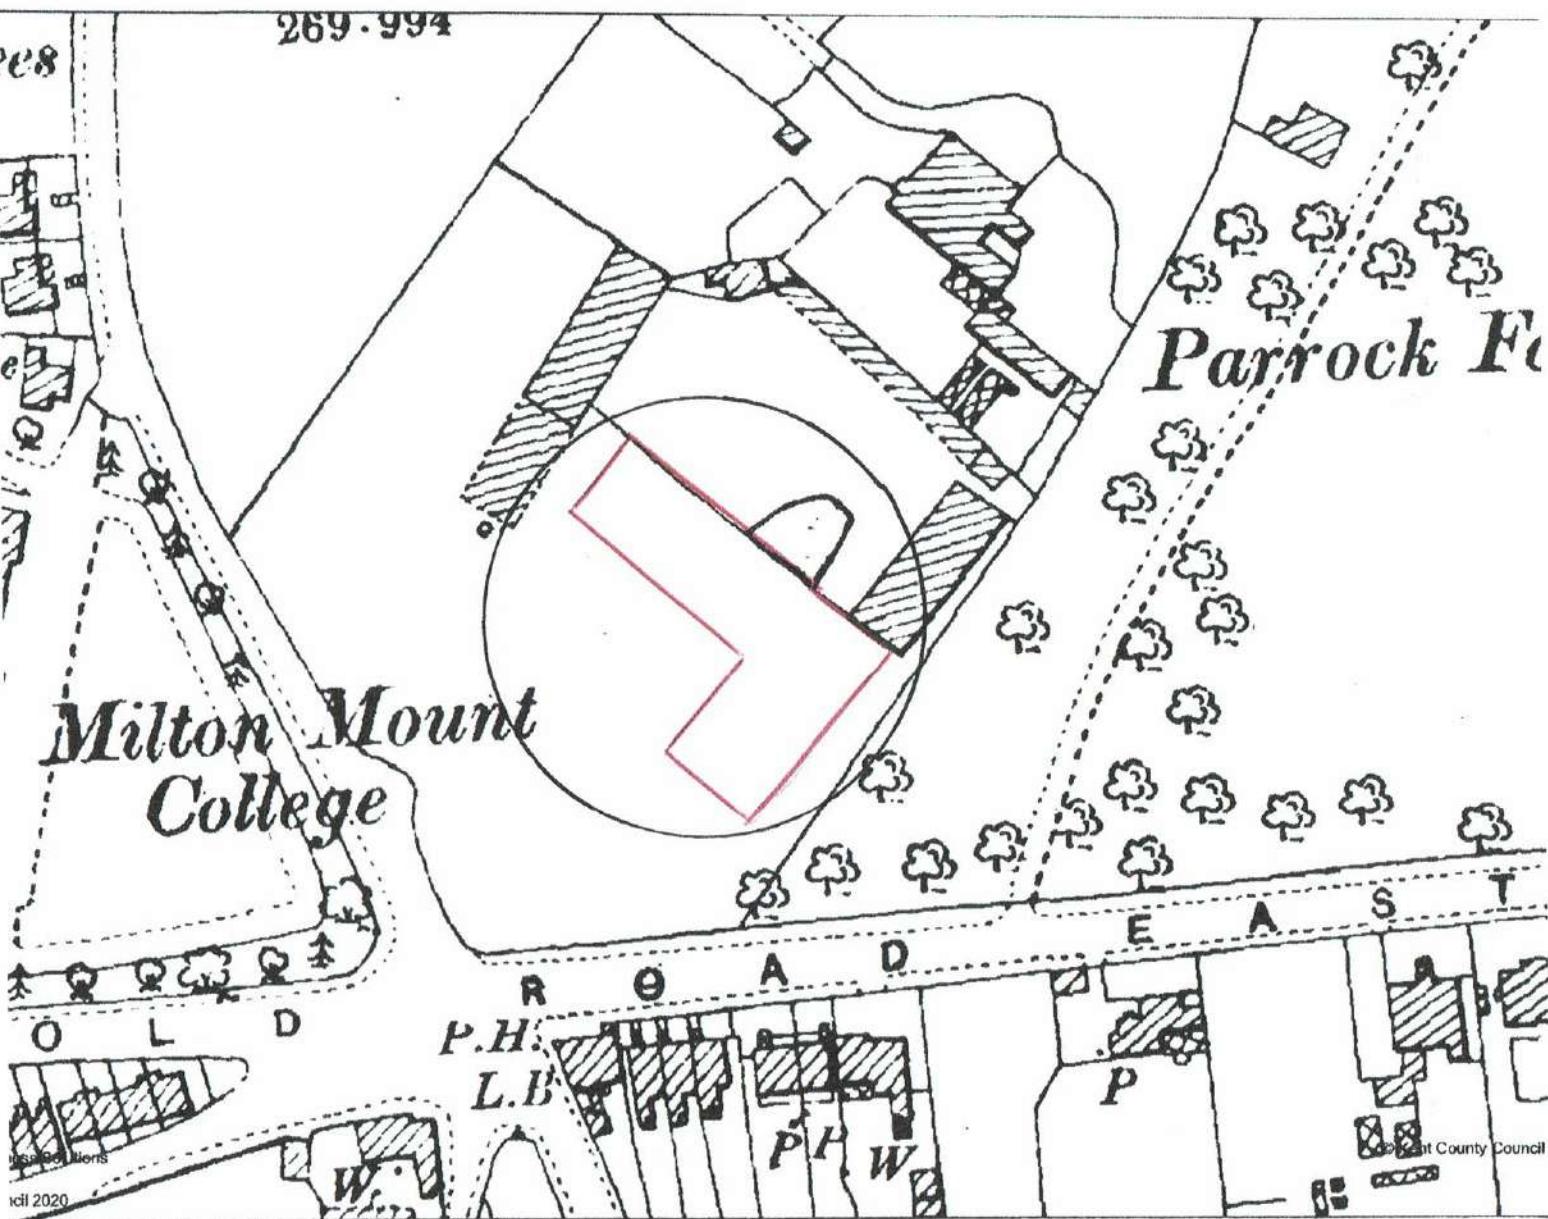
OS map scale 1:1250: 1897-1900.

5.3 OS map scale 1:1250 1897-1900:
On site: No significant change.
Off site: The building to the northeast has been enlarged at its north end, the building to the west also having been enlarged at its south end. Residential development in the form of terraced dwellings together with a public house has occurred on the south side of Old London Road, within 200m from the southeast corner of the site.

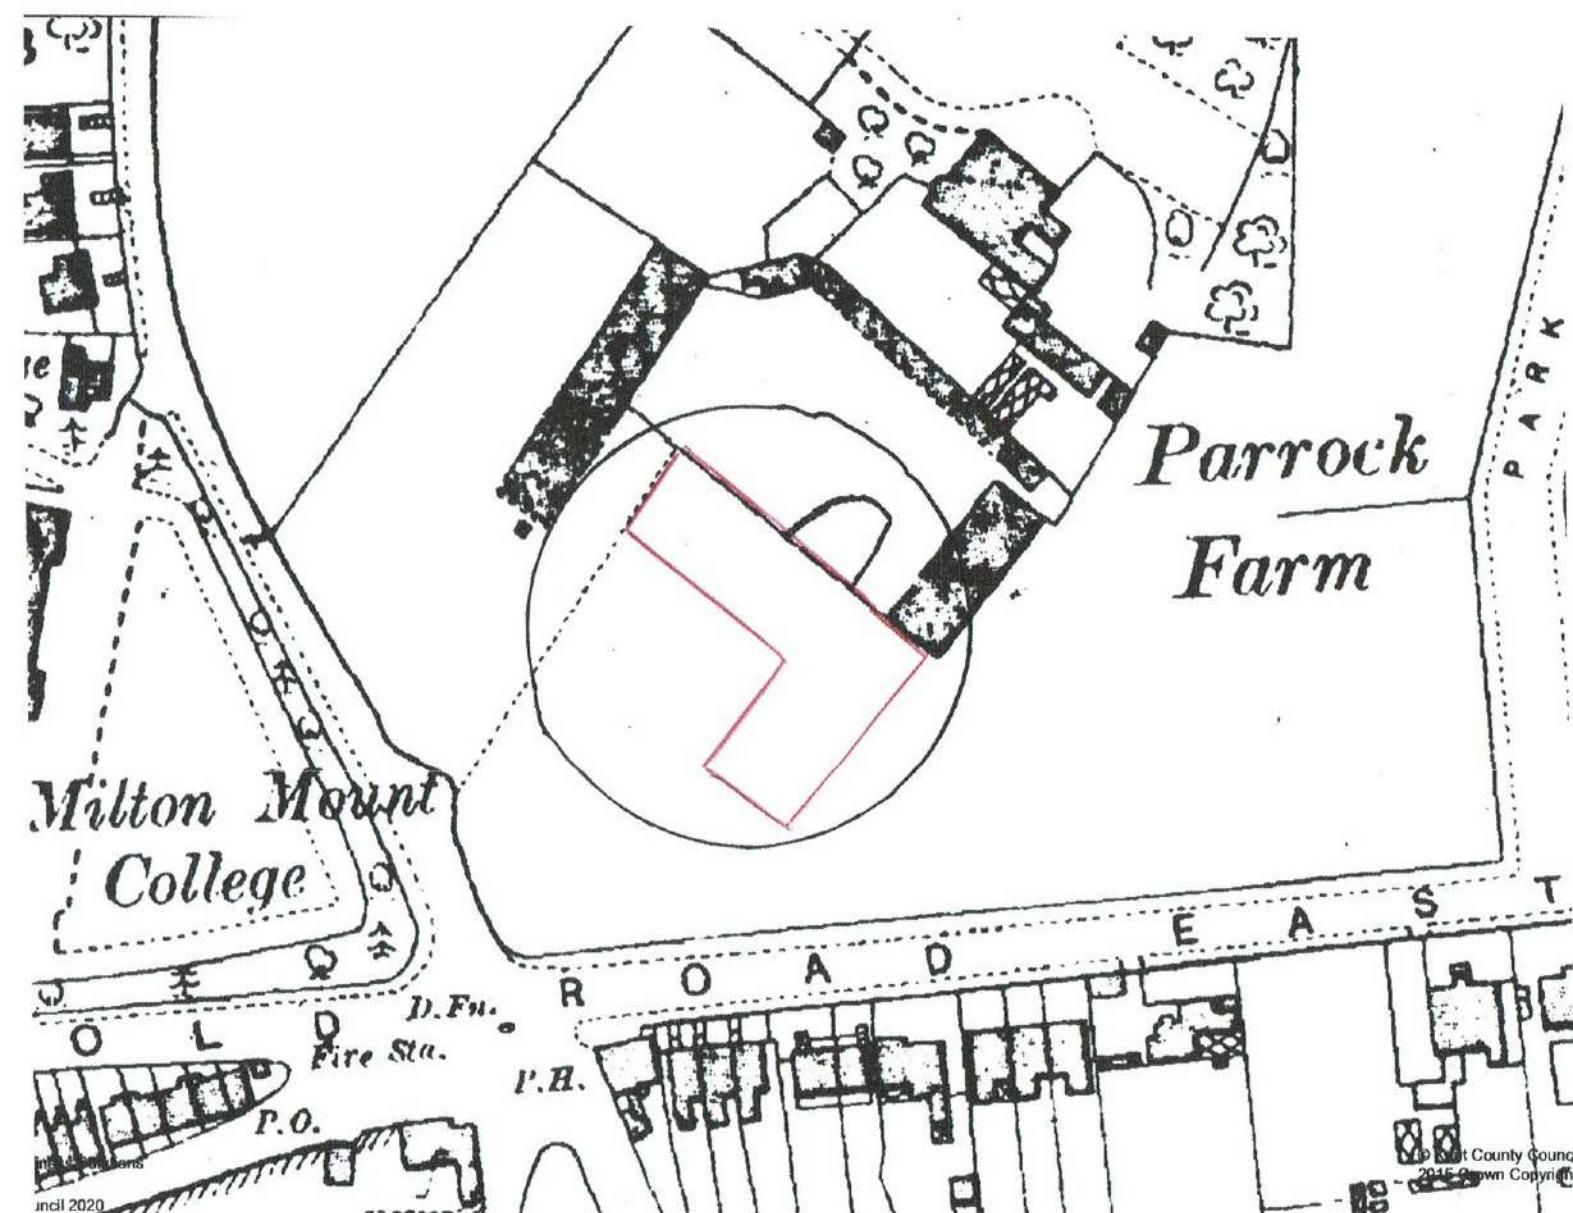
Land at Old Manor Drive, Gravesend.
OS map scale 1:1250: 1907-1923.

5.4 OS map scale 1:1250 1907-1923:
On site: No significant change.
Off site: Additional terraced dwellings have been constructed on the south side of Old London Road.

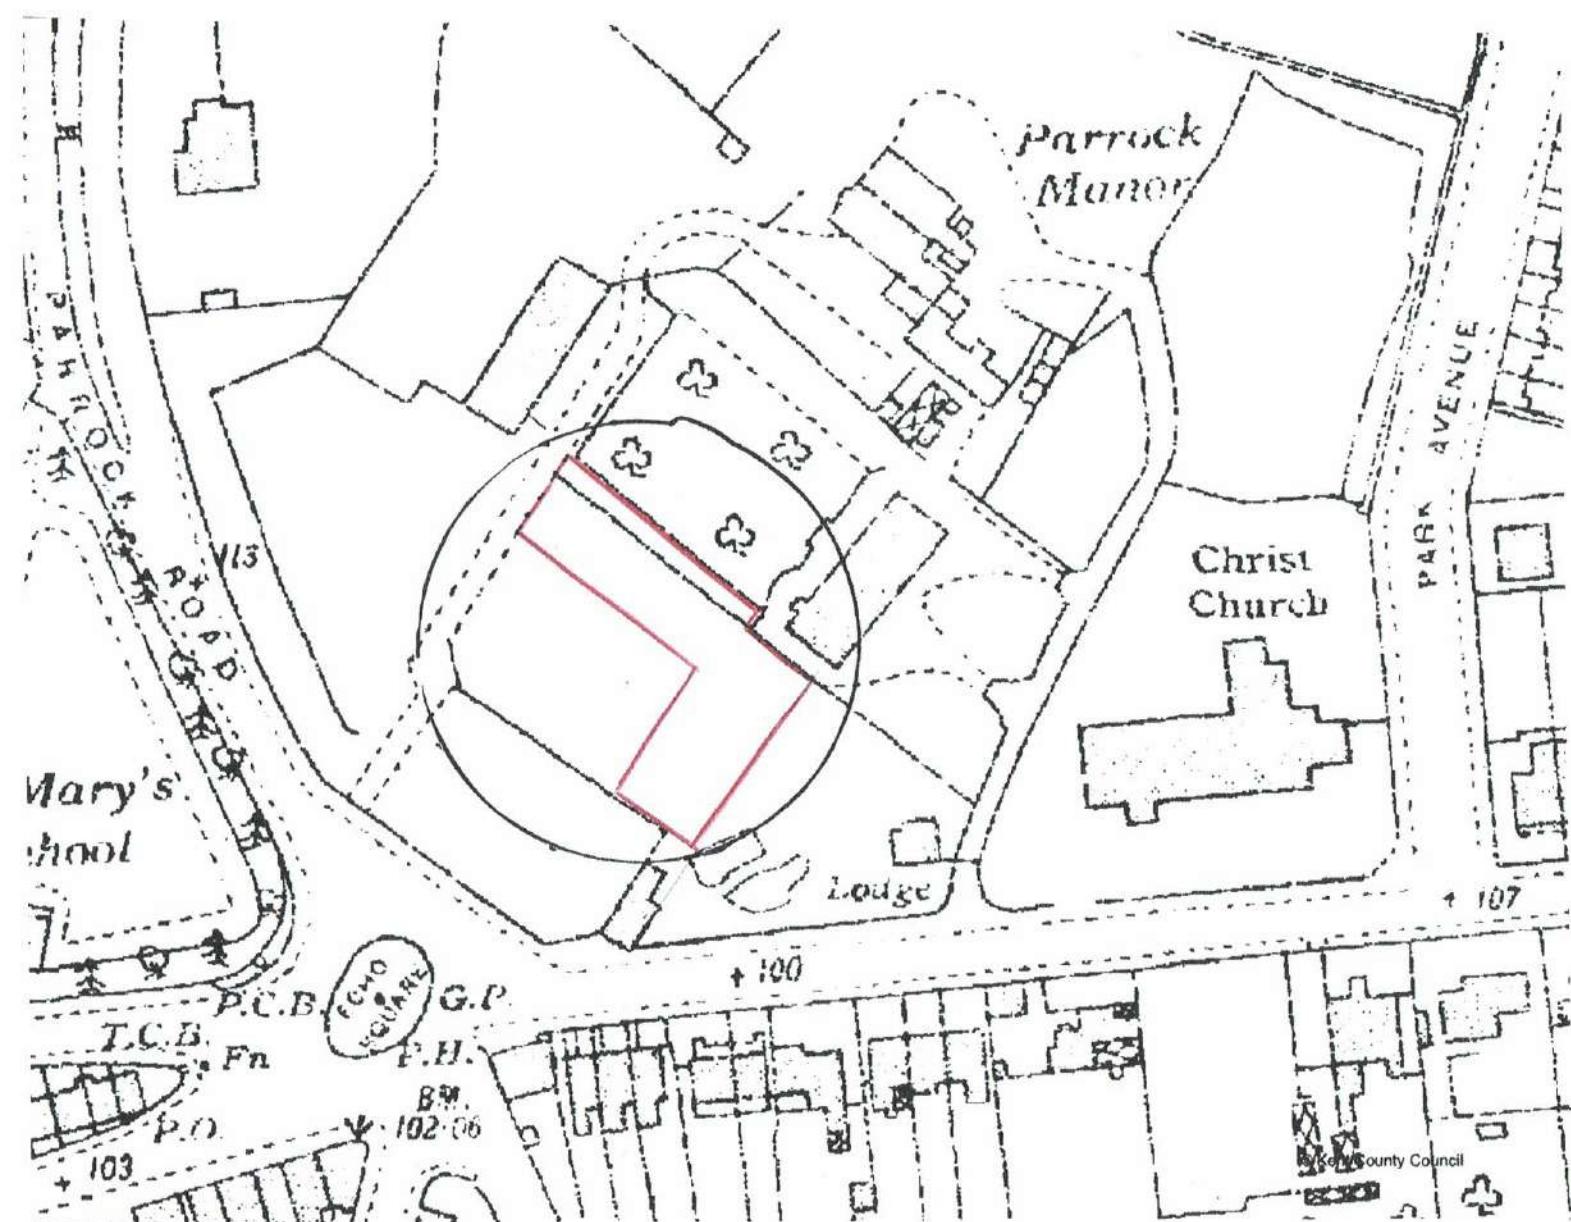
Land at Old Manor Drive, Gravesend.
OS map scale 1:1250: 1929-1952.

On site: No significant change.

Off site: The former pond to the north has been infilled. Two ponds and a building of residential appearance are denoted adjacent to the site's southeast corner. A church has been constructed within 150m to the east of the site.

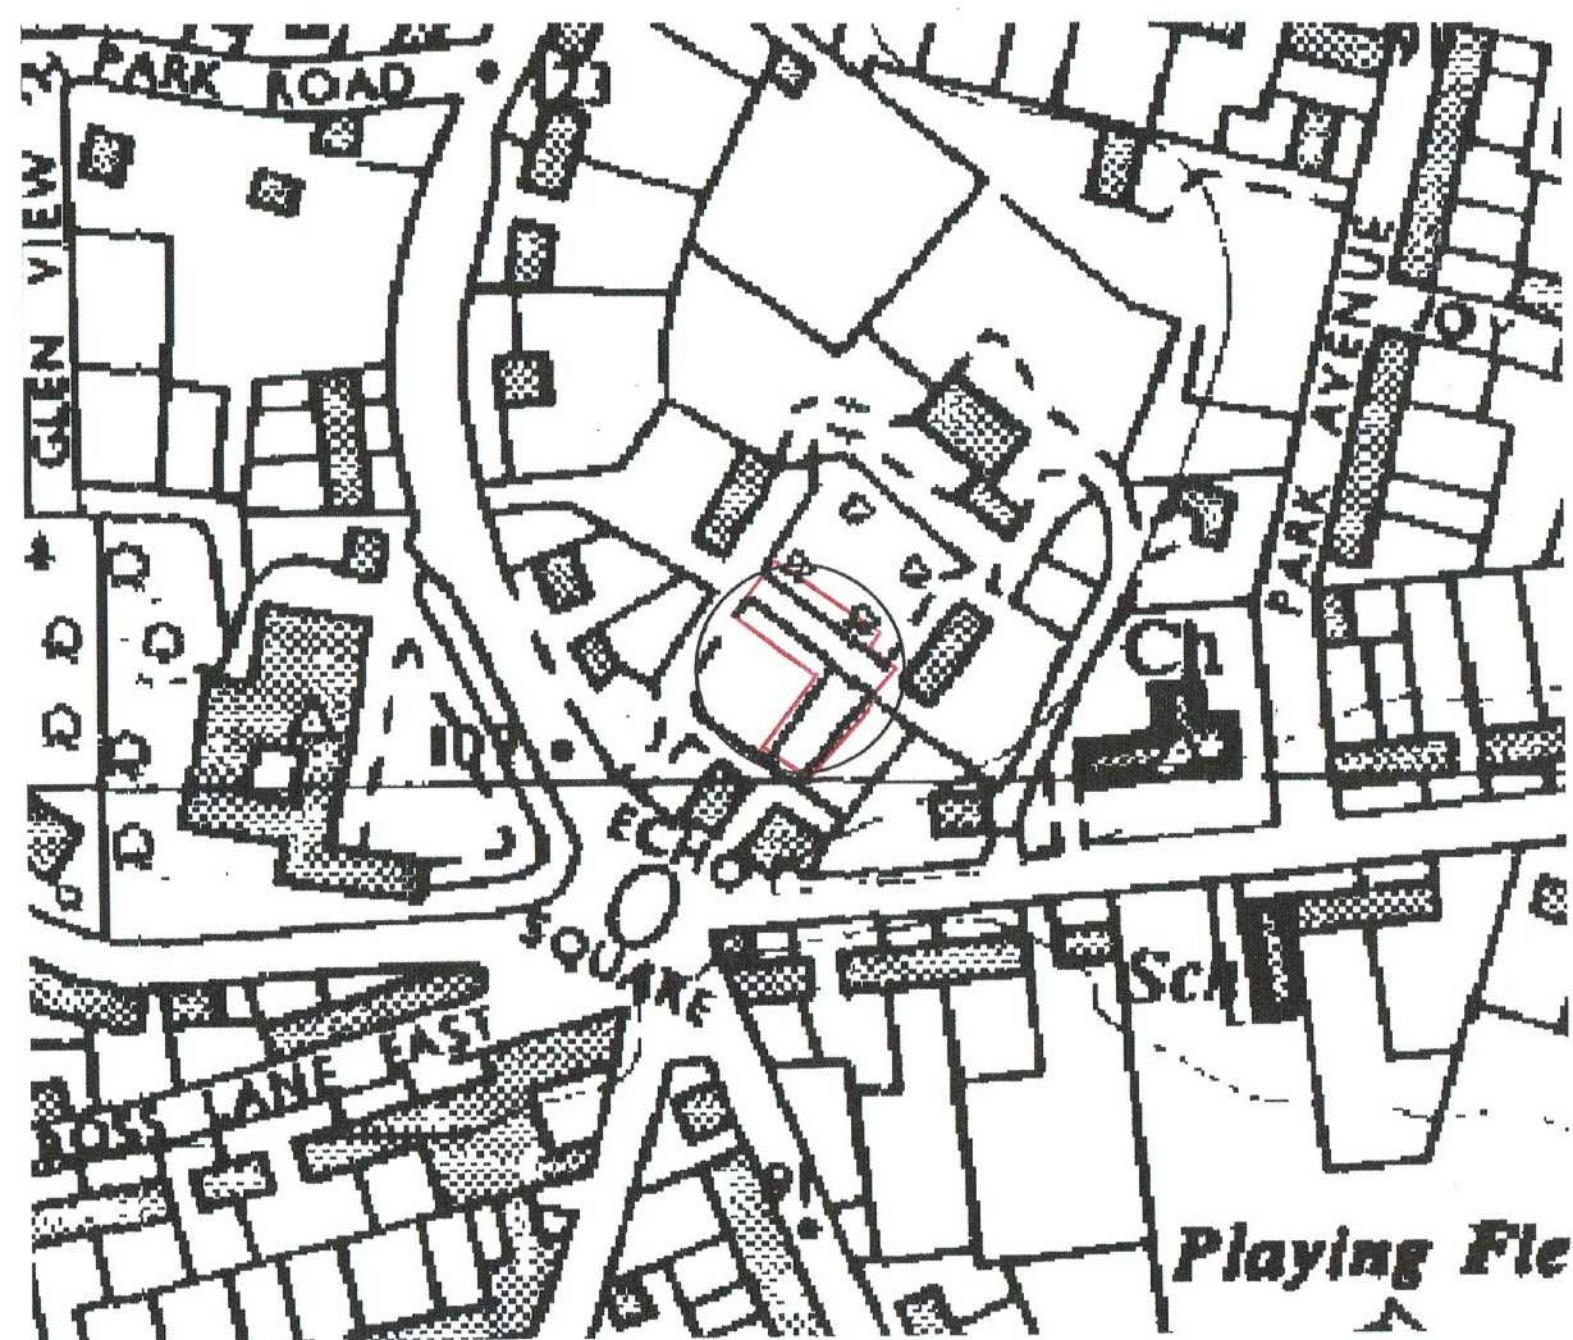
OS map scale 1:10560: 1961-1962.

On site: The site remains undeveloped though its north end now forms part of two neighbouring plots.

Off site: Extensive residential development has occurred within the area surrounding the site, a narrow track having been developed along the west boundary of the site. The ponds to the southeast have been infilled and developed with buildings. A school has been constructed within 250m to the southeast.

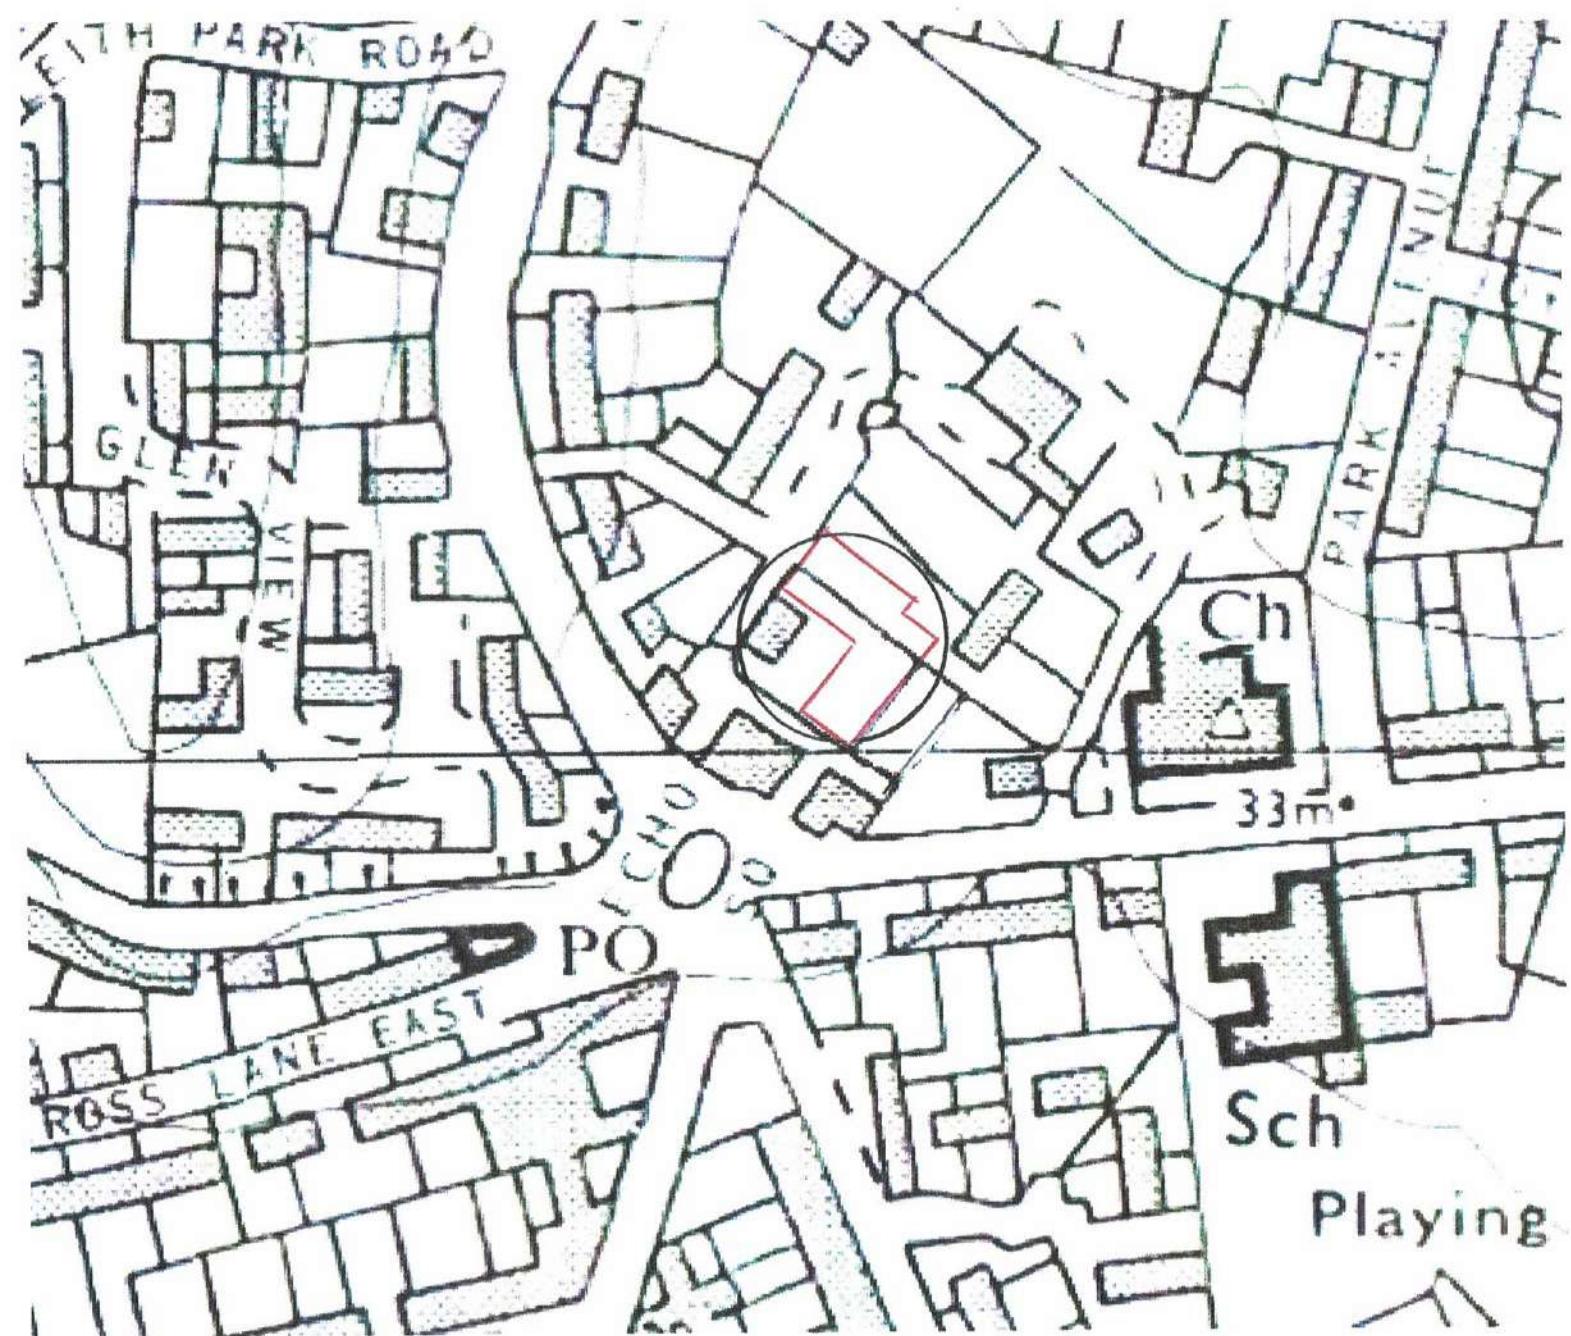
OS map scale 1:10000: 1980-1982.

On site: No significant change.

Off Site: A building of residential appearance has been constructed adjacent to the site's west corner. Further residential development has occurred within 400m to the north, south and northwest of the site.
