Preliminary Roost Assessment/ Ecological Impact Assessment (EcIA)

Section of 1-2 Stonebridge Road, Northfleet, Gravesend DA11 9DR

9th June 2025

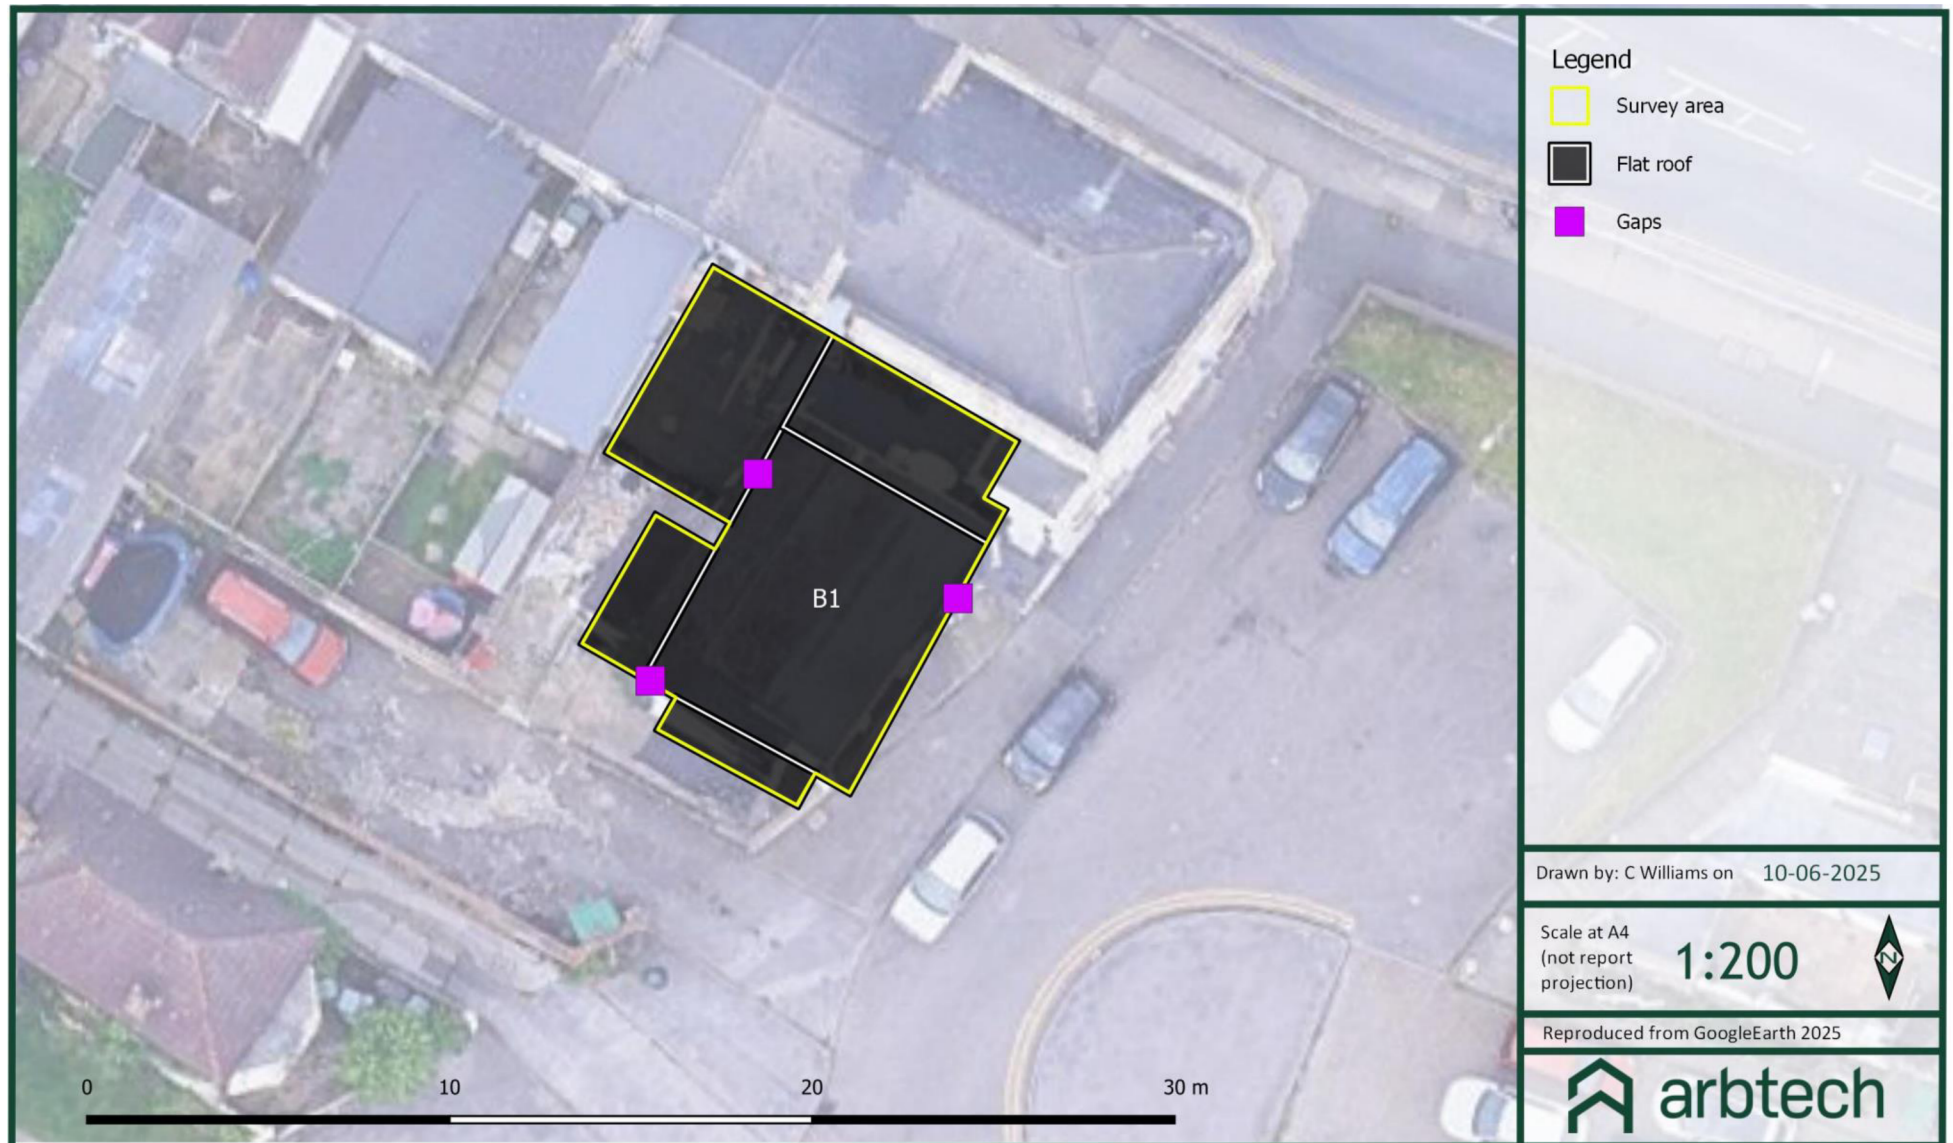
Appendix 1: PRA plan

<i>Summary of Survey Findings</i>	<p>There is one survey buildings on site, designated as B1.</p> <p>B1 is two storey, south-western extension section of a larger end-of-terrace residential and hot food takeaways building. The section B1 is comprised of a main flat roof, two sub flat roofs to the south-west and north-west as well as a single story flat roof to the north-east connecting it to the main building and used for rear access into its second storey.</p> <p>The flat roofs are all covered in intact felt, and the exterior walls are rendered without cracks or gaps. Timber fascia cladding is present around the eastern, southern and western sections of the building which is mainly intact but with small crevices and holes in three isolated areas. The northern elevation is tiled without gaps. Window and door frames are intact. No bat evidence is found anywhere on the external walls, which facilitated inspection being painted white.</p> <p>There are no loft spaces in the affected section, however there is a sealed former beer cellar under B1 without suitable access for bats. No bat evidence was found anywhere inside the cellar.</p> <p>No trees are found on site.</p>

<i>Recommendations</i>	<p>Further night surveys are considered disproportionate in this instance. Instead, a non-licensed precautionary working methodology (PWM) is recommended below:</p> <p><u>The PWM will consist of:</u></p> <p>A check of the fascia boards/roofing felt with a torch and endoscope from an elevated platform or scaffold by a licenced bat surveyor immediately before the main work commences for any live bats or bat evidence. If neither is found they will then give a 'toolbox talk' to the contractors present, and then supervise a soft-strip of the fascia boards/roof felt overhangs by hand, checking constantly for evidence and that no bats are being disturbed.</p> <p>If any bats or fresh bat evidence is found during this, all works will cease, and a bat license applied for. Night bat surveys in the active bat season of May-September may be required to support this.</p> <p>Once the supervision is completed and if no bats are found, no further mitigation is required.</p> <p>As enhancement measures, two woodcrete crevice bat boxes could be installed on or within the walls of the new building, (3-5m high, south or south-west side without illumination or obstruction).</p>

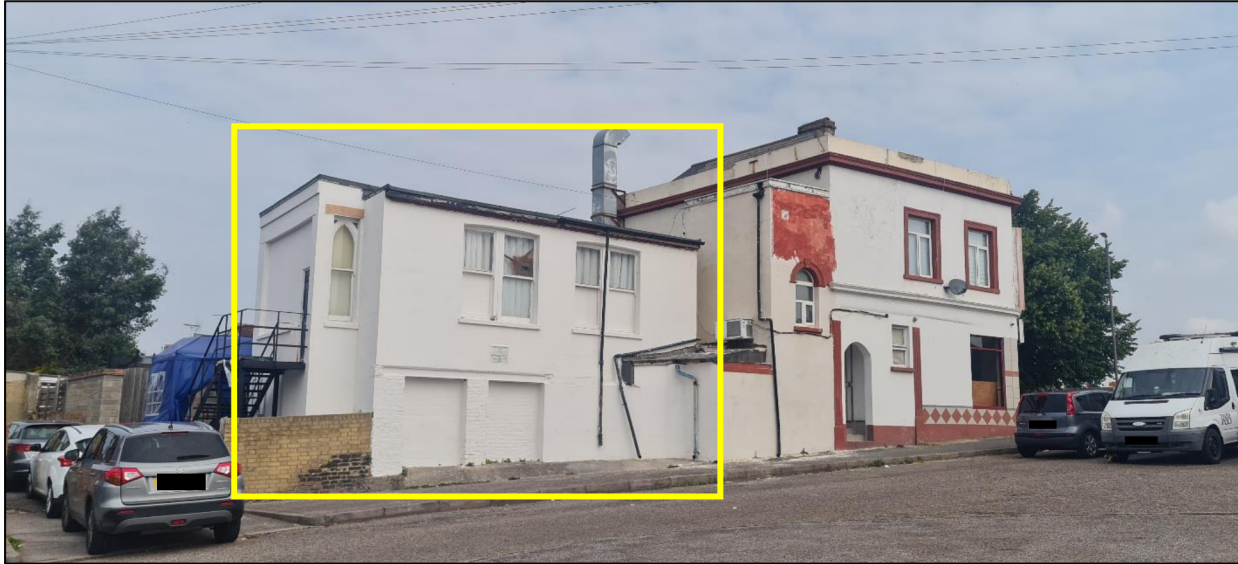
Photo 1: Looking north-west at B1
(the left, flat roofed section
highlighted).

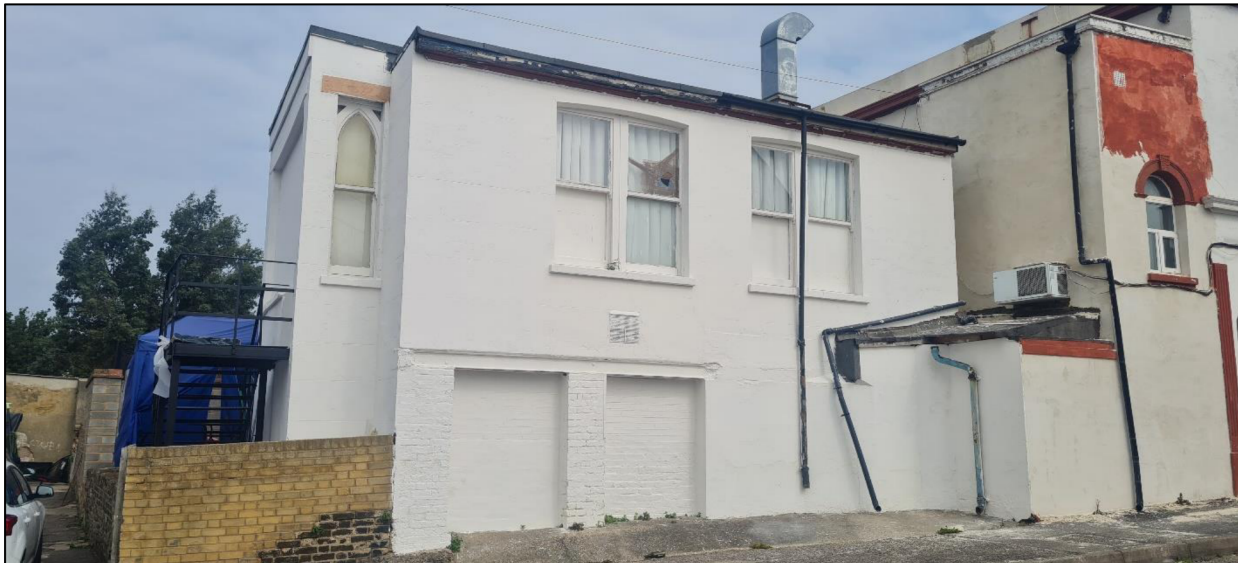
Photo 2: Looking north-west at the
eastern and southern elevations of
B1

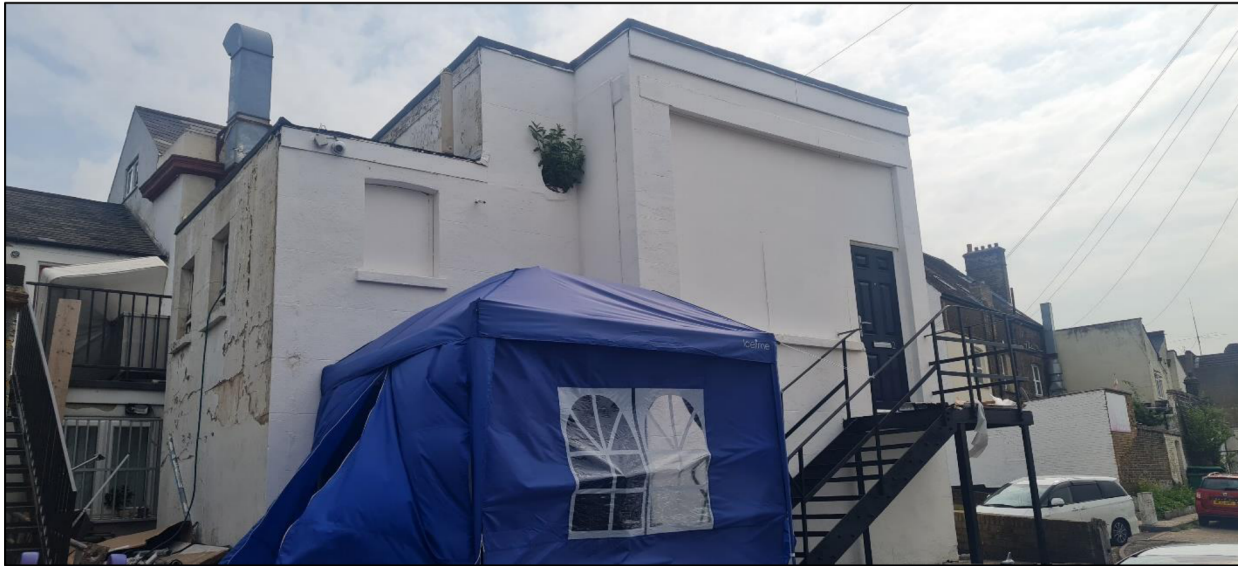
Photo 3: Looking north-east at the southern and western elevations of B1.

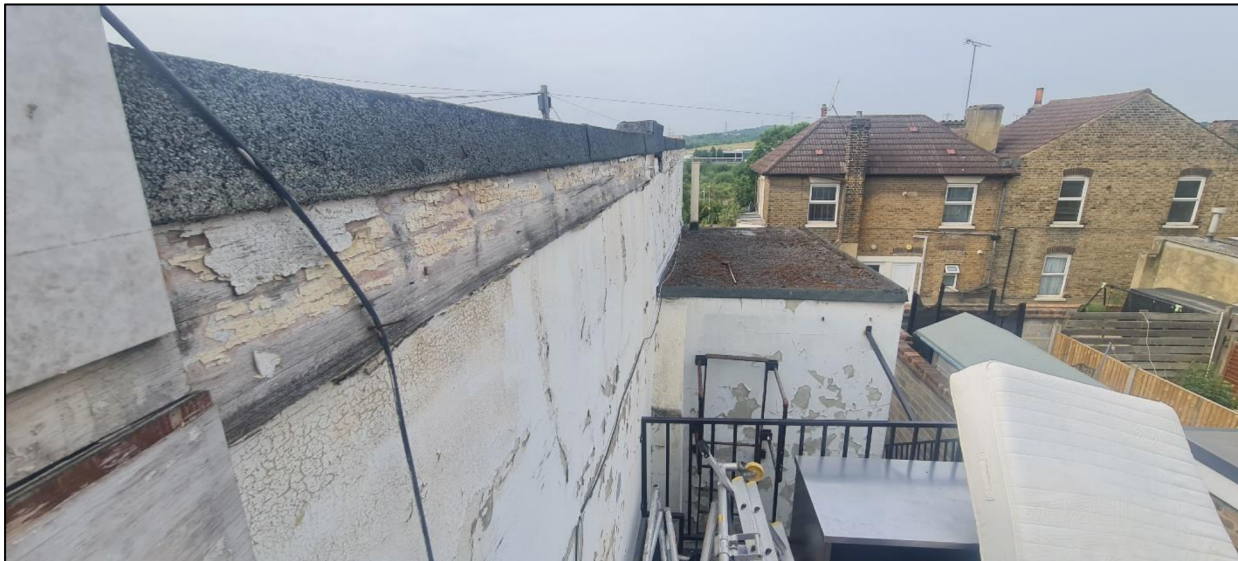
Photo 4: Looking south along the western elevation of B1.

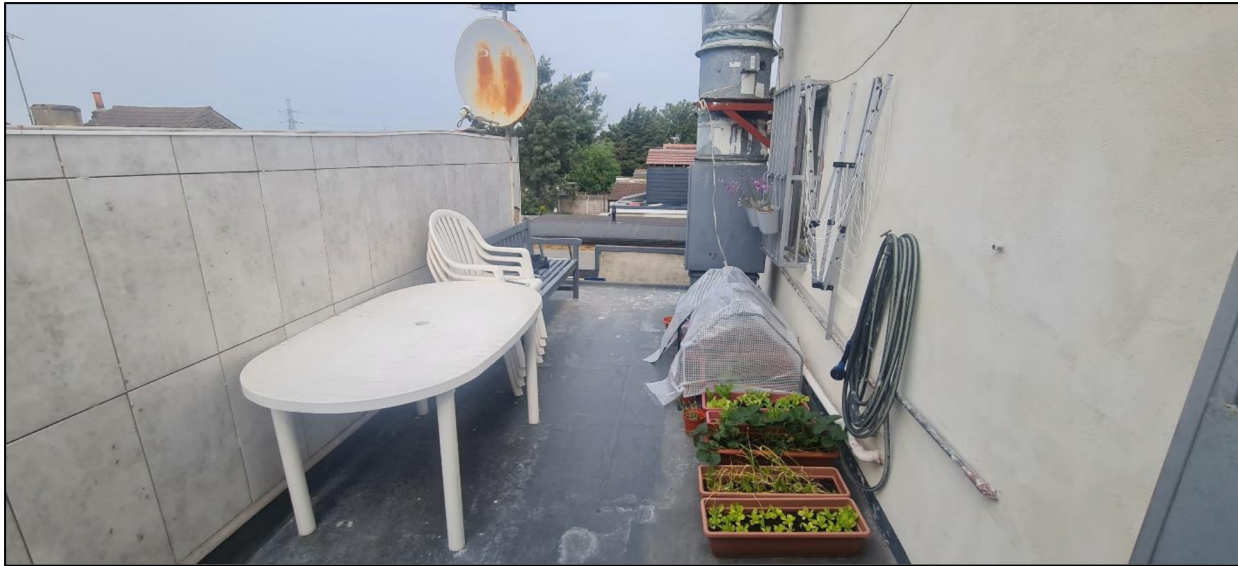
Photo 5: Looking east across the connecting flat roof section, between the northern part of B1 and the unaffected north building section.

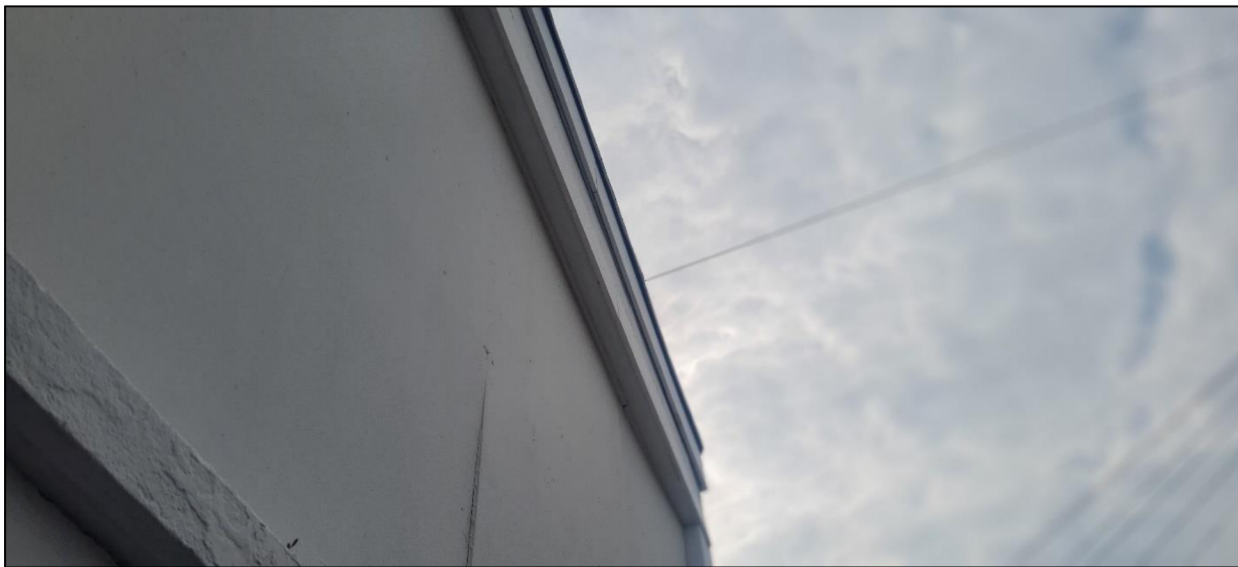
<i>Foreseen Impacts</i>	<p>Although the gaps in the fascia boards and under the roofing felt in places are theoretically of use by crevice-dwelling bats, the immediate local area is not of particularly good habitat quality, and no bat roosts are roosts suspected likely within the isolated building defects due to a total lack of bat evidence around and underneath - therefore no impacts on roosting bats are foreseen if basic mitigation measures are followed.</p>

Photo 6: Small gap seen under fascia on southern elevation of B1.

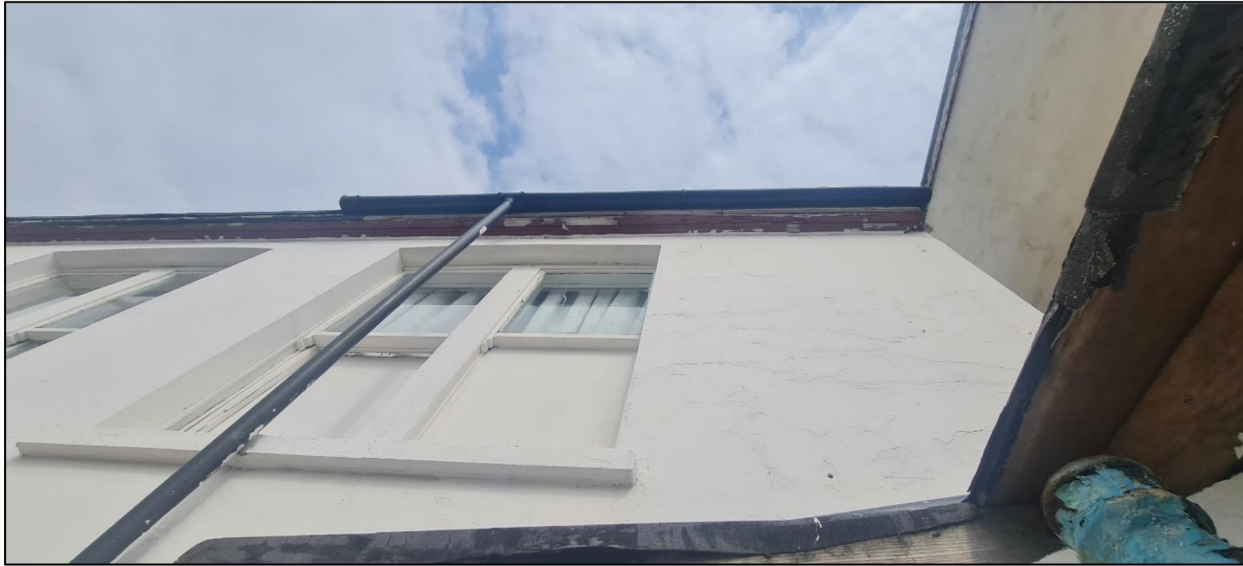
Photo 7: Small gap seen under fascia on eastern elevation of B1.

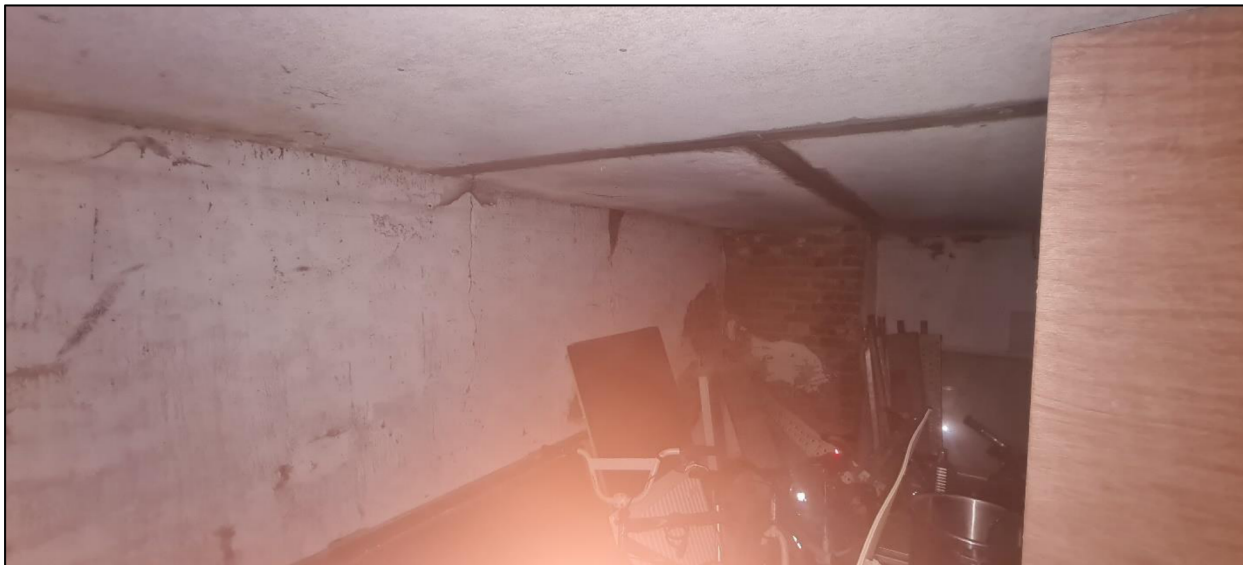
Photo 8: Inside the small, sealed basement of B1.
