**Natwest Gravesend  
30 King Street  
Gravesend  
Kent  
DA12 2XX**

## **Heritage Statement**

Date: December 2022

Our Reference: 22-184-AS-HS

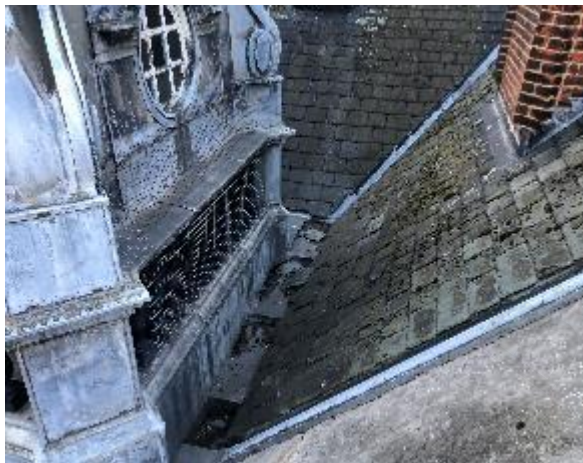
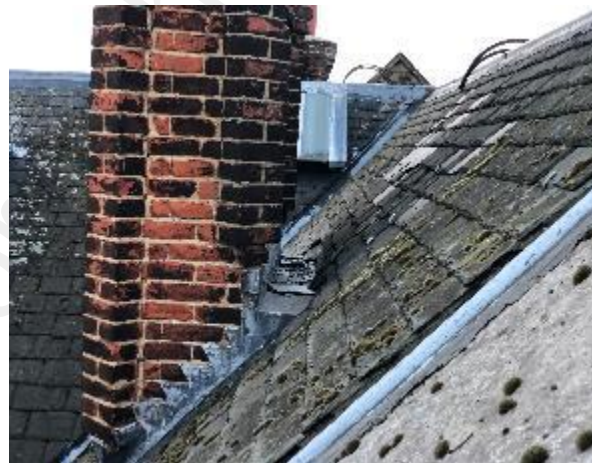
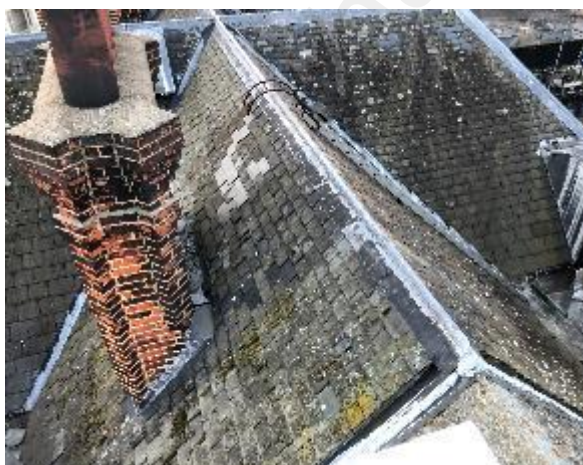
Slipped and broken slates to main roof

Where required, roof slates are to be replaced with *Westmoreland* substitutes, to be reclaimed. All slates are to be re-hung to match existing coursing.

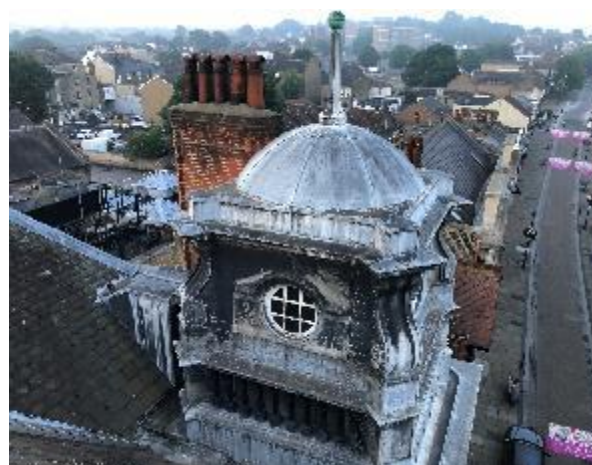
Poorly dressed leadwork to turret

The roof is constructed with a number of valleys weathered in lead which discharge into channel gutters. These appear to be the principal source of the water ingress being experienced. It is recommended they be re-lined as part of the planned refurbishment works. Upon stripping the natural slate covering, allowance has been made to retain the existing slates, with a nominal allowance for approximately 25% replacement. A similar allowance has been made for timber repairs, the installation of mineral wool insulation, a breathable membrane and new timber battens. Valley, hip and lead detailing should also be renewed together with the refurbishment of the leadwork to the timber framed turrets.

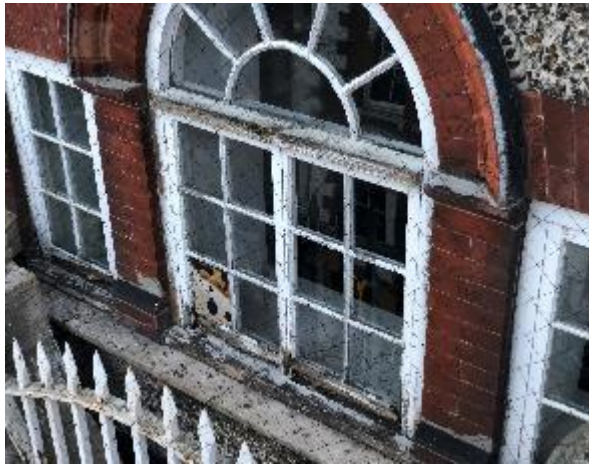
Broken window pane

In addition to the roofing works, it is recommended the elevations to King Street and Windmill Street be part refurbished; including the undertaking of sympathetic cleaning, isolated stone repairs and decoration of previously coated items. These works include repairs to the timber and metal framed windows, rainwater goods and bracketry.

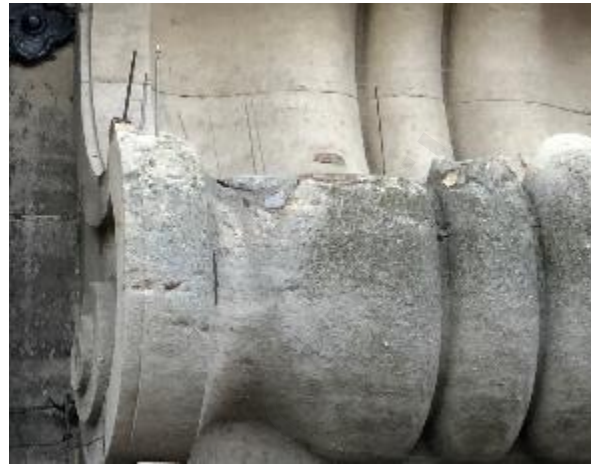
Spalling stonework

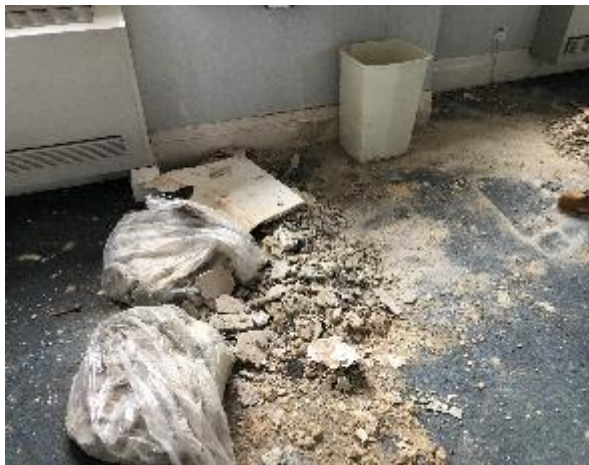
Large amounts of debris from water ingress

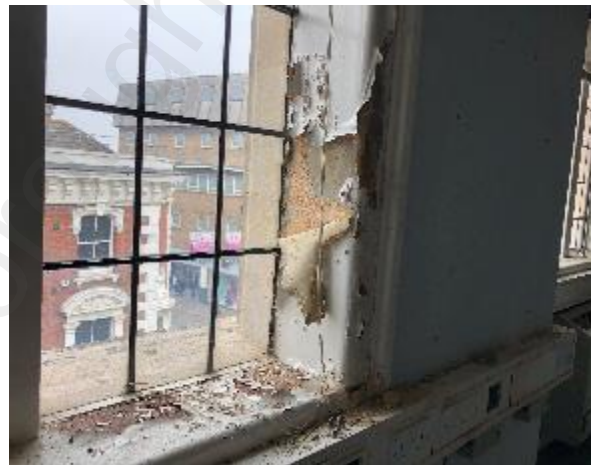
Spalling of plasterwork

Internally, it is proposed the affected areas of the accommodation at second floor level be stripped out, including the suspended ceilings and electrical installation. Defective and delaminating plaster should be removed in order to allow any trapped moisture to be expelled. Removal of the suspended ceiling will result in a loss of artificial lighting and it is recommended wall mounted lighting be installed together with surface mounted wiring in PVC mini-trunking.

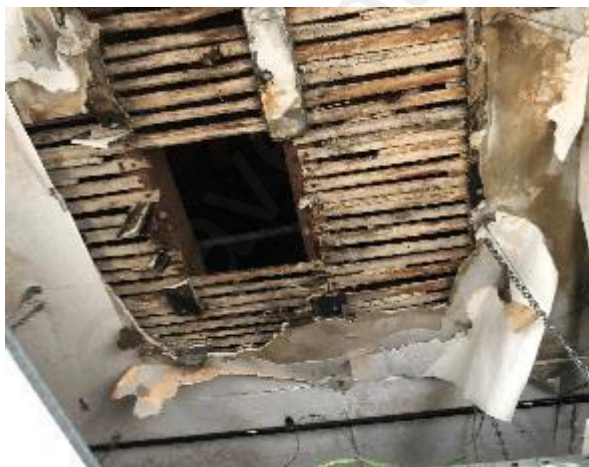
Rot infestation to ceiling

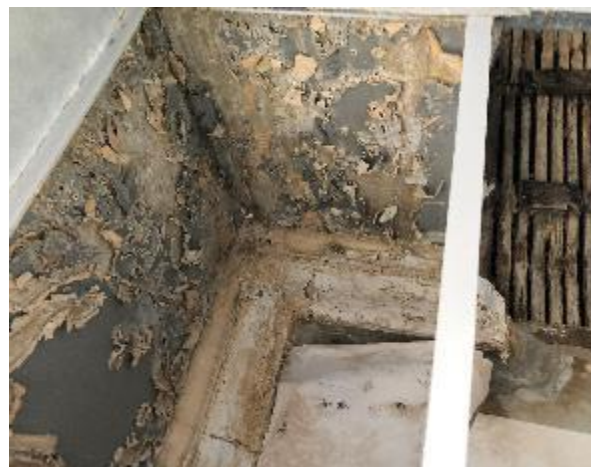
Spalling of plasterwork
