REPAIR WORKS

Job Title: MEOPHAM GREEN CHURCH  
WROTHAM ROAD  
MEOPHAM  
KENT  
DA13 0QA

Dwg Title: PART PLAN & ELEVATIONS  
AS PROPOSED

Dwg No.: 05

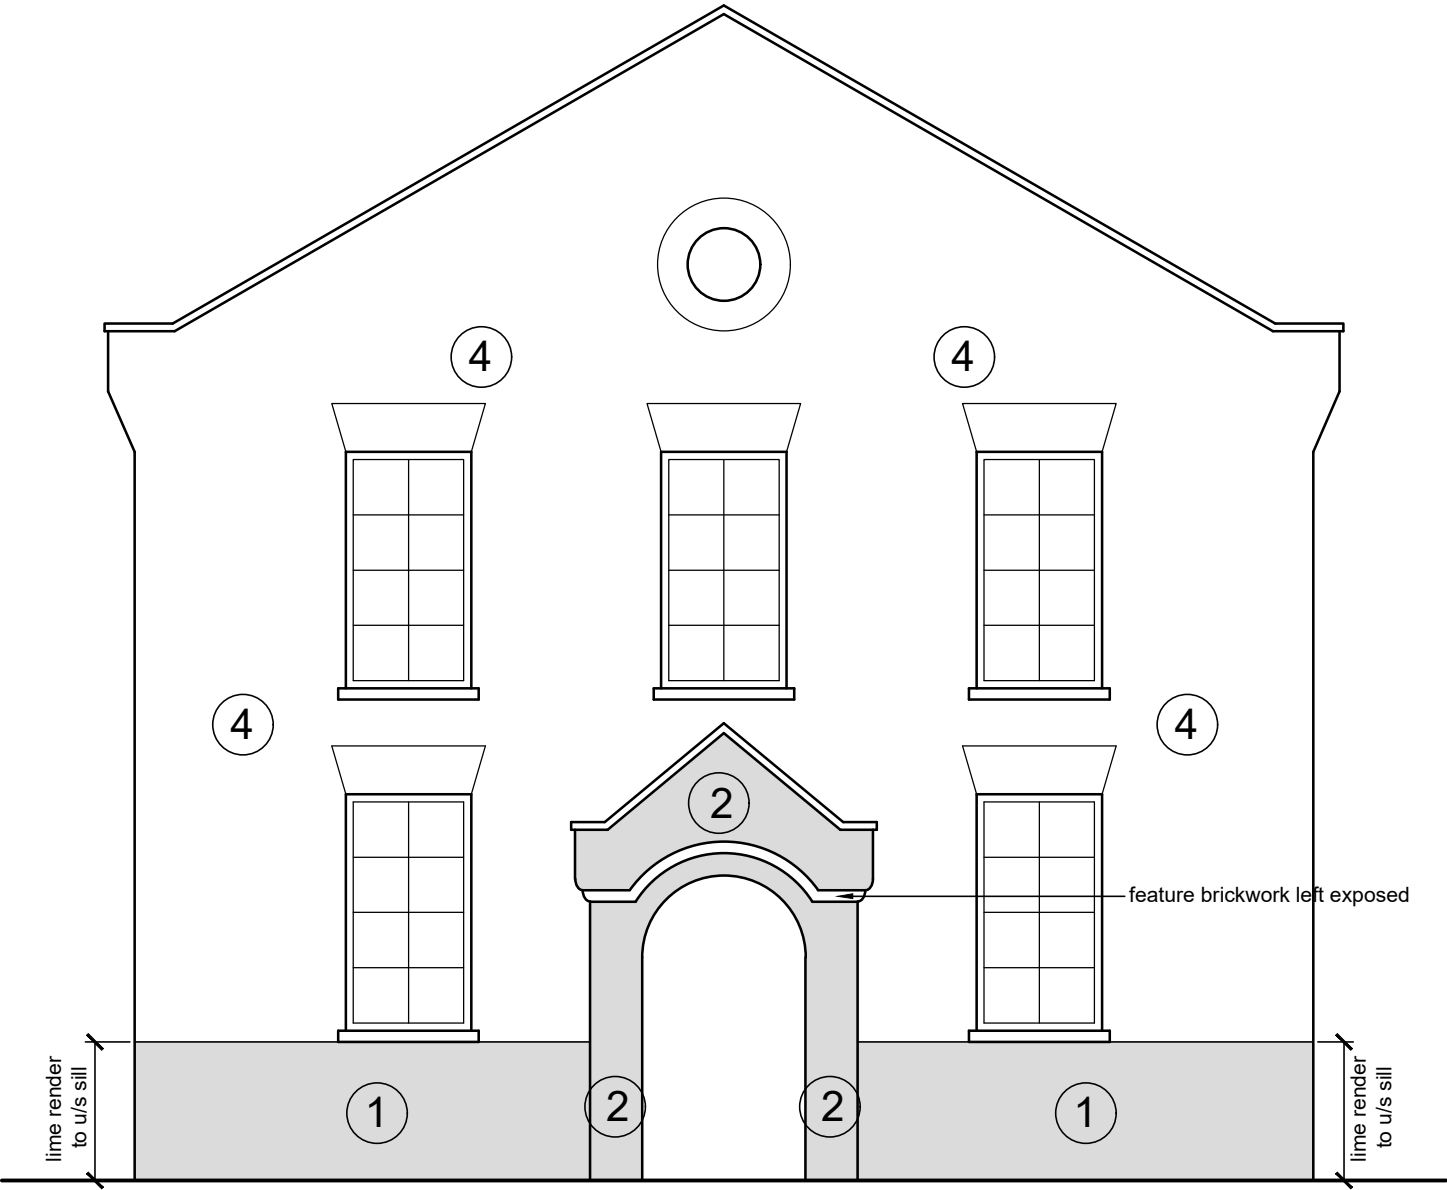
FRONT (EAST) ELEVATION  
(1:50)

- The render has been struck with ashlar pointing and a paint finish
  - Photographic evidence indicates that this elevation has been render for a number of decades

- Probably due to disproportionate movement, the render is now damaged with areas of cracking and delminating from the brickwork wall.
  - The existing render will be removed (not including recent rear extension) and a new lime mortar based render will be applied to the same area.

- 1
- PLINTH
  - Prepare existing brickwork and apply suitable lime render
  - Prepare renered and paint suitable lime paint
- 2
- PORCH (ALL EXTERNAL ELEVATIONS)

- Prepare existing brickwork and apply suitable lime render leaving feature brickwork exposed
  - Prepare renered and paint suitable lime paint
- 3
- PORCH (INTERNAL)

- 4
- UPPER FACADES
  - Remaining upper facades of front elevation to retain cleaned brickwork
