LOGGIA REPAIR:

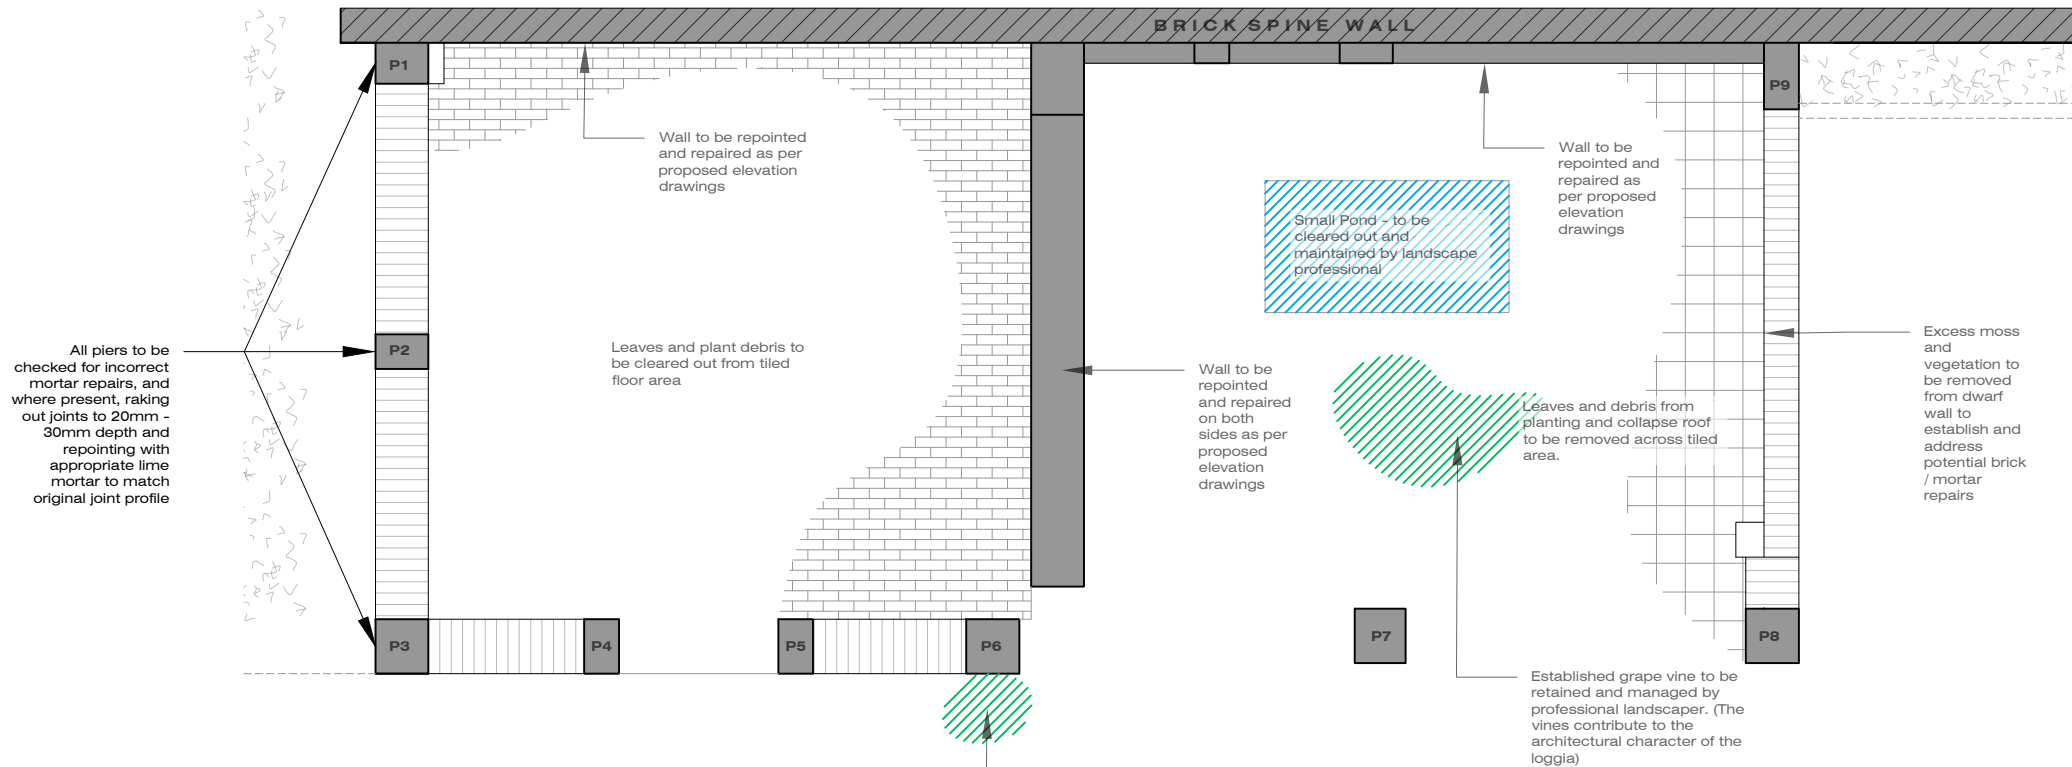
PROPOSED GROUND FLOOR PLAN

Exposed brickwork and mortar joints will be cleaned and inspected to identify areas of inappropriate cement repairs, missing mortar, or damaged brickwork. (All brick piers - from P1 to P9 as annotated on the drawing have areas of incorrect mortar repairs.)

Ground Floor Repair -

All leaves and debris will be cleared from floor areas. The collapsed timber structure and remaining sections of the existing roof will be carefully dismantled to allow full access to the loggia and adjoining masonry.

Existing planting will be cut back where necessary by a qualified landscape professional. Vegetation will be retained where appropriate and reinstated once the new roof structure is in place.

Defective joints will be carefully raked out and repointed in lime mortar to match the original composition. A mortar sample will be taken from deep within the existing joints and analysed to ensure an accurate match.

Where bricks are missing or severely damaged, replacements will be introduced using reclaimed bricks to match the existing in size, colour and texture.

Concentrated areas of spalled brickwork (as identified on the elevation drawings) will be addressed through careful removal and, where possible, turning of bricks to expose sound faces. Where this is not feasible, matching reclaimed bricks will be used.

Cracks in the masonry, as identified on the elevation drawings, will be repaired in accordance with the structural engineer's report, including localised rebuilding where required and stitching with stainless steel Hellfix bars at every third course.

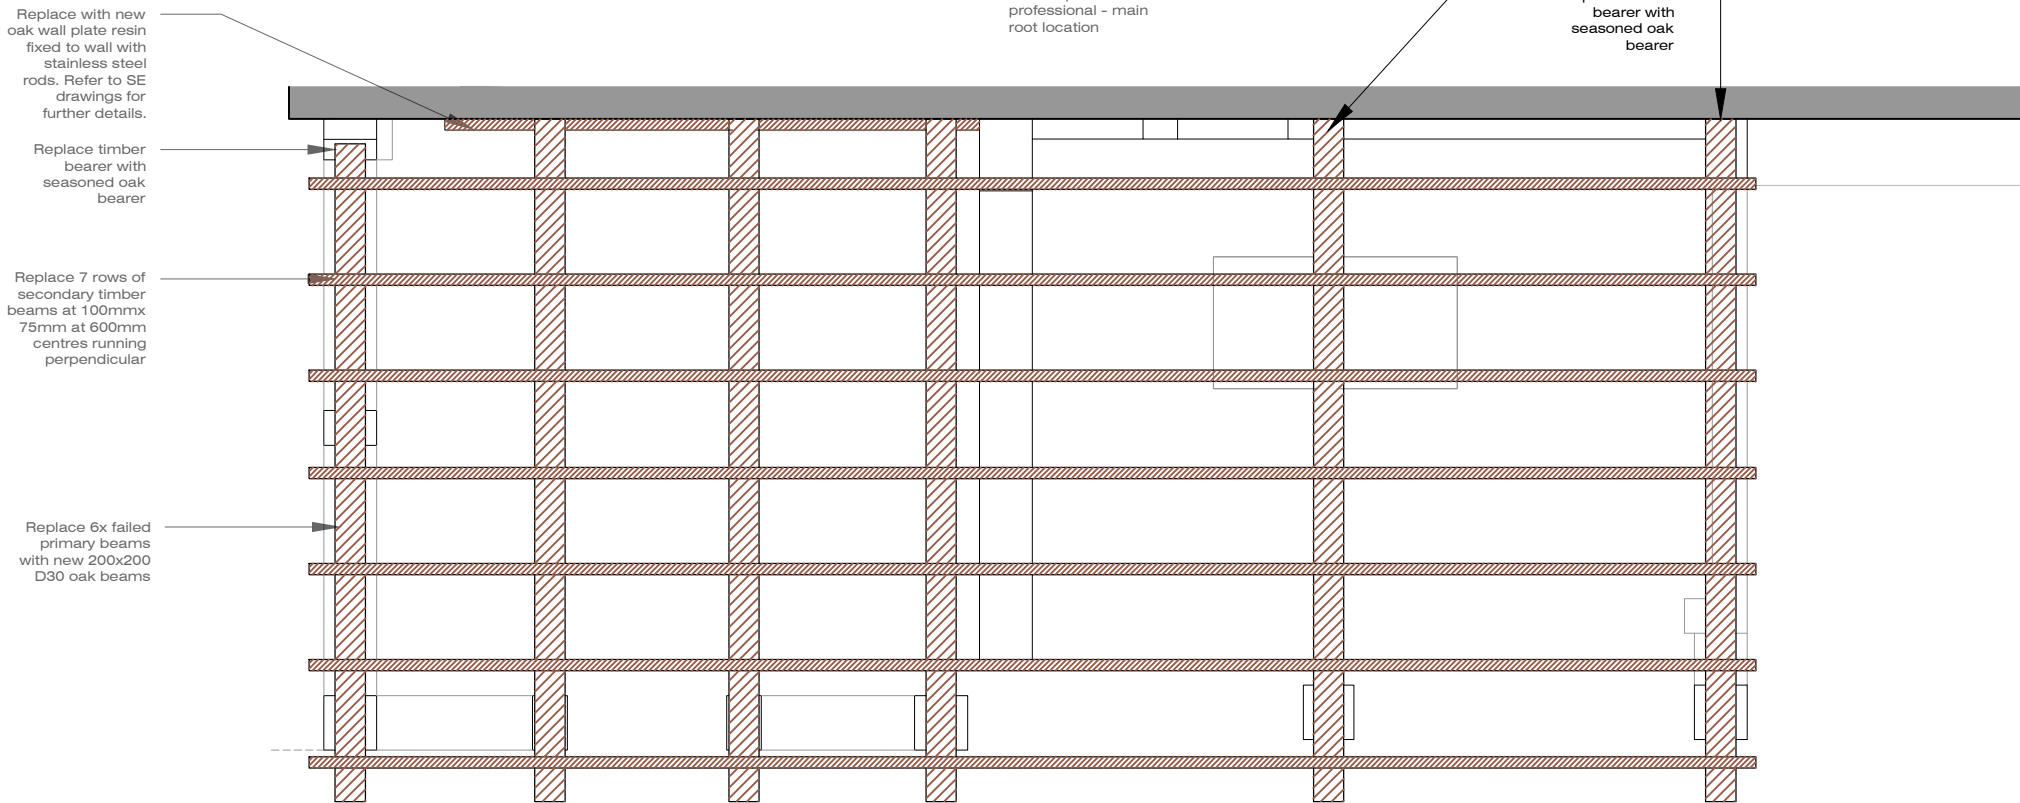
PROPOSED ROOF PLAN

All corroded iron brackets currently built into the garden wall will be removed to prevent further corrosion jacking.

Once existing timber structure has been safely removed and the masonry repairs have taken place, the new roof structure can be installed on a like-for-like basis in terms of design arrangement and materials, with improved structural capacity.

The primary beams will be increased from 150 x 150mm to approximately 200 x 200mm to provide adequate strength for the span and the imposed load of mature planting.

Secondary rails will remain of similar proportions (approximately 100mm wide x 75mm deep) but will be formed in oak to improve durability.

A new timber wall plate will be installed and fixed using stainless steel fixings to avoid future masonry damage.

The rebuilt structure will retain the historic character and planting function of the loggia while ensuring it is structurally sound and fit for purpose.
