**McCARTHY & STONE RETIREMENT LIFESTYLES LIMITED**

**GRFC BOWLS CLUB, CHURCH WALK, GRAVESEND, KENT, DA12 2TU**

**GROUND INVESTIGATION REPORT**

April 2024  
Report No. CCL03525.CU18

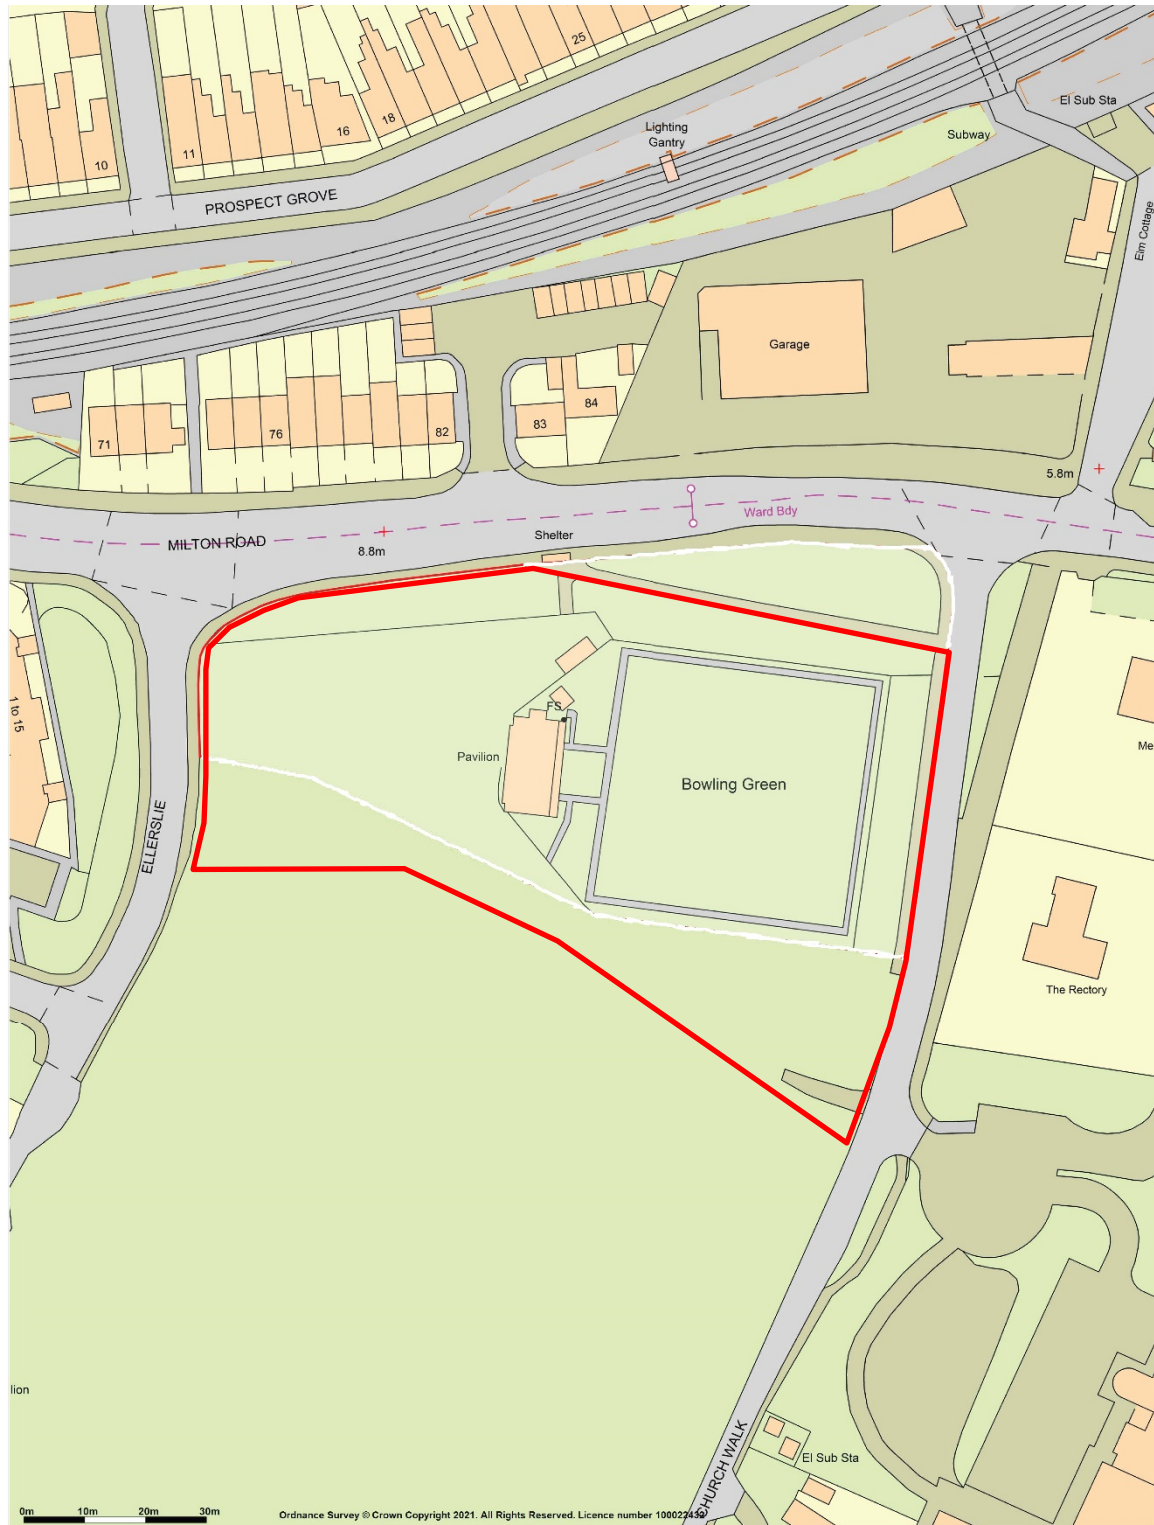
FIGURE 2

**SITE PLAN**

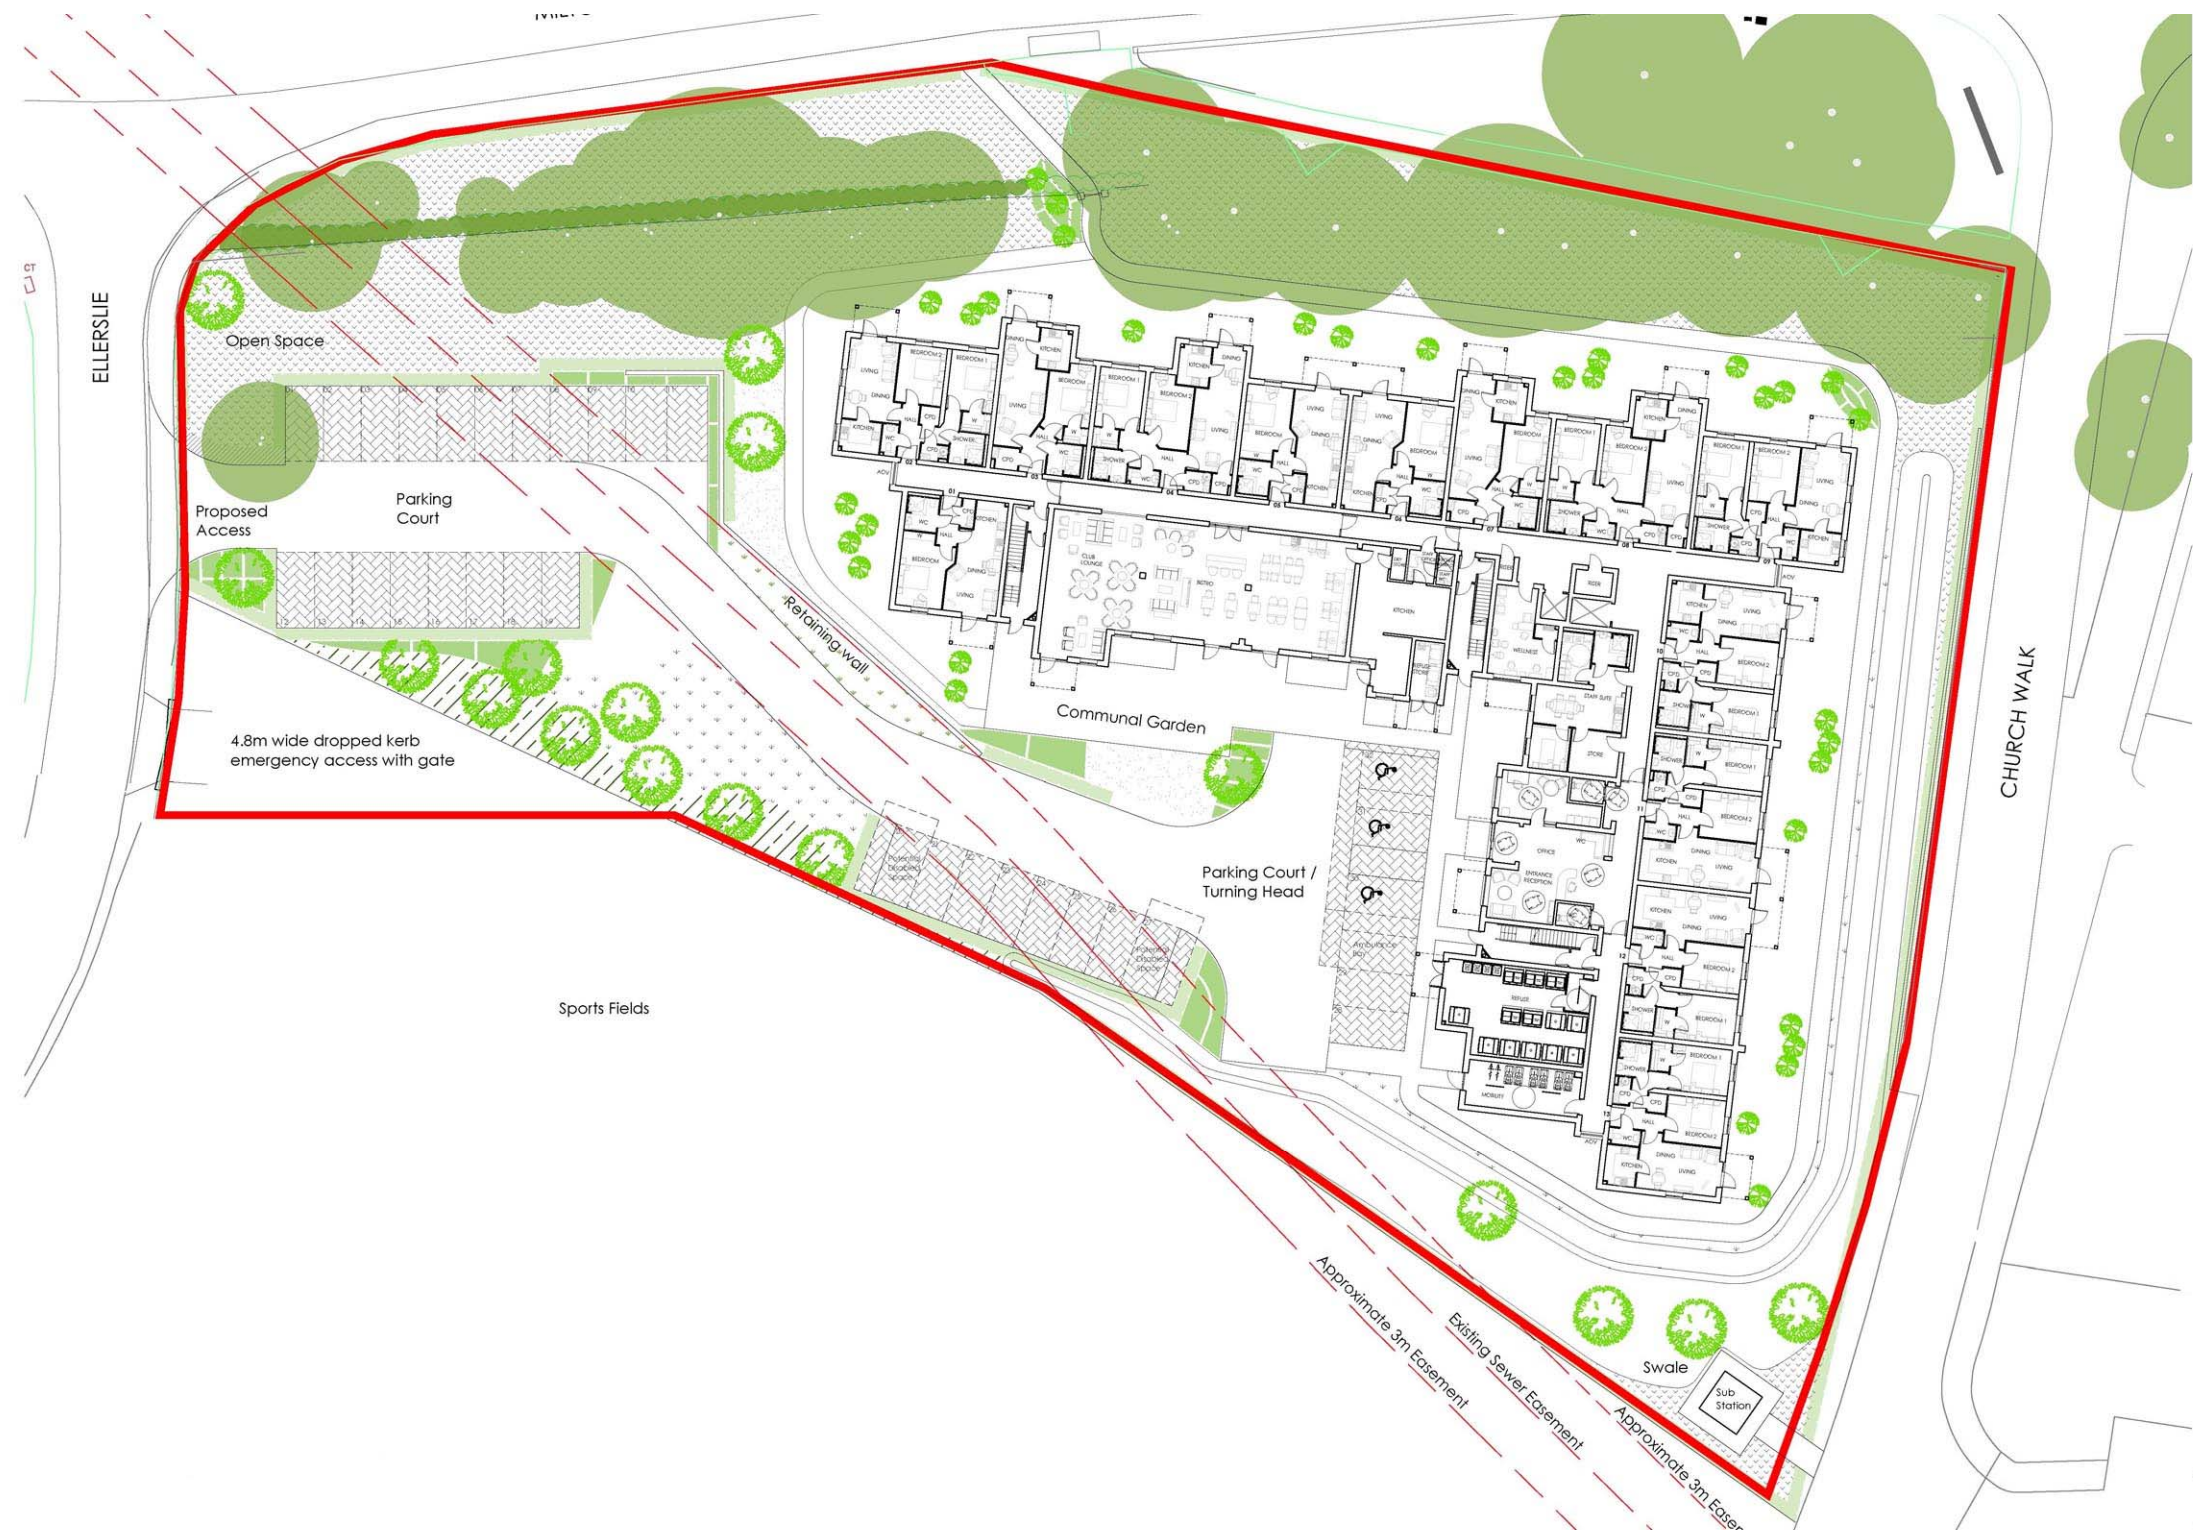
FIGURE 4

PROPOSED DEVELOPMENT PLAN

A residential development is proposed at GRFC Bowls Club, Church Walk, Gravesend, Kent. The site is currently occupied by a former bowls club, comprising a bowling green and a pavilion, and part of a sports ground. The proposed development comprises a four storey block of apartments, together with car parking, and managed landscaping areas. Residents of the development will be of retirement age.
