**Ref: 3852/21**

**PROPOSED REDEVELOPMENT AT  
THE CUSTOM HOUSE, THE TERRACE,  
GRAVESEND, KENT DA12 2BW.**

**PHASE I GEO ENVIRONMENTAL DESK STUDY  
AND PRELIMINARY RISK ASSESSMENT**

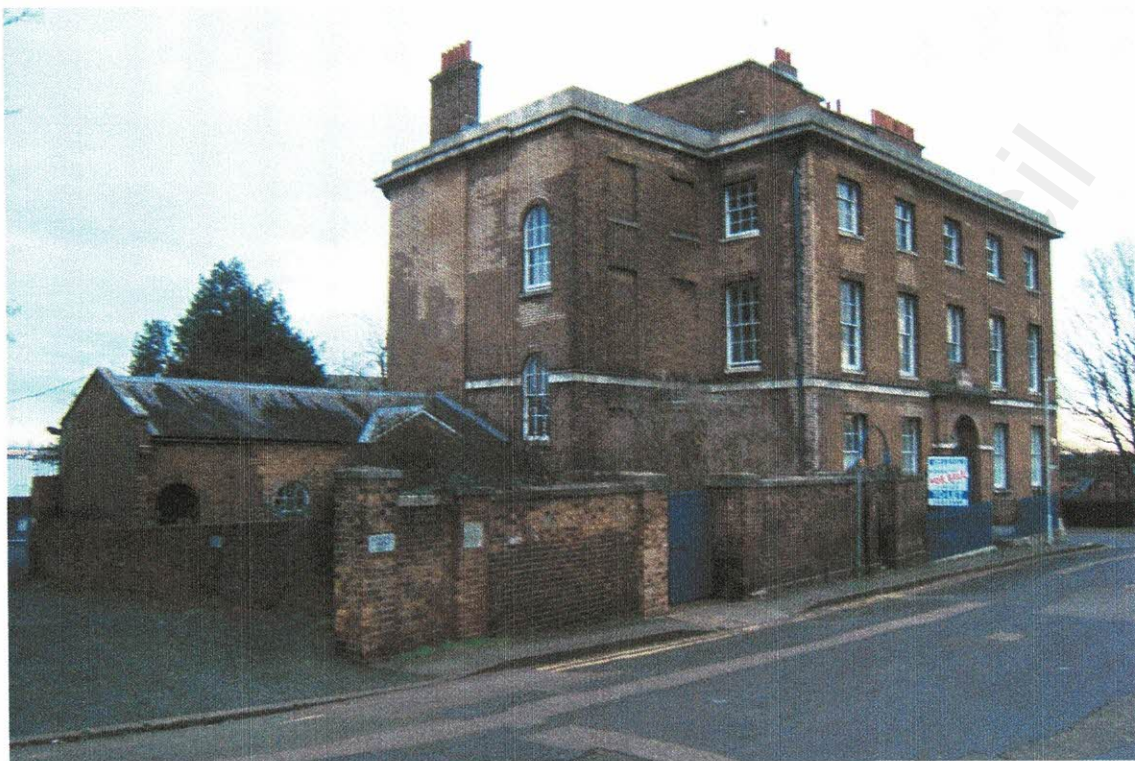
Plate 1

- 7.1 An inspection of the site was undertaken on 25<sup>th</sup> February 2021 during dry, overcast weather conditions.
- 7.2 The site was situated within a predominantly residential area to the north of Gravesend town centre.
- 7.3 An historic, three-storey brick building known as The Custom House with a slate roof and incorporating a basement area was located on the front, southeast corner of the site (Plate 1). A three-storey projection extended from the rear of the building and a two-storey extension was present on its west elevation.
- 7.4 Steel railings were present along the front of the building alongside the public footpath, a brick wall approximately 1.5m in height forming the remainder of the

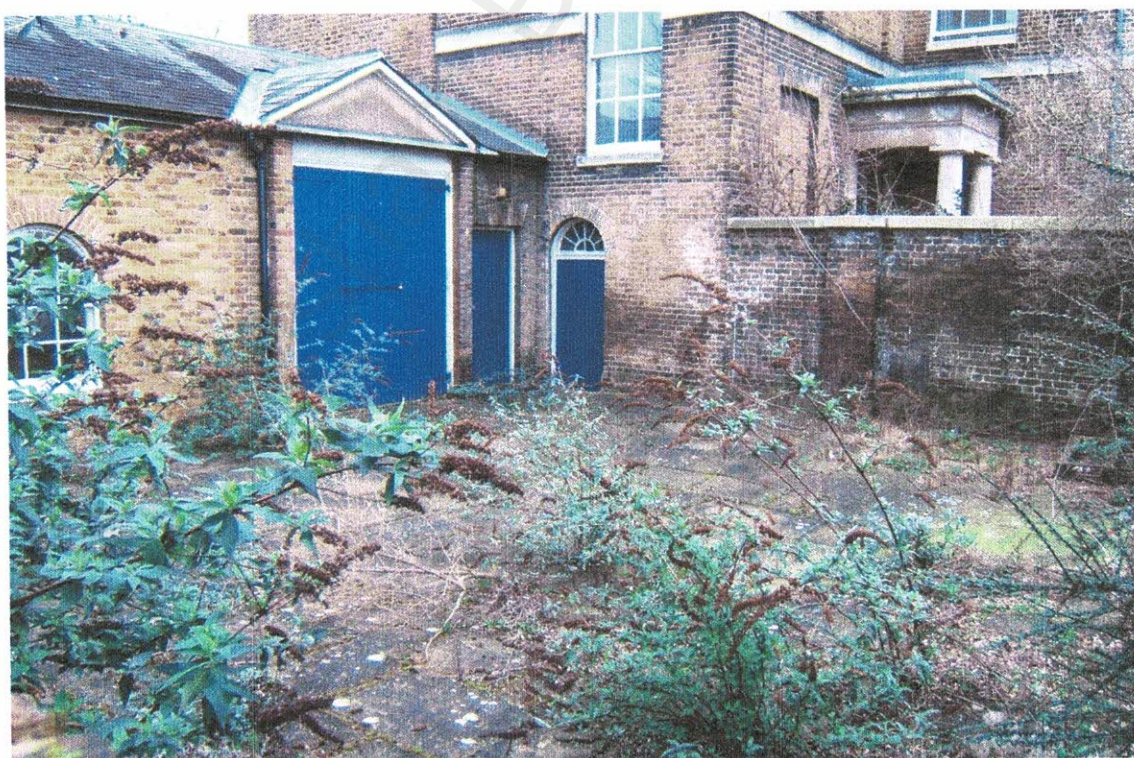
Plate 2

site's front boundary. A small area of paved garden with emergent weeds and Buddleia shrubs was present to the front of the side extension, enclosed by the boundary wall (Plate 2).

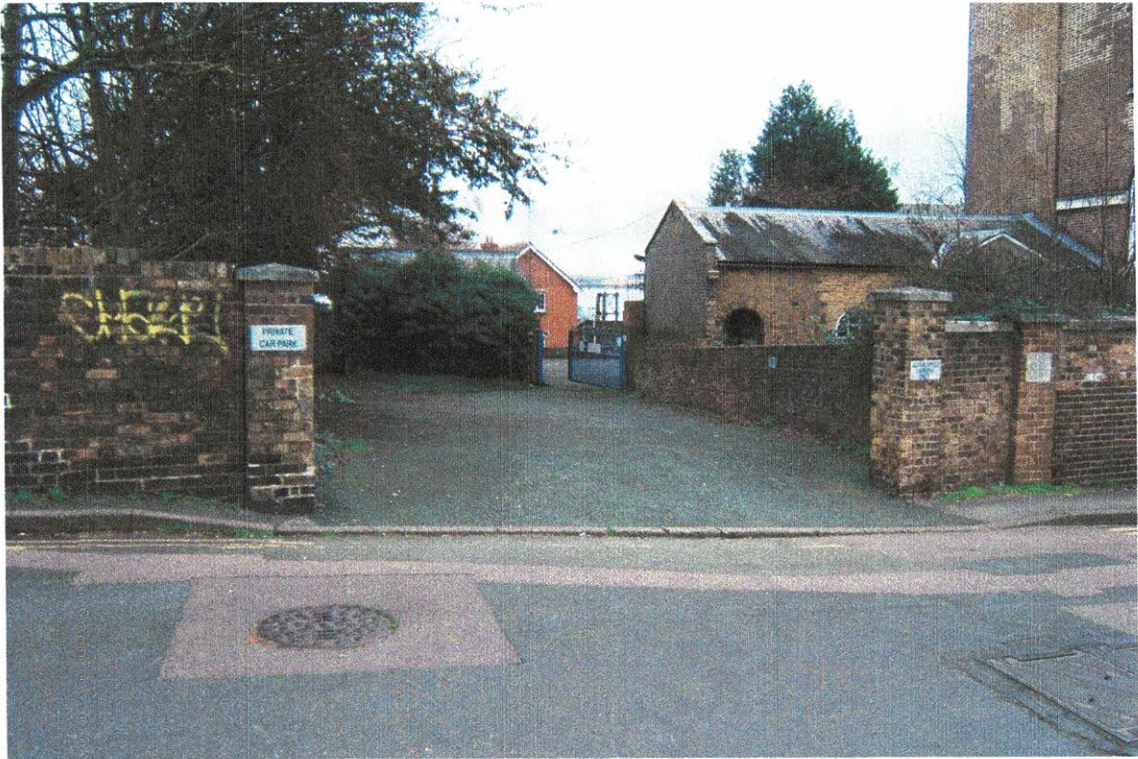
Plate 3

- 7.5 Access to the rear of the site was gained from its southwest corner via an open tarmac drive bordered on its west boundary with ornamental shrubs (Plate 3). A padlocked steel gate was located at the end of the drive.

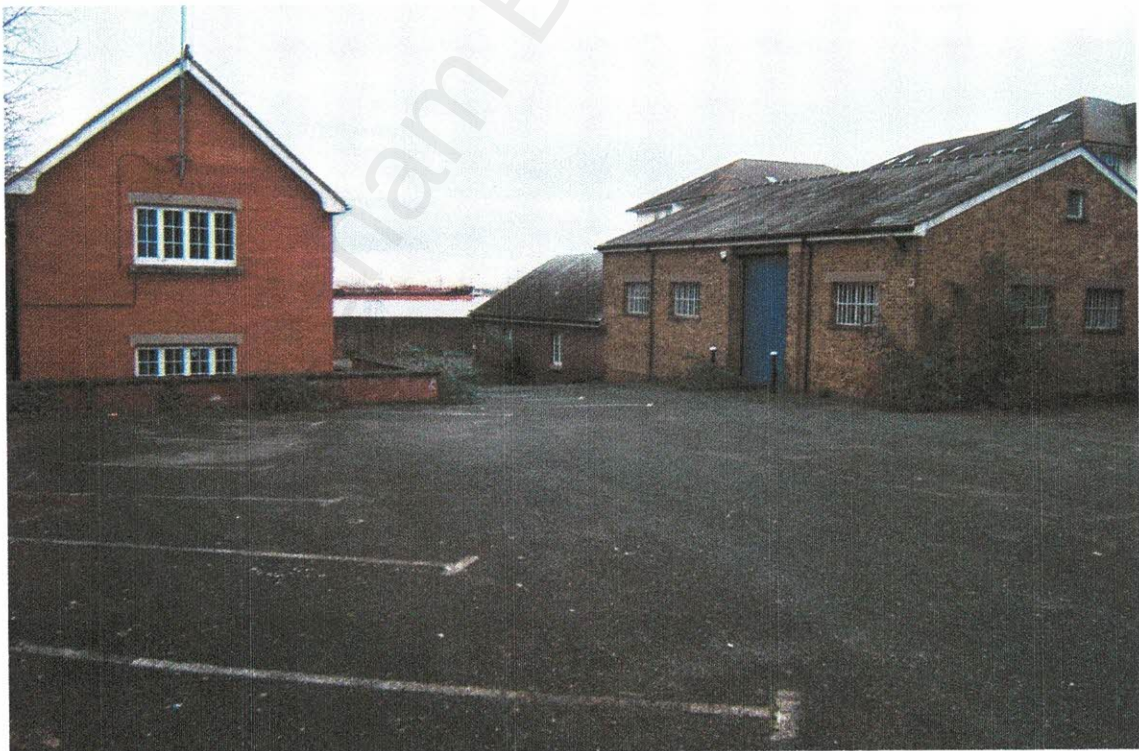
Plate 4

- 7.6 Entry through the gate provided access to a larger expanse of gently sloping, tarmac surfacing with designated parking bays on its west side (Plate 4). An adjoining pair of historic, single-storey brick buildings under slate roofs were located on the east side of the tarmac surfacing. The buildings are understood to have previously contained a boat-building workshop. A two-storey former office building of more recent construction under a tiled roof was located on the west side of the site.

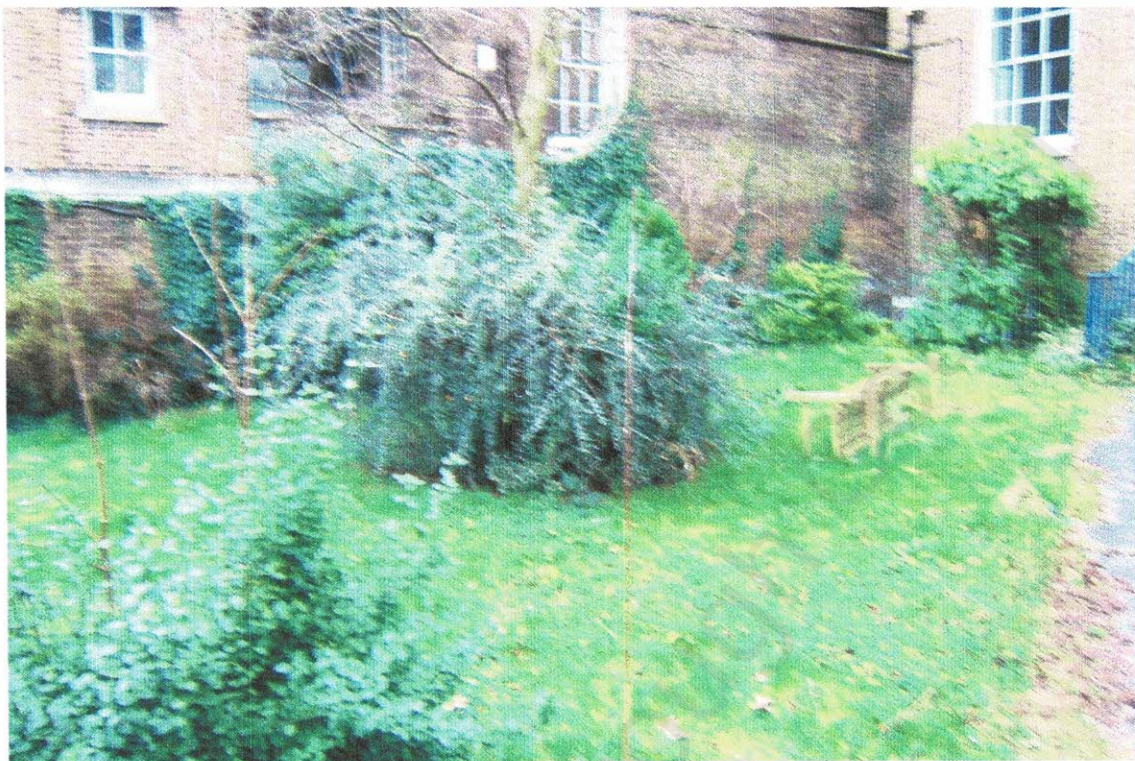
**Plate 5**

- 7.7 The front boundary wall extended through the central section of the site to the rear of the former workshop, enclosing the rear garden of The Customs House. The garden consisted mainly of lawn with ornamental trees and shrubs including a large Holly (Plate 5).

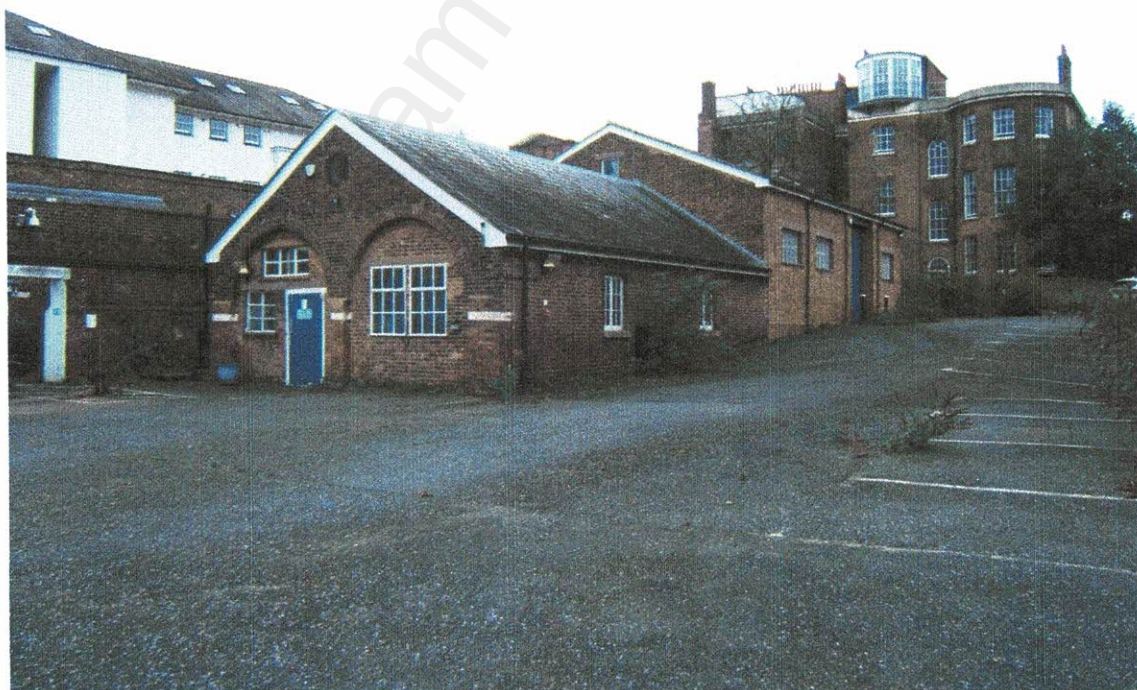
**Plate 6**

- 7.8 Tarmac surfacing extended beyond the former workshop and offices to the rear of the site (Plate 6), the north and west boundaries of which were formed by 2m to 3m high brick walls.

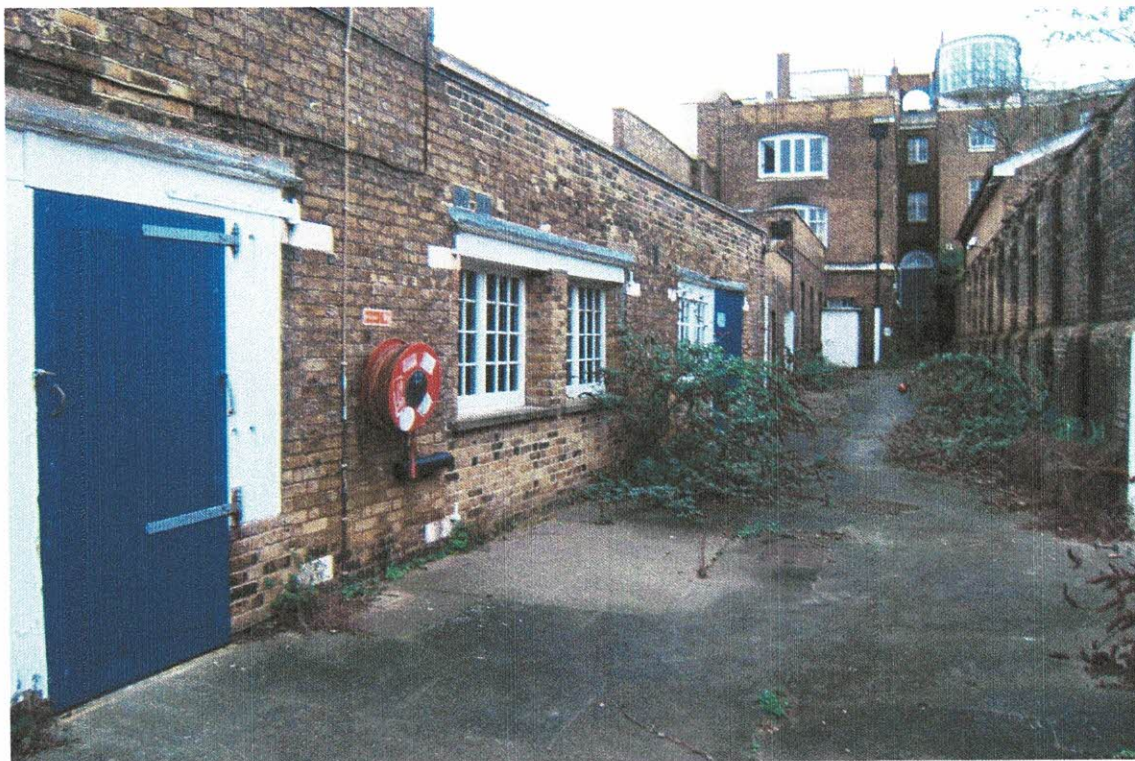
**Plate 7**

- 7.9 The east section of the site was separated by a brick wall approximately 3m in height which passed alongside the east elevation of the workshop to the site's rear boundary, an archway providing pedestrian access from the main area of tarmac onto a narrow section of concrete surfacing which extended from the rear of The Custom House to the north end of the site (Plate 7).

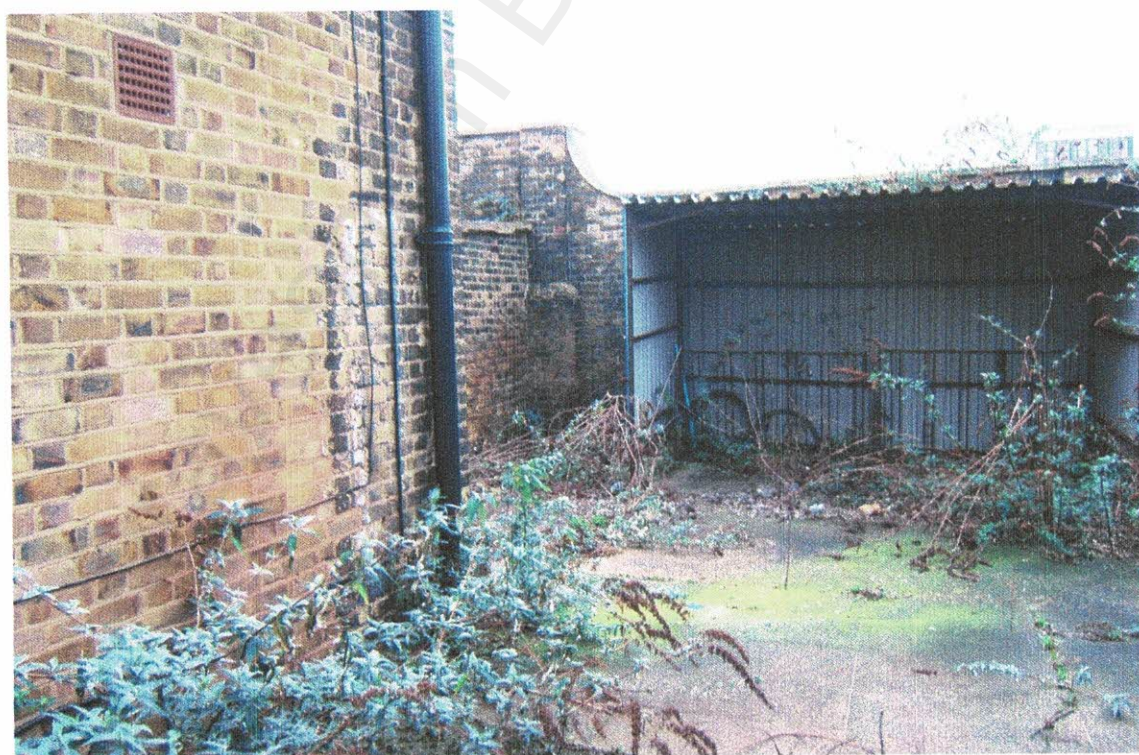
**Plate 8**

- 7.10 An elongate, single storey building which is understood to have originally comprised stabling for horses was present along the east side of the site. Emergent weeds and Buddleia shrubs were in evidence along the edges of the concrete surfacing, a disused cycle shed being located opposite the northwest end of the building (Plate

8). The flank walls of the buildings formed the east boundary of the site.

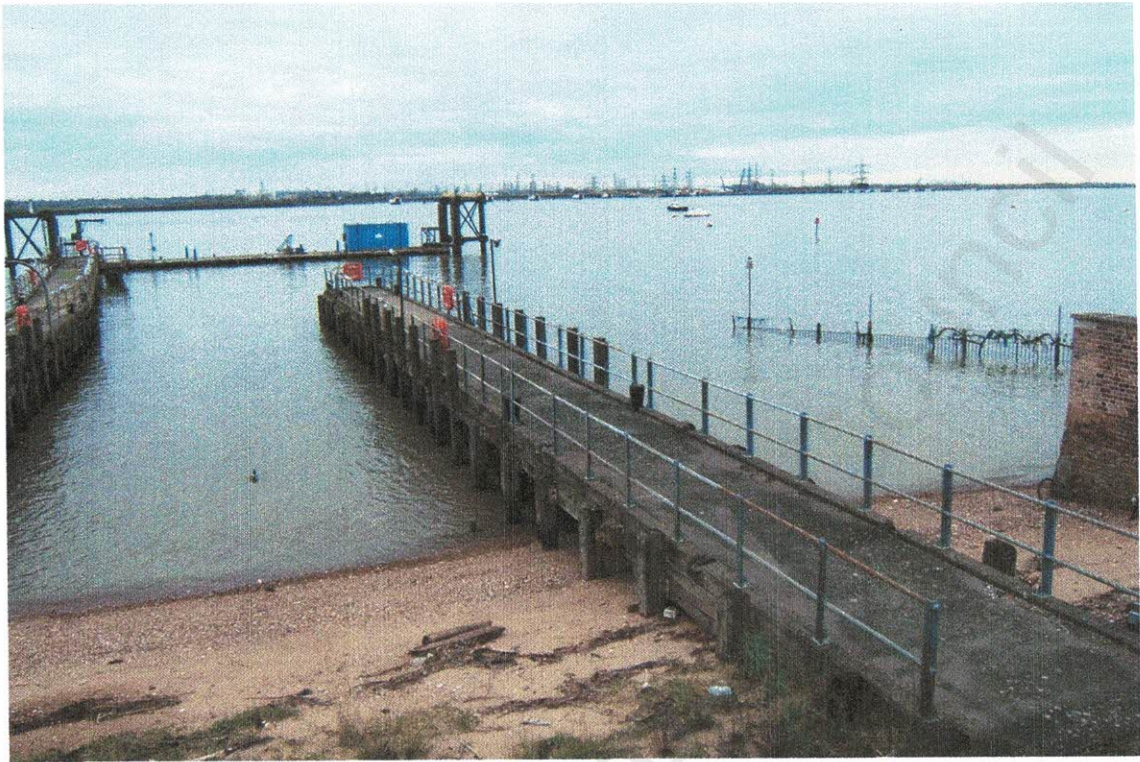
**Plate 9**

- 7.11 Steel flood gates and associated sheet piles were incorporated within site's north boundary, together with a flight of steps which provided access to the shore of the adjacent Thames Estuary (Plate 9).
- 7.12 A disused generator was located within the northwest corner of the site (Plate 10).
- 7.13 An area of private vehicular parking was situated beyond the west boundary of the site, a small public car park being present on the south side of The Terrace to the front of The Custom House. Residential properties of various ages and an ornamental public park were present to the east.
- 7.14 No visual or olfactory evidence of significant contamination was observed either on or in the vicinity of the site at the time of the inspection.

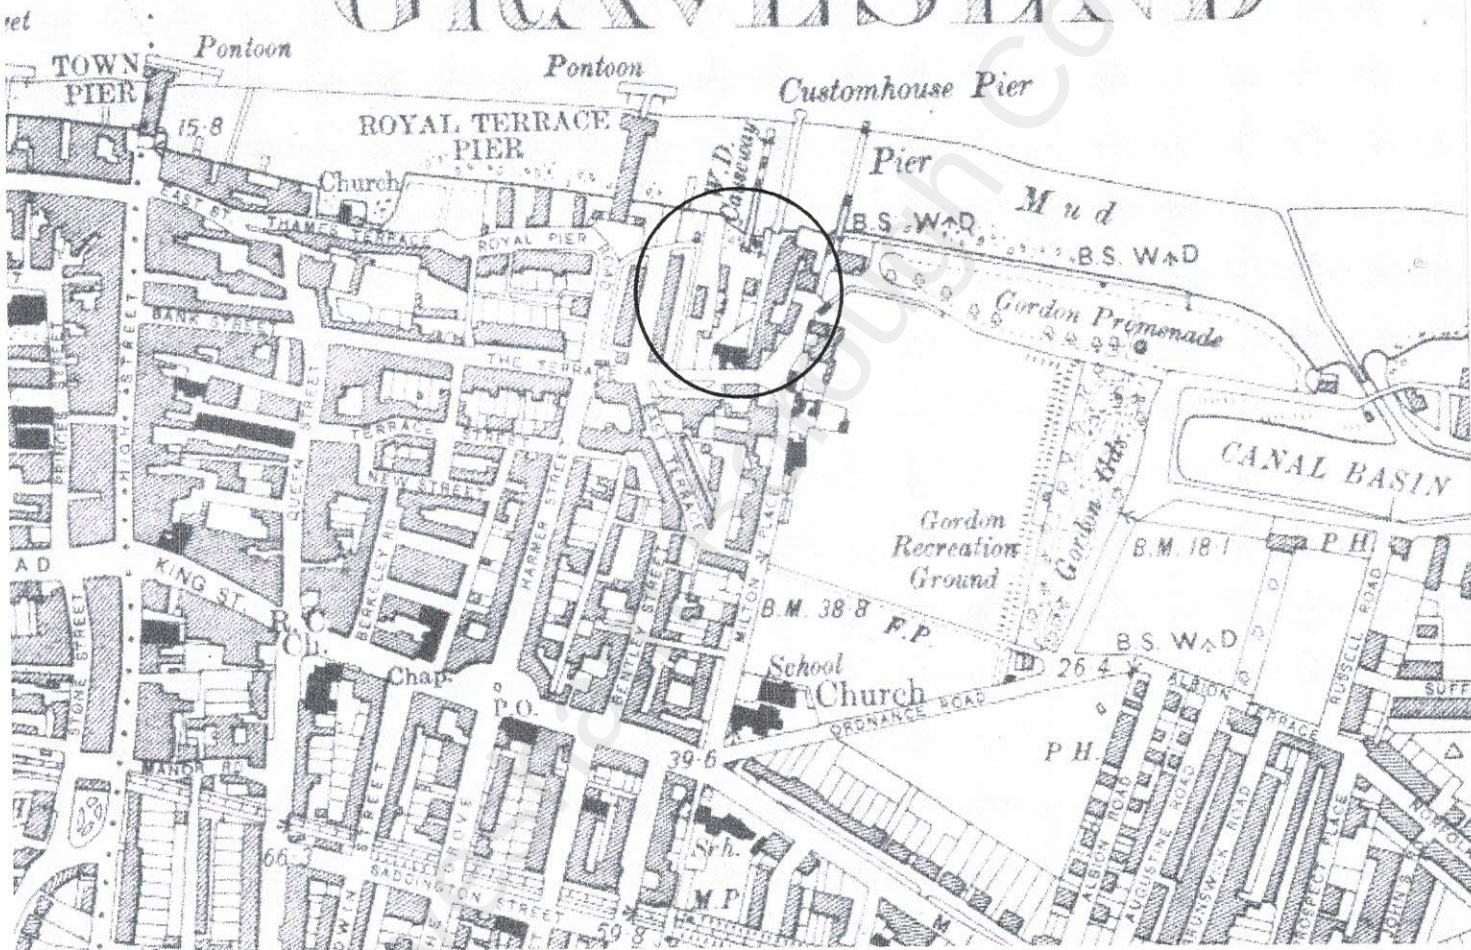
*On site:* No significant change.

*Off site:* No significant change.

Custom House, The Terrace, Gravesend.  
OS map scale 1:2500 1923.
