RE: 22a High Street
Gravesend
DA11 0BA
2 No. Box Frames & Sashes

RE: 22a High Street
Gravesend
DA11 0BA
Cross section of proposed
Sash window replacements

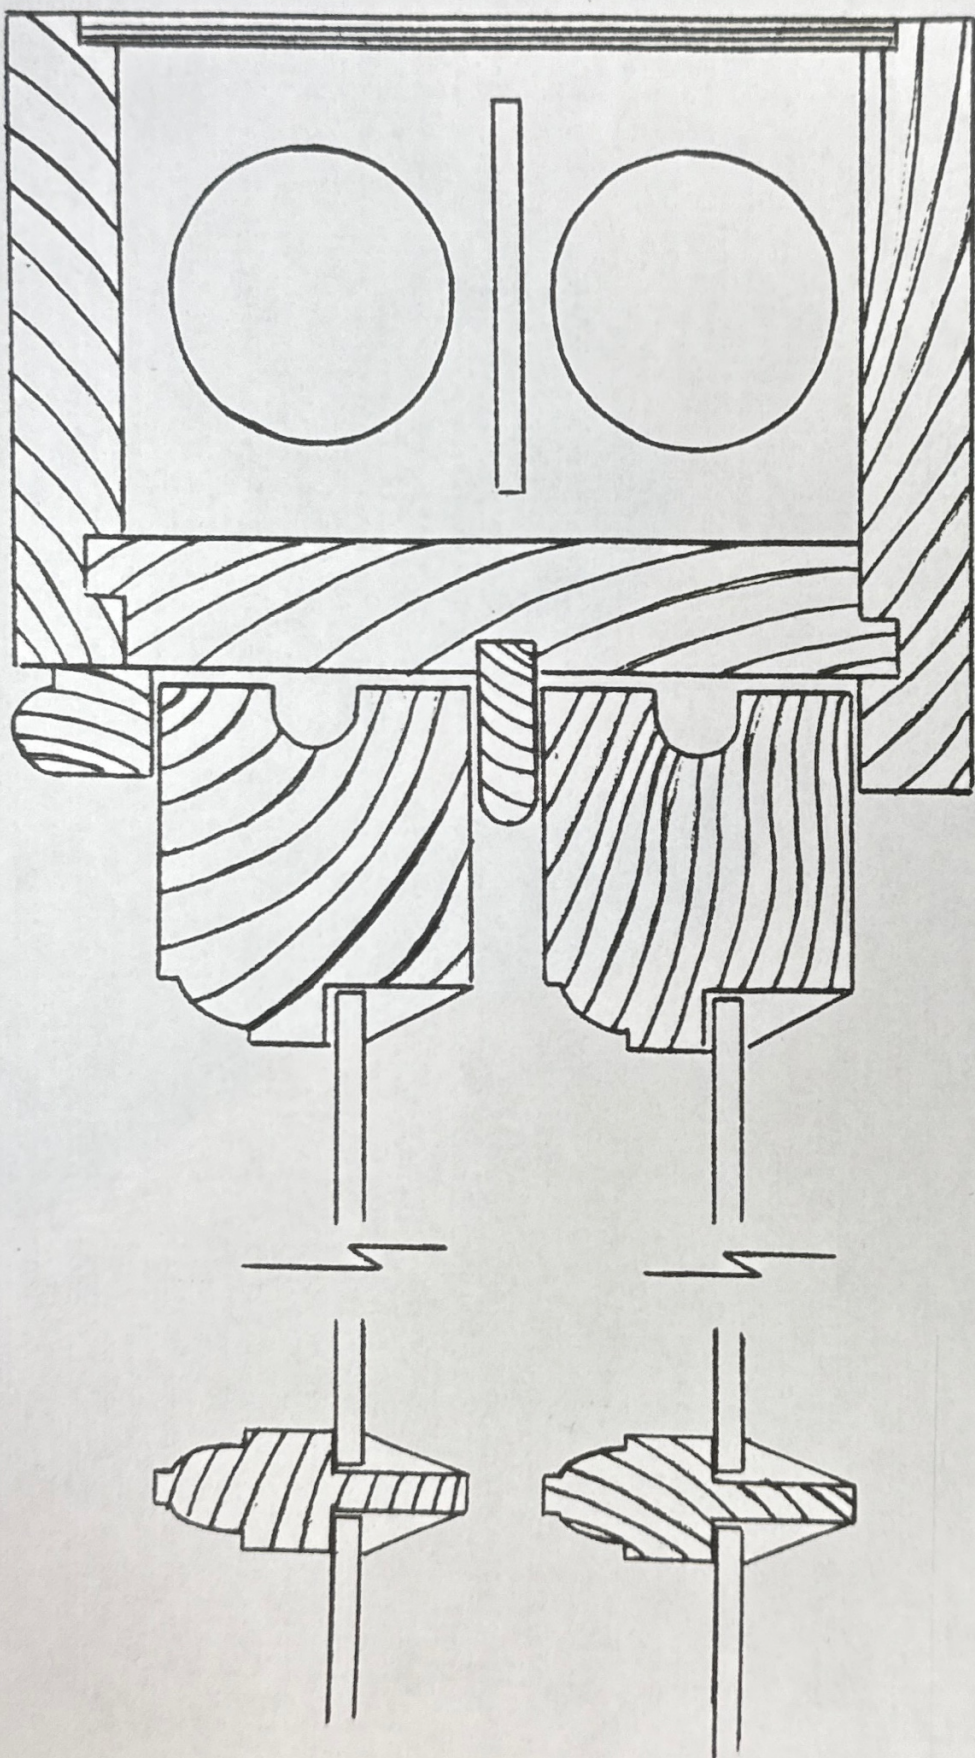
Cross section of Box Frame
Upright, Sash Stiles and
Glazing Bars

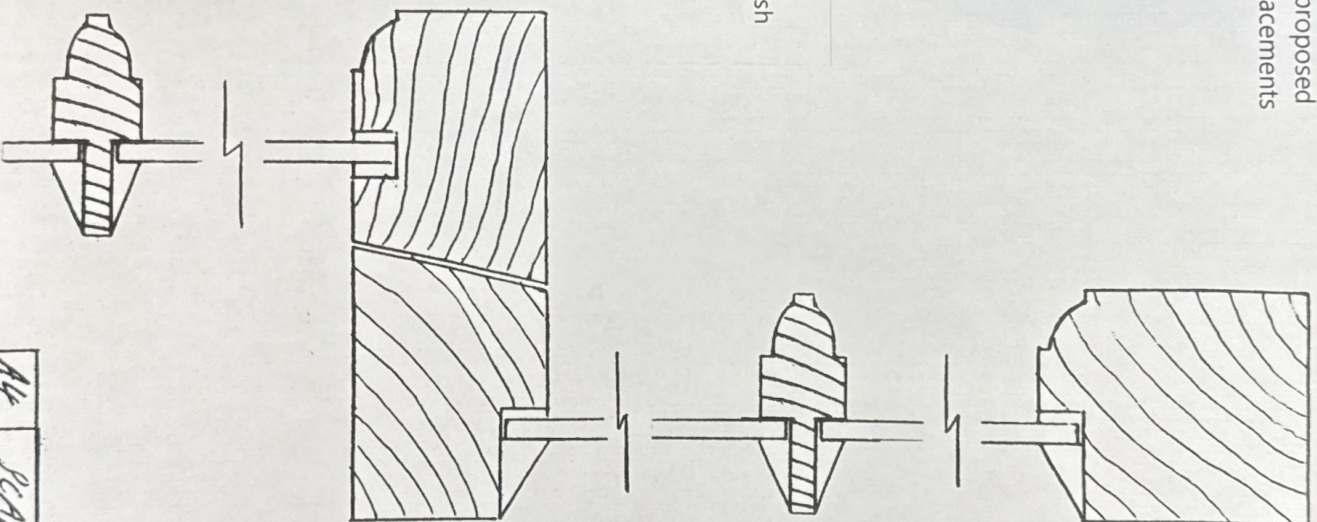
Cross section of Top Sash
and Lower Sash
Meeting Rail and
Glazing Bar

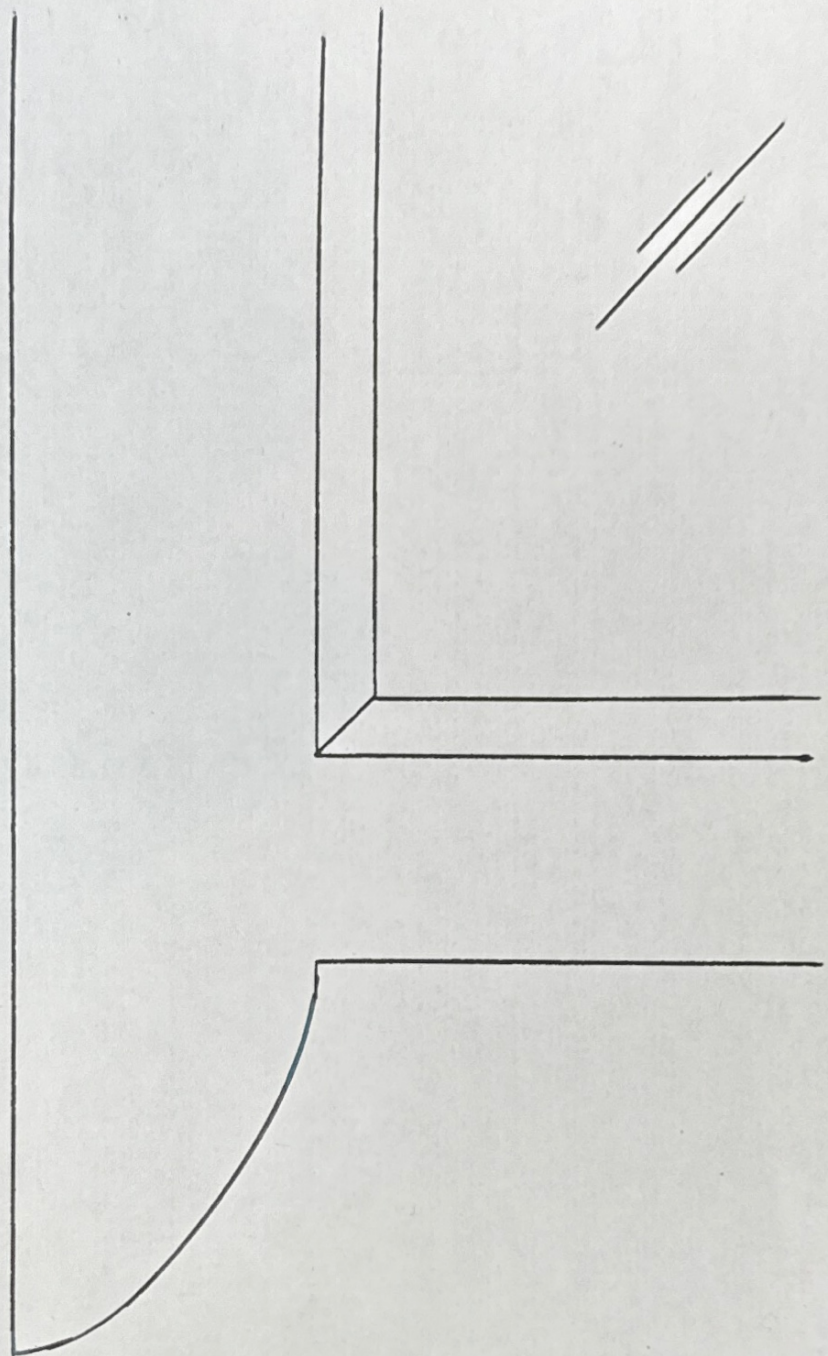
Sash Horn detail of proposed
Sash window replacements
