**PHASE 1 ENVIRONMENTAL REPORT**  
**of a site at**  
**COBHAM LODGE, VALLEY DRIVE, GRAVESEND,**  
**KENT, DA12 5UE**  
**for**  
**BRELEY DESIGN LIMITED**

**Project No 1532**  
**Report ref: 1532-P1E-1-C**  
**Issued: 06 February 2019**  
**Revision: C**

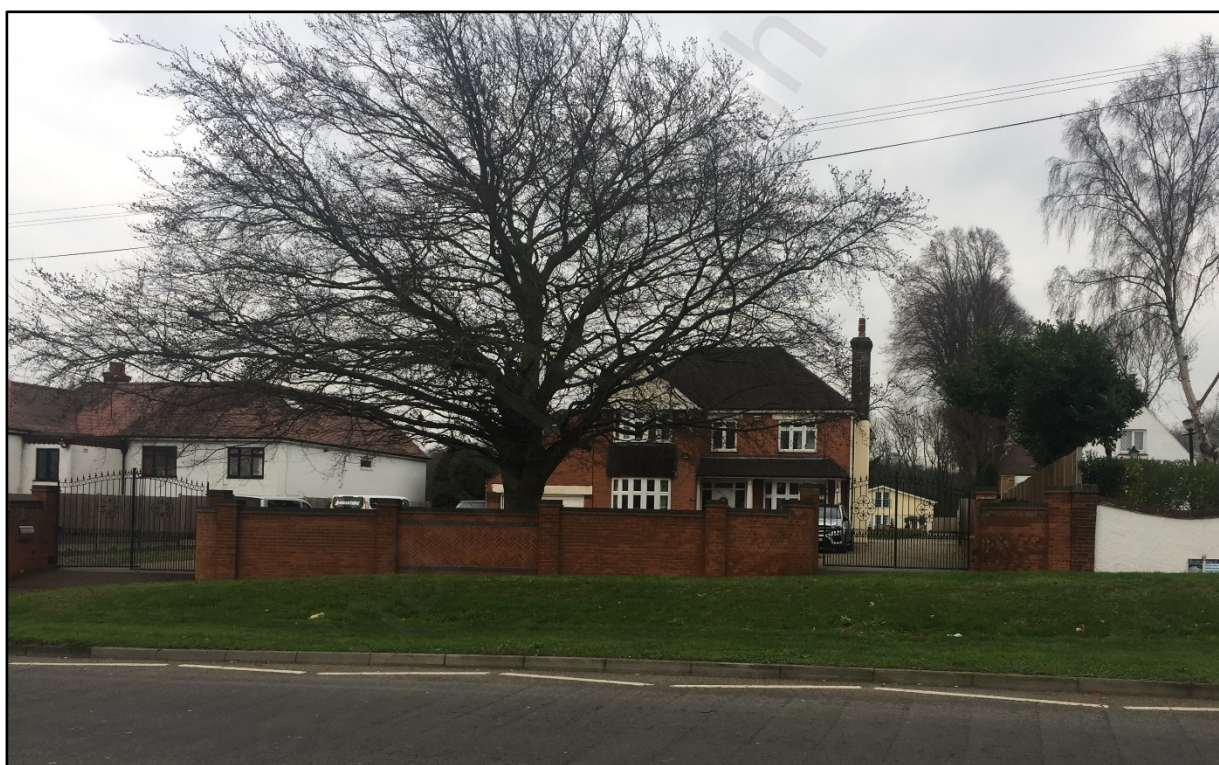
The site comprises a single residential property with the main two-storey dwelling, of traditional masonry construction, located towards the west end of the site and there is a secondary building, again two-storey, towards the east end of the site. The main dwelling has an integral garage, which at the time of the visit was being used for storage of domestic items. The secondary building is used for recreation.

**Photograph 1: View of the site from Valley Drive**

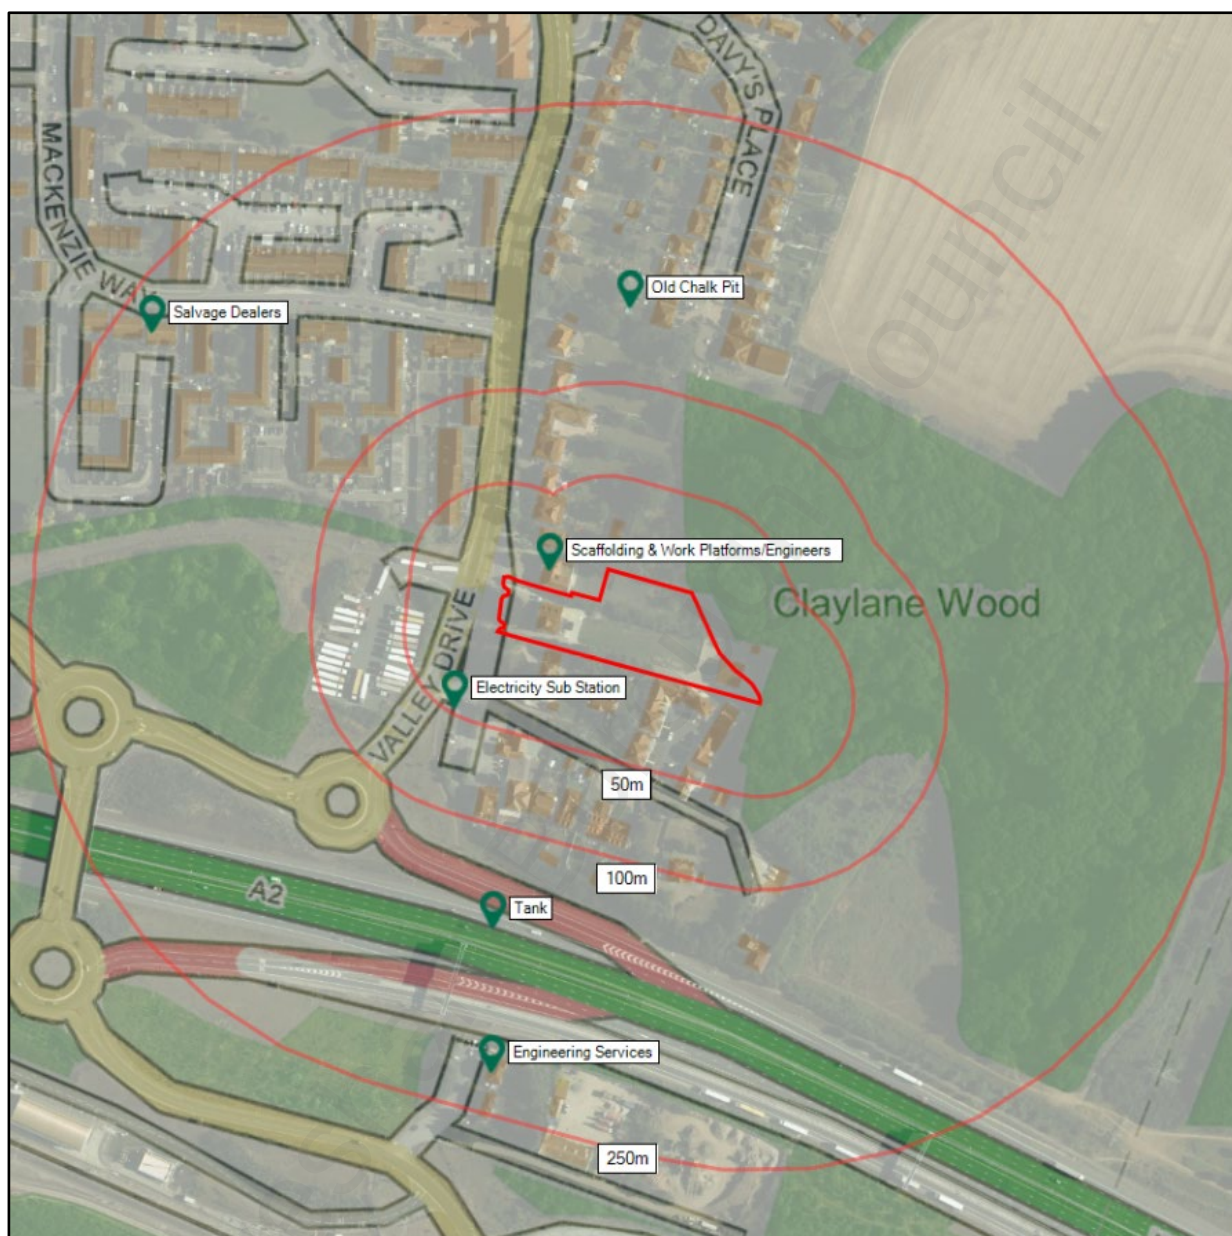
Figure 2: Potential sources of contamination within 250m of the site

Potentially contaminating commercial activities have been identified in the vicinity. The general topography falls to the north. This is assumed to be the general direction of the hydraulic gradient, therefore sources to the south and within the near vicinity are considered to have the most potential to impact the site. These include an electricity substation and engineering services.

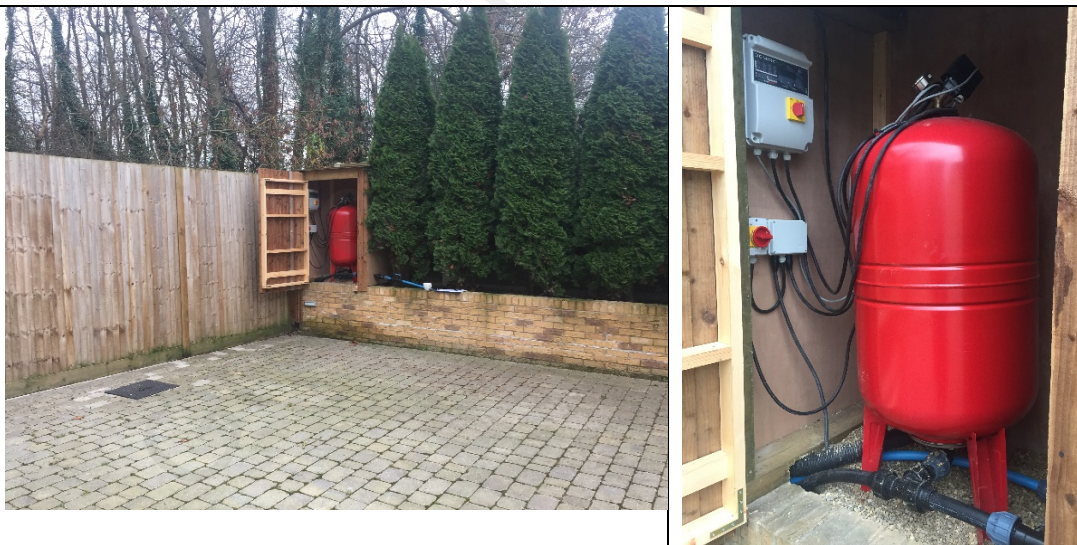
Groundwater Pump in Southeast Corner of Site
