**REPORT ON  
GROUND INVESTIGATION  
AT  
COLDHARBOUR ROAD  
NORTHFLEET  
GRAVESEND**

| <b>Report Title:</b> | Report on Ground Investigation at Coldharbour Road, Northfleet, Gravesend. |
| <b>Report Number:</b> | AG3571-23-AR62 |

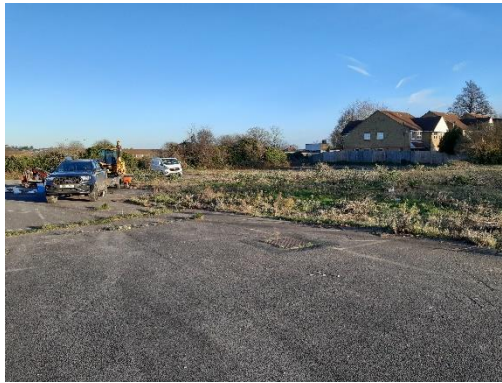
Photograph looking east across the site.

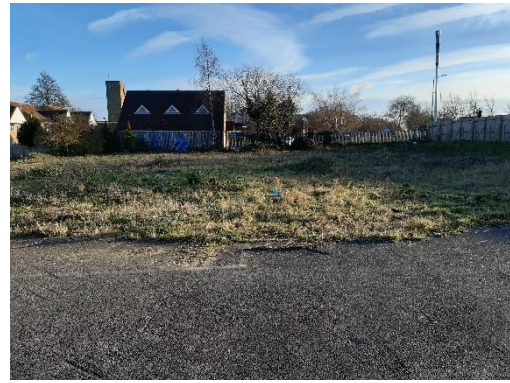
Photo looking south-east across the site.

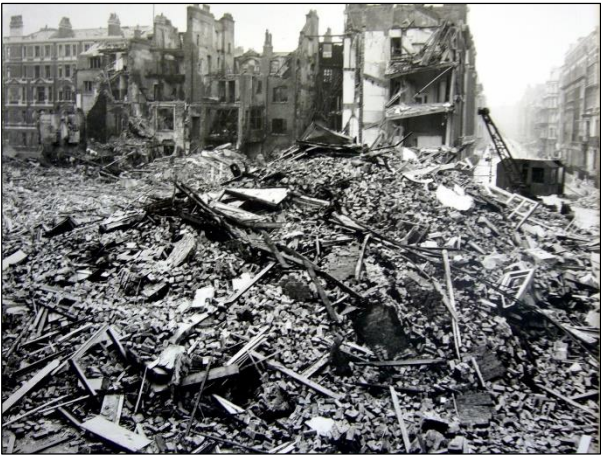
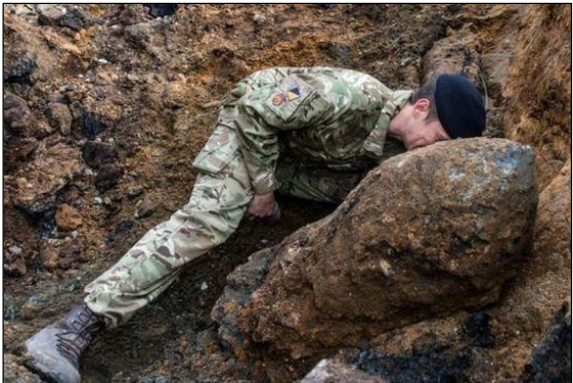
**Top:** J-curve Effect - Due to angle of entry, unexploded bombs would often end their trajectory at a lateral offset from point of entry, often ending up beneath adjacent extant structures/sites. The photograph above shows 250kg bomb found in Bermondsey pointing upwards, demonstrating ‘J-curve’

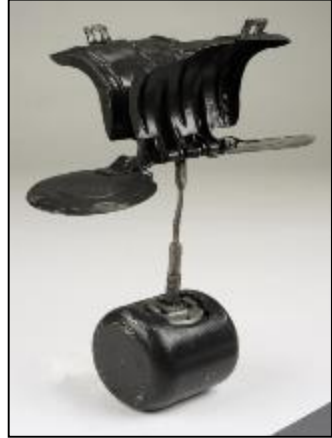
SD2 Butterfly Bomb

| Bomb Weight | 2kg (4.41lb) | | | |
| Explosive Weight | 7.5oz (212.6 grams ) of TNT surrounded by a layer of bituminous composition. | | | |
| Fuze Type | 41 fuze (time) , 67 fuze (clockwork time delay) or 70 fuze (anti-handling device) | | | |

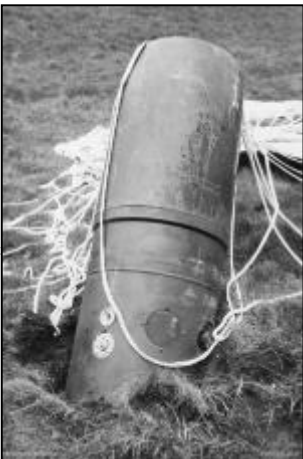
Parachute Mine (Luftmine B / LMB)

| Bomb Weight | 987.017kg (2176lb) | | | |
| Explosive Weight | 125-130kg (276-287lb) | | | |
| Fuze Type | Impact/ Time delay / hydrostatic pressure fuze | | | |
| Use | Against civilian, military and industrial targets. Designed to detonate above ground level to maximise damage to a wider area. | SC | | |

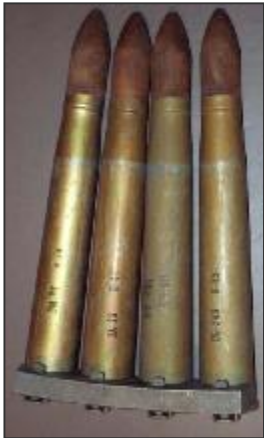
40mm Bofors Projectile

| Projectile Weight | 1.96lb (0.86kg) |
| Projectile Dimensions | 40mm x 310mm (1.6in x 12.2in) |
| Ceiling | 23,000ft (7000m ) |

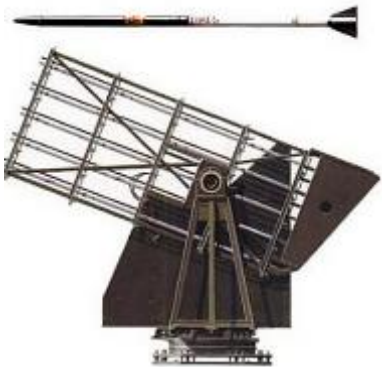
Unrotated Projectile (UP) – Z Battery

| Projectile Weight | 84lb (24.5kg) |
| Dimensions | 1930mm x 82.6mm (76 x 3.25in) |
| Use | As a short range rocket-firing anti-aircraft weapon developed for the Royal Navy. It was used extensively by British ships during the early days of World War II. The UP was also used in ground-based single and 128-round launchers known as Z Batteries. |

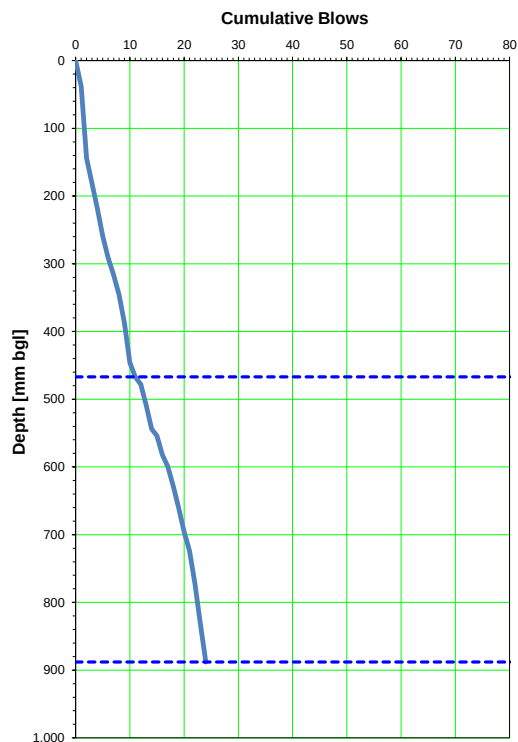
**Notes:** TRL Equation :  $\text{Log}_{10}(\text{CBR}) = 2.480 - 1.057 \times \text{Log}_{10}(\text{mm/blow})$  from IAN 73/06 Revision 1 (2009)  
Tested in accordance with in house method, based upon TRL Road Note 31 & 8

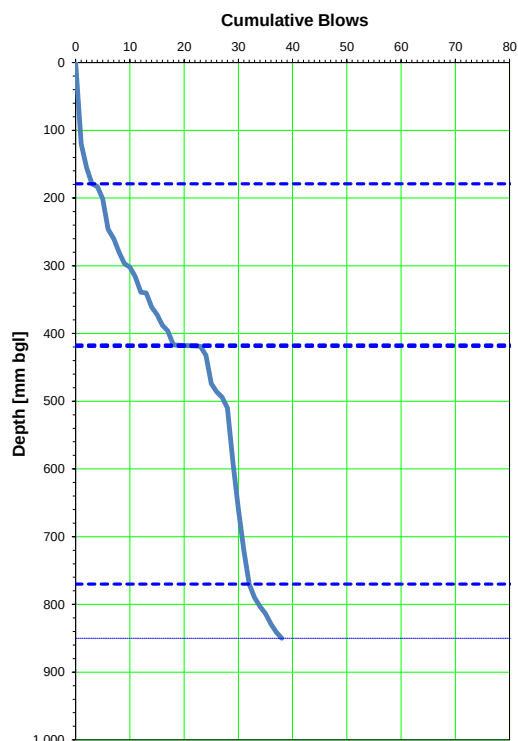
**Notes:** TRL Equation :  $\text{Log}_{10}(\text{CBR}) = 2.480 - 1.057 \times \text{Log}_{10}(\text{mm/blow})$  from IAN 73/06 Revision 1 (2009)  
Tested in accordance with in house method, based upon TRL Road Note 31 & 8

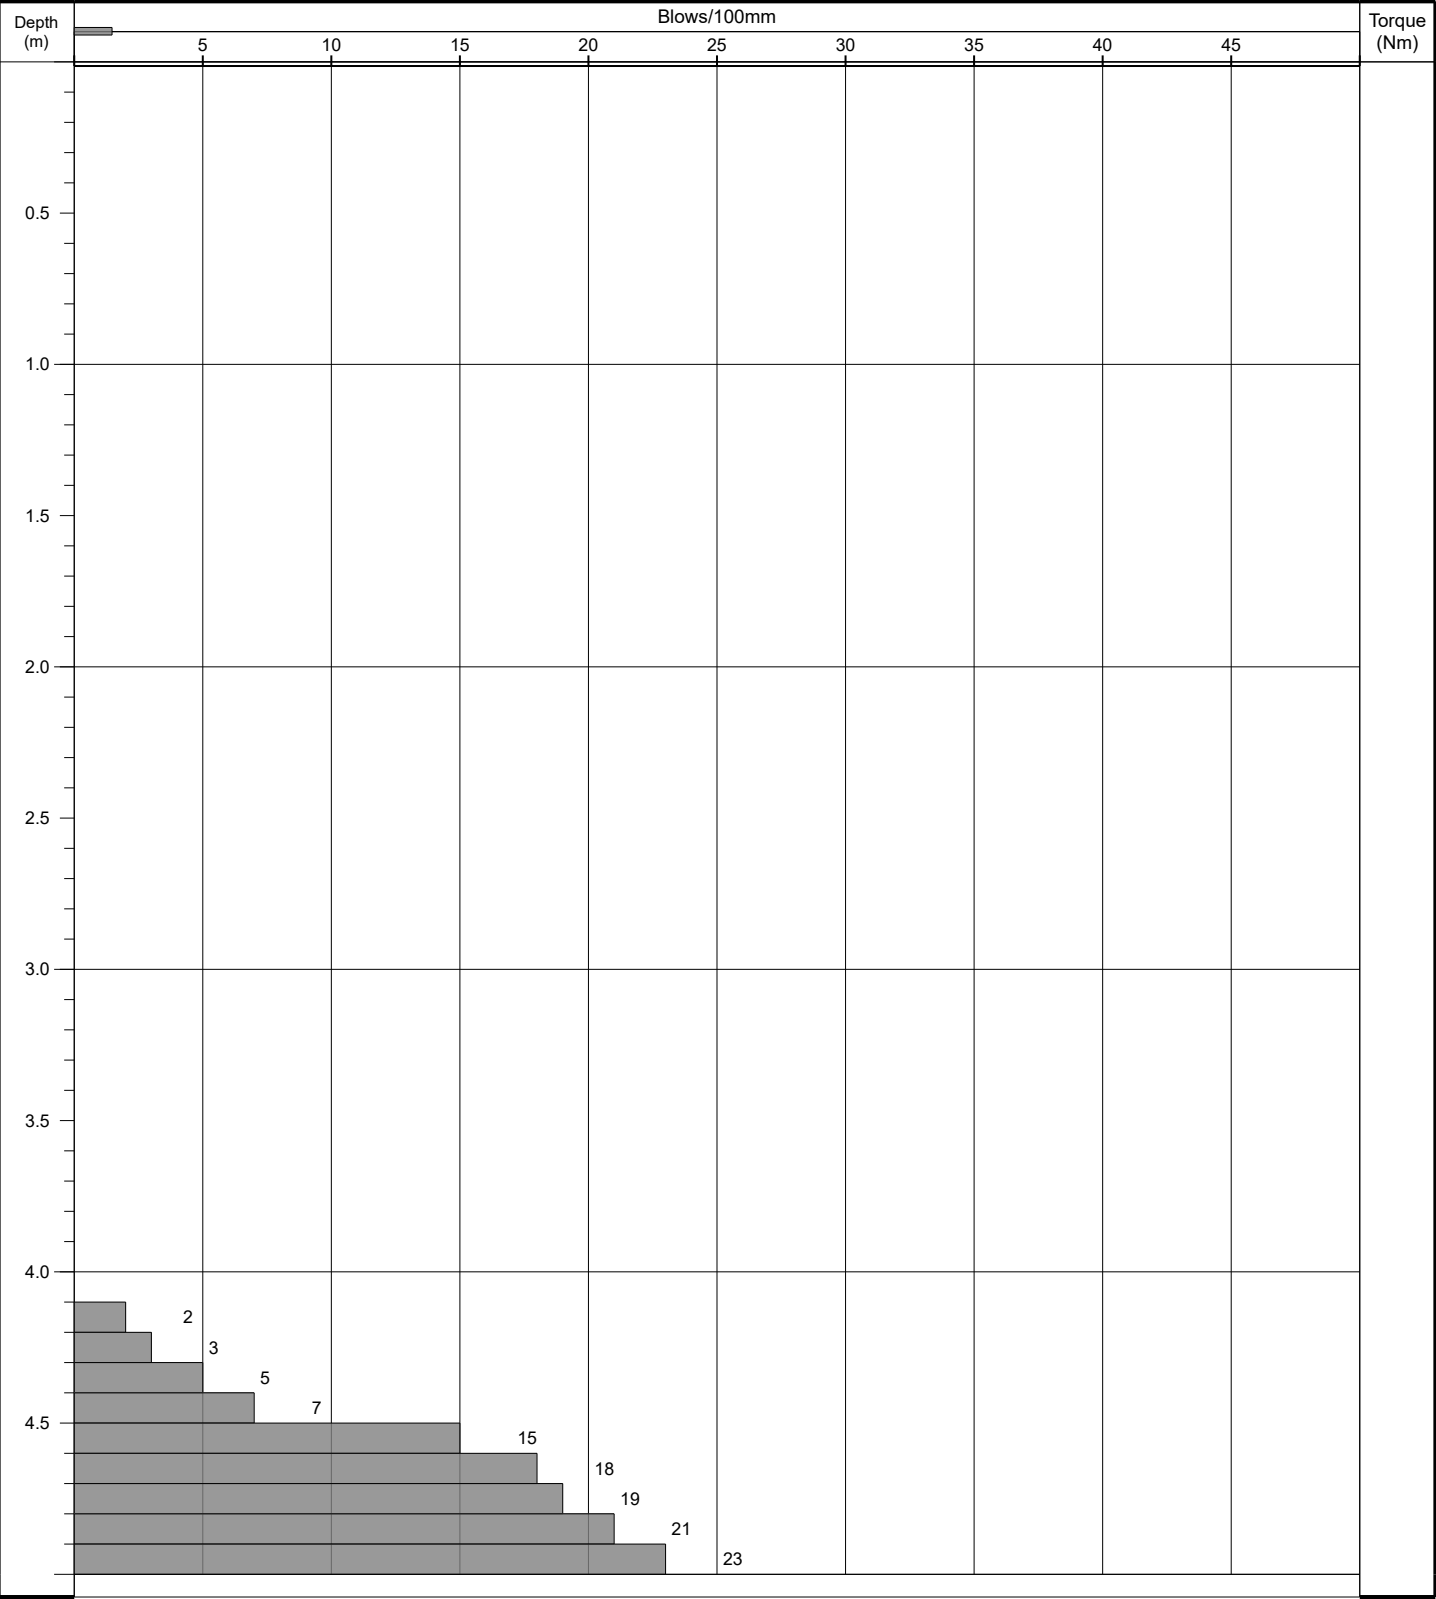
**Remarks:** Dynamic probe follow on from base of DCS103.
