## **Remediation Strategy**

**Clifton Slips, West Street,  
Gravesend, Kent, DA11 0BW**

**Prepared for: Quinn Estates Ltd.**

**Reference: EES 18.376.6**

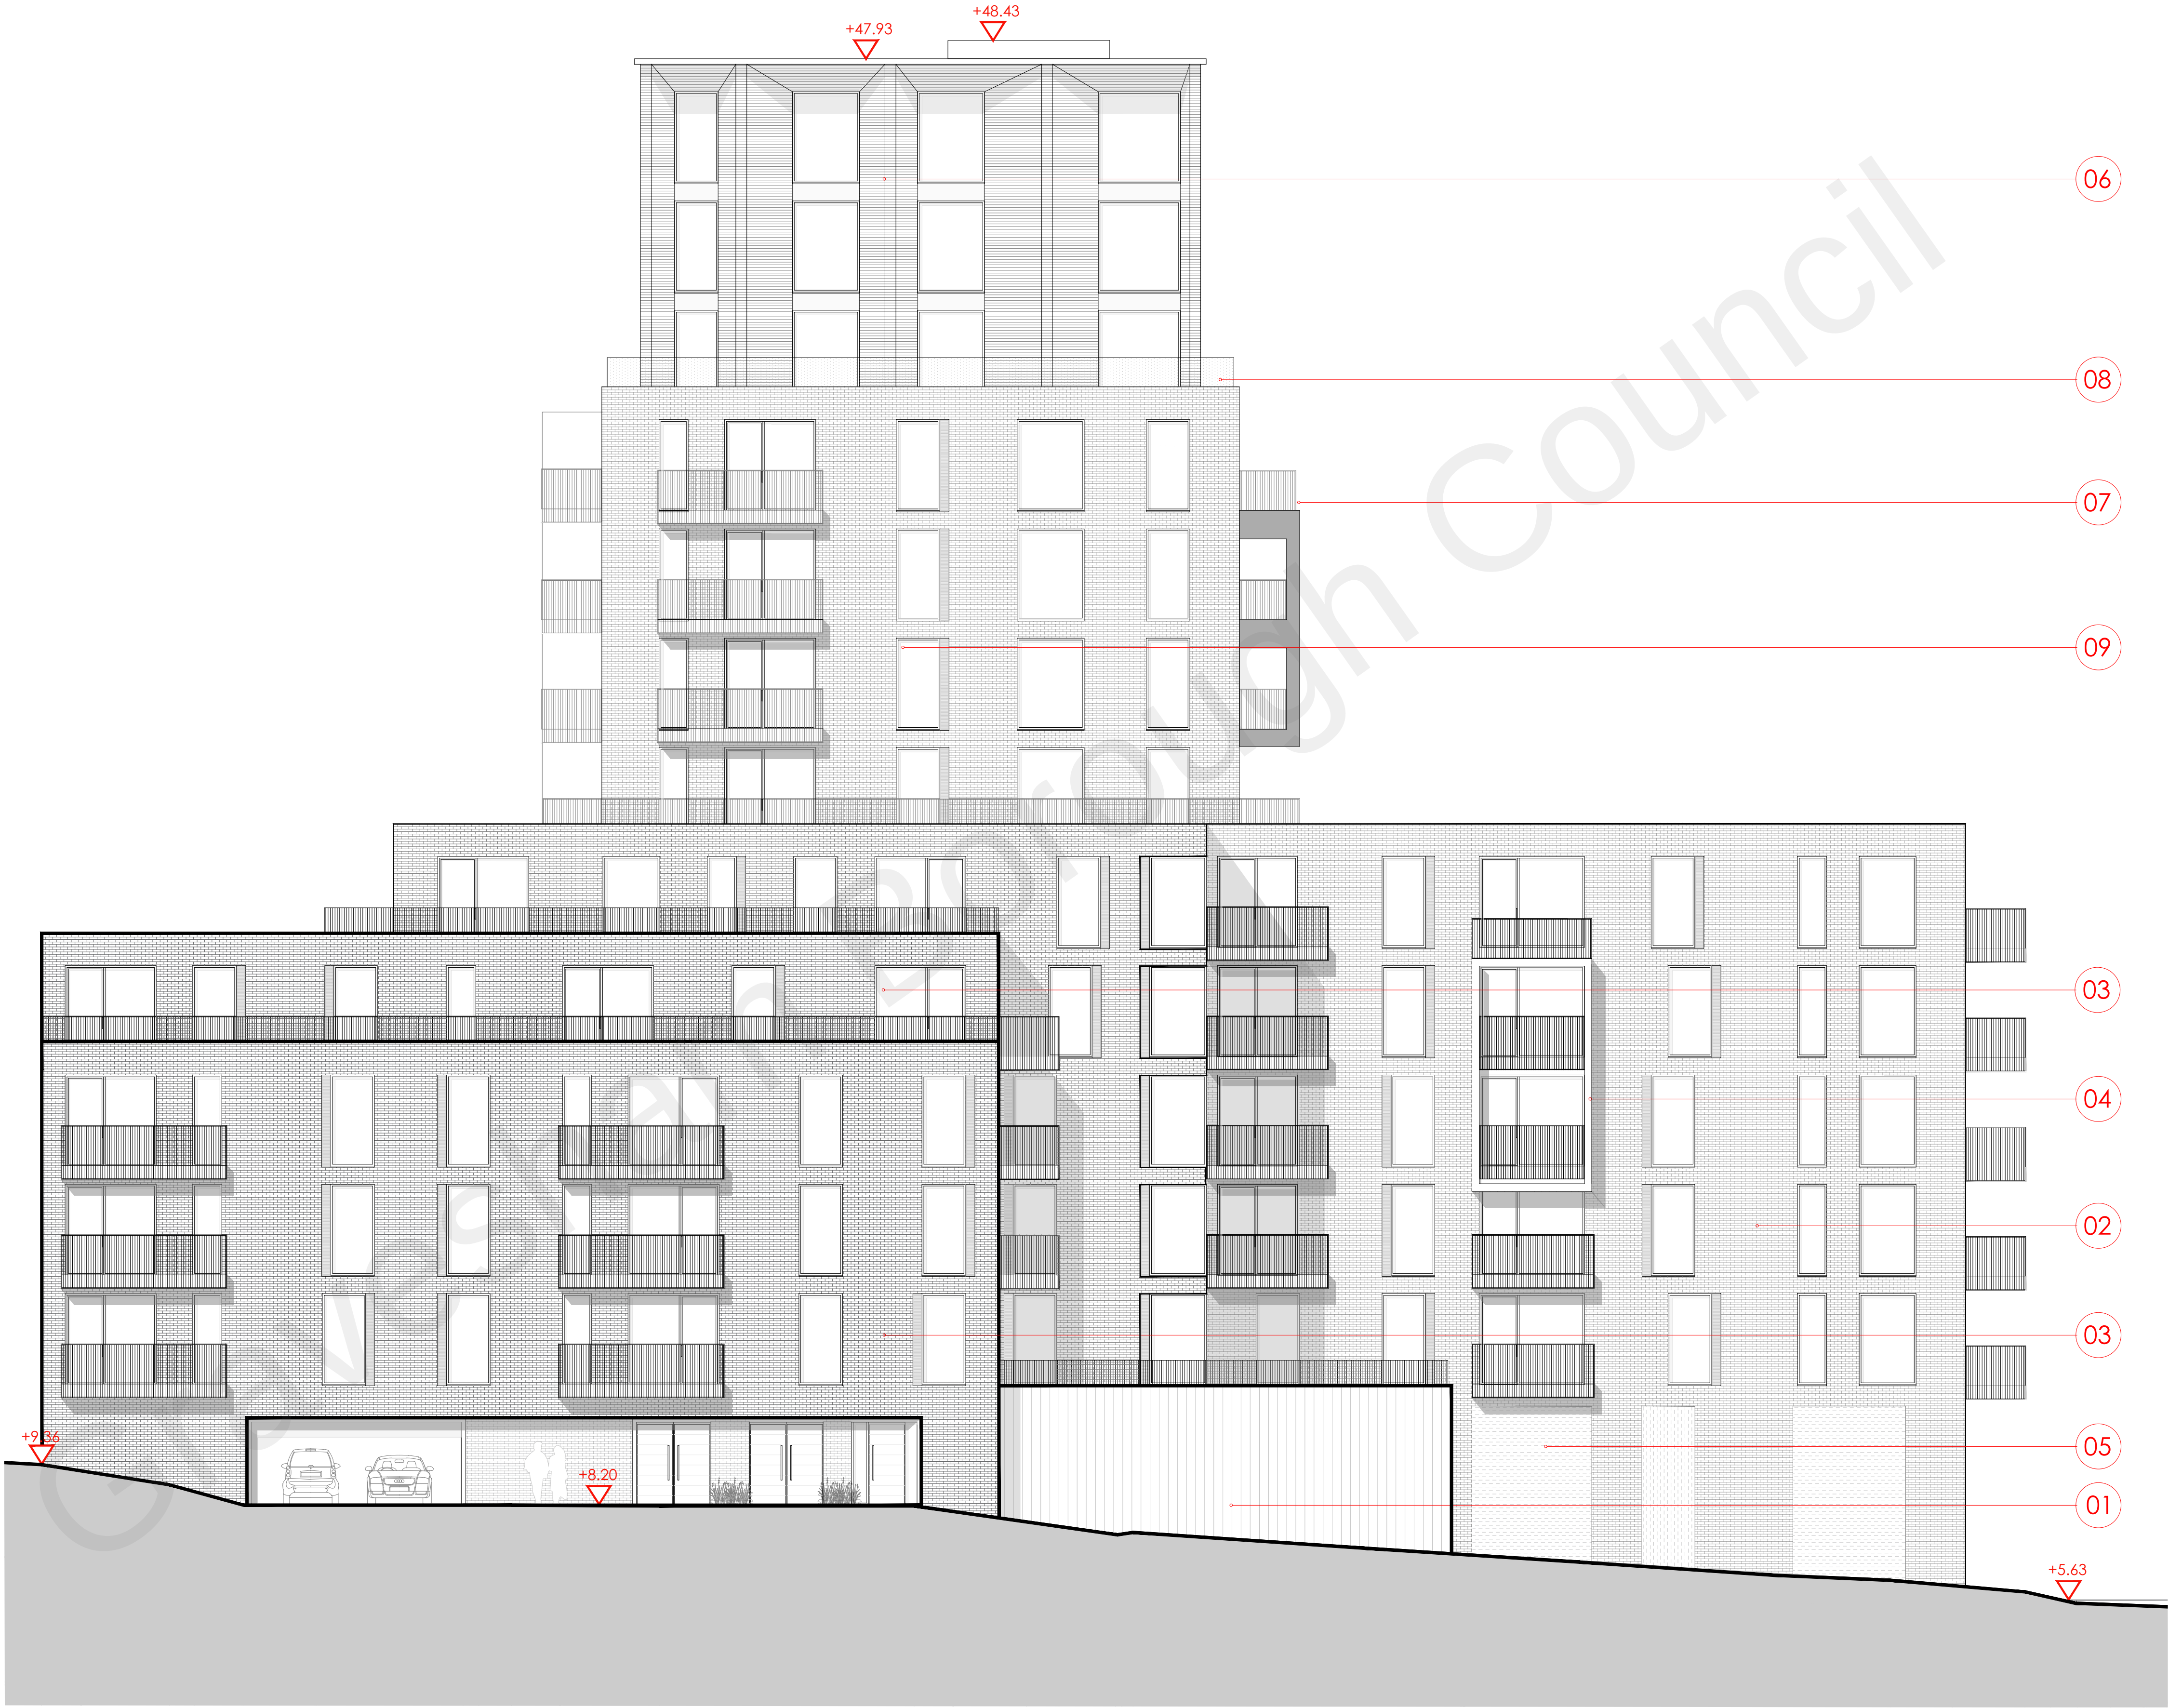
## CLIFTON SLIPWAYS, GRAVESEND STUART ROAD BLOCK - ELEVATION A

- PROJECT MATERIAL PALETTE
- 01 Vertical Timber cladding.
  - 02 Light grey Brick.
  - 03 Buff Brick.
  - 04 Metallic coloured feature surround
  - 05 Hit and Miss brickwork to provide ventiation to car parking level.
  - 06 Angled buff brick slip cladding system.
  - 07 Metallic coloured Powder coated balustrade
  - 08 Glazed Balustrade.
  - 09 Metallic feature vent panels.
