## **Main Investigation Report**

at  
**Worcester Close, Gravesend, Kent, DA13 9LB**

for  
**Frankham Projects Limited**

**Reference: 20374/MIR Rev1.2**  
**October 2022**

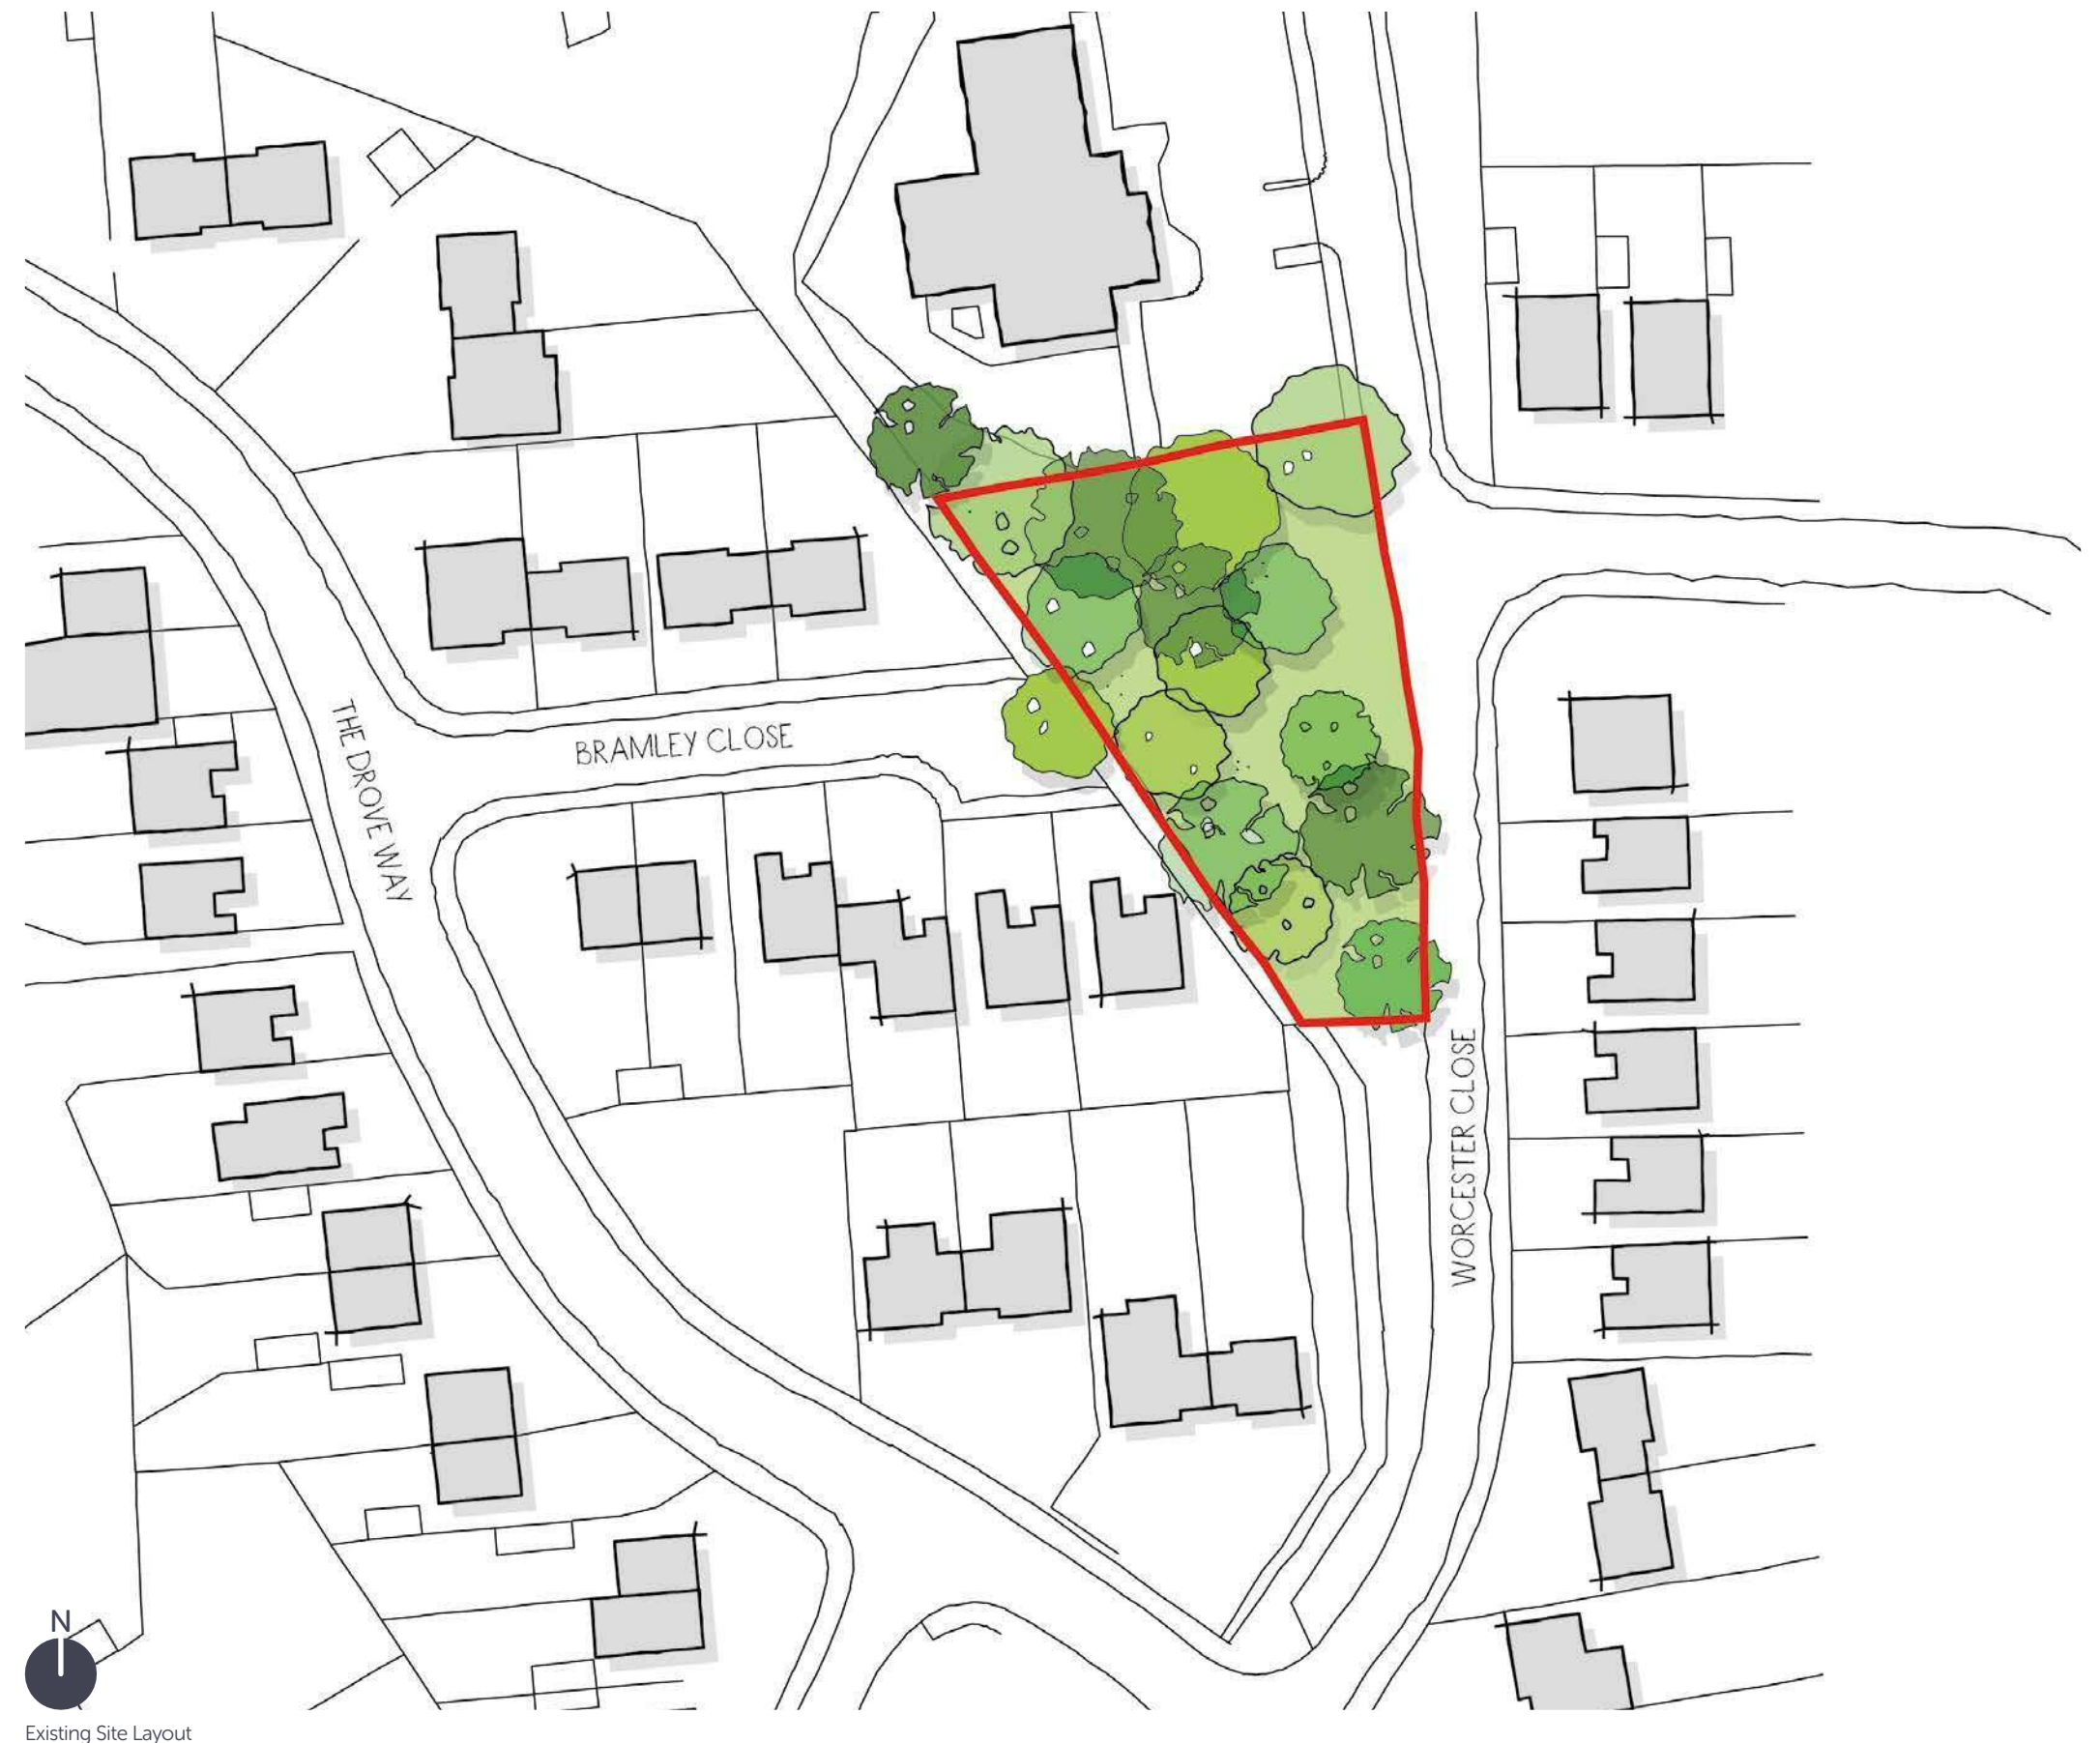
Existing Site Layout

The site has an area of circa 0.139 ha. and is currently an undeveloped area with a number of mature trees. Vehicular access to the site is from Worcester Close with additional pedestrian access from Bramley Close.

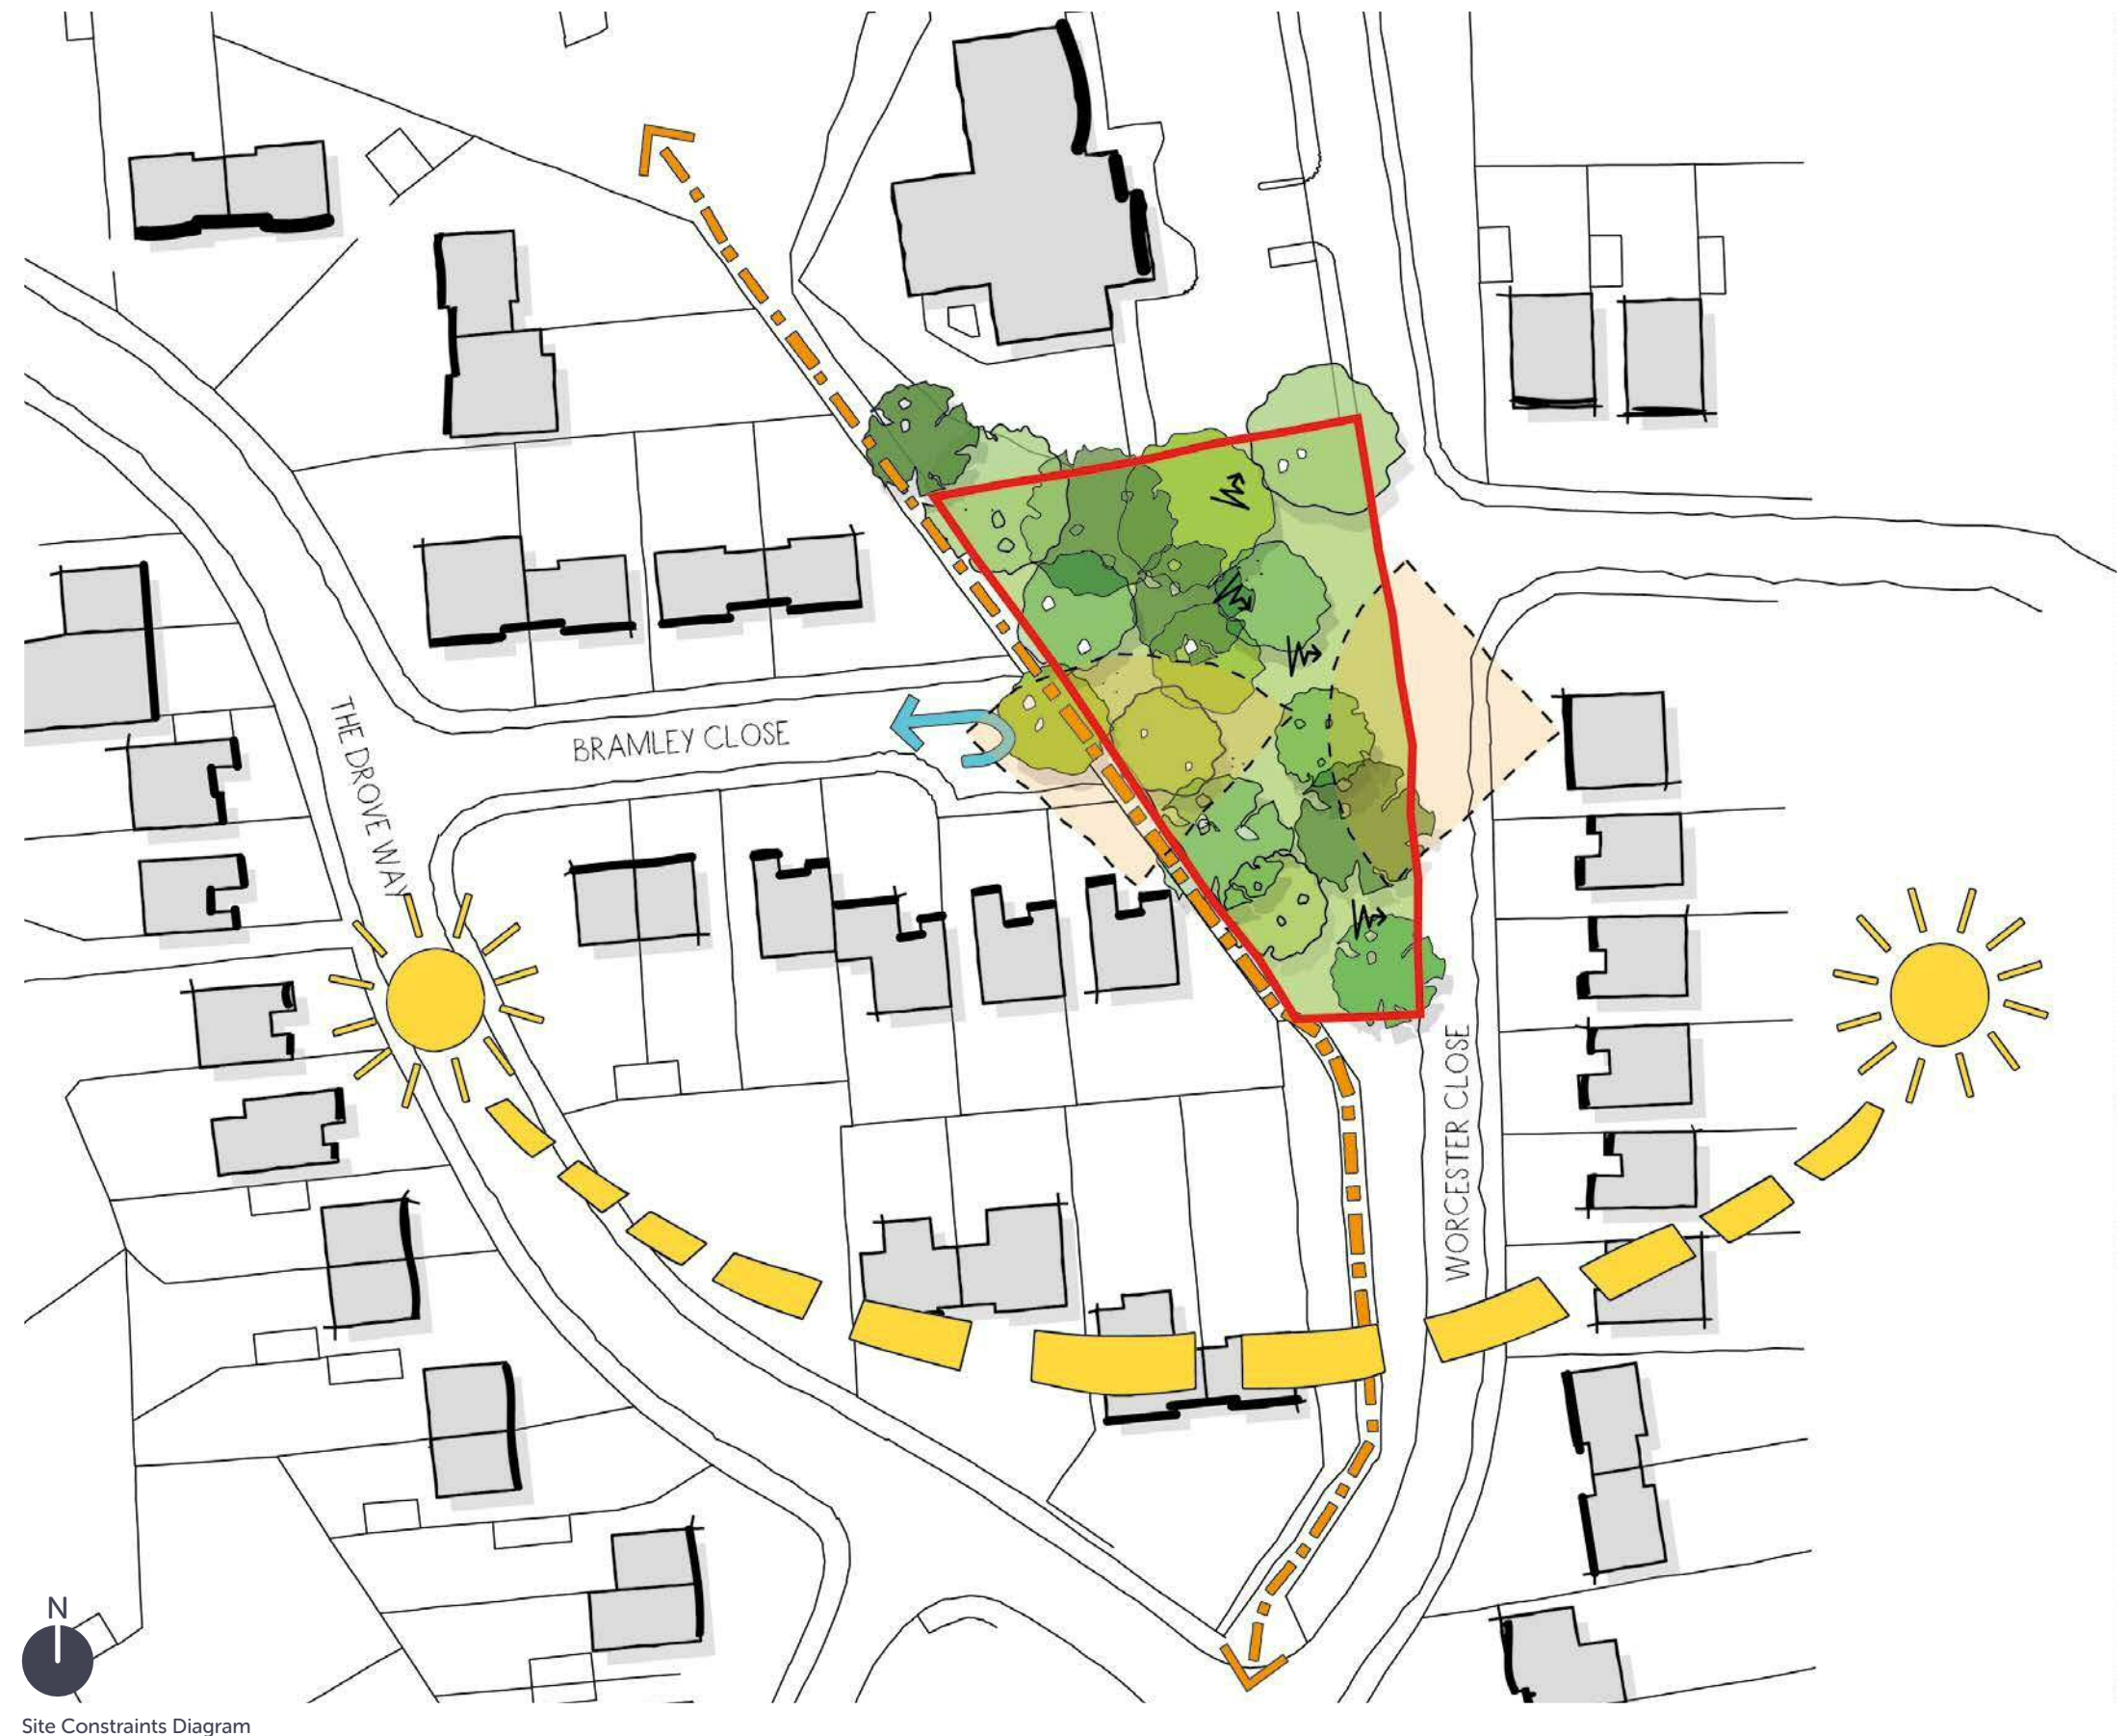
The site includes a number of constraints:

- > The site is an irregular shape, wider at the north, and narrows to the south.
- > Habitable room windows overlook the site from the existing adjacent houses.
- > There is no vehicular access from Bramley Close.
- > There is a significant level change across the site.
- > The site contains a number of existing trees.

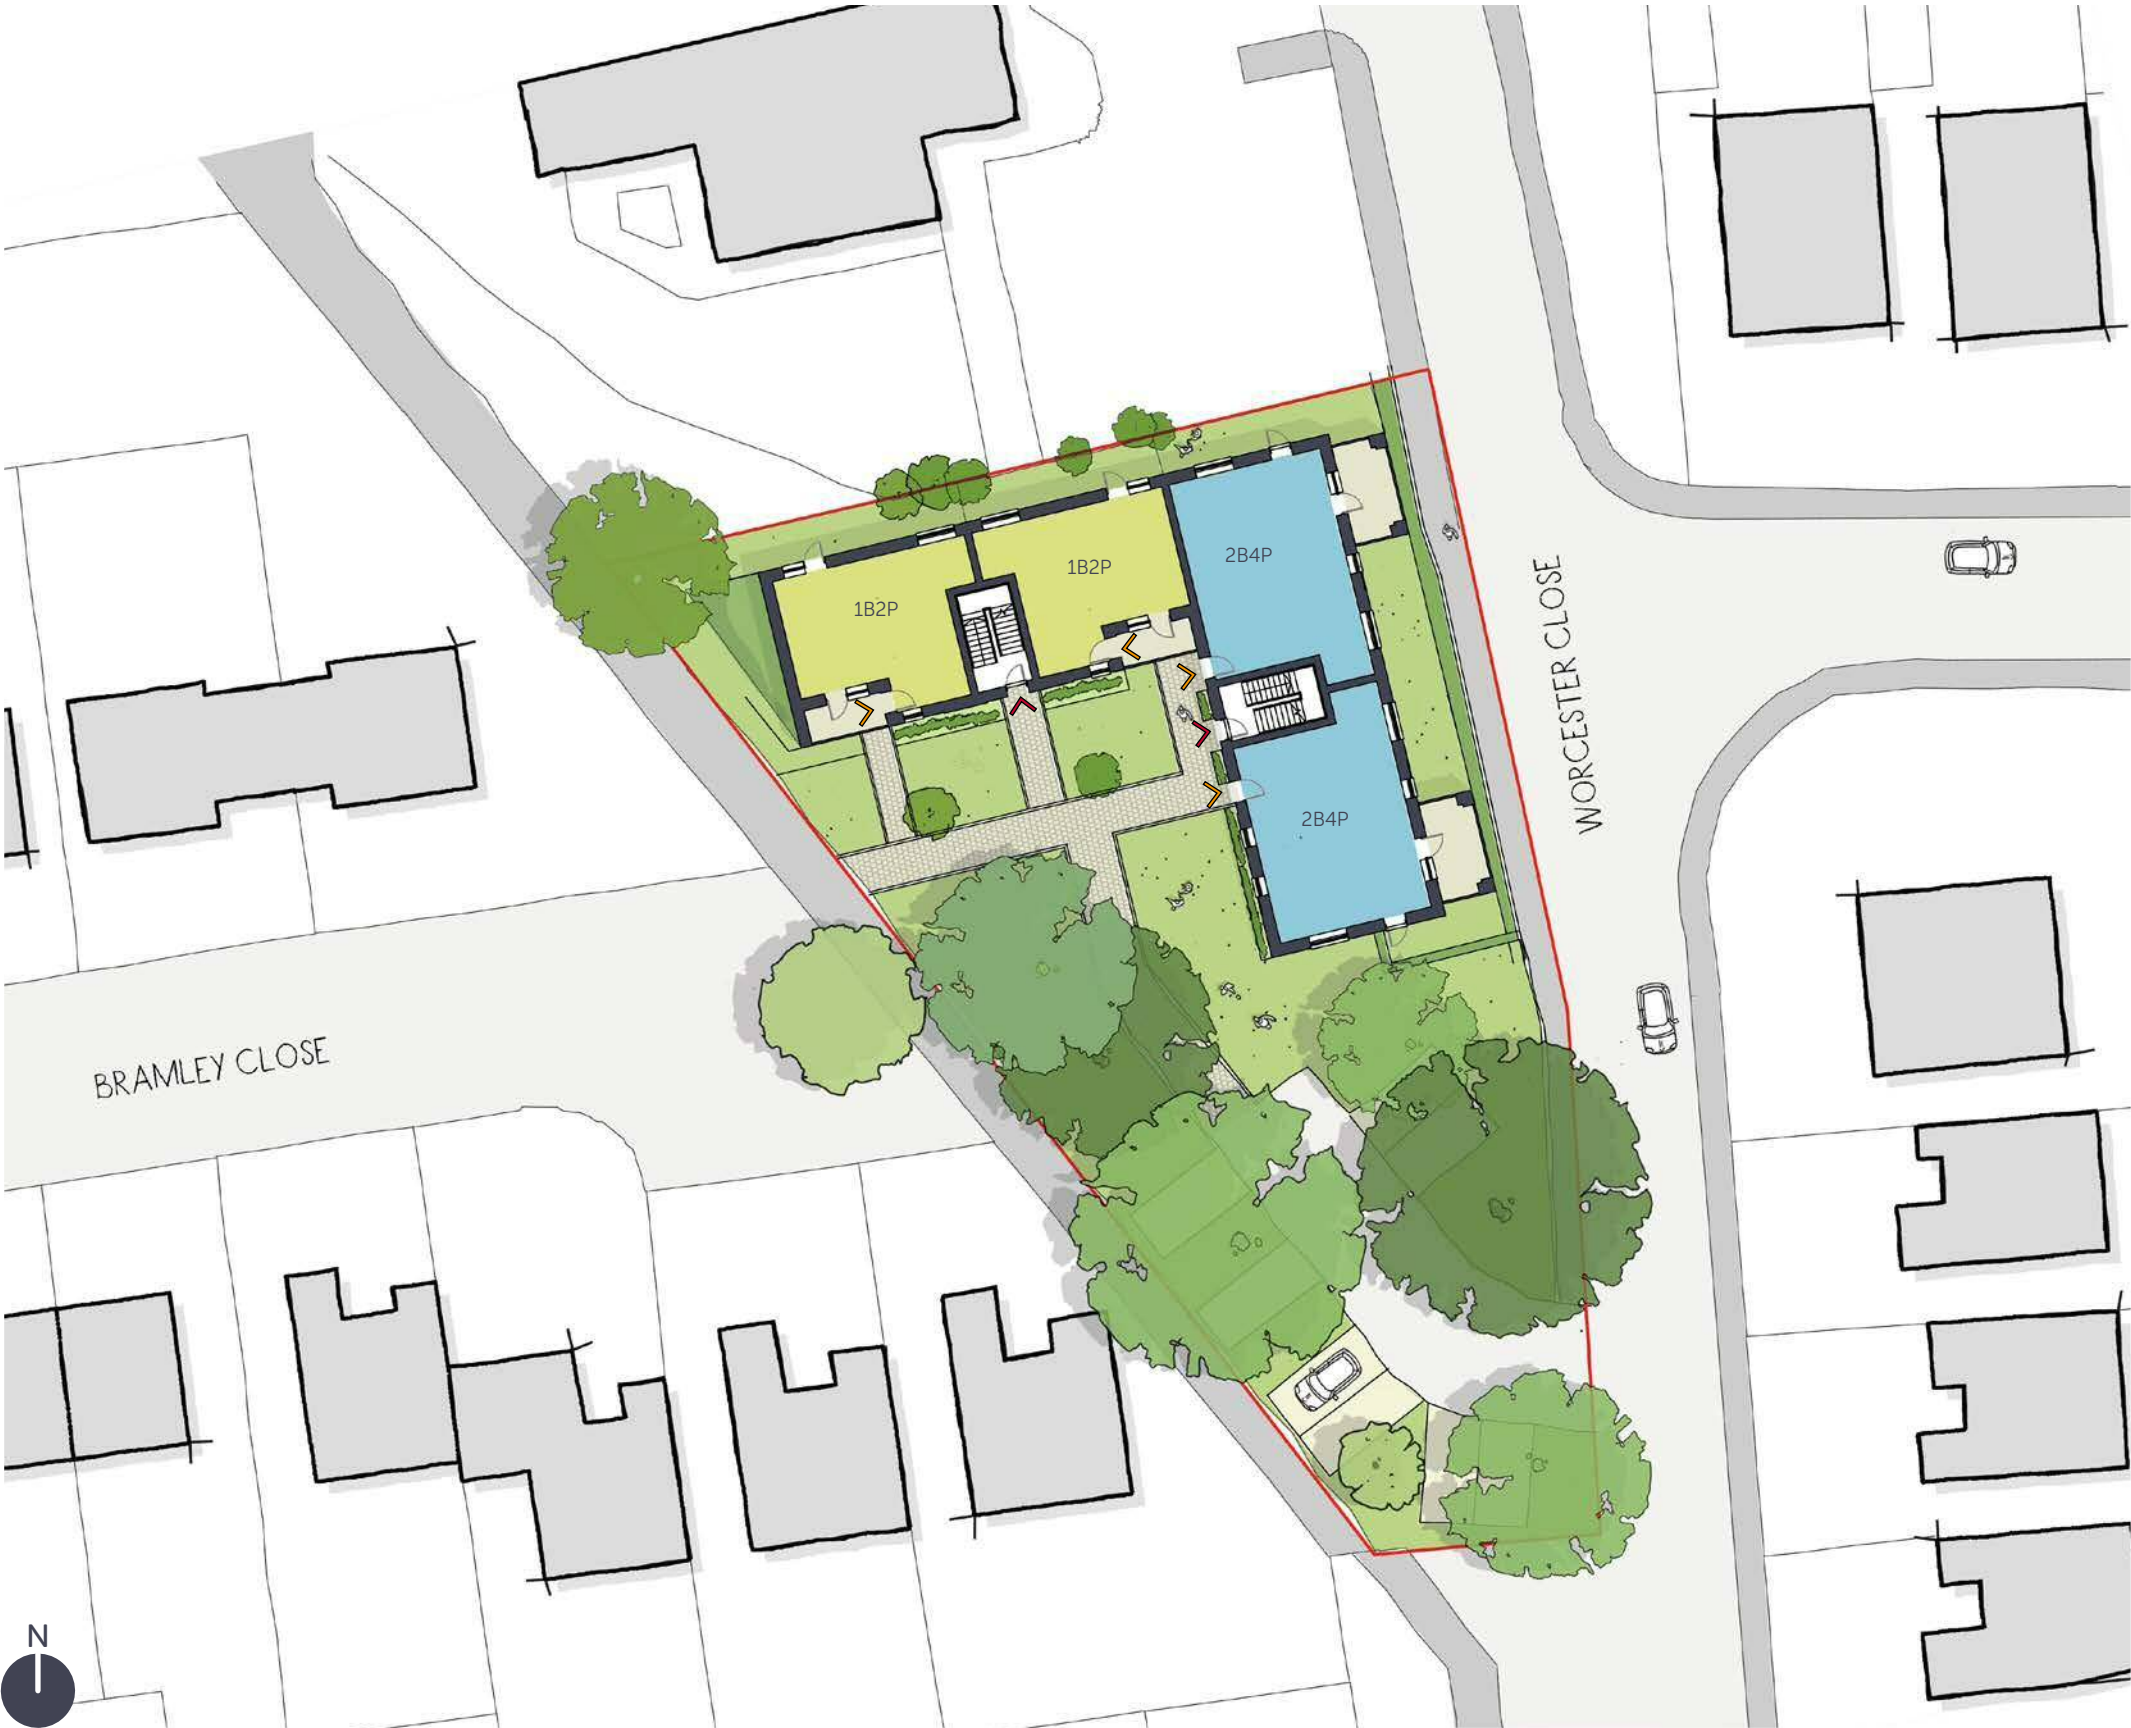
Site Layout

The layout has been developed following our site analysis to enhance active frontage onto Worcester Close and provide a focal point from Bramley Close. The footprint of the building has been further considered to respect the established build line, in keeping with adjacent buildings on Bramley Close.

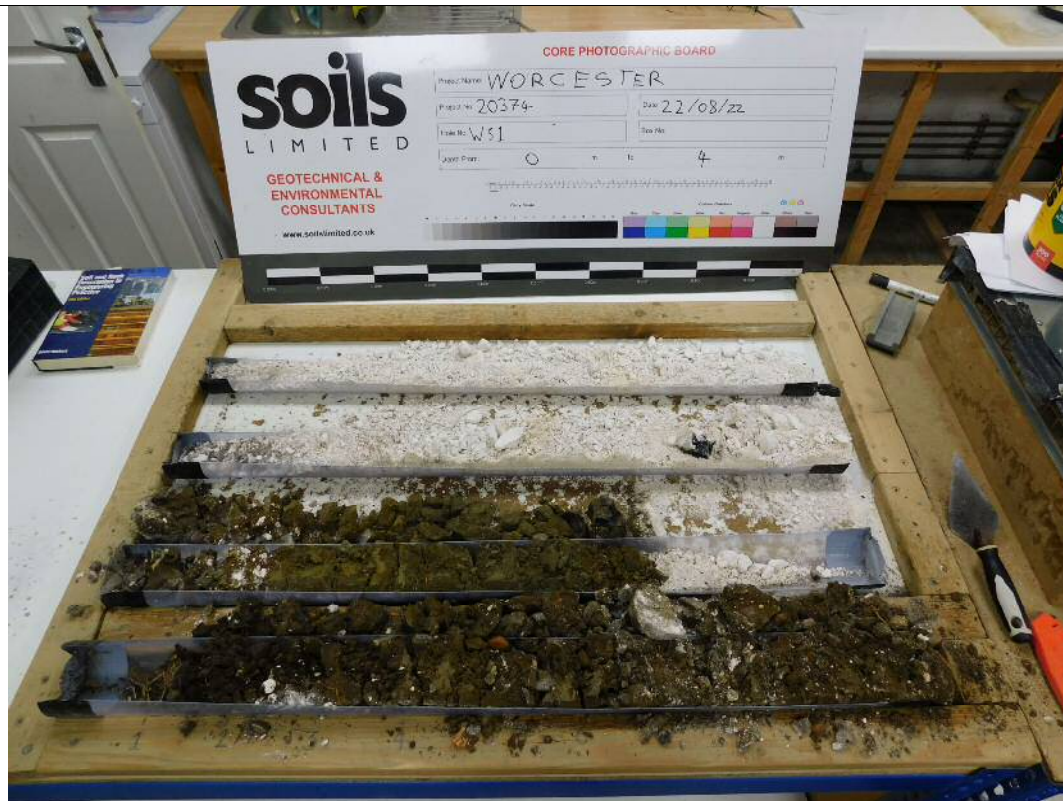
**Photo 1:** WS1: 0.00m – 4.00m bgl

Soils described as Made Ground was encountered only in WS1 from ground level to depth of 1.20m bgl. The presence of Made Ground could possibly be from soils excavated during the construction of a possible drainage system underlying the site, as a manhole was seen during the site works. It was also noted that WS1 was undertaken on an area of higher elevation of the site, potentially of mounded reworked material.

Soils described as LSNCK were found from ground level and directly beneath the Made Ground within WS1 in each of the four exploratory hole locations to depths of between 0.75m (WS2) and 1.70m bgl (WS1).

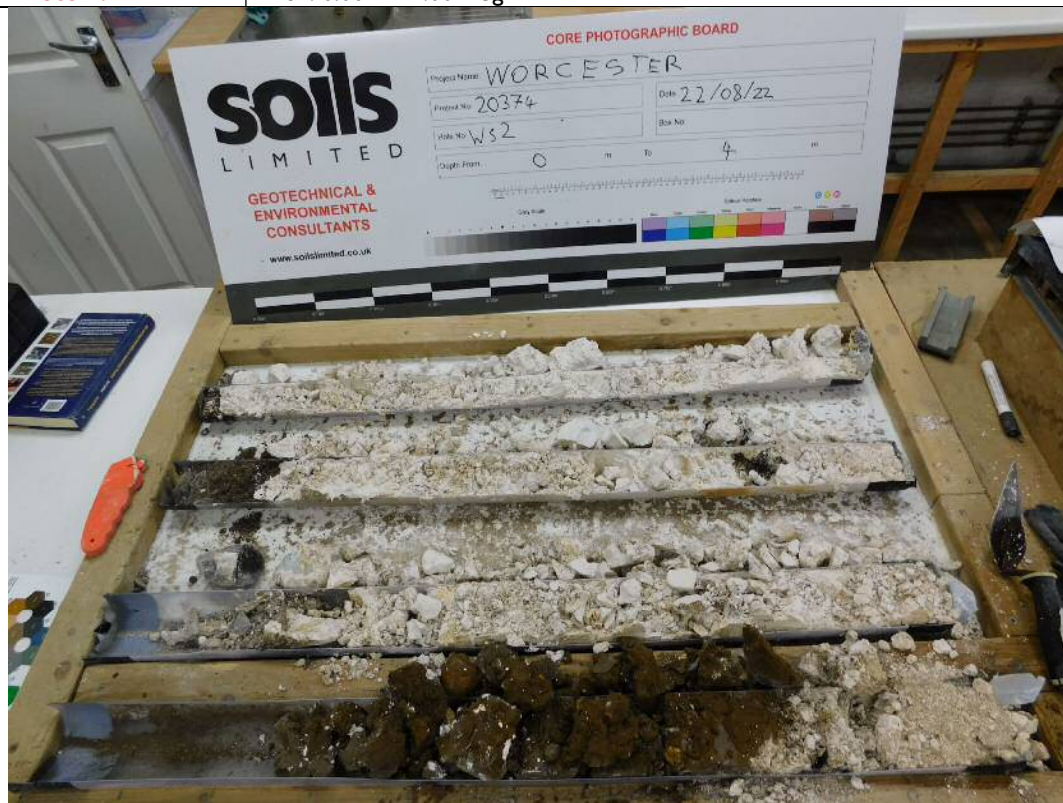
**Photo 2:** WS2: 0.00m – 4.00m bgl

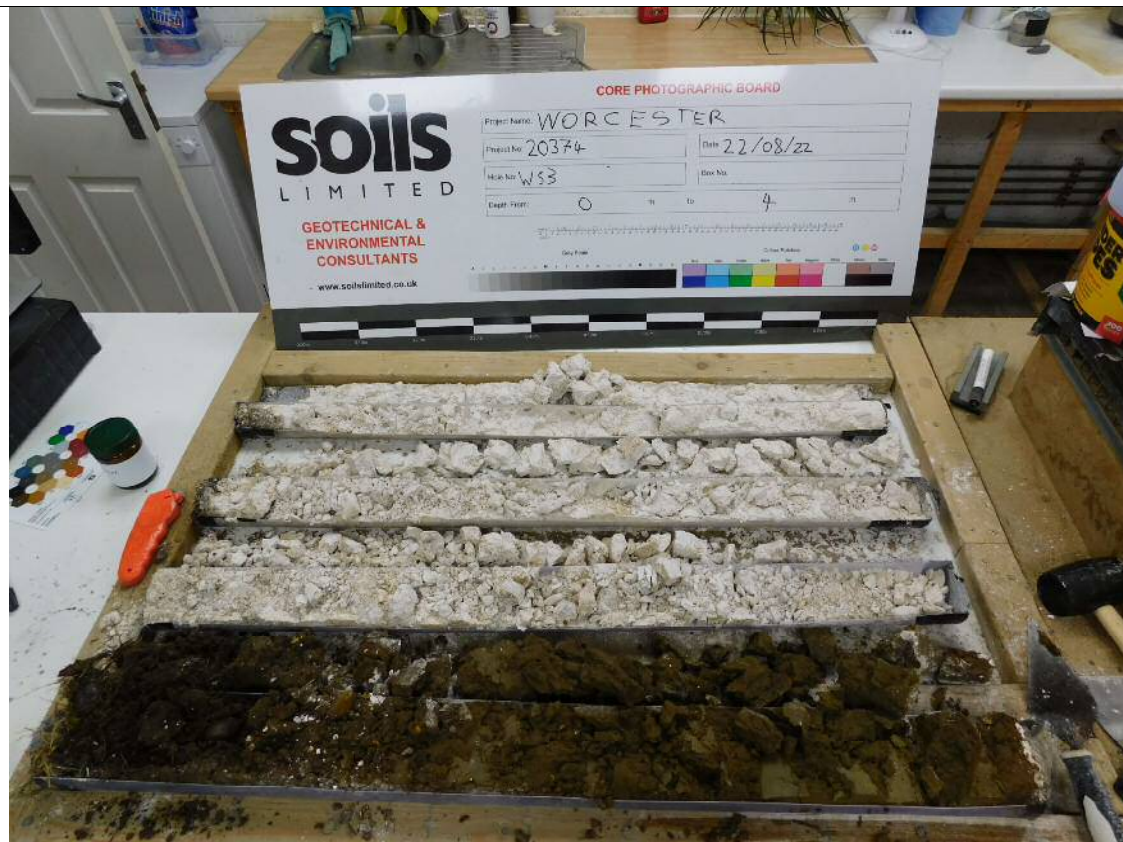
**Photo 3:** WS3: 0.00m – 4.00m bgl

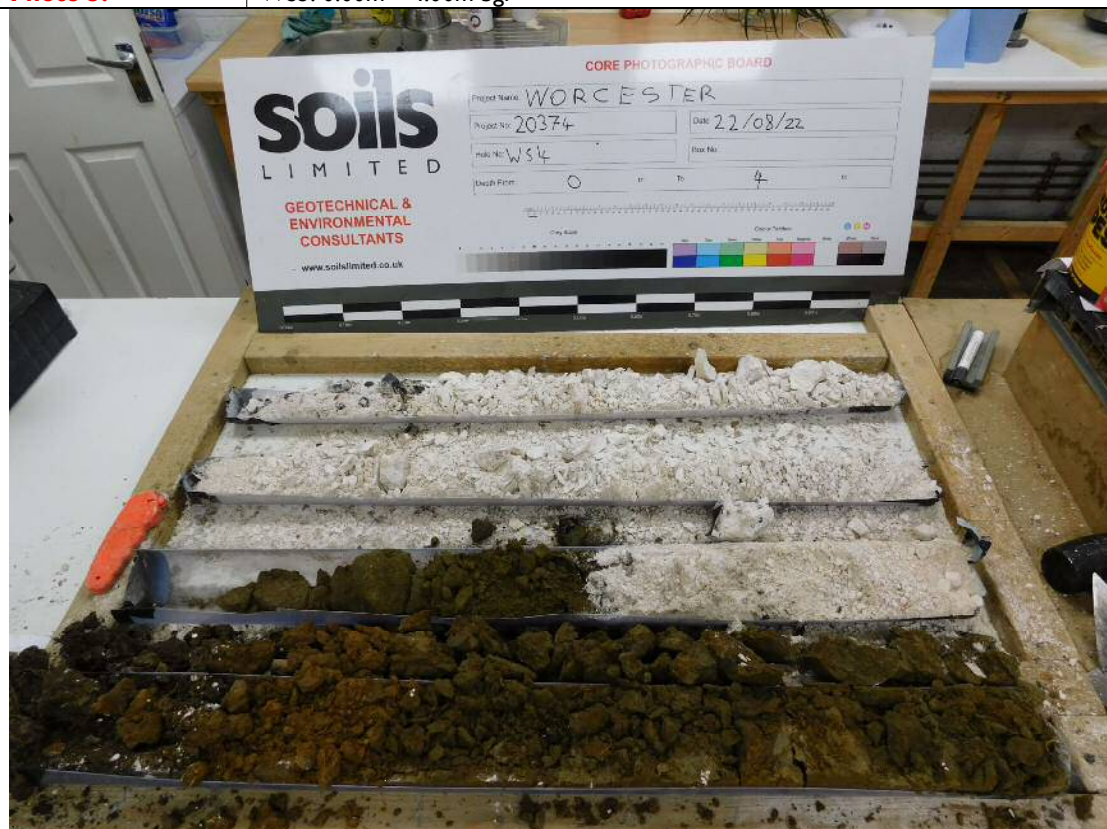
**Photo 4:** WS4: 0.00m – 4.00m bgl
