# Preliminary UXO Risk Assessment

| <b>Project</b> | Worcester Close, Gravesend |
| <b>Site Address</b> | Worcester Close, Gravesend DA13 9LB |
| <b>Report Reference</b> | PA16287-00 |

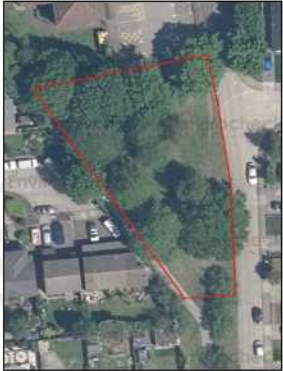
| <p>Site location and description/current use</p> | <p>The site is located in Gravesend within the diocese of Rochester, Kent.</p> <p>According to recent aerial photography, the site is currently occupied by undeveloped land covered in vegetation.</p> <p>To the north of the site is hardstanding ground, currently in use as a car park for the Downs Way Medical Practice. The east of the site is bordered by Worcester Close. To the south and west of the site is bordered by some residential structures, hard standing ground and undeveloped land, presumed to be in use as the residential structures gardens and driveways.</p> <p>The site is approximately centred on the OS grid reference: <b>TQ 63644 70237</b>.</p> |
