Worcester Close, Istead Rise, GRAVESEND, DA13 9LB

## Detailed Unexploded Ordnance (UXO) Risk Assessment

| <b>Project Name</b> | Worcester Close, Gravesend |

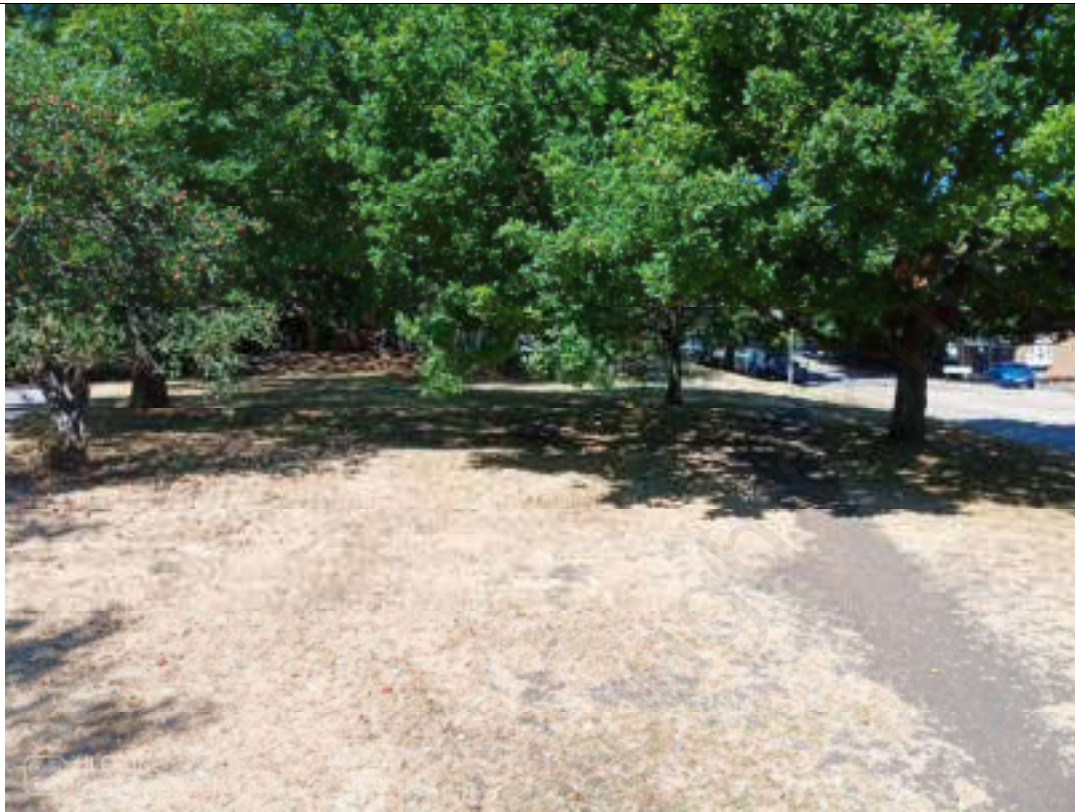
**Photo 1:**

Site area with numerous large mature trees. View looking north.

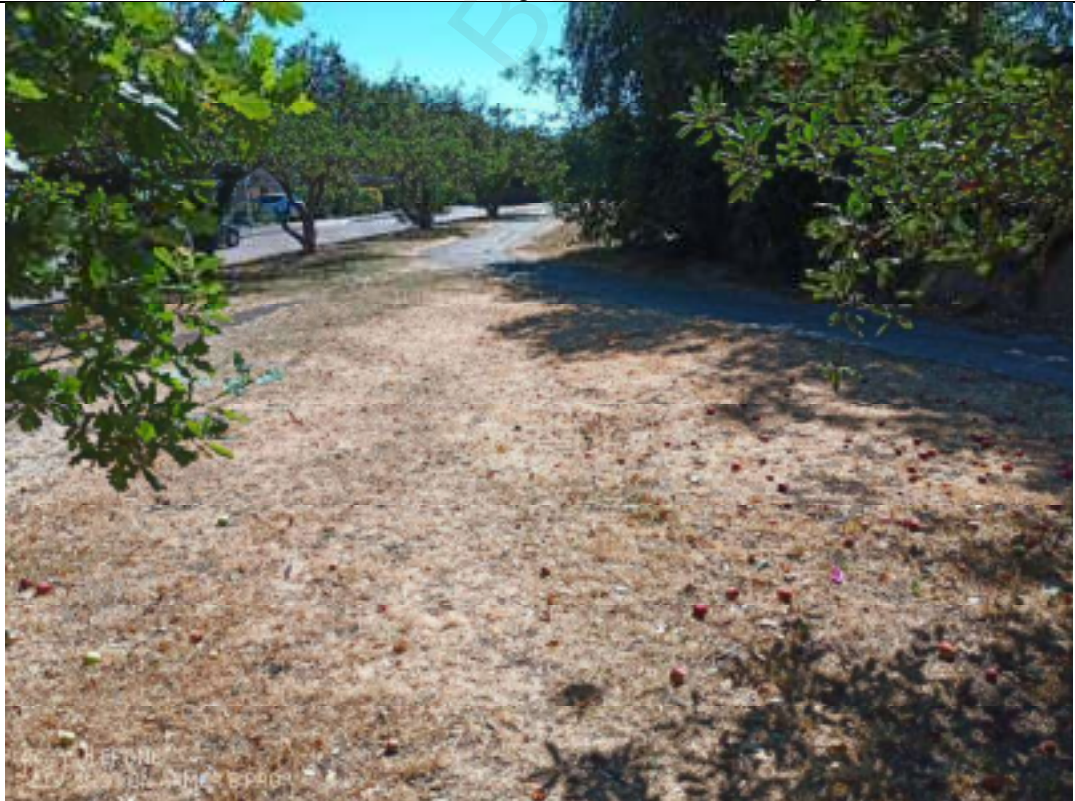
**Photo 2:**

Hardstanding footpath onsite. View looking south.

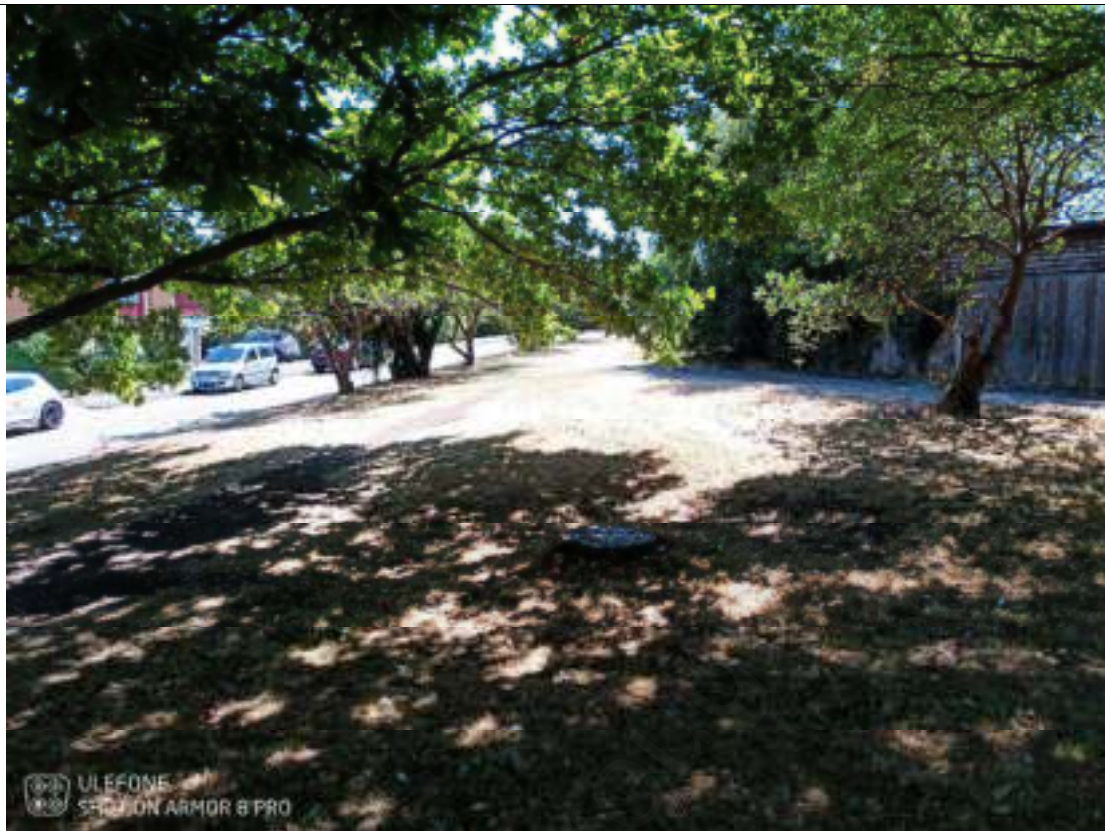
**Photo 3:** Manhole seen near the centre of the site. View looking south.

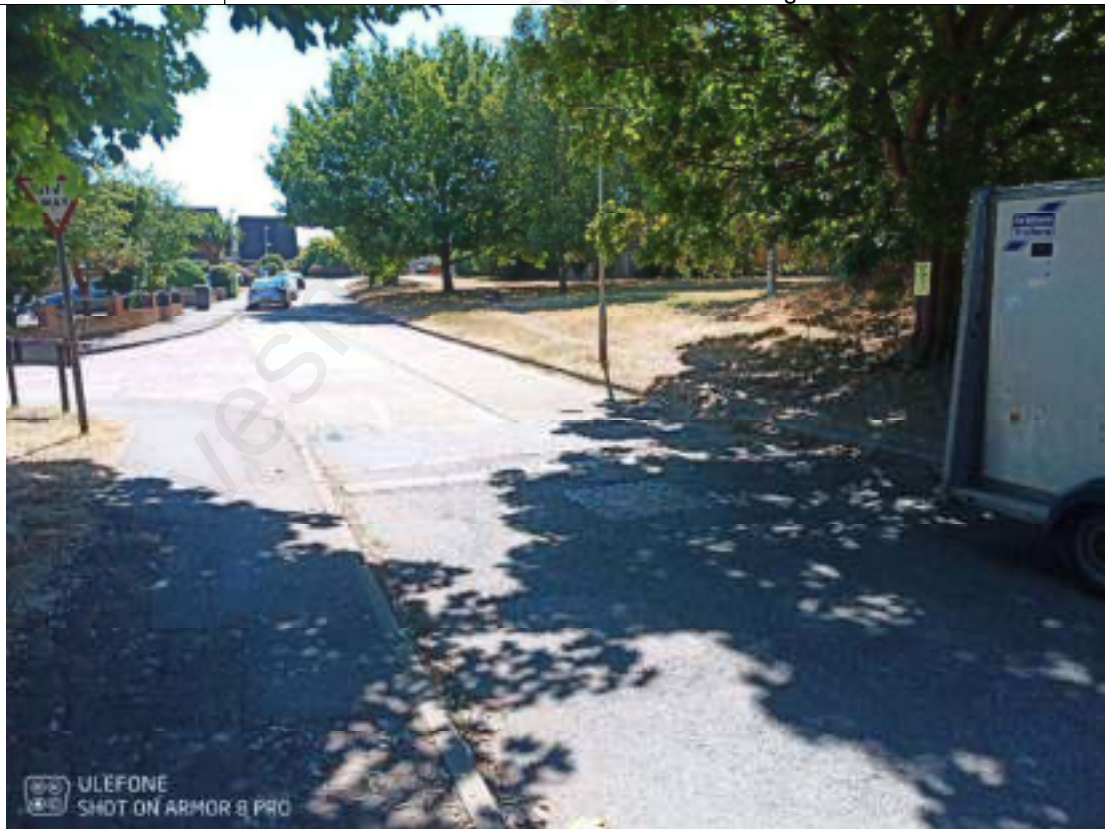
**Photo 4:** Road of Worcester Close, with site area on the right. View looking south.

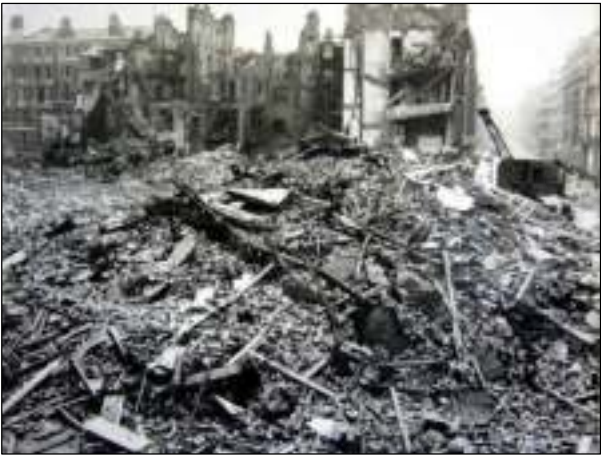
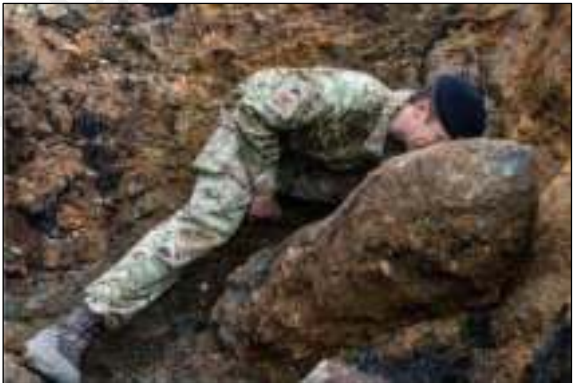
**Top:** J-curve Effect - Due to angle of entry, unexploded bombs would often end their trajectory at a lateral offset from point of entry, often ending up beneath adjacent extant structures/sites. The photograph above shows 250kg bomb found in Bermondsey pointing upwards, demonstrating ‘J-curve’

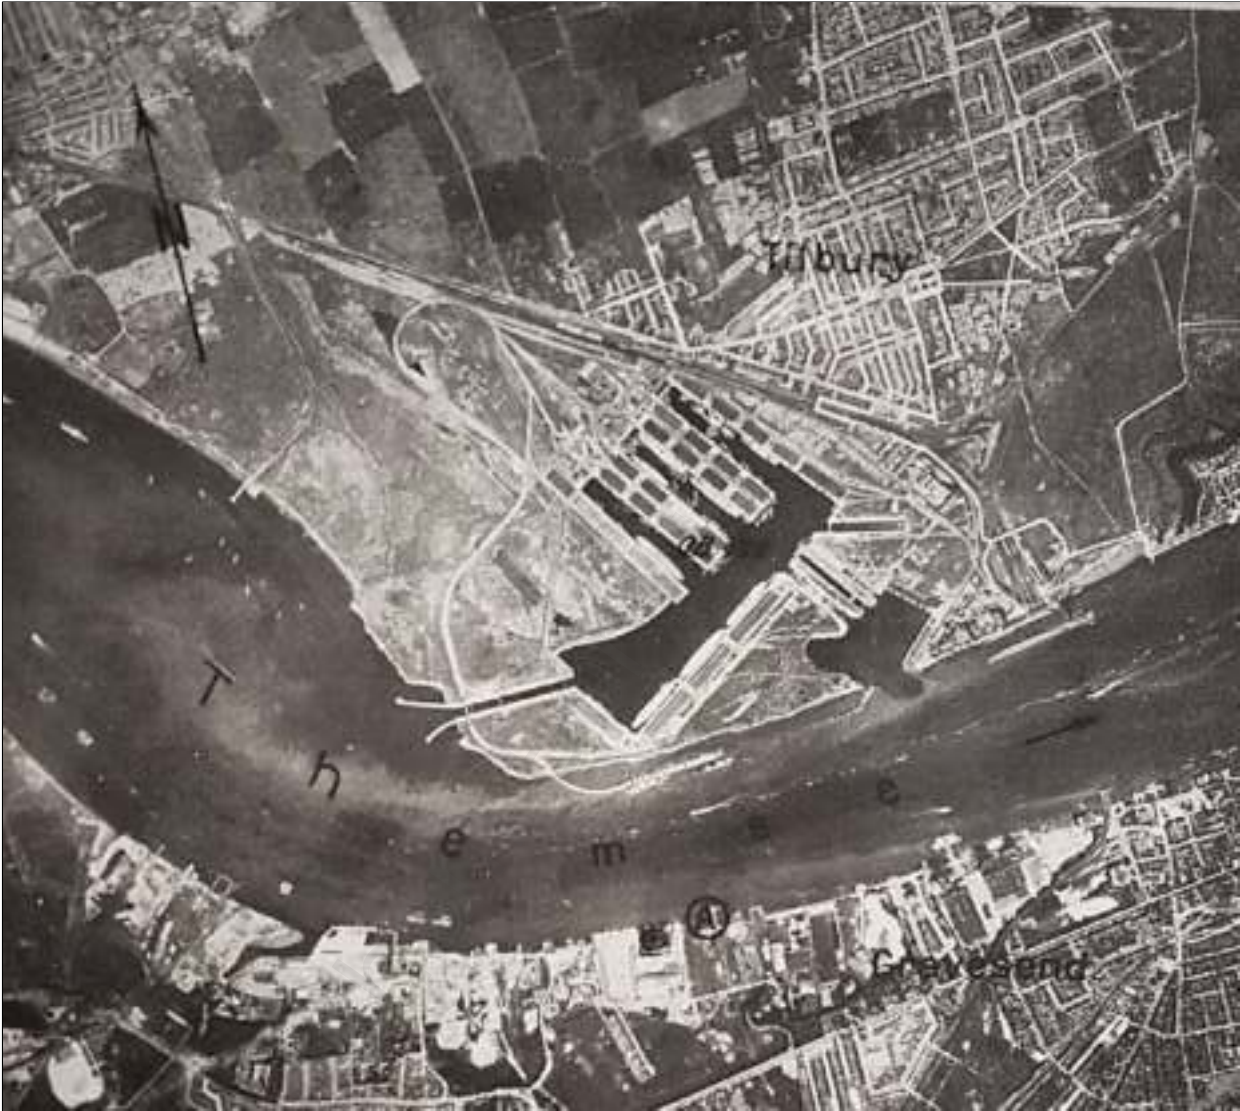
This is just one photograph from the German reconnaissance coverage of the Britain, which highlighted known Luftwaffe bombing targets. The above photo was taken 4<sup>th</sup> June 1939 and highlights a power station in Gravesend, approximately 4.2km north of the site.

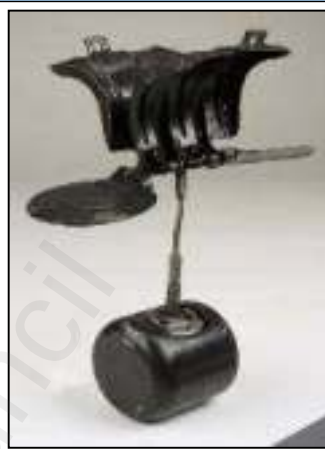
**SD2 Butterfly Bomb**

| Bomb Weight | 2kg (4.41lb) | | | |
| Explosive Weight | 7.5oz (212.6 grams ) of TNT surrounded by a layer of bituminous composition. | | | |

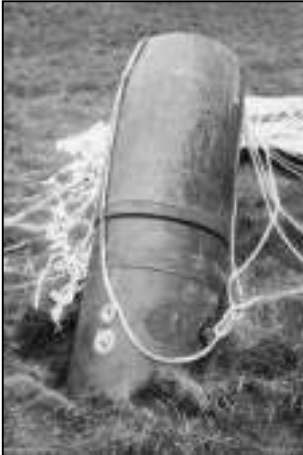
**Parachute Mine (Luftmine B / LMB)**

| Bomb Weight | 987.017kg (2176lb) | | | |
| Explosive Weight | 125-130kg (276-287lb) | | | |

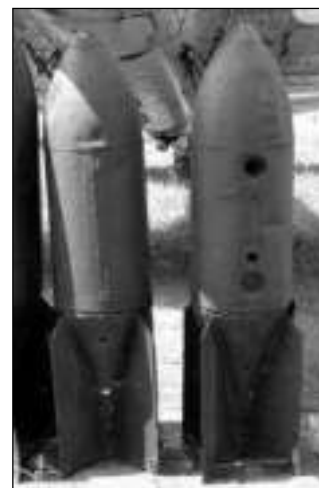
QF 3.7 Inch WWII Anti-Aircraft Projectile

| Ceiling | 30,000ft to 59,000ft |

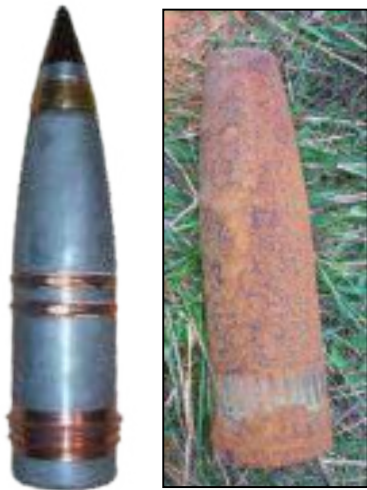
40mm Bofors Projectile

| Ceiling | 23,000ft (7000m ) |

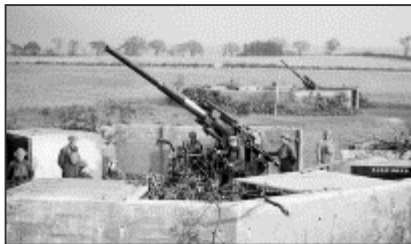
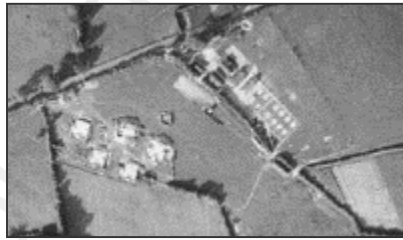
| Projectile Weight | 1.96lb (0.86kg) |
| Projectile Dimensions | 40mm x 310mm (1.6in x 12.2in) |

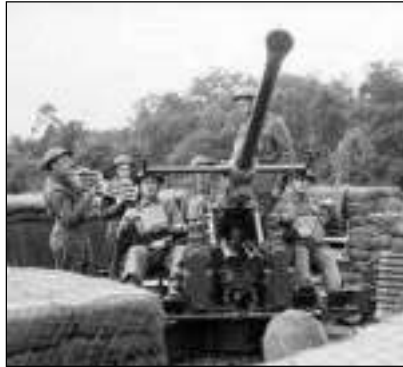
Unrotated Projectile (UP) – Z Battery

| Use | As a short range rocket-firing anti-aircraft weapon developed for the Royal Navy. It was used extensively by British ships during the early days of World War II. The UP was also used in ground-based single and 128-round launchers known as Z Batteries. |

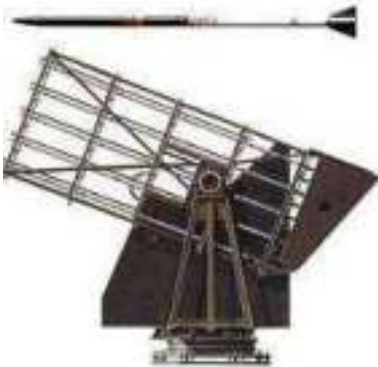
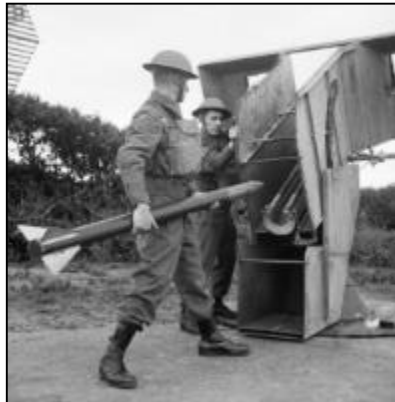
| Projectile Weight | 84lb (24.5kg) |
| Dimensions | 1930mm x 82.6mm (76 x 3.25in) |
