# Algeco Gravesend

Report Title: Flood Risk Assessment

Project Number: G28565

Deliverable Number: G28565-PER-XX-XX-RP-C-00001

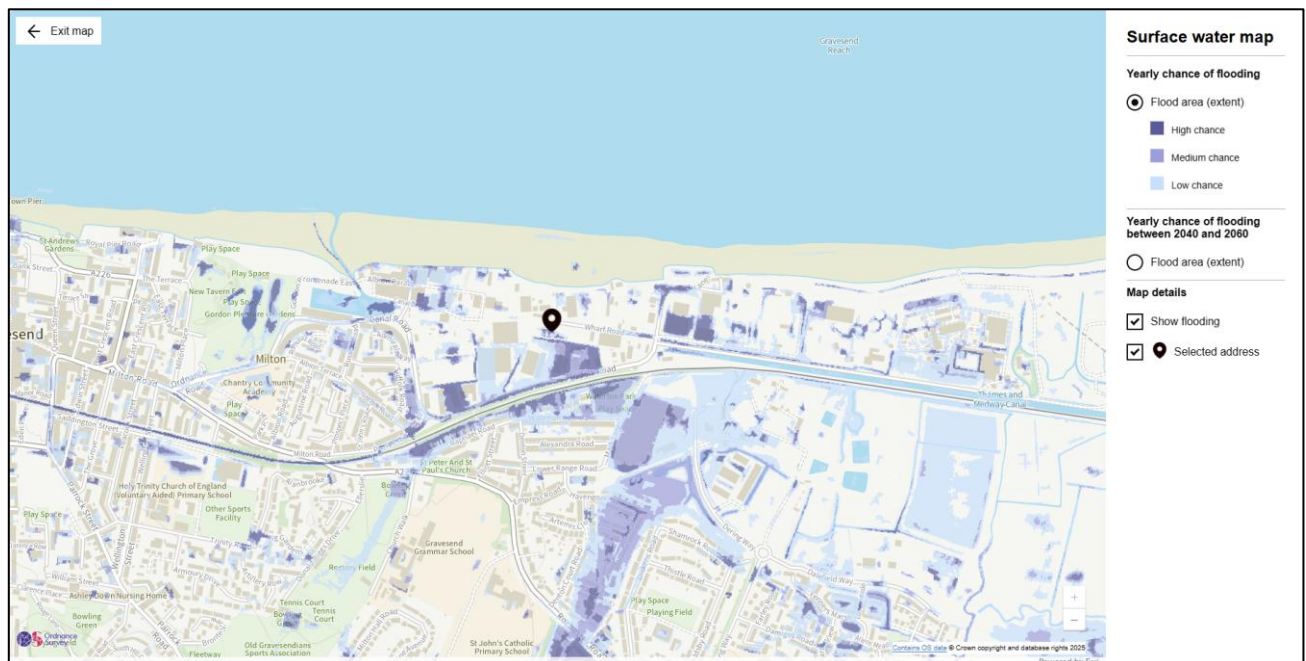
Figure 1 - Surface Water Flood Map – Annual Likelihood of Flooding 1 in 30.

- 7.12 The LTFMfE surface water flood risk map for the development location show that the site is located in an area predominantly at a **medium** risk of surface water. This can be seen in Figure 1 and is included in **Appendix H**. The chance of surface water flooding at this site could be between 1% (1 in 100) and 3.3% (1 in 30) each year. The development should therefore take this into consideration to ensure the flood risk from surface water can be managed.

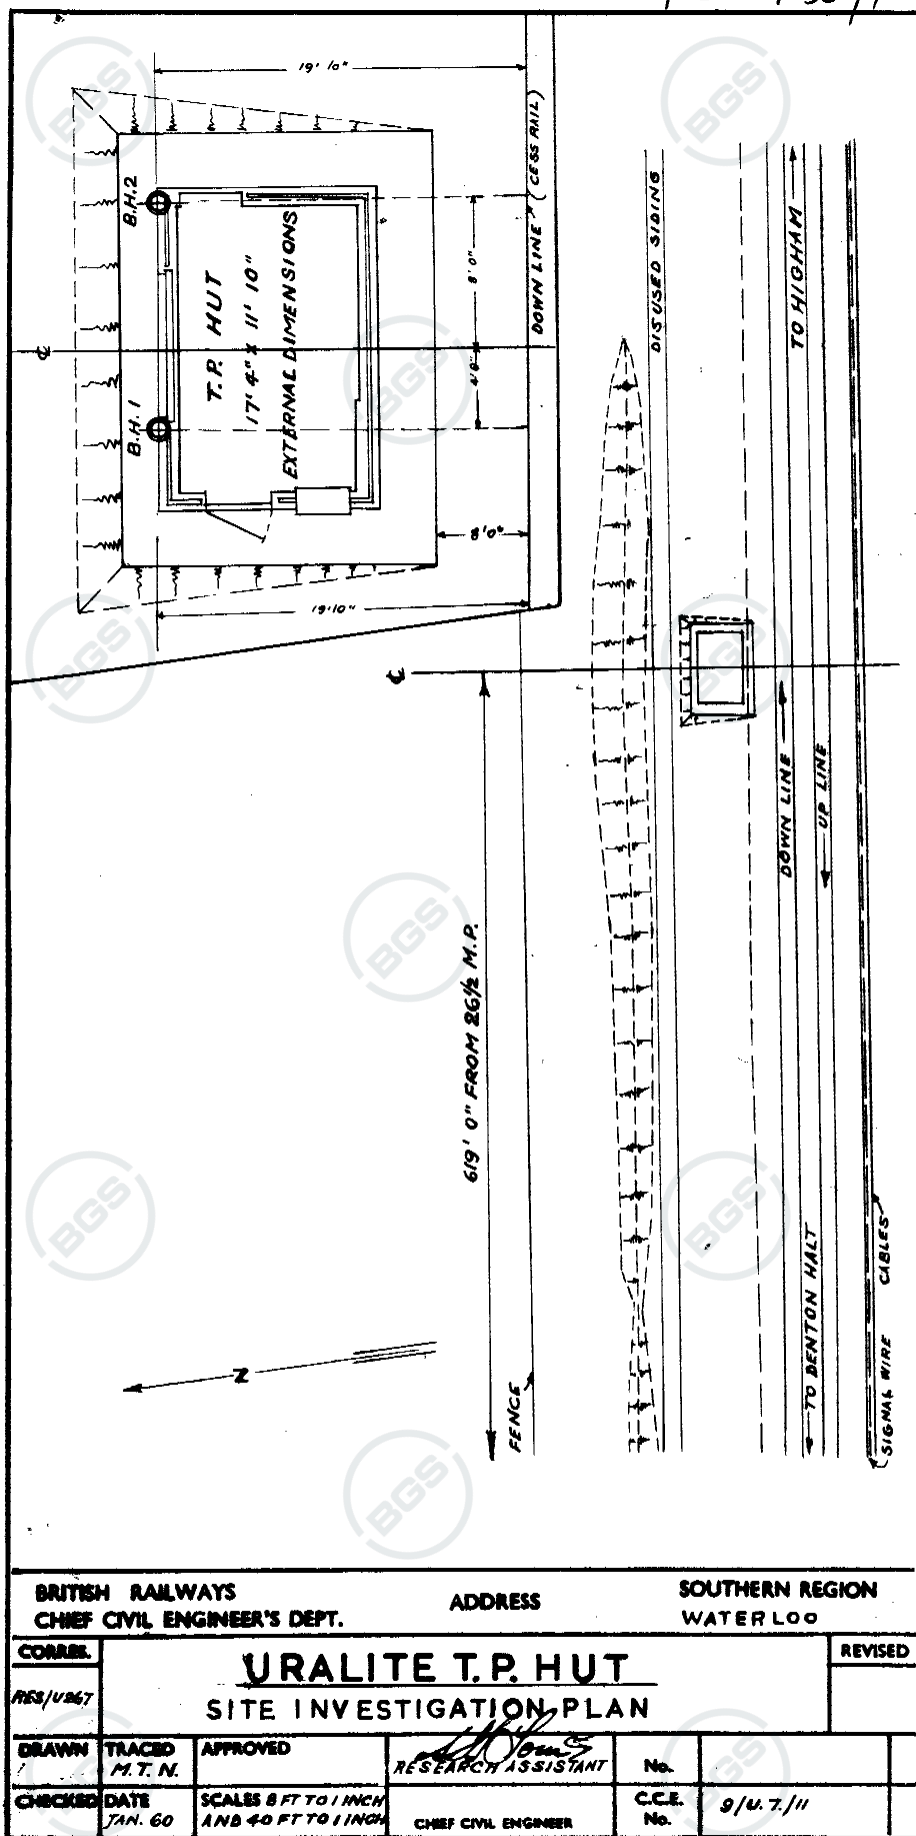
TQ 67 SE 1

3.11 The sets of BGS boreholes log (ref: TQ67SE76 -79) recorded that no groundwater was encountered. However, a different set of BGS boreholes logs (ref: TQ67SE1 -2) taken just North of the site recorded that groundwater was encountered with water level that was observed around 3.35m bgl.

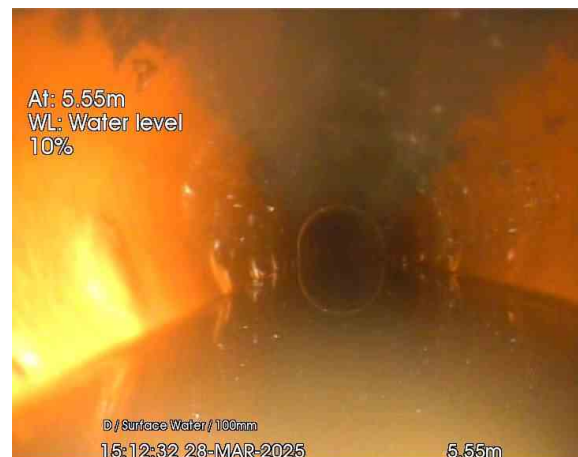
GYF 1\_5-08m\_151222.jpg, 00:00:19, 5.08 m  
Settled deposits, fine, 5% cross-sectional area loss

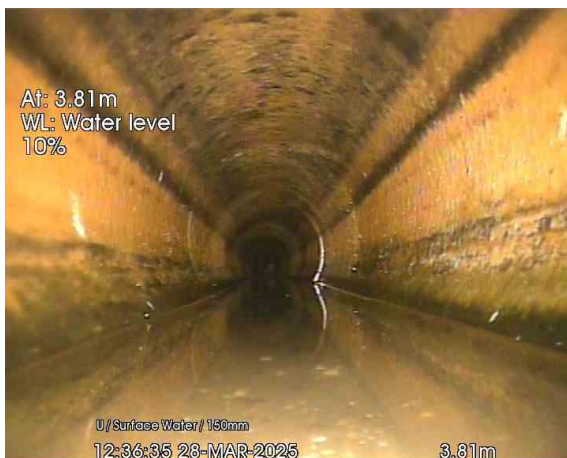
CP01 LAT D\_1-09m\_123615.jpg, 00:00:31, 1.09 m  
 Attached deposits, encrustation from 3 o'clock to 4 o'clock, 5% cross-sectional area loss
