**Planning Statement to support a  
Retrospective Planning Application  
for Emergency Works to the Roof**

**Gravesend Old Town Hall  
High Street  
Gravesend  
DA11 0AZ**

**Kent County Council Strategic and Corporate Services**

P251 Statement

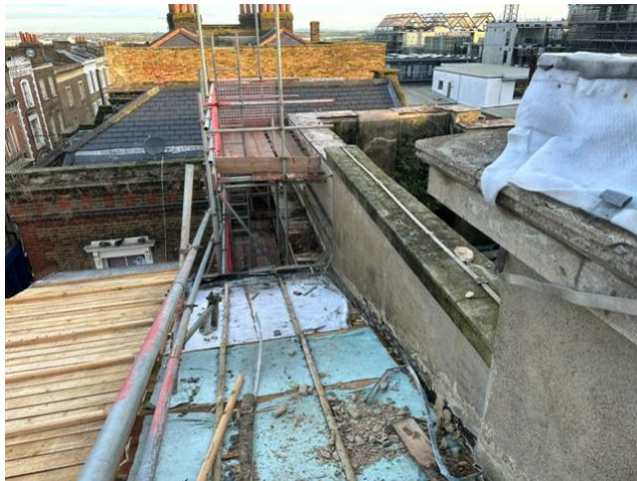
View 1

Photographs of the roof showing the extents of the lead coverings that were stolen.
