# Preliminary Ecological Appraisal and Roost Assessment

31<sup>st</sup> Gravesend Scout Hut, Hampton Crescent, Gravesend, DA12 4HZ

Corstorphine & Wright

‘The demolition of the existing building, to be replaced with a new hut.’

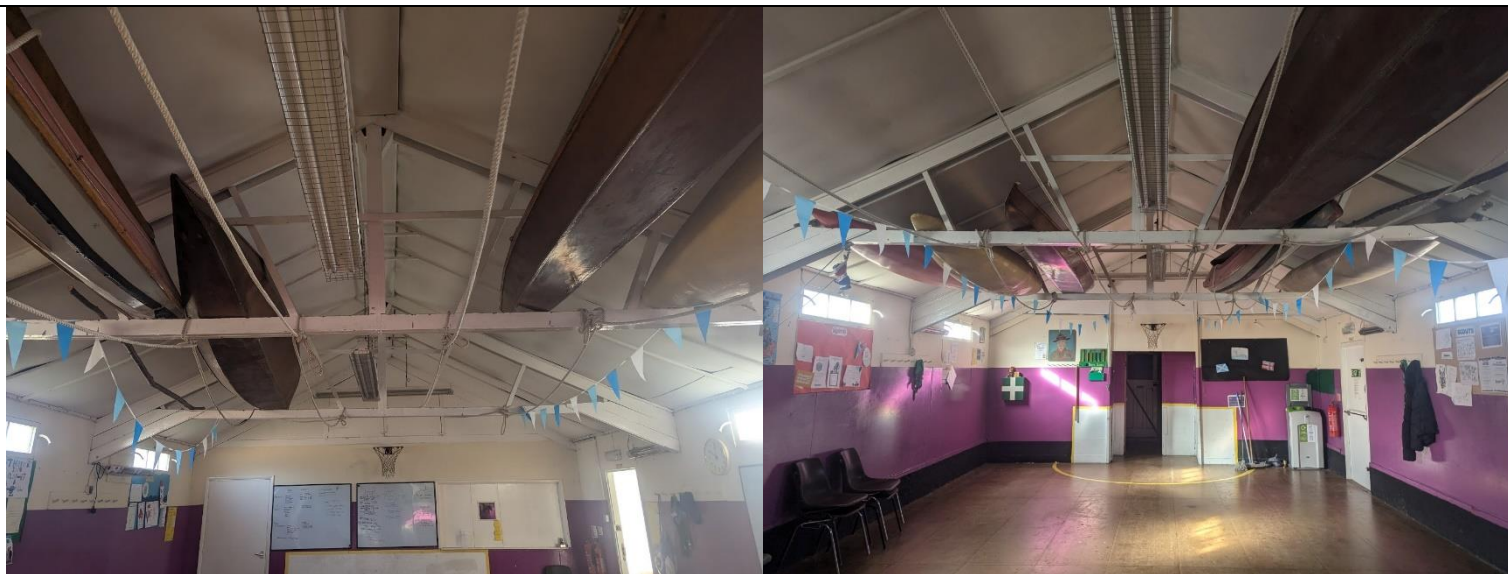
Figure 2: Inside B1

| <i>Summary of Survey Findings</i> | <p><b>EPSL data</b><br/>A review of the Magic.gov database returned no granted EPSL records or class licence returns for bats within 2km of the site.</p> <p><b>Roosting habitat [Buildings]</b><br/>No evidence of bats was found on or within B1, however <b>B1</b> has <b>moderate</b> suitability to support roosting bats.</p> <p><i>Exterior</i><br/>B1 is a one storey pitched-roof cabin, with an attached storage container extension to the west. The cabin is constructed from timber boarding on all elevations, though on the southernmost elevation the boarding is particularly damaged and lifted, allowing space for crevice dwelling bats to roost [see figure 8, appendix 5]. The other three elevations also have areas of lifted timber board, and the western elevation has a gap of missing timber. The storage container's roof is flat, and the extension itself is intact. B1 has felt roofing on both the container and the cabin. There are small windows that line each elevation, these have wooden frames that are often lifted; however, the gaps will not keep the bats safe from weather impacts, light or predators. There are two entrances to the building, one to the north and one to the south of B1, the doors are wooden and intact, but there is a gap in the timber panelling above the southern door that would be suitable for a crevice dwelling bat [see figure 9, appendix 5].</p> <p>There is one loft space within the interior of B1. It can be found in the eastern part of the building.</p> <p><i>Interior</i></p> |

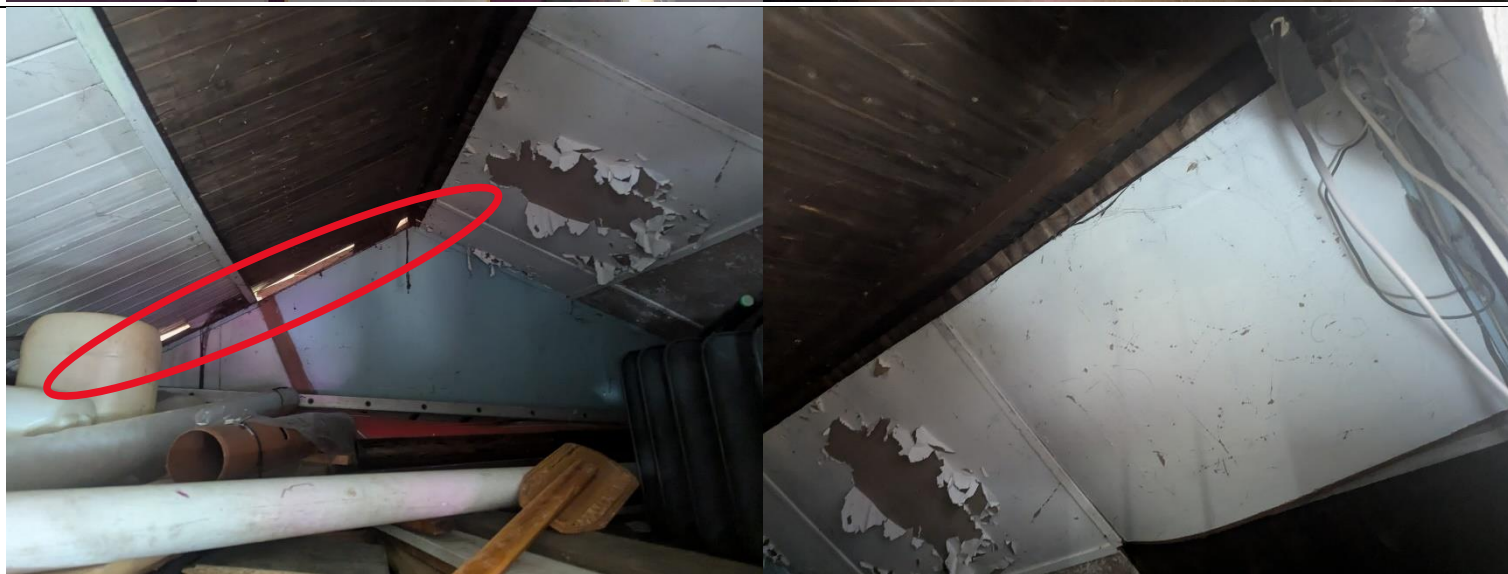
Figure 3: L1 interior

| | <p><b>Loft 1</b></p> <p>The interior of L1 [see figure 3, appendix 5] is partly clad in wooden panelling, as some areas are damaged or missing. The floor is constructed of timber beams and supports various items in storage, due to the floor being covered, the surveyor was unable to enter the loft and evidence of bats may have been missed. The light ingress is minimal, coming only from the gaps along the eastern elevation [see figure 3, appendix 5]. These gaps are large enough to allow void dwelling bats to enter. The loft temperature at the time of the survey was 18°C and the humidity was at 65%. The loft space measures approximately 3m x 1.5m. No evidence of bats was found in L1.</p> <p>Whilst no evidence of roosting bats was found, due to the suitability for void dwelling bats to enter the loft space and the gaps in the timber boarding on all elevations, B1 is assessed to be of <b>moderate value</b> to support roosting bats.</p> <p><b>Roosting habitat [Trees]</b></p> <p>The two scattered trees on-site do not present any roosting features for bats.</p> |

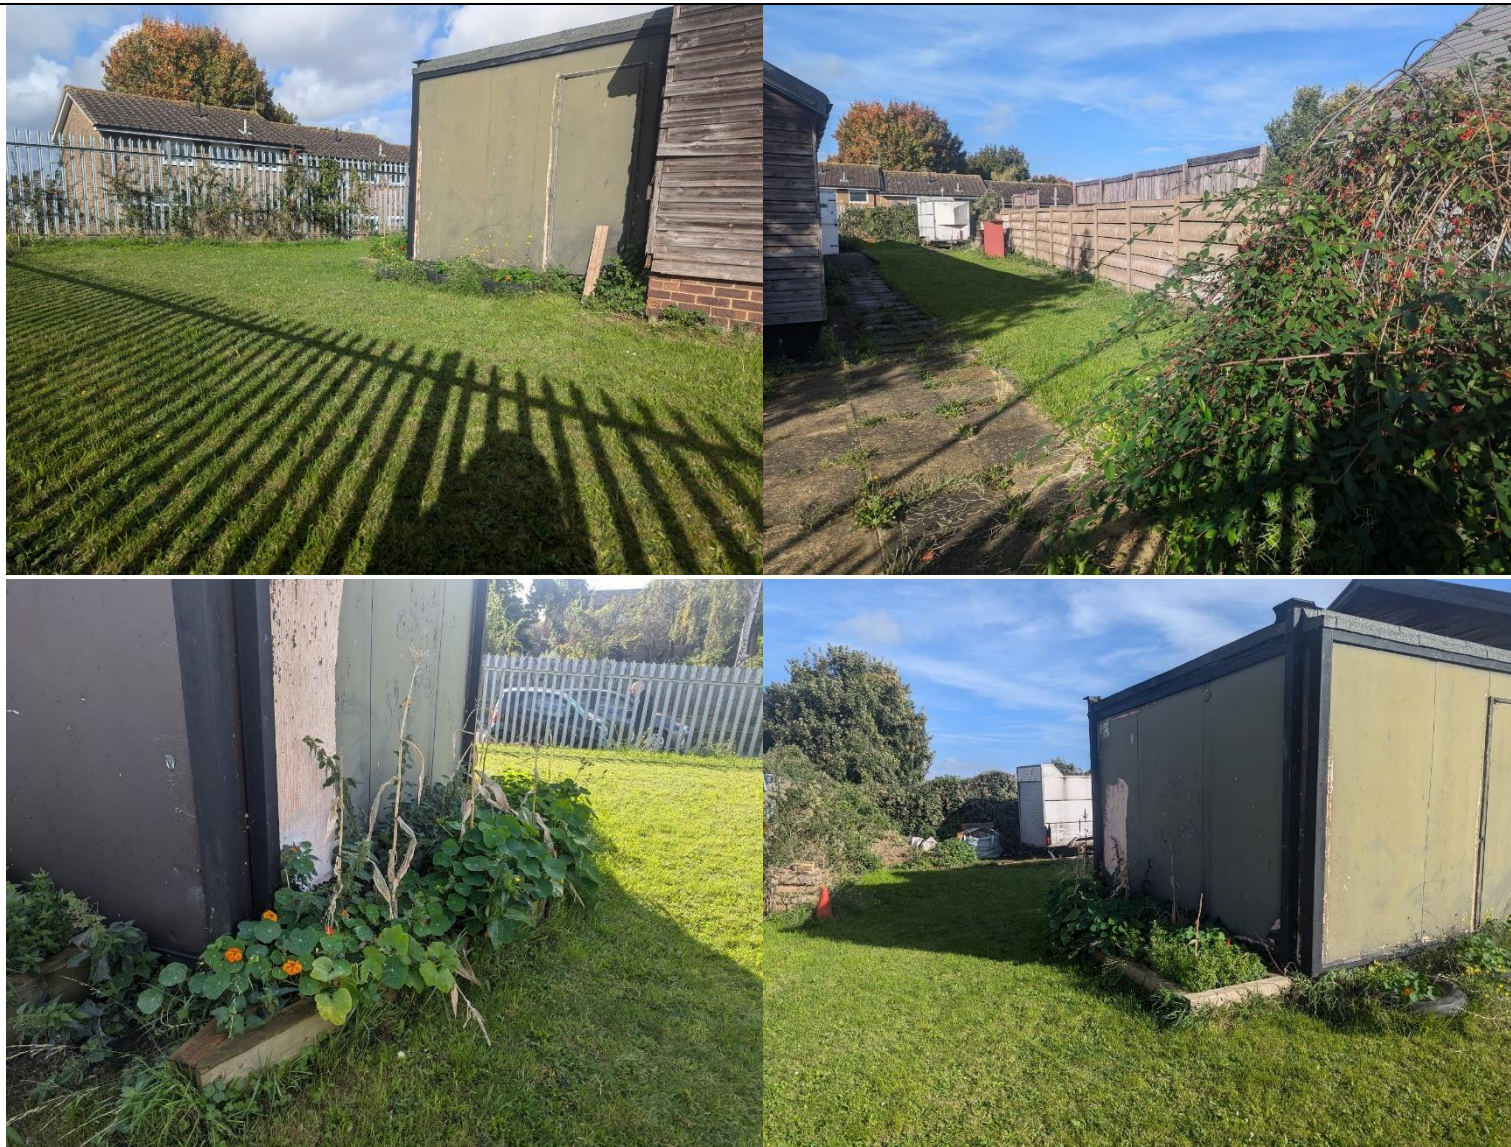
*Figure 4: Modified grassland*

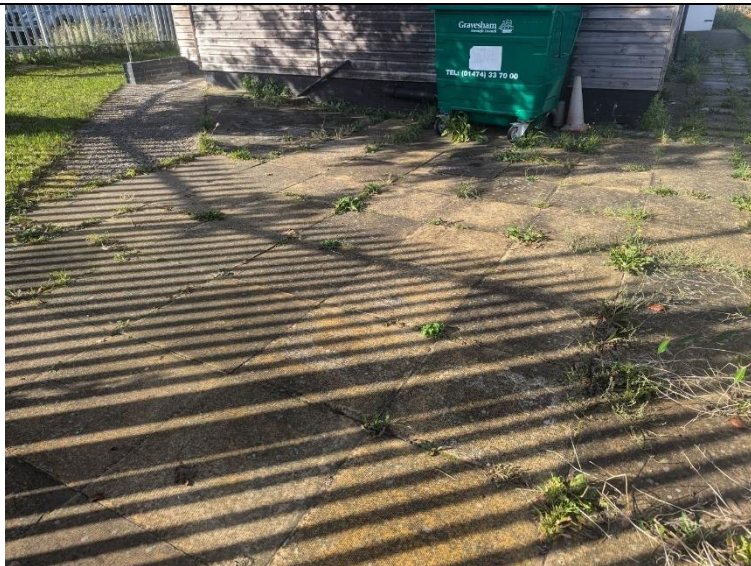
*Figure 5: Sealed surface*

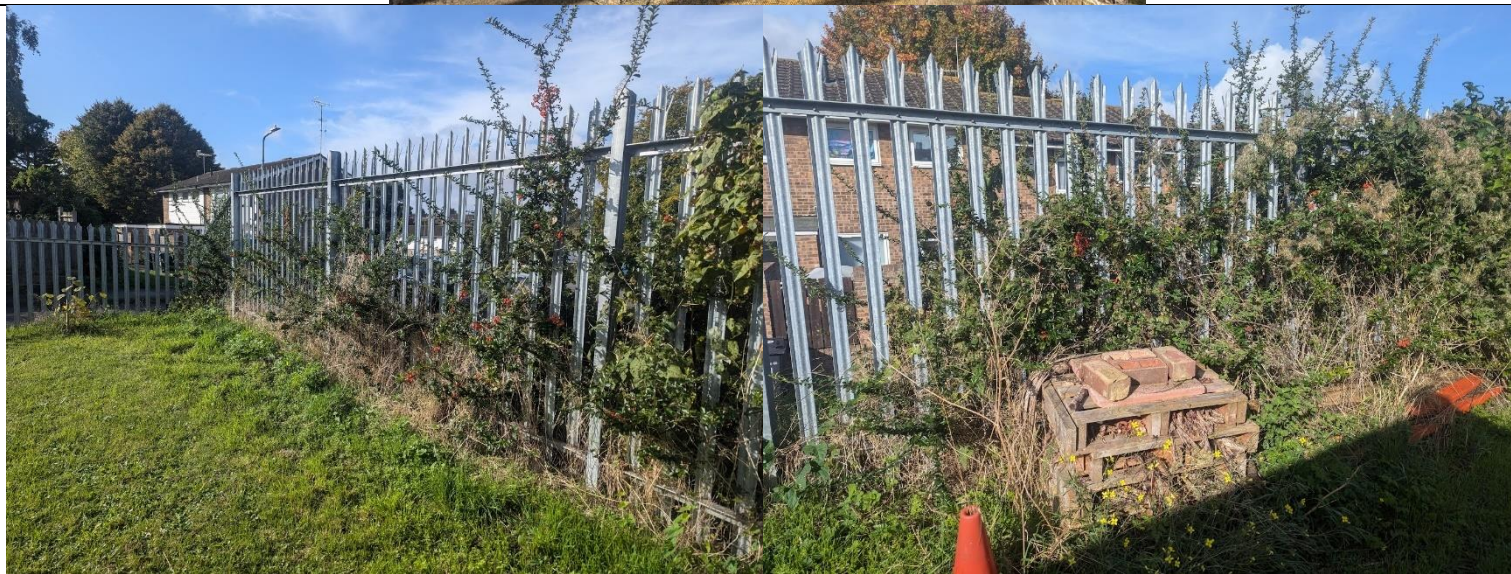
| <i>Summary of Survey Findings</i> | Cotoneaster was identified along the western and northern border, it is listed as an invasive, non-native species under Schedule 9 of the Wildlife and Countryside Act 1981 [see figure 6, appendix 5]. |
| <i>Foreseen Impacts</i> | Construction could result in the spread of cotoneaster. |

*Figure 6: Cotoneaster along the western border*

| <i>Recommendations</i> | Any plants present on Schedule 9 of the Wildlife and Countryside Act 1981 are prohibited from release into the wild due to their capacity to cause ecological, environmental or socio-economic harm. Where Schedule 9 species are grown in private gardens, larger scale gardens, estates and amenity areas reasonable measures will be taken to confine them to the cultivated area so as to prevent their spreading to the wider environment and beyond the landowner's control. As such, not preventing the spread of cotoneaster currently present on site, into the wild (i.e. the western verge), this could constitute an offence. As such it is recommended that cotoneaster is be dug up, including roots, and disposed of in line with appropriate controlled waste measures, or controlled during construction works to prevent the spread off-site. |

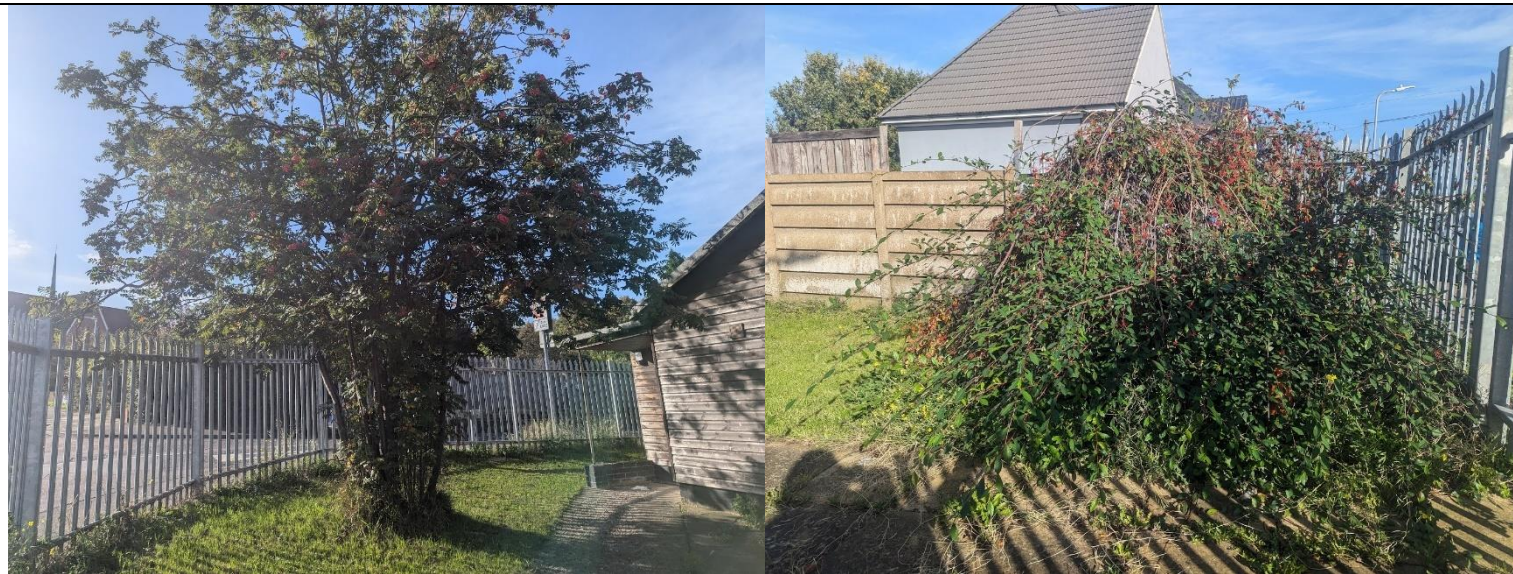
*Figure 7: (32)*  
scattered trees

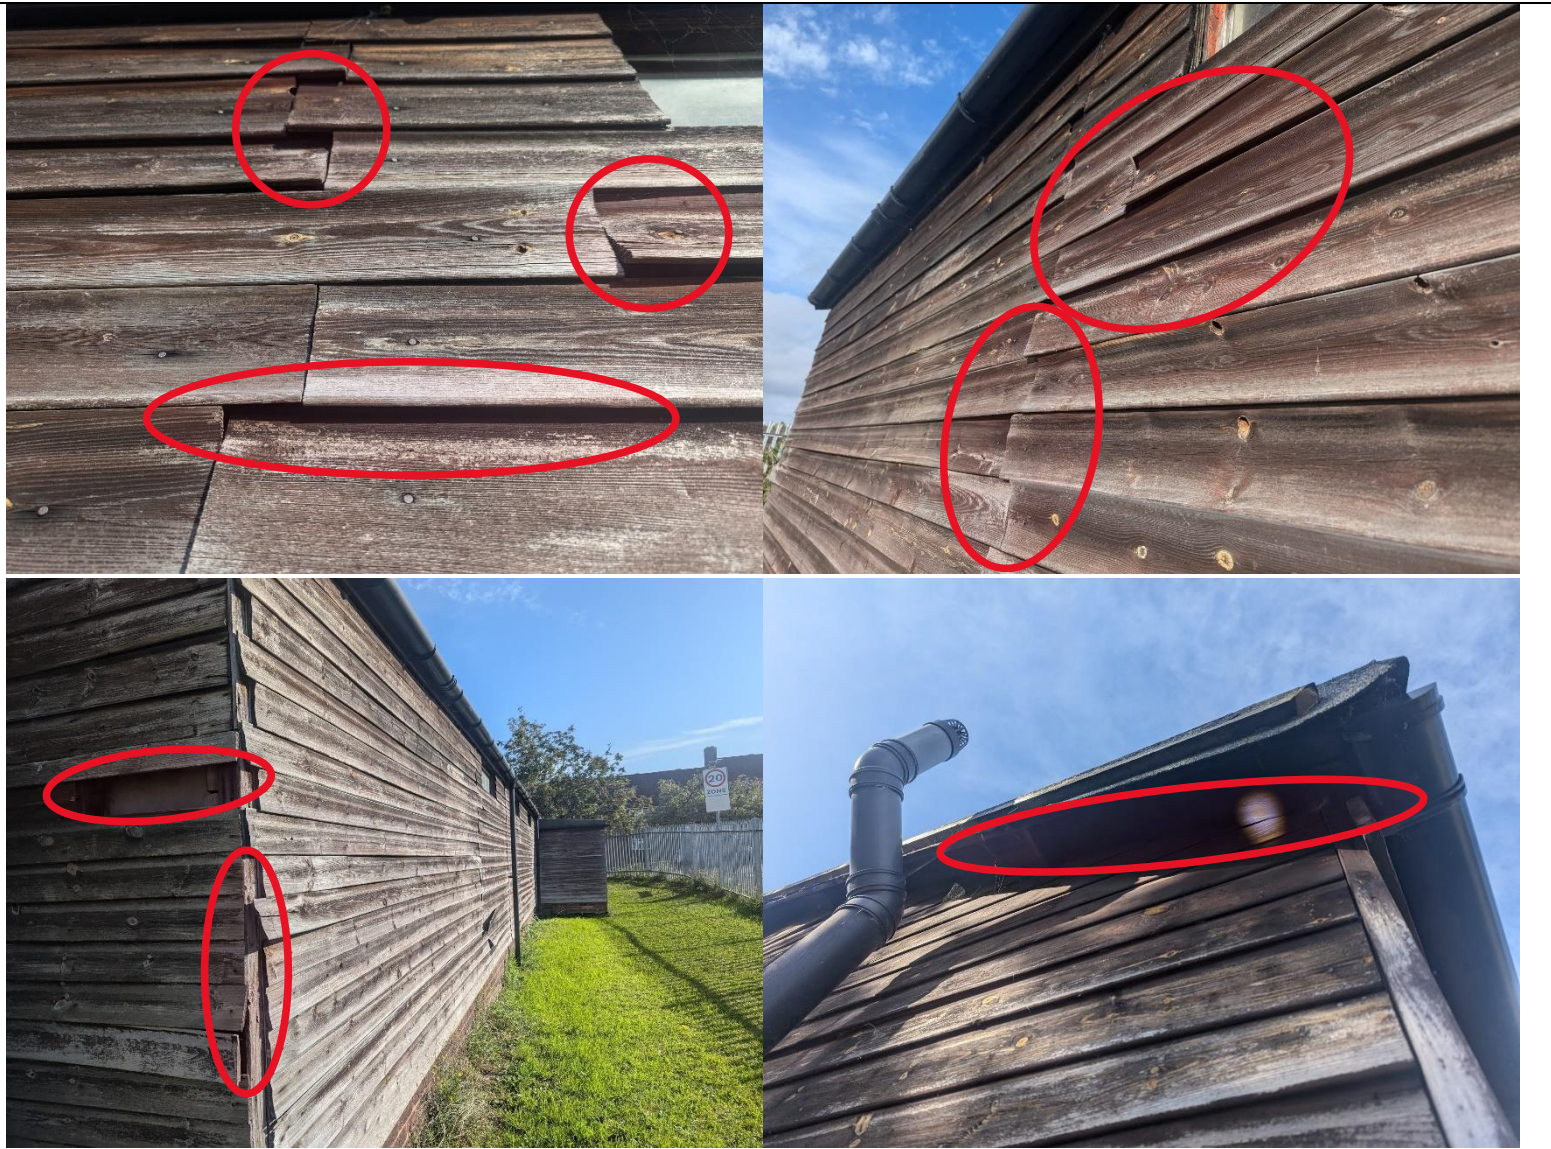
*Figure 8: Damage and gaps under timber boarding*

| <i>Recommendations</i> | <p><b>Roosting habitat [Buildings]</b></p> <p><b>Two</b> bat emergence/re-entry surveys are required on <b>B1</b> during the active bat season (May – September) to confirm presence/likely-absence of bats roosting in or on the building.</p> <p>These survey visits should be completed during the optimal survey period mid-May to August inclusive. The survey visits should be at least three weeks apart.</p> <p>Sub-optimal: early May and September. Would require greater justification of timing e.g., weather conditions, known local bat activity.</p> <p>One of the surveys could be a dawn re-entry survey, or both can be at dusk if supported by night vision aids (NVA).</p> |

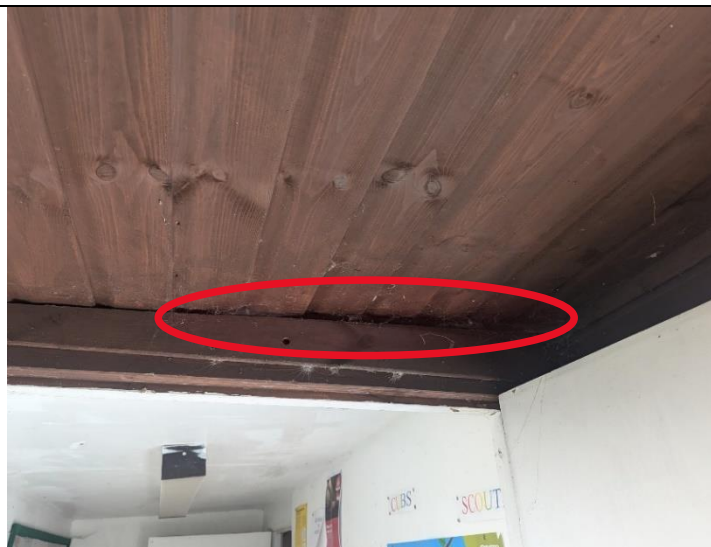
Figure 9: Gap under the timber of the southern entrance, above the door.
