Proposed residential development  
Lower Higham Road  
Gravesend

## Ground Investigation Report

**Proposed residential development  
off  
Lower Higham Road  
Gravesend  
DA12 2ND**

**GROUND INVESTIGATION REPORT**

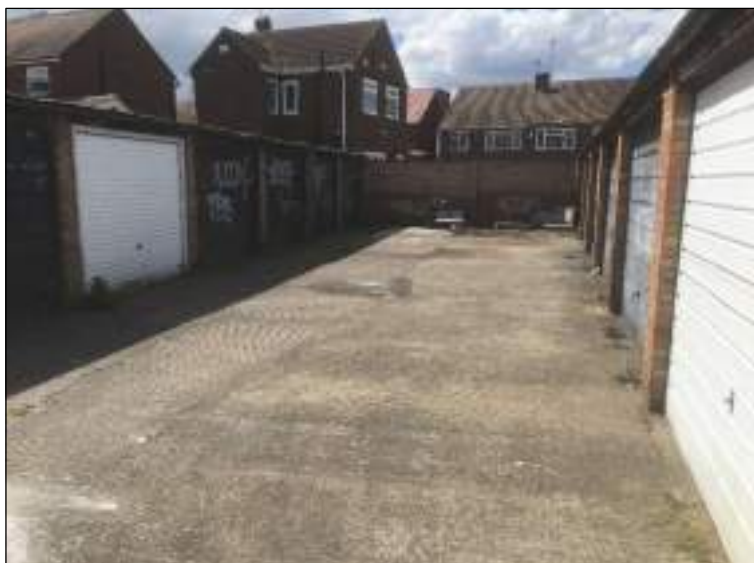
**Photograph 1**

The site looking west.

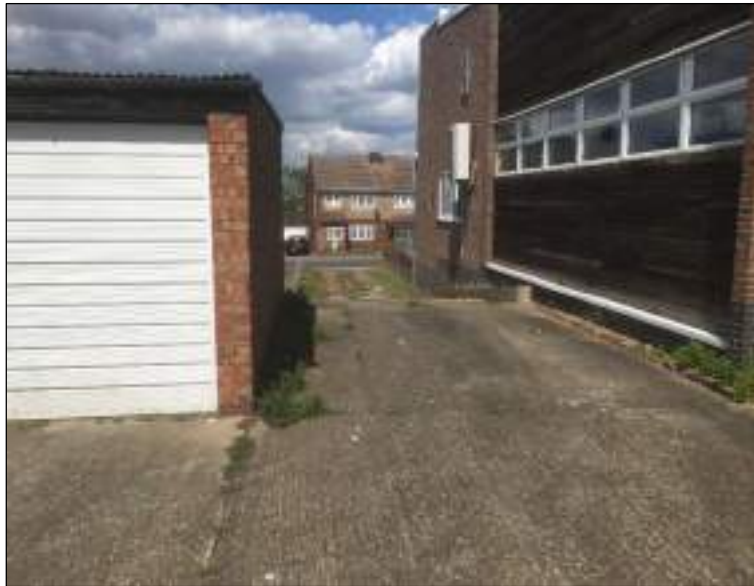
**Photograph 2**

The site looking north showing access track to site.
