## **PRELIMINARY ECOLOGICAL APPRAISAL**

**LOMER FARM, MEOPHAM**

| <b>Date of report</b> | 16 <sup>th</sup> September 2021 |
| <b>Client Name</b> | Hawkspare Ltd |

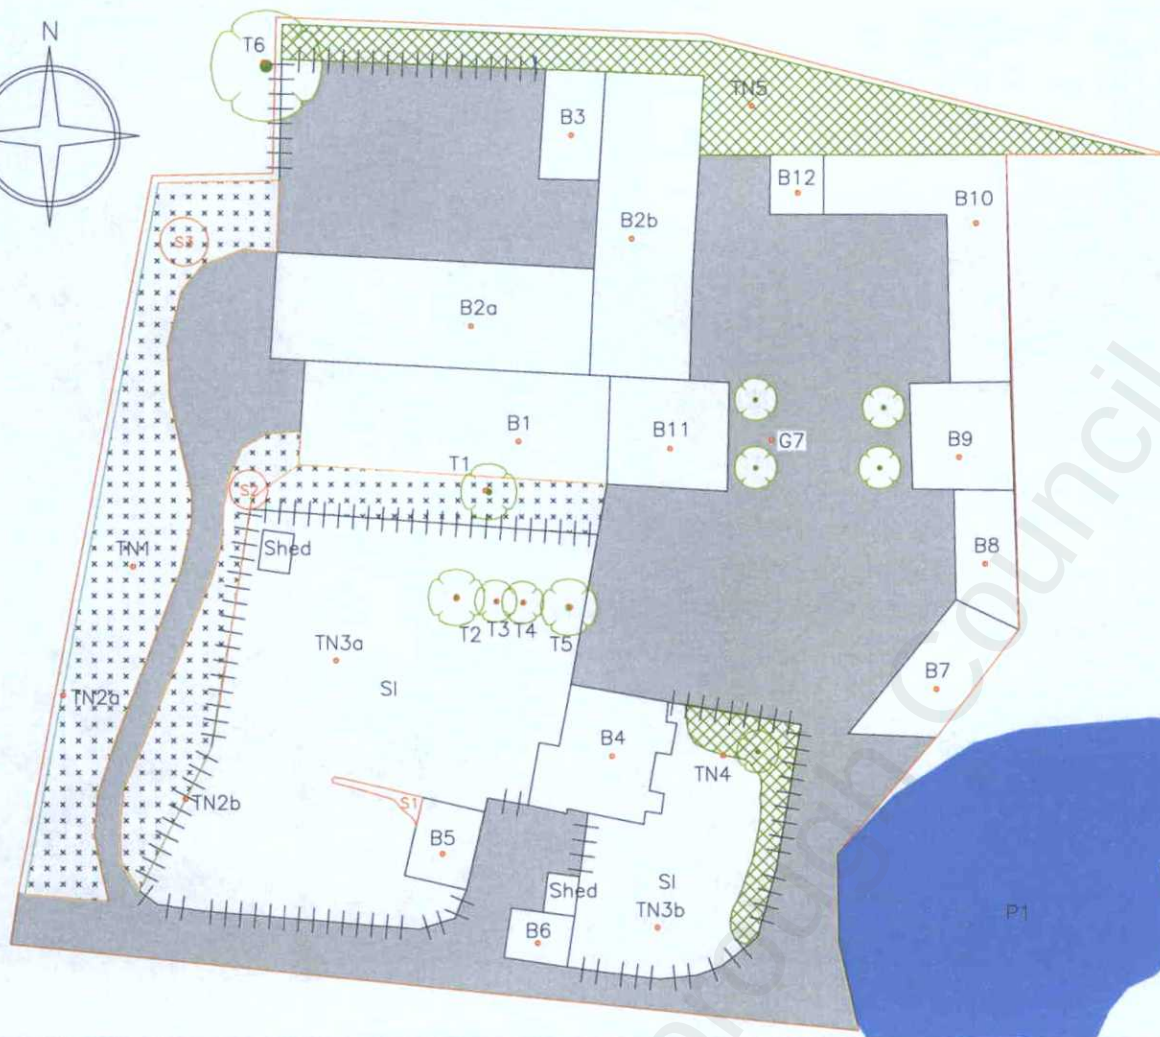
| Revision | | Description | Date | Drawn by |
|---|---|---|---|---|
| Figure 1 Map | | | | |

3.2.1 The Site consists of a number of interconnected buildings which are surrounded by hardstanding. To the south-east of the Site is a large pond. There are arable fields to the north, west and south and to the east are residential houses of Meopham village and the A227. The habitats present on Site are shown within Figure 1 and photographs of selected target notes are provided in Figure 2.

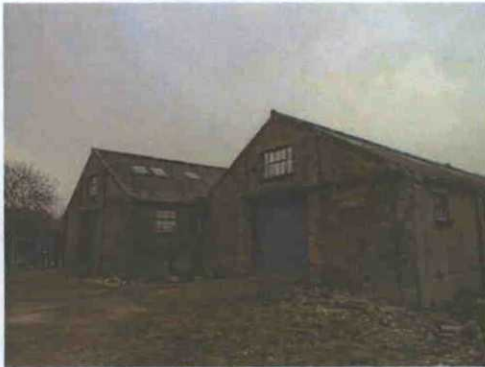
- 3.3.2 Building B1 is constructed of brick with a pitched asbestos roof and sliding metal doors and is used as a workshop. The windows are blocked and there are skylights throughout. Internally, insulation is visible on parts of the roof pitches. B1 has 'Moderate' potential for roosting bats and the following features are suitable for bats:

- Two holes in the brick work on the western elevation leading into a possible cavity wall
  - A gap at the eaves on the southern side
  - A gap between the corrugated roof overlap and the gable wall.

The western end of B1 and B2a

4.2.3 A single bat emergence survey is recommended for B3, B9, B11 and B12. Two bat emergence surveys are recommended for B1, B2, B7 and B8. The surveys will determine whether bat roosts are present in the buildings. Under BCT guidelines, the survey should be undertaken between May and August. If a bat roost is detected a European Protected Species (EPS) licence will be required to permit the proposed work.

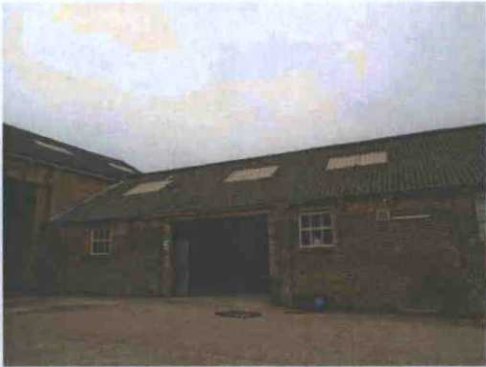
- 3.3.3 B2 is an L-shaped brick building with a pitched asbestos roof and sliding metal doors. In B2a, insulation is visible on parts of the roof pitches. The windows are blocked and there are skylights throughout. The northern part of B2b is used for business storage and is open to the roof. There is an archway through the ground and first floor section of B2b. In the archway, there are some 50 raptor pellets and splashing from perches at the top of the blockwork pillars; the size, composition and shape of the pellets suggest that this is a kestrel *Falco tinnunculus* perch. B2 has 'Moderate' potential for roosting bats and the following features were noted:

- Holes in the brick work on the western elevation
  - Gap between the corrugated roof overlap and the gable wall.
  - Access gap at the eaves
  - Access into the building at the top of the blockwork, in the archway

Northern elevation of B2a

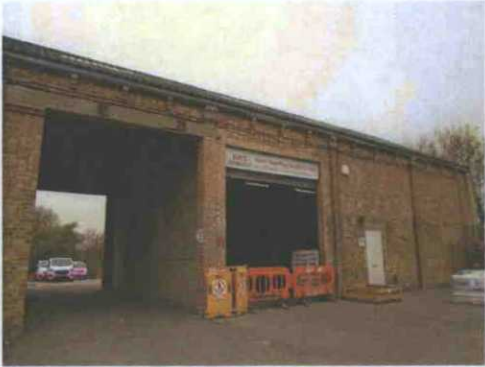
Building B2b, from the east

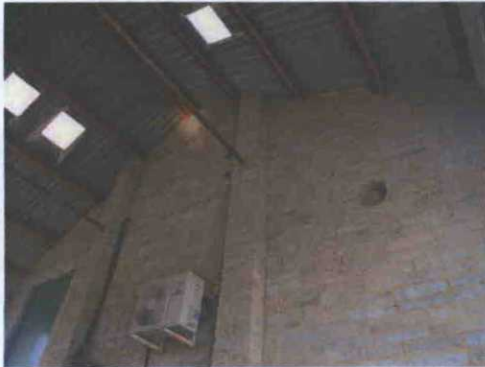
The archway of B2b showing gap at the top

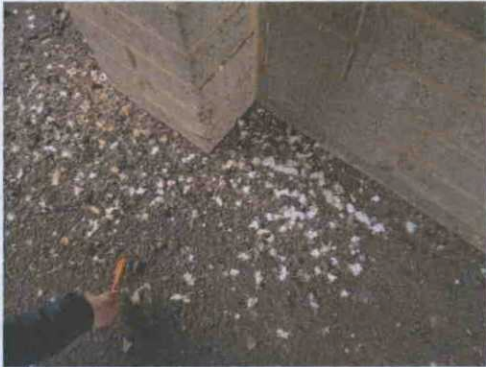
Kestrel pellets and droppings

4.4.5 It is recommended that two nest boxes for kestrel are installed on nearby trees. Little owl and tawny owl may also use these types of boxes. Schwegler 2TF nest box or similar should be used. The box should be mounted at least 5m high, preferably with a clear flight path to the box. The box should face east, north-east or south-east.

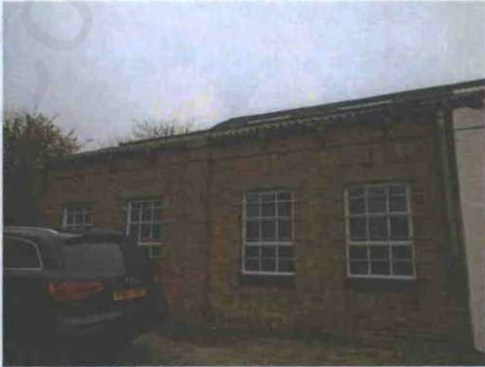
- 3.3.4 B3 is a small brick building with a pitched asbestos sheet roof that overlaps the brick at the eaves by 2cm. There is potential for a bat roost beneath the overlap of the roof material on the south gable. B3 has 'Low' potential for roosting bats.

The western side of B3

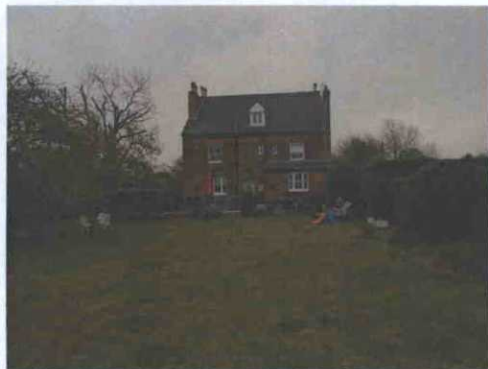
- 3.3.5 B4 is a two-storey brick house with a pitched slate roof on a north-south axis and concrete ridge tiles and a wooden barge board at the eaves. There is a single storey lean-to on the western elevation and a loft conversion with two dormer windows on the east roof pitch. The bay windows have small roofs with clay tiles that are moss covered and unsuitable for roosting bats. The eaves at the gables are mortared with

no potential for bats noted on the south or north elevations. B4 has 'Moderate' potential for roosting bats and the following features were noted:

- On the east and west elevations, a gap between the brick and the soffit with a maximum width of 200mm
- Lifted lead flashing where the dormers meet the roof pitch.
- Gaps in the roof tiles on the western pitch and where the roof pitch meets the dormer windows.

House B4

4.2.2 The proposals involve reconfiguration of the business park. The residential area and buildings B4, B5 and B6 are excluded from these proposals and no further surveys are recommended for these buildings.

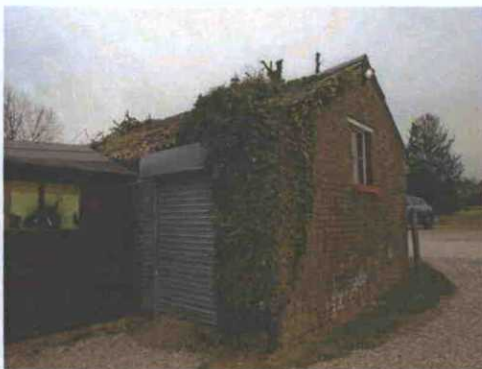
3.3.7 Building B6 is a brick building with a metal sliding door on the northern elevation and a simple pitched asbestos corrugated roof. The windows are boarded and there is a wooden barge board which is missing on the southern elevation, creating access at the eaves. The roof is lined with timber sarking. B6 has 'Moderate' potential for roosting bats.

Garage B6

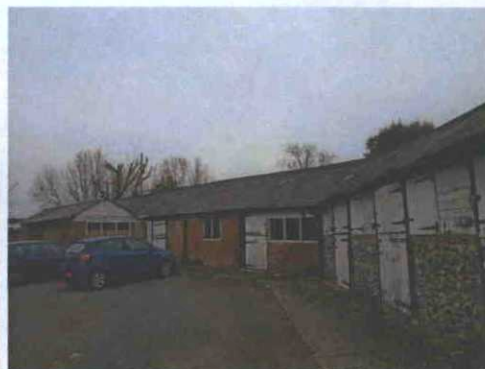
3.3.8 B7 is a stable building with flint walls and half-pitched roof with slate tiles and concrete ridge tiles. The stable building adjoins a brick wall. The eaves are open and the windows have been boarded. There is a large hole in the roof where the slates are missing and birds' nests were noted, including three barn swallow *Hirundo rustica* nests. The concrete ridge tiles are suitable crevice features and the inside is suitable for void-dwelling species. B7 has 'Moderate' potential for void-dwelling bats.

3.3.9 Building B8 is of similar construction to B7 however there are windows on the western elevation making it light inside and no access points were noted. Birds' nests were noted. The concrete ridge tiles are suitable crevice features and the inside is suitable for void-dwelling species. B8 has 'Moderate' potential for void-dwelling bats.

Stables B7 and B8

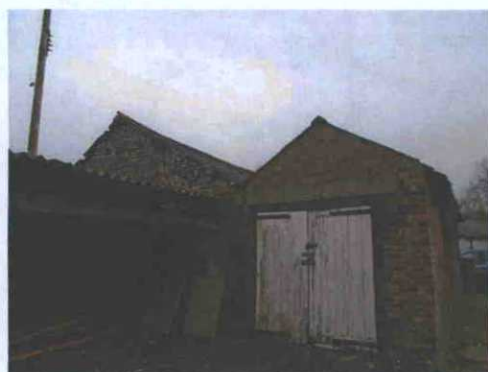
3.3.10 Building B9 is a brick building with a simple pitched roof covered with slate tiles and concrete ridge tiles. Light enters the building through partially boarded windows, the eaves and a hole in the roof on the east pitch which is covered in clear plastic. There is a small boarded section where this building joins B8 and a mezzanine section to the north which is dark and 0.5m high. There is evidence of water ingress throughout. Birds' nests were noted. There is access in at the eaves on the western elevation. B9 has 'Low' potential for void-dwelling bats.

B9

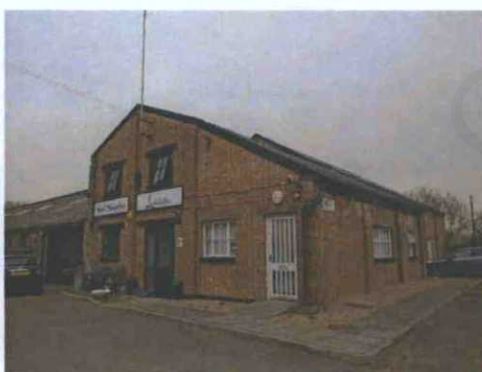
- 3.3.12 Building B11 is a brick building, used as a business unit with false ceilings installed. There is a modern pitched corrugated roof and a gap under the soffit on the eastern elevation. B11 has 'Low' potential for bats.
- 3.3.13 Building B12 is a small business unit constructed of a brick with a shallow pitched corrugated asbestos roof. There is a gap at the eaves on the western elevation. B12 has 'Low' potential for bats.
- 3.3.14 In addition, there are two timber garden sheds, Sh1 and Sh2 which did not support any potential bat roost features or evidence of bat use.

B11

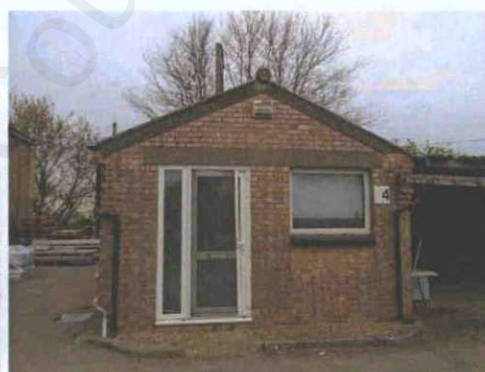
B12

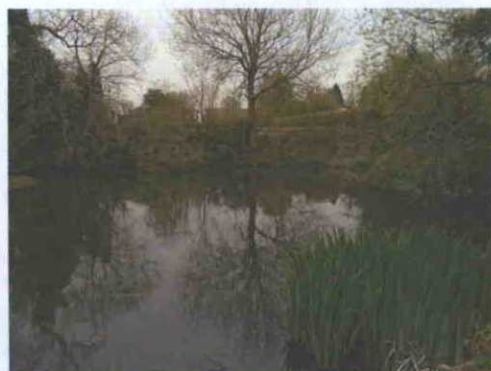
- 3.6.1 Pond P1 was subject to an HSI assessment on 28th April 2021. P1 is a large circular waterbody, measuring 20m by 40m and the perimeter is vegetated with mature trees including mature ash, goat willow *Salix caprea* and hawthorn. Small fish were noted and there is a reasonable coverage of aquatic plants including bogbean *Menyanthes trifoliata*. The HSI score was 0.49 'poor' and the score for each factor is shown below. Although the score was 'poor', an eDNA survey was undertaken due to the proximity of the pond to the Site.

- 3.6.2 P1 was sampled for GCN environmental DNA on the 28<sup>th</sup> April 2021. Only the western half of the pond was accessible for sampling and no GCN eggs or small newt eggs were found. The eDNA result was negative and is provided in Appendix 2.

Pond P1 adjacent to the site

4.3.1 The adjacent pond has been subject to an HSI assessment for its suitability to support GCN and resulted in a score of 0.49 'poor'. A presence/likely absence eDNA survey has been carried out within the breeding period (28th April 2021) which resulted in a negative result. An egg search of vegetation was also undertaken and no GCN eggs were found. The pond network in the landscape is poor and the terrestrial habitat on Site is poor therefore there are no further recommendations in relation to great crested newts.

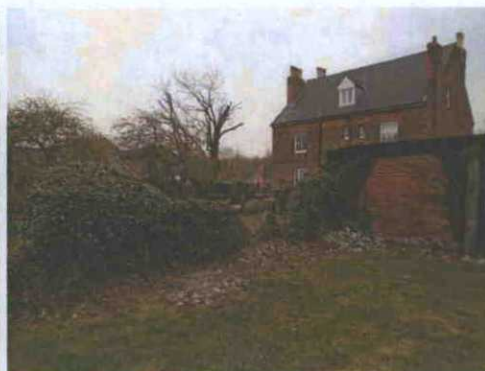
- 3.2.6 There is a short garden lawn TN3a to the west of the house. It is managed to 400mm and consists of perennial rye-grass *Lolium perenne*, cock's foot *Dactylis glomerata*, red fescue *Festuca rubra*, white clover *Trifolium repens*, creeping buttercup *Ranunculus repens*, creeping thistle *Cirsium arvense*, cut-leaved cranesbill *Geranium dissectum*, common mallow, yarrow *Achillea millefolium*, fat hen *Chenopodium album*, self-heal *Prunella vulgaris*, creeping cinquefoil *Potentilla repens*, field bindweed, thyme-leaved speedwell *Veronica serpyllifolia* and daisy *Bellis perennis*.
- 3.2.7 In the section of lawn to the east of the house, TN3b, there is Spanish bluebell *Hyacinthoides hispanica*, early dog-violet *Viola reichenbach*, primrose *Primula vulgaris*, wood anemone *Anemone nemorosa*, red dead-nettle *Lamium purpureum* and ground ivy *Glechoma hederaceae*.

- 3.2.9 S1 is a pile of flint rubble at the base of a partially collapsed flint wall, S2 is a low mound of flint, ceramic, concrete and earth and S3 is a pile of concrete paving slabs and elder brash.

Garden lawn TN3a and flint wall S1

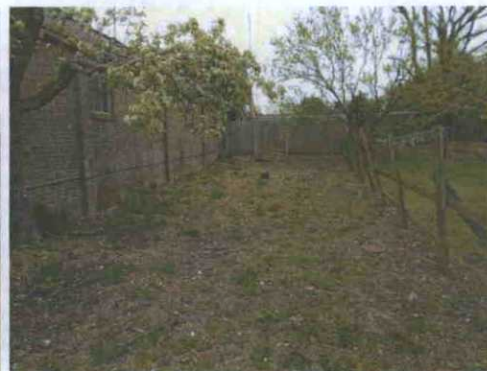
- 3.2.5 There is a track along the western edge of the Site which is rubble with ephemeral species TN1. The vegetation includes lords-and-ladies *Arum maculatum*, field forget-me-not *Myosotis arvensis*, common field-speedwell *Veronica persica*, thyme-leaved speedwell *V. serpyllifolia*, English stonecrop *Sedum anglicum*, rosebay willowherb *Chamaenerion angustifolium* and white dead-nettle *Lamium album*.

Ephemeral TN1

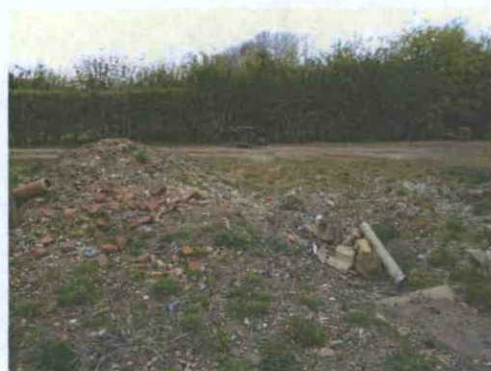
Spoil S2

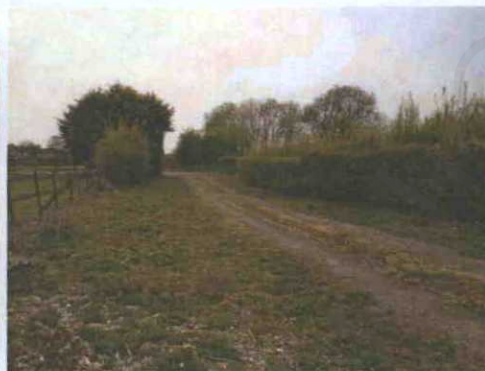
- 3.2.8 The hedge TN2a along the western boundary consists of hazel *Corylus avellana* and hawthorn with occasional elder. This is approximately 3m high and not regularly managed. Parallel to this is a section of hedge TN2b composed of similar species and a short section (10m) of leylandii *Leylandii x cupressus* hedge which is 3m high.

Hedge TN2a and ephemeral TN1

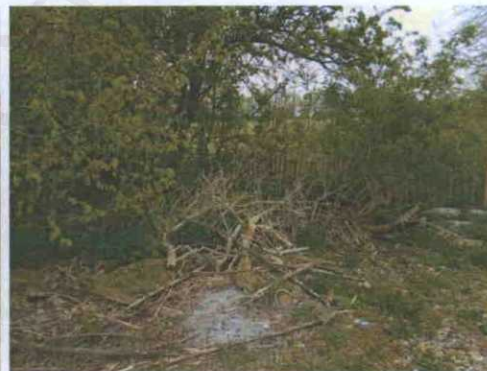
Spoil S3
