**LUSTRE**  
CONSULTING

**2 VALE ROAD - NORTHFLEET**

**SUPPLEMENTARY PHASE 2 SITE INVESTIGATION**

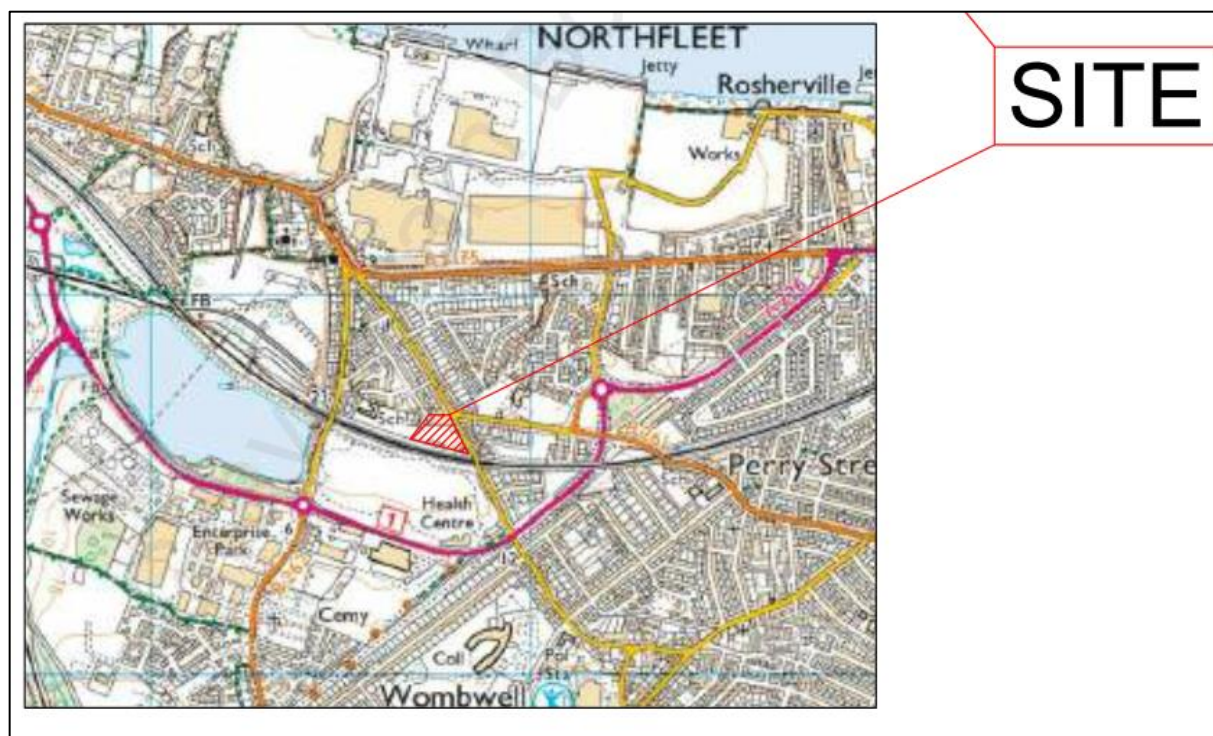
Figure 1: Extract from Desk Study Assessment Report undertaken by Brownfield Solutions Ltd showing wider site area owned by BRT Properties hashed in red

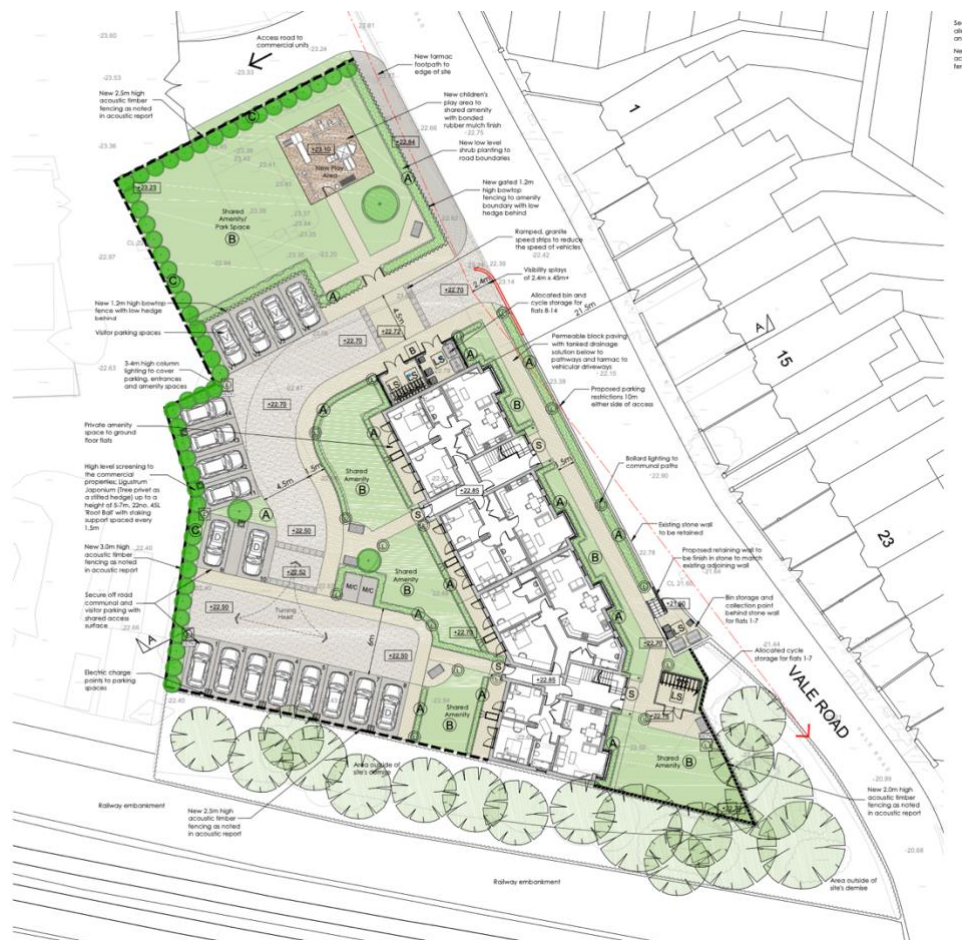
- 1.3 This report has been prepared to a new planning application for *'Erection of a three-storey building within rooms in the roof space to provide 14 x two bedroom self-contained flats with associated access, car parking and amenity space.'* Soft landscaped areas include soft verges, communal gardens and public open space; no private gardens are proposed.
- 1.4 Figure 2 illustrates the proposed development scheme.

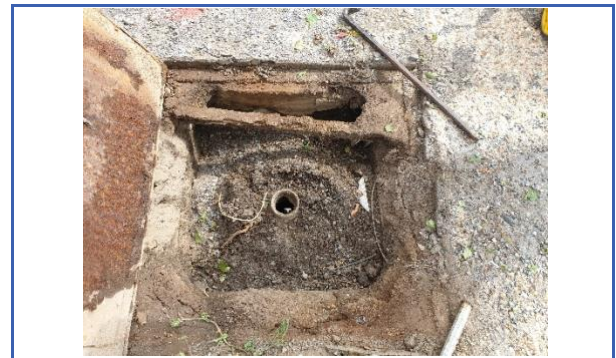
*Fill point infrastructure within manhole*

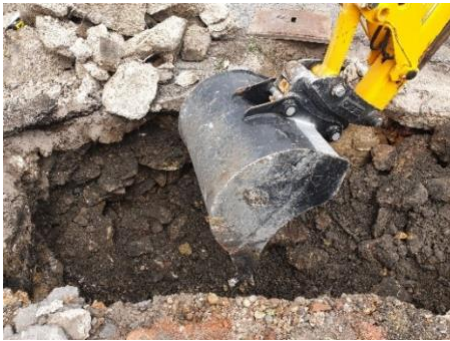
- 3.9 Within TP203 ground conditions beyond the concrete slab (logged as side A) were consistent with anthropogenic fill material to a depth of 3.3m bgl. This comprised silty sand gravel with moderate ash content. Gravel was recorded as chalk, brick, glass, slate, concrete and brick. At 3.3m bgl ground conditions were recorded as yellowish brown and greyish brown silty slightly gravelly SAND with gravels comprising flint and chalk. This layer remained unproven to base of the excavation at 3.8m bgl.

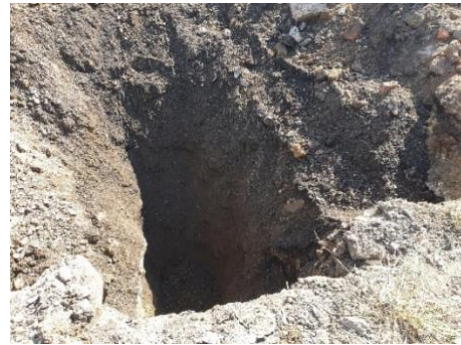
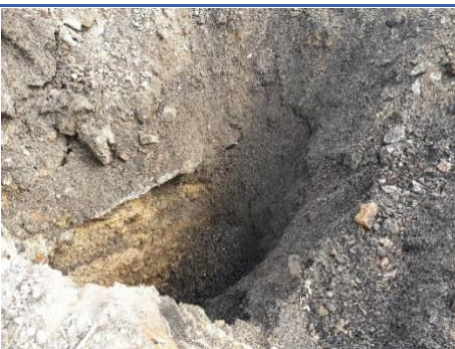
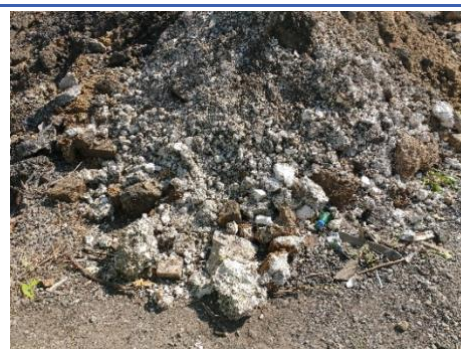
TP204

- 3.10 Within TP204, reworked natural soils broadly similar to those encountered in TP203 were identified from a depth of 1.3m bgl in the excavation undertaken adjacent to the concrete slab. The reworked natural soils were described as orangish brown sandy gravelly CLAY. Gravels comprised flint and chalk. This was underlain by natural soils comprising white structureless CHALK at depth of 2.5m to base of the excavation at 2.8m bgl.

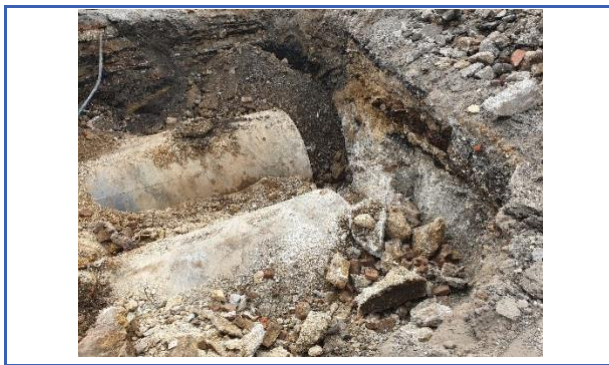
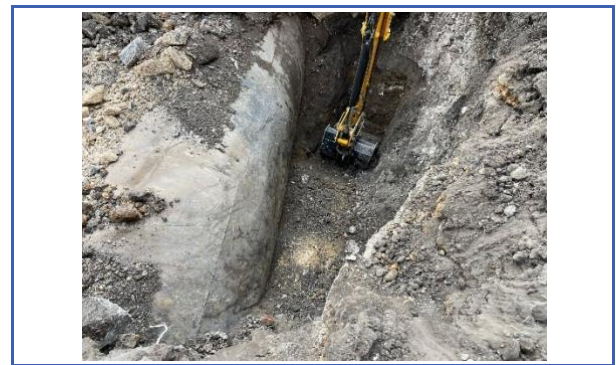
- 3.11 Further excavation was then undertaken through the concrete slab as this was suspected to be a protective cap above the USTs. Two cylindrical tanks were identified beneath the concrete. The fill point identified above related to the southern tank, with a second tank identified to the north which had a fill point at the opposite end of the tank. The excavation was progressed to expose the tanks on three sides (northern, southern and western); access

constraints prevented the excavation from completely exposing eastern end of the tanks. Both tanks were orientated from east to west and measured approximately 1.8m in diameter and are estimated to be 10m in length. The depth to the top of the tank was estimated to be 1.7m bgl. It is noted that based on a 1.8m diameter, the base of the tanks would be at an approximately depth of 3.5m bgl. Excavations TP203 and TP204 would therefore have been deep enough to coincide with lower half of the tanks i.e. most likely area of soils to have been impacted by any leaks originating from tanks. Further excavation was then undertaken along the northern side of the tank (TP205). Ground conditions were consistent with reworked naturals encountered in TP204; however, these soils were identified to extend to the base of the hole at 4.6m bgl.

- 3.12 Both tanks appeared to be in good condition with **no evidence of corrosion, damage or loss of integrity**. No visual or olfactory evidence of hydrocarbon contamination associated with tanks was observed. However, a small area of staining (no odour or elevated PID readings) possibly representing a minor historical spill from surface was identified along the northern side of the tanks extending to a depth of approximately 2.4m bgl. As noted above the USTs are located immediately off-site, rather than within the planning boundary.
- 3.13 The excavation around the tanks has been temporarily re-instated pending arrangement of tank decommissioning and removal at a future date. This comprised backfilling with arisings and sealing of the surface with concrete to prevent infiltration of surface water.

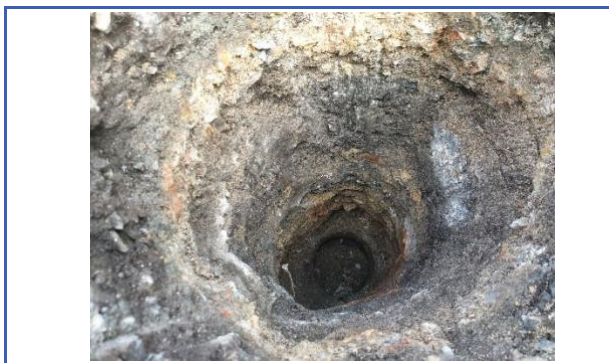
- 4.3 Made Ground was encountered from a depth of 0.15m bgl to a depth of 18.8m bgl and comprised a mixture of both granular and cohesive material.
- 4.4 Granular Made Ground was encountered to a depth of 2.7m bgl which was broadly similar to Made Ground encountered within trial pit excavations undertaken both in the former forecourt of the petrol filling station and offsite adjacent to the west of the former shop footprint. However, slight hydrocarbon odour was noted from 0.15 to 0.6m bgl likely associated with coal tar within bituminous materials.

*BH201 – hand pit*

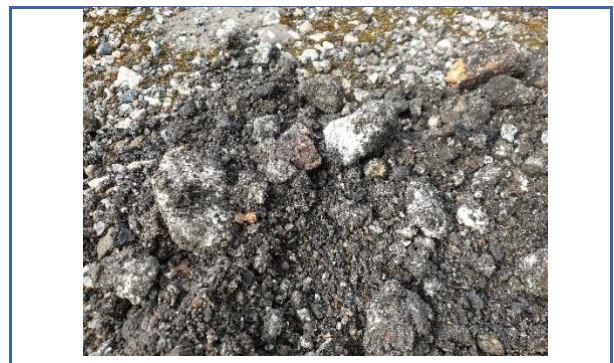
*BH201 arising to 2.7m bgl*

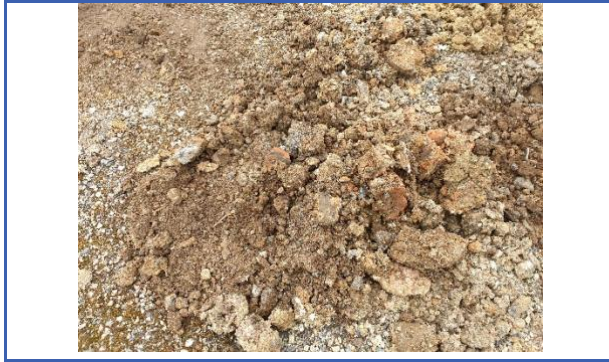
- 4.5 This was underlain by predominantly cohesive Made Ground to a depth of 10.3m bgl. Cohesive Made Ground comprised slightly sandy gravelly silty CLAY with varying amounts and types of anthropogenic constituents. Localised high proportions of metal were

*BH201 representative arisings 2.7-6.5m*

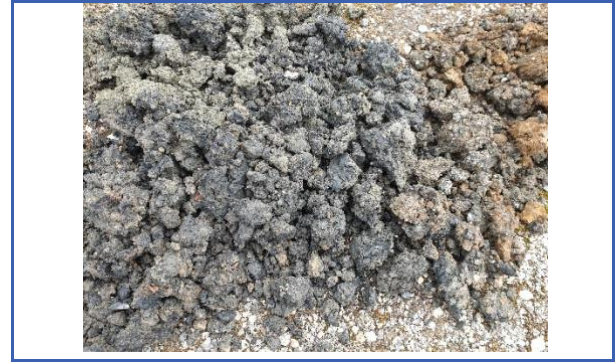
encountered throughout the cohesive Made Ground as well as occasional coarse gravel size fragments of coal tar with an accompanying slight hydrocarbon odour. Suspected ACM cement was encountered from 4.7m to 6.5m bgl. Organic clay and inclusions of wood were encountered within cohesive Made Ground from 7.9m bgl to 9.3m bgl.

*BH201 representative arisings 7.9 – 9.3m bgl*

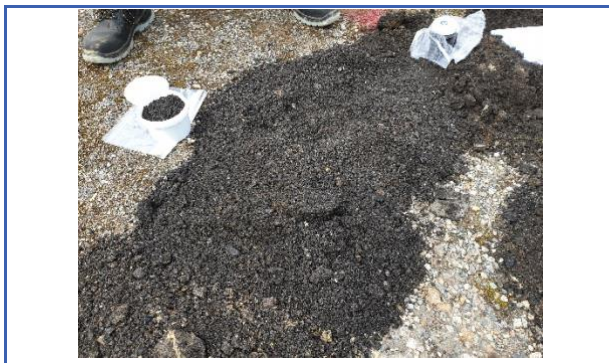
- 4.6 From a depth of 10.3m bgl to base of Made Ground at 18.8m bgl Made Ground was granular and predominantly comprised black silty sand GRAVEL with high ash content. This material was considered to be consistent with bottom ash. Other anthropogenic materials in minor quantities included metal, brick, wood and slate. Suspected ACM cement was encountered at a depth of 11m bgl. From 18m to 18.8m bgl materials appeared to comprise demolition rubble and included degraded coal tar likely from felt roofing as well as brick, slate and concrete.

*BH201 – representative arisings 10.3-18m bgl*

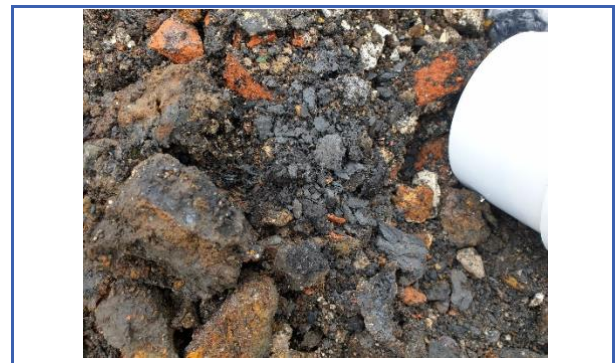
*BH201 – representative arisings 18-18.8m bgl*

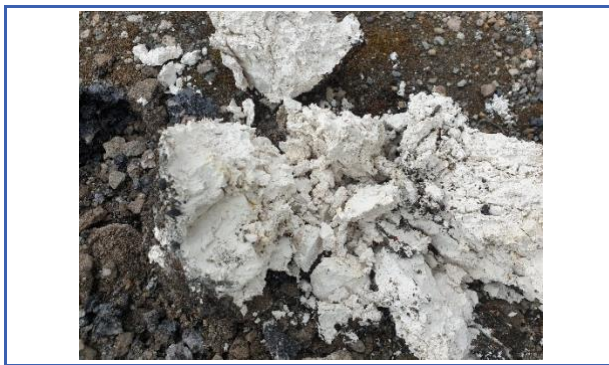
- 4.8 Chalk arisings were encountered from a depth of 18.8m bgl. These became damp from approximately 20m bgl and were recovered as silty water from below the water strike at 21m bgl. A band of flint was encountered from 25 to 25.3m bgl.
- 4.9 It appears from early recovery of arisings that chalk is likely structured at this depth, however, recovery was limited and became structureless in appearance when damp. Chalk arisings were therefore described as structureless chalk composed of cream slightly gravelly SILT. Gravel is medium density and white with rare inclusions of flint gravel.
- 4.10 No visual or olfactory evidence of hydrocarbon or solvent contamination was identified. No elevated concentrations were identified from in-situ PID headspace readings.

*BH201 – Chalk arisings 18.8 to 20m bgl*

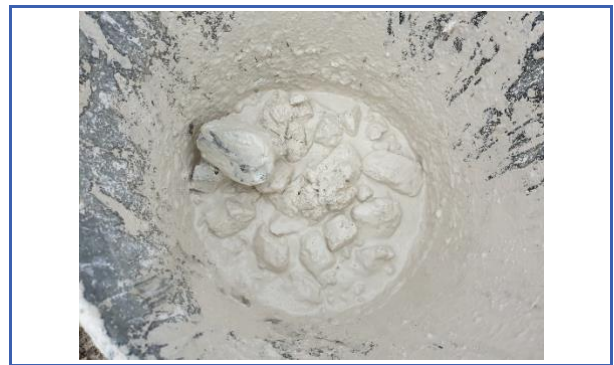
*BH201 – chalk arisings circa 25m bgl*

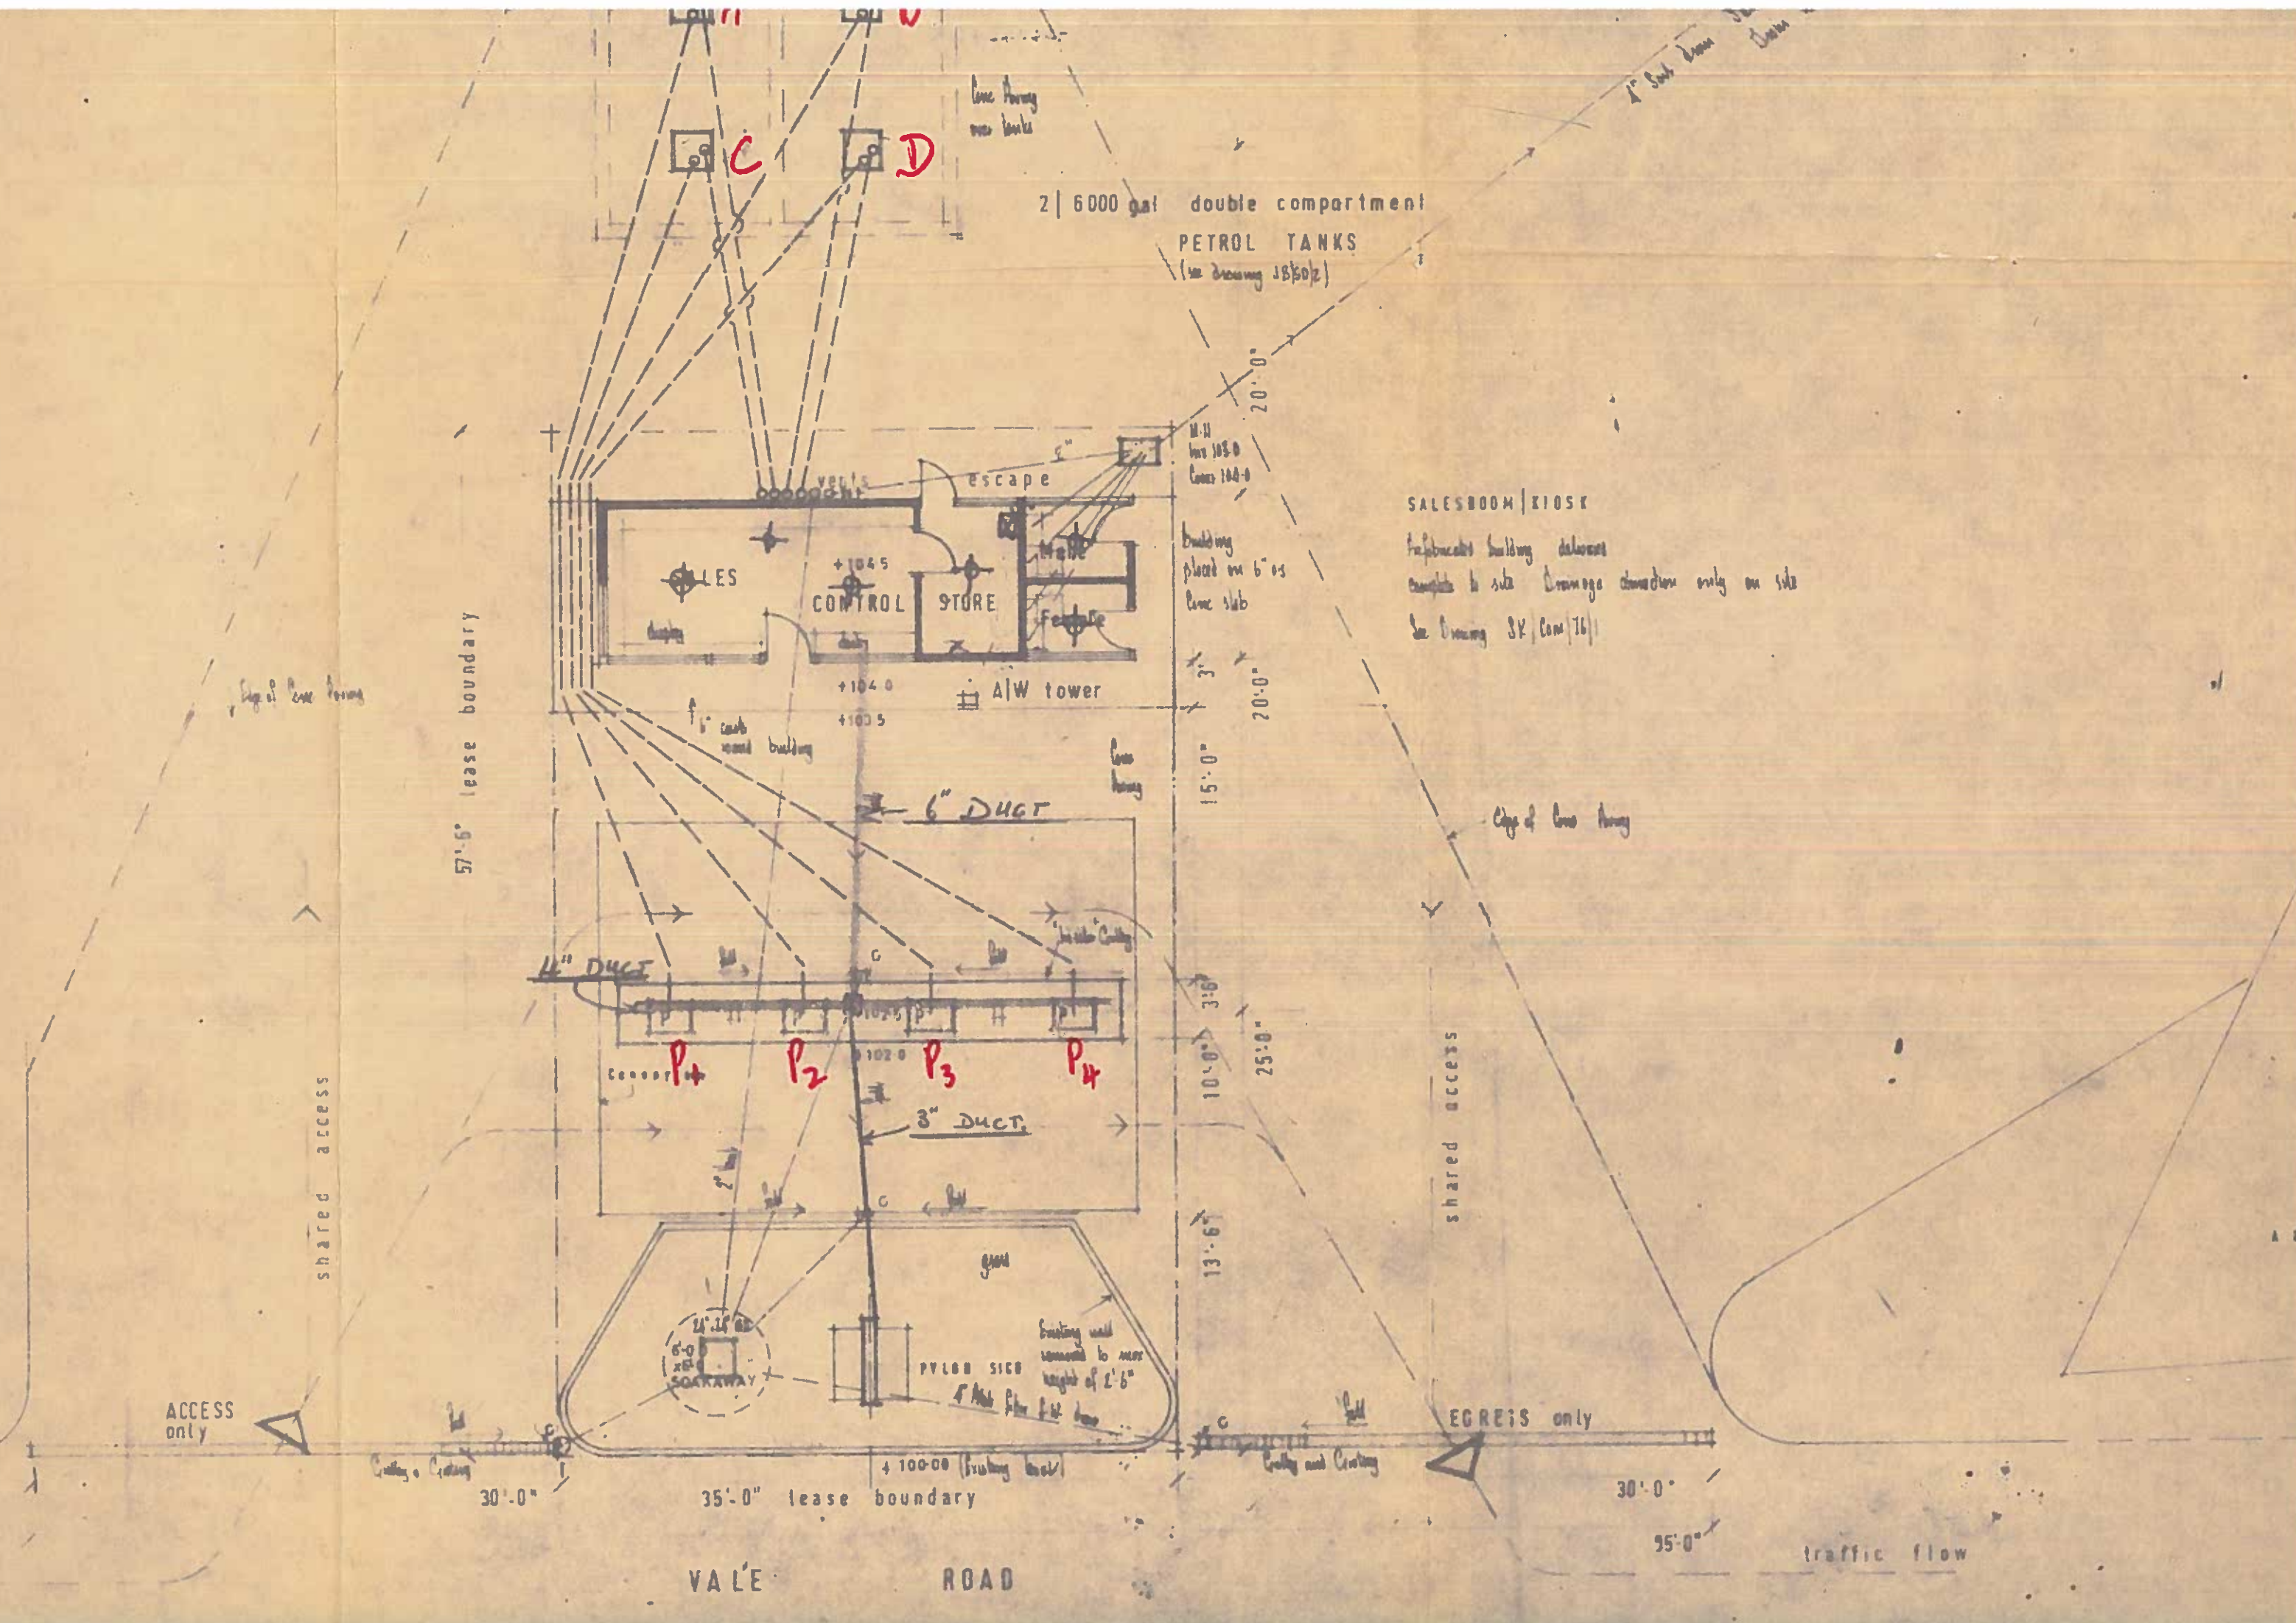
2 | 6000 gal double compartment  
PETROL TANKS  
(see drawing 18/50/2)

SALESBOOM KIOSK  
fabricated building delivered  
complete to site drainage connection only on site  
see drawing 34/Com/16/1
