# Bat Surveys Report: Tourmalene, 63 Old Watling Street, Gravesend

Client Mr H Sangha  
Reference S1207.001  
Issue One  
Date 30 June 2023

In May 2023, Crossman Associates was commissioned to undertake a bat survey of Tourmalene, 63 Old Watling Street, Gravesend DA11 7NT. Development proposals include demolition and replacement.

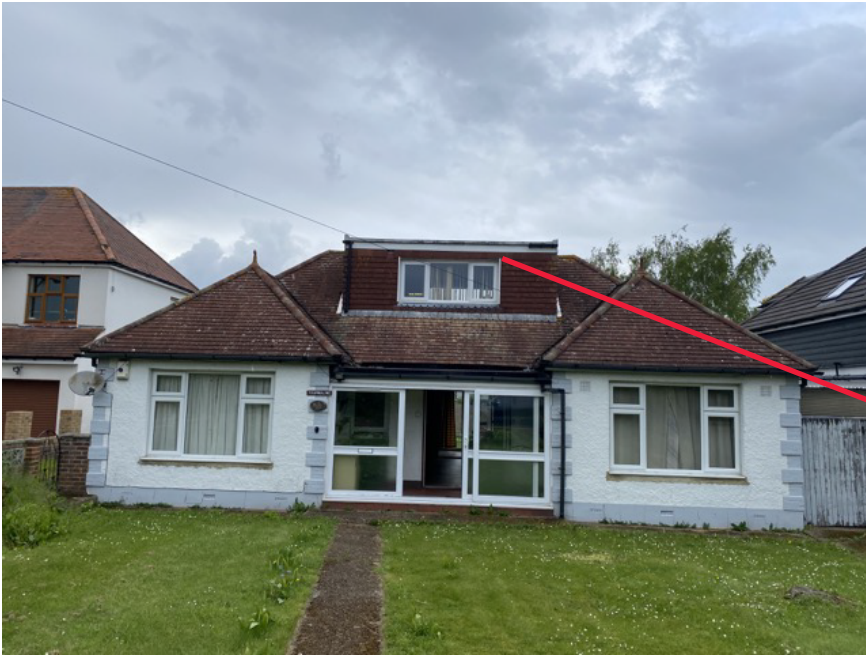
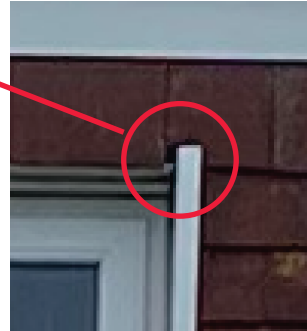
Photograph 1:

Front- Southern elevation

Bat emergence location

| Survey Date | 31/05/2023 | 29/06/2023 |
|---|---|---|
| Emergence survey | <b>21.25 a common pipistrelle bat emerged from a gap between the window and the wall hanging tile southern elevation dormer.</b> | <b>21.25 a common pipistrelle bat emerged from a gap at the wall hanging tile northern elevation dormer.</b> |

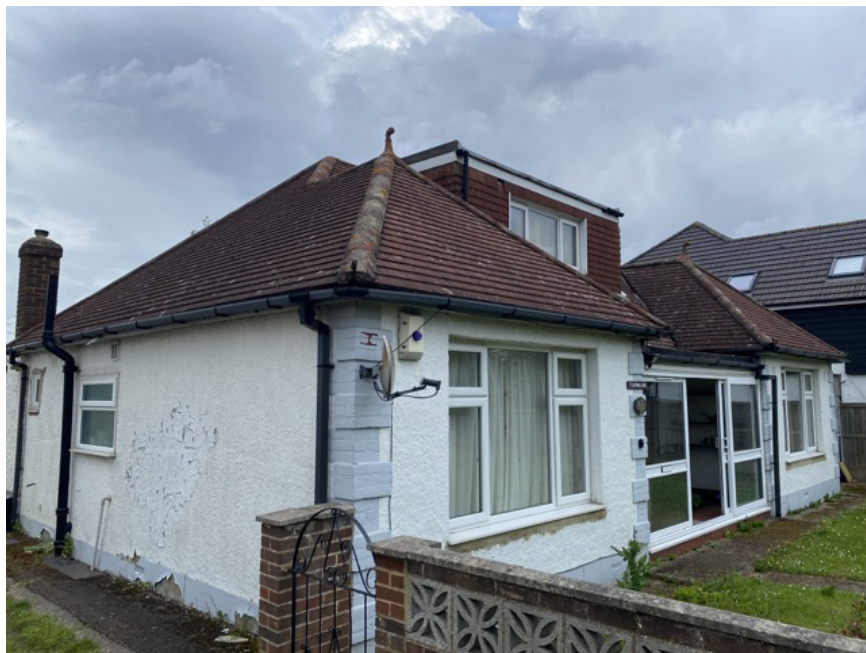
Photograph 2:

Southwestern elevation

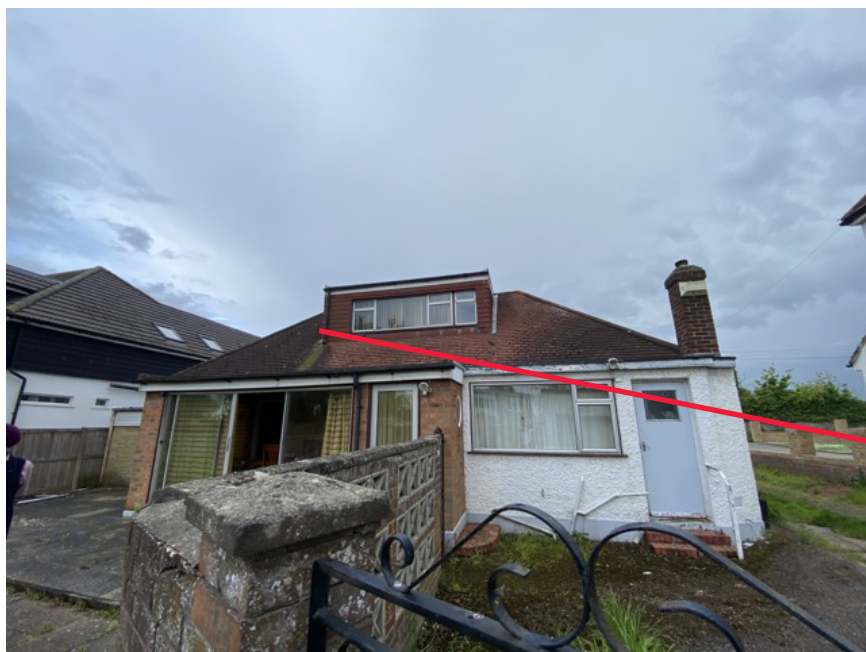
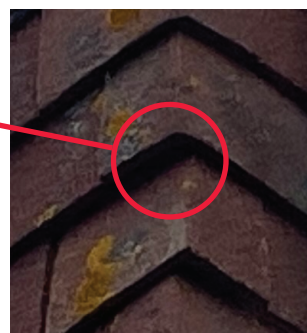
Photograph 3:

Back - Northern elevation

Bat emergence location

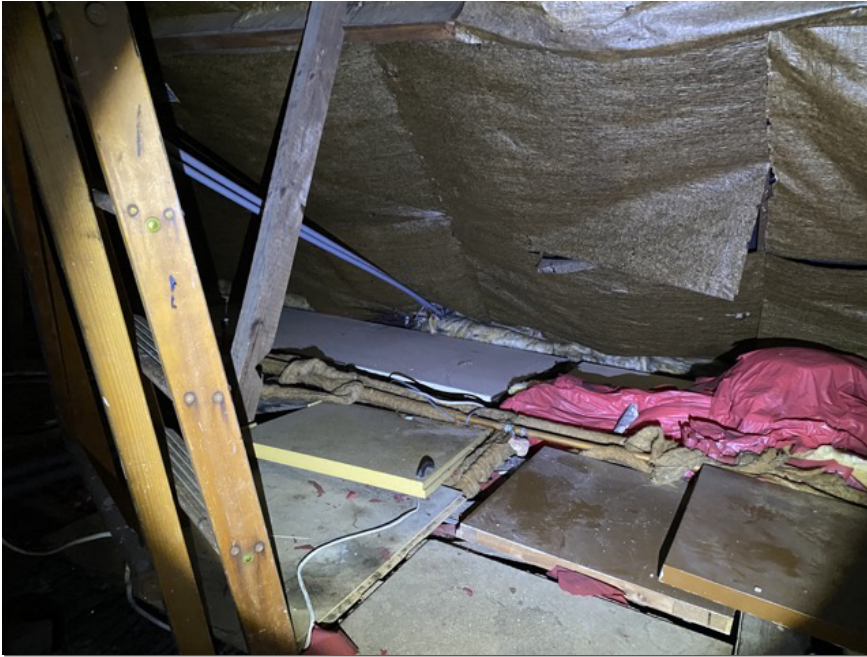
Photograph 4:

Roof void

| Building | Feature | Feature Description | Bat suitability |
|---|---|---|---|
| | Interior | <p>Areas of living accommodation are composed of rooms with well-sealed rooms with plaster and painted walls and ceilings. The roof voids are insulated, exposed timbers and type 1 bituminous sarking lining. No gaps were observed.</p> | |

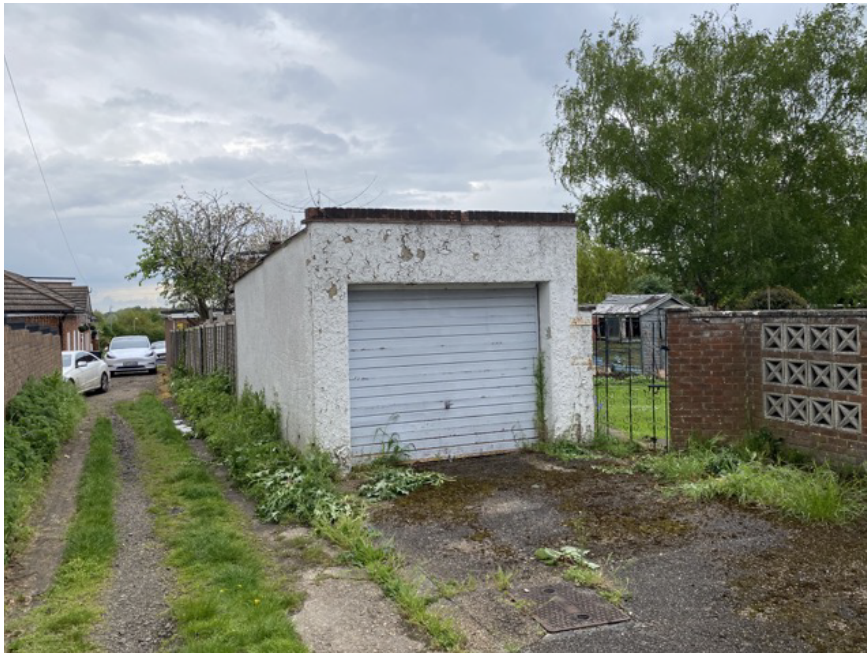
Photograph 5:

Garage

| Building | Feature | Feature Description | Bat suitability |
|---|---|---|---|
| | Garage | The garage walls and roof remain in good condition, no gaps or cracks were observed. | Negligible suitability ☒ |

- 3.10. The garage offers no significant bat roosting opportunities and is assessed to have **negligible Suitability** for roosting bats.
- 3.11. During the scoping survey no droppings, staining, feeding remains or actual bats were observed in any aspect of the building. No evidence of bat activity was noted.

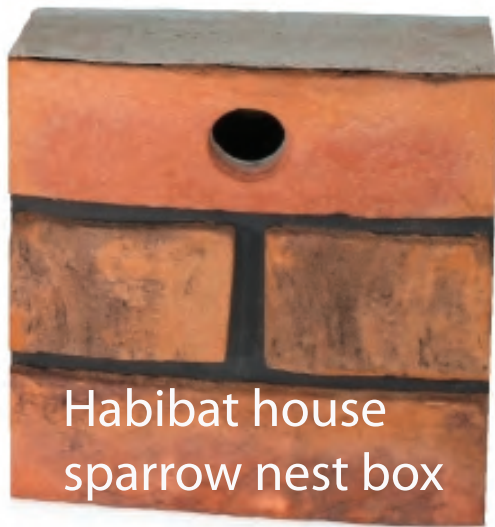
Habibat house  
sparrow nest box

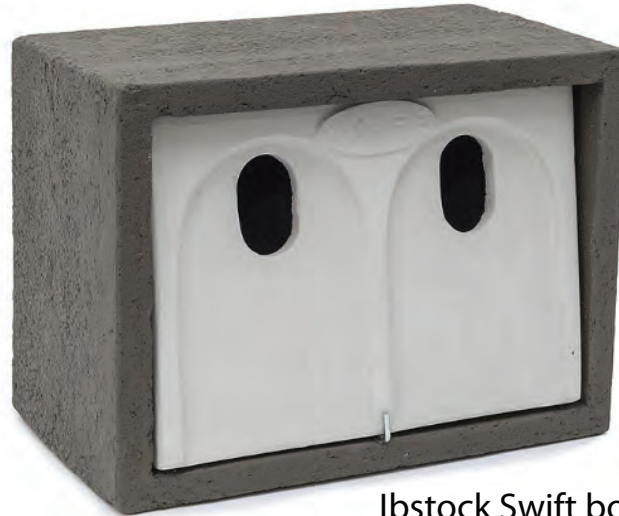
Vivara woodstone sparrow  
nest box; suitable for both  
integral fitment or surface  
mounting

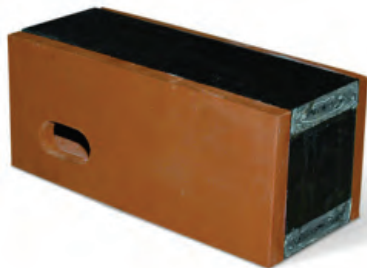
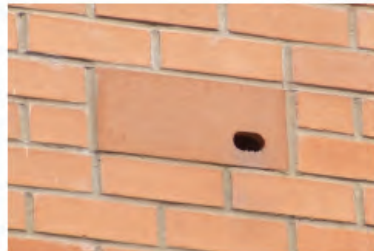
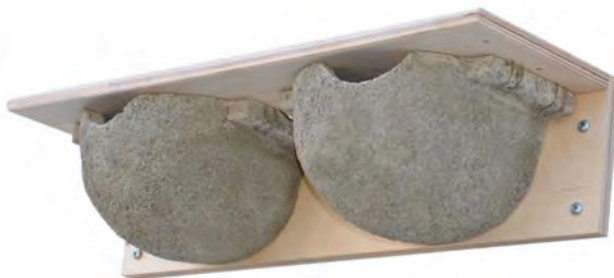
Schwegler model 9b

Schwegler house martin box model 9 b double is a suitable box for house martins and can be used to encourage the uptake of a building by this species. The boxes can be attached to the exterior walls in a sheltered position; ideally beneath the eaves. At least two sets should be placed on an averaged size house.
