# Preliminary Ecological Appraisal and Roost Assessment

53 Villa Road, Rochester, Kent, ME3 7BU

This report is prepared to inform a planning application with Gravesham Borough Council. The proposal is described as: Demolition of existing bungalow and erection of three bungalows.

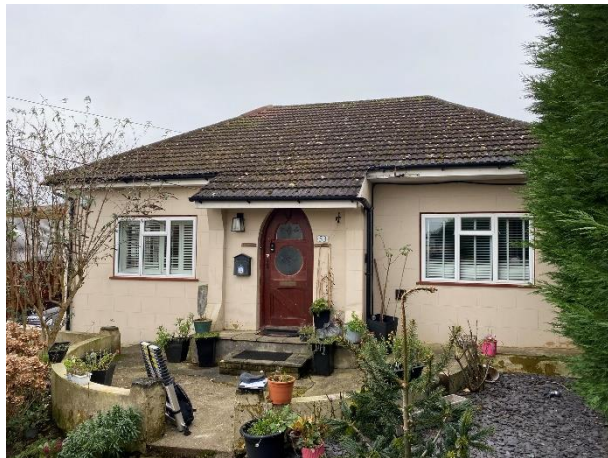
| <p><i>Summary</i></p> <p>B1 is a residential bungalow and will be demolished for the proposed development. B1 consists of brick and block build and rendered finish, with a hipped, pitched roof with clay tiles. The loft was converted into a bedroom with a small loft section surrounding the bedroom. A gap around a ventilation pipe within the loft that provided internal access, and was where a small number of droppings were observed. To the exterior, there was a gap within the soffit, raised tiles and gaps surrounding the Velux window. The building has a <b>moderate habitat value</b>.</p> | | | |

| <i>Recommendations</i> | <p><b>Roosting habitat [Buildings]</b><br/><b>Three bat emergence or re-entry surveys (BERS)</b> are required for B1 during the active bat season (optimal May to August, suboptimal September) to confirm presence and categorise the roost observed to be present within the building. <b>Two surveyors</b> with infrared cameras will provide coverage of <b>B1. DNA analysis</b> of the droppings collected from B1 and <b>Biological Records Data</b> will be required in addition to the roost information provided by the BERS and will be used to inform an EPSL application to Natural England. Surveys should be a minimum of three weeks apart. The EPSL application requires that surveys have been undertaken within the most recent active bat season and planning permission must have been granted and all relevant wildlife-related conditions have been discharged prior to submission.</p> <p><b>Two bat emergence or re-entry surveys</b> are required for <b>B2</b> during the active bat season (optimal May to August, suboptimal September) to confirm presence or likely-absence of a bat roost in the building. <b>Two surveyors</b> with infrared cameras will provide coverage of <b>B2</b>. If bat roosts are confirmed in the building an additional survey may be required to characterise the roost and to inform an EPSL application to Natural England. Surveys should be a minimum of three weeks apart. The EPSL application requires that surveys have been undertaken within the most recent active bat season and planning permission must have been granted and all relevant wildlife-related conditions have been discharged prior to submission.</p> <p><b>Roosting habitat [Trees]</b><br/>Tree removal required to facilitate the proposed development includes the felling of the trees within the northern line of trees and removal of approximately 20-30m of the line of trees. No further survey or mitigation is required for the felling of these trees, however in the unlikely event that a bat or evidence of bats is discovered during works, work must stop and a bat licensed ecologist contacted for further advice.</p> <p><b>Foraging and commuting habitat</b><br/>No further surveys are required. However, due to the removal of the trees on site this will lead to a reduction of foraging and commuting habitat and should be mitigated by the inclusion of planting a native hedgerow or native tree species within the proposed landscape plan.</p> <p><b>Artificial lighting</b></p> |

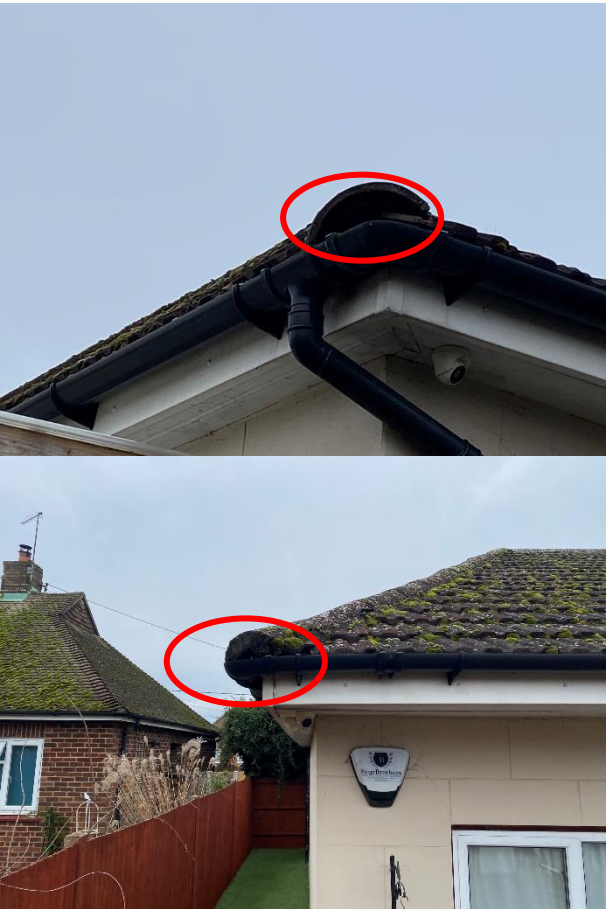
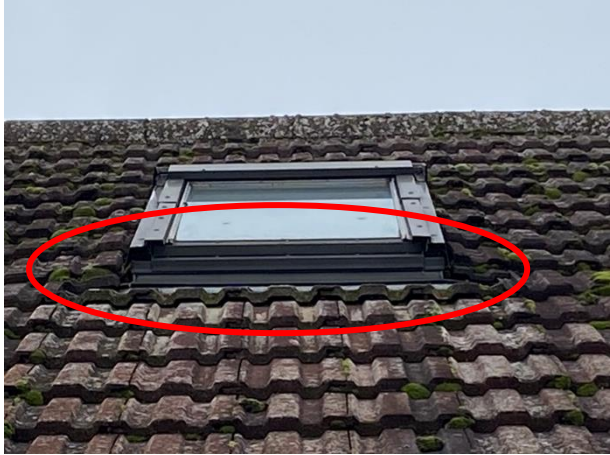
| Roof | Clay tiles | <b>Condition/description</b><br>Approximately 12 gaps were identified within the roof tiles. These were located around the Velux window, and within missing mortar on the end ridge tiles of the southwestern and northeastern corner.<br><br><b>Suitability/access/evidence of bats</b><br>The gaps were large enough to provide suitable roosting opportunity for crevice dwelling bats. | |

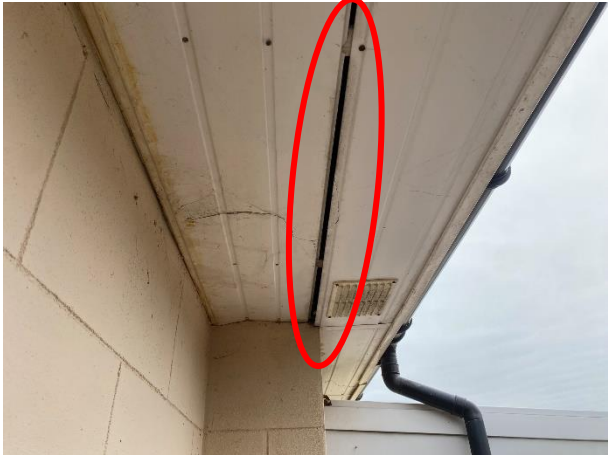
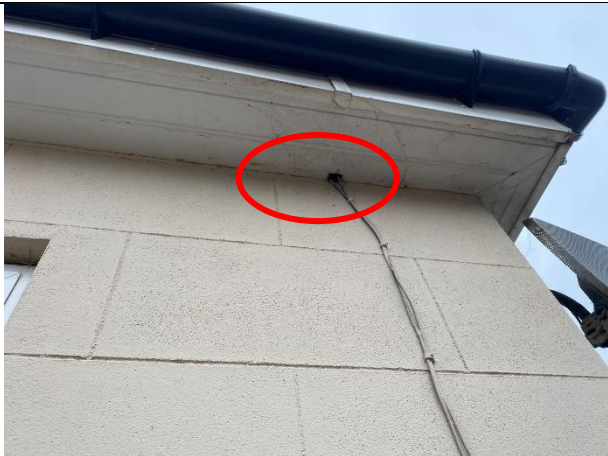
| Eaves | Plastic soffit box | <p><b>Condition/description</b><br/>Most of the soffit appeared well fitted, except a section along the southern elevation where two sections had split. This is immediately below where possible bat droppings were observed. Also, a cable entering the soffit provided a small gap.</p> <p><b>Suitability/access/evidence of bats</b><br/>These gaps could provide entry into the soffit box and loft space for crevice dwelling bats.</p> | |

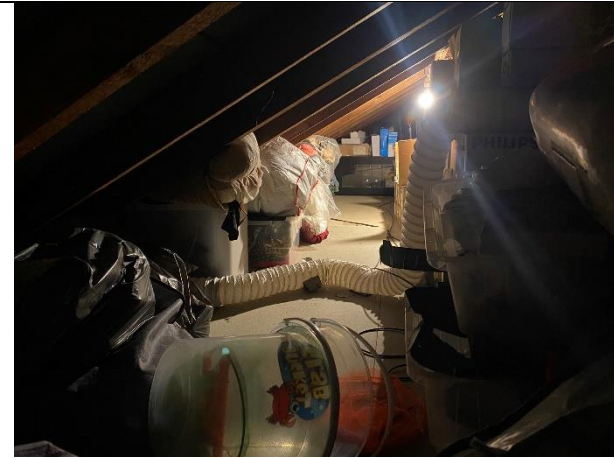
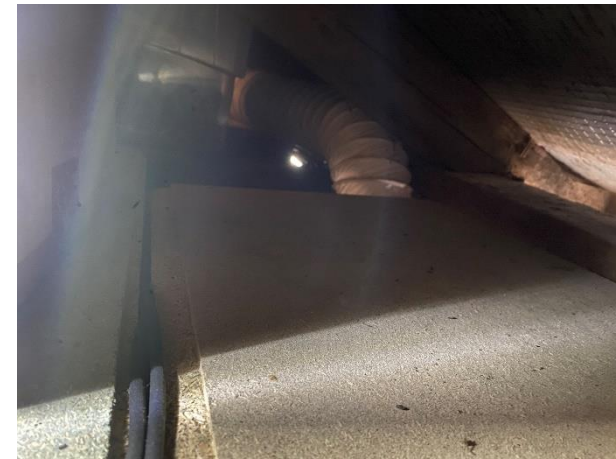
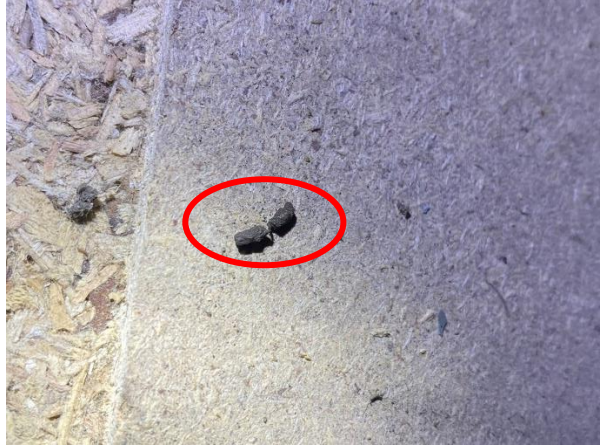
| Internal voids | Converted loft space | <b>Condition/description</b><br>The loft void surrounds a converted bedroom space. This area is currently used for storage and is approximately 8m long and 2 m wide along the northern and southern elevation and 6m long and 2.5m wide within the eastern and western elevation. The conditions were recorded as 56% humidity and 11.5c.<br><br><b>Suitability/access/evidence of bats</b> | |

The rafters were lined with plastic lining imbedded with small gauge mesh. The only daylight observed was surrounding a plastic vent that enter the loft from the outside. Daylight was observed around this and ~10 potential bat droppings were observed.

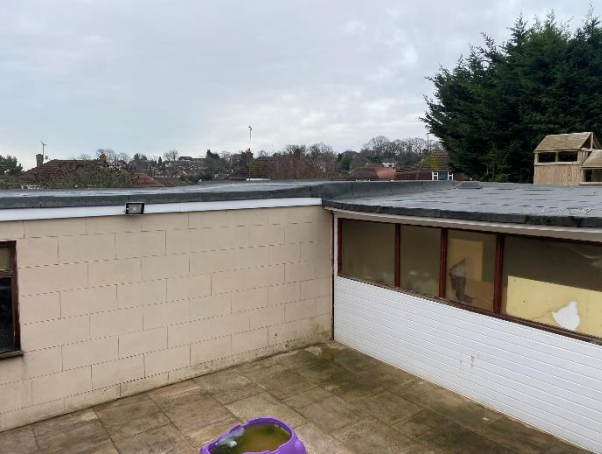
| <p><i>Summary</i></p> <p>B2 is a detached garage made from brick and block that extends into a wooden outbuilding and shed. The entirety of B2 consists of a flat roof covered with roofing felt and will be demolished for the proposed development. The roof and walls appeared in good condition; however, gaps were observed within the plastic fascia plate surrounding B2 and via broken glass pane. No signs of bats were identified however the gaps identified could provide roosting potential for crevice dwelling bats. The building has <b>a moderate habitat value</b>.</p> | | | |

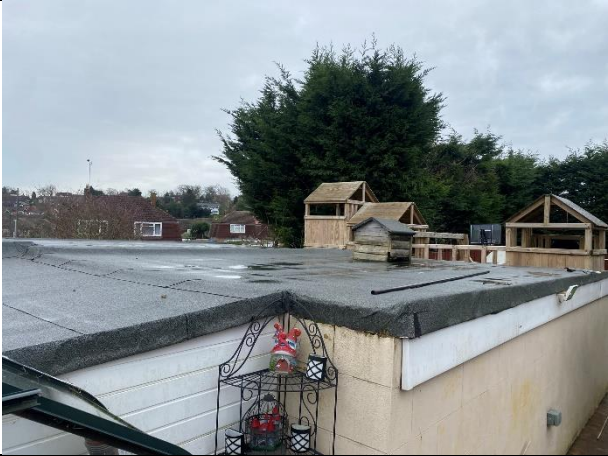
| Roof | Timber with felt | <p><b>Condition/description</b><br/>The flat roof appeared well covered with roofing felt, no gaps observed.</p> <p><b>Suitability/access/evidence of bats</b><br/>N/A</p> | |

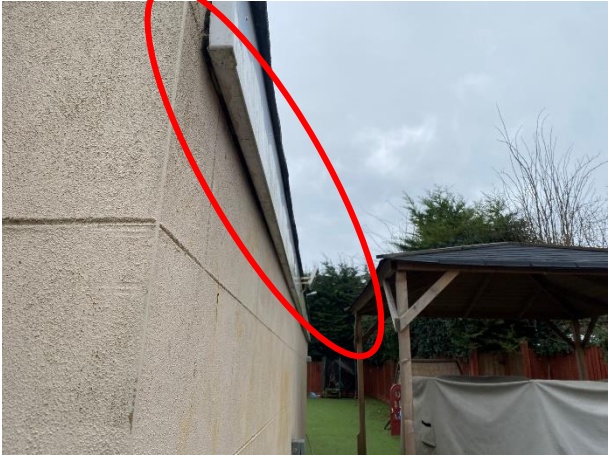
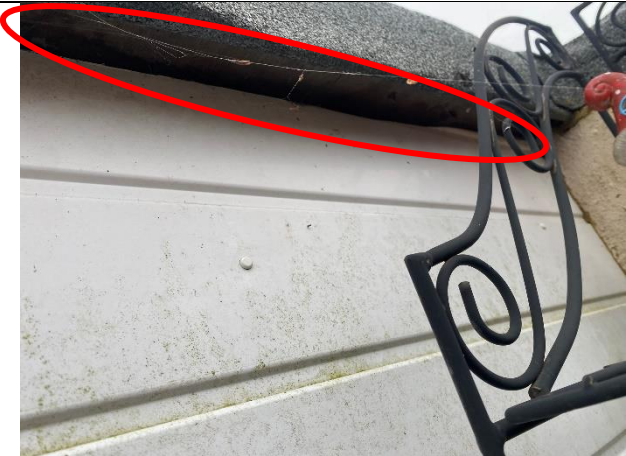
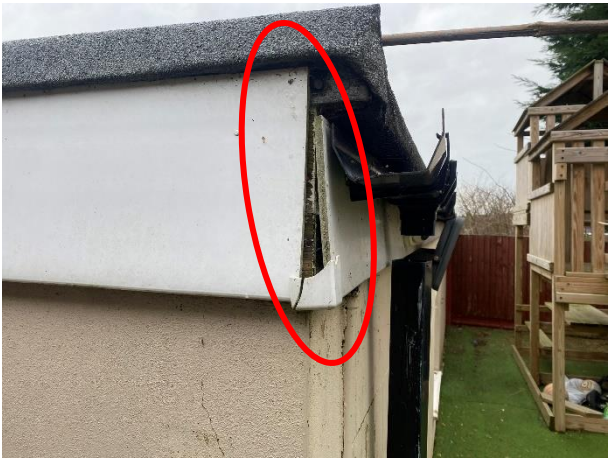
| Barge boards/fascia boards | Plastic | <p><b>Condition/description</b><br/>A plastic fascia plate surrounding the western and southern elevation of B2. Gaps were identified within this area, via a raised board, cracked end piece and ill-fitting joins between the felt and the plastic.</p> <p><b>Suitability/access/evidence of bats</b><br/>These gaps are large enough to provide roosting potential for crevice dwelling bats.</p> | |

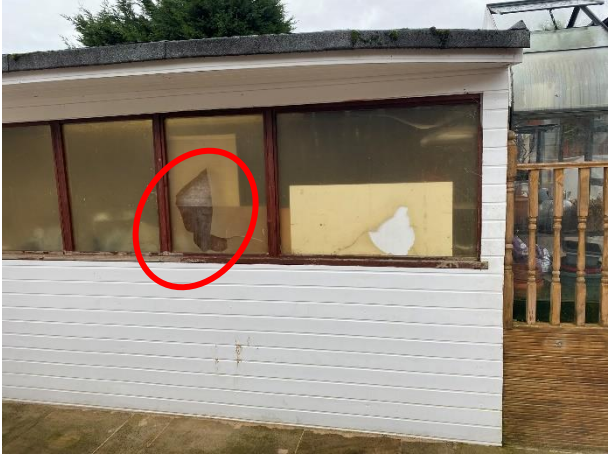
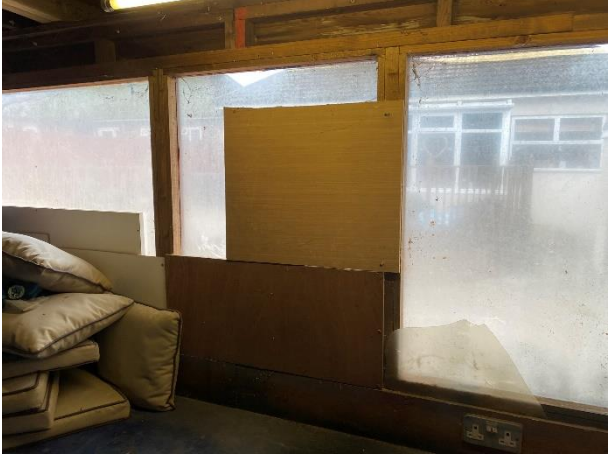
| Window/doors frames and lintels | Timber | <p><b>Condition/description</b><br/>There was a broken glass pane within the shed section of B2. This was partially covered by a wooden board, but not entirely.</p> <p><b>Suitability/access/evidence of bats</b><br/>A gap was identified between the wooden board and the broken glass pane and may provide access into the shed for crevice and/or void dwelling bats. However, no signs were identified within the interior.</p> | |

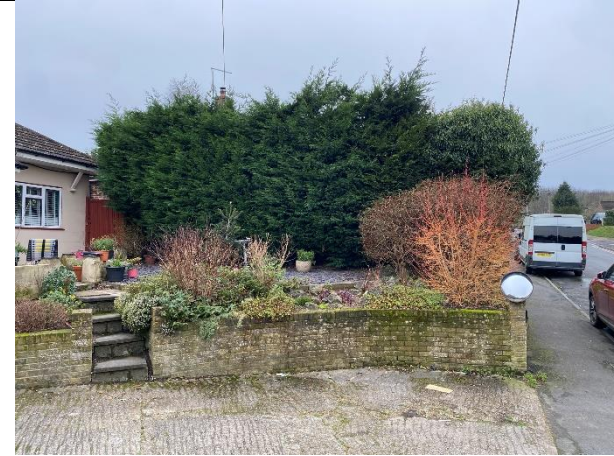
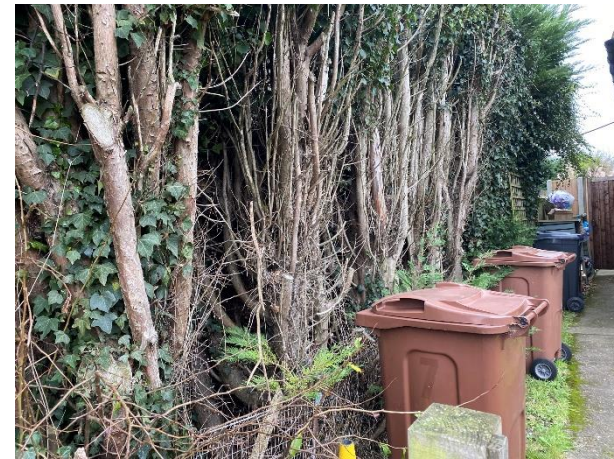
The line of trees within the northern section of the site are multi-stemmed *Leylandii* conifers, with ivy observed growing with the canopy. These trees are due to be felled for the proposed development. Although gaps were observed between the multi-stemmed trunks, it is unlikely that bats will be utilising these features due to the absence of clear flight path on the eastern side and the pruning management on the western side. This allows for a high level of light ingress and sub-optimal roosting conditions due to exposure to the elements. These trees **are assessed as PRF -None.**

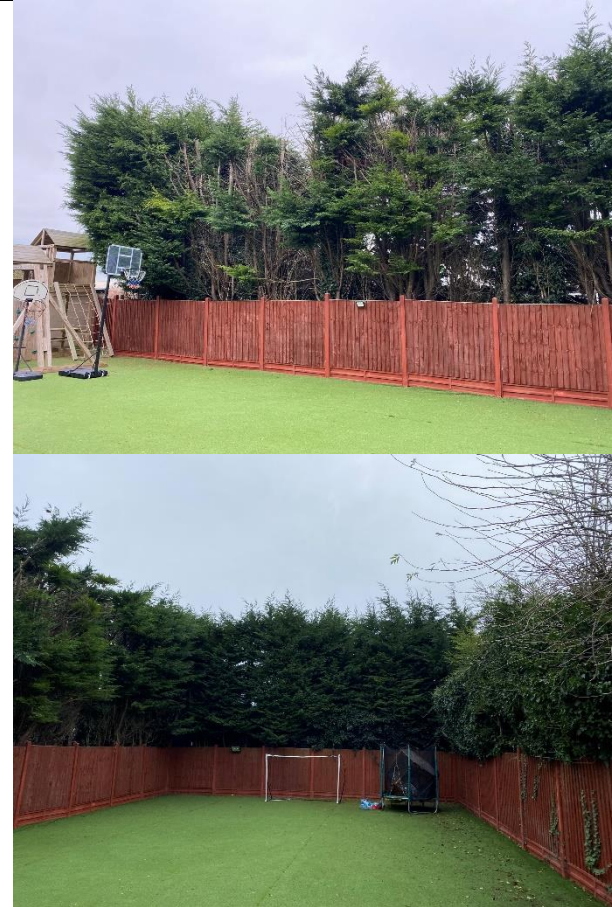
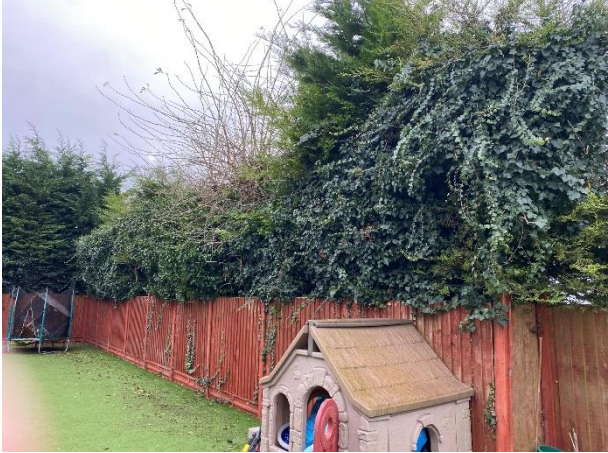
Surrounding the rear garden within the southern section of the site is a line of *Leylandii* conifer. It was not possible to access the trunks of the trees due to their location behind a 2m high fence. However, ground level observations showed the trees to multi-stemmed, with ivy observed growing within the canopy. Approximately 20-30m of the line is due to be felled for the proposed development. Although gaps were observed between the multi-stemmed trunks, it is unlikely that bats will be utilising these features due to exposure to weather conditions, light ingress and absence of clear flight path due to the density of the canopy. These trees **are assessed as PRF -None.**

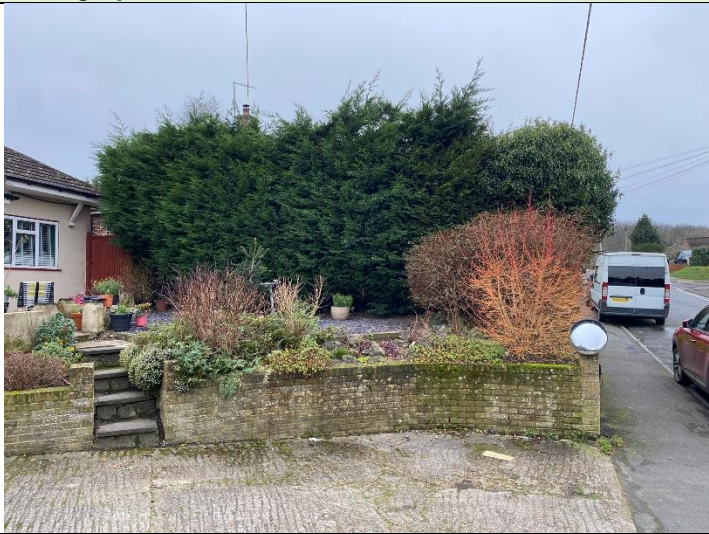
| Artificial grass | |
|---|---|
| | Figure 6: The <i>Leylandii</i> trees within the northern section of the site. These are due to be felled for the proposed development. |
