## Refurbishment and Demolition Asbestos Survey

2 Vale Road, Northfleet, Gravesend, Kent DA11 8BZ

Site Ref: TAG/A/0000TT6329

Survey Date: 9<sup>th</sup> October 2020

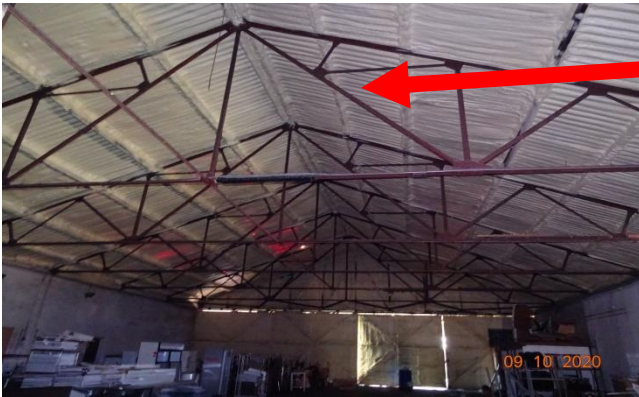
The bulk sample of the cement taken from the corrugated panels to front of the roof has proven positive to contain **Chrysotile (White Asbestos)**.

Location Ref 1: Sample TAG/A/S-02- R-Hand Workshop Including Enquires Office - **ASBESTOS DETECTED CHRYSOTILE (WHITE ASBESTOS).**

| Loc/ref | Location Description | Sample No / Element Inspected | Type of Asbestos Detected | Notes |
|---|---|---|---|---|
| 1 | R-HAND WORKSHOP INCLUDING ENQUIRES OFFICE | SAMPLE TAG/A/S-02 CEMENT PRODUCT TO CORRUGATED CEILING/ROOF | <b>ASBESTOS DETECTED<br/>CHRYSTILE (WHITE ASBESTOS)</b> | See Location<br>Ref:19 Corrugated Roof |

| Loc/<br>ref | Location Description | Sample No / Element Inspected | Type of Asbestos<br>Detected | Notes |
|---|---|---|---|---|
| 19 | CORRUGATED ROOF | SAMPLE TAG/A/S-02 CEMENT PRODUCT TO CORRUGATED ROOF FRONT | <b>ASBESTOS DETECTED CHRYSOTILE (WHITE ASBESTOS)</b> | Approx. 1,110m <sup>2</sup><br>Material must be removed prior to refurbishment |

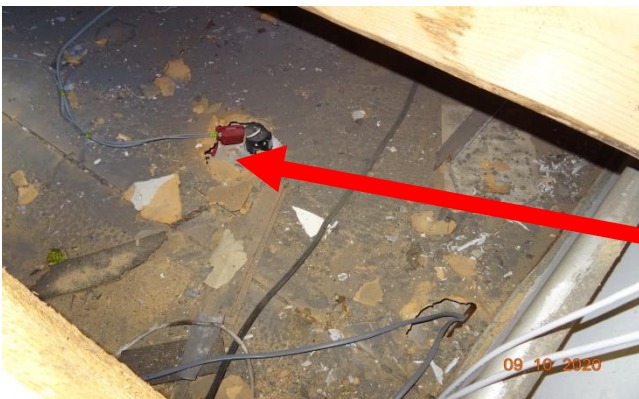
Location Ref 4: Sample TAG/A/S-07- Ceiling Voids To Main Reception And WC - **ASBESTOS DETECTED AMOSITE (BROWN ASBESTOS).**

| Loc/ref | Location Description | Sample No / Element Inspected | Type of Asbestos Detected | Notes |
|---|---|---|---|---|
| 4 | CEILING VOIDS TO MAIN RECEPTION AND WC | CONSISTENT WITH SAMPLE TAG/A/S-07 INSULATION BOARDS TO OLD CEILING | <b>ASBESTOS DETECTED<br/>AMOSITE (BROWN ASBESTOS)</b> | See Location<br>Ref:18 Void to Floor |

| Loc/<br>ref | Location Description | Sample No / Element Inspected | Type of Asbestos<br>Detected | Notes |
|---|---|---|---|---|
| 18 | VOID TO FLOOR | CONSISTENT WITH SAMPLE TAG/A/S-07 INSULATION BOARDS TO OLD CEILING | <b>ASBESTOS DETECTED AMOSITE (BROWN ASBESTOS)</b> | Approx. 190m <sup>2</sup><br>Material must be removed prior to refurbishment |

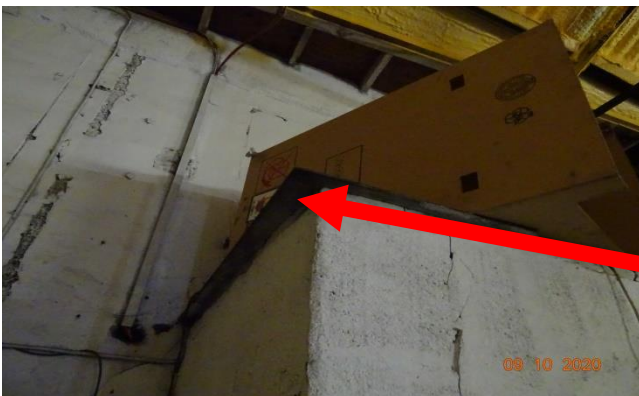
The bulk sample of the cement taken from the workshop above the staircase has proven positive to contain **Chrysotile (White Asbestos)**.

Location Ref 5: Sample TAG/A/S-10- Workshop - **ASBESTOS DETECTED CHRYSOTILE (WHITE ASBESTOS).**

| Loc/ref | Location Description | Sample No / Element Inspected | Type of Asbestos Detected | Notes |
|---|---|---|---|---|
| | | SAMPLE TAG/A/S-10 CEMENT PANELS TO ABOVE THE STAIRCASE | <b>ASBESTOS DETECTED<br/>CHRYSTILE (WHITE ASBESTOS)</b> | Approx. 15m <sup>2</sup><br>Material must be removed prior to refurbishment |

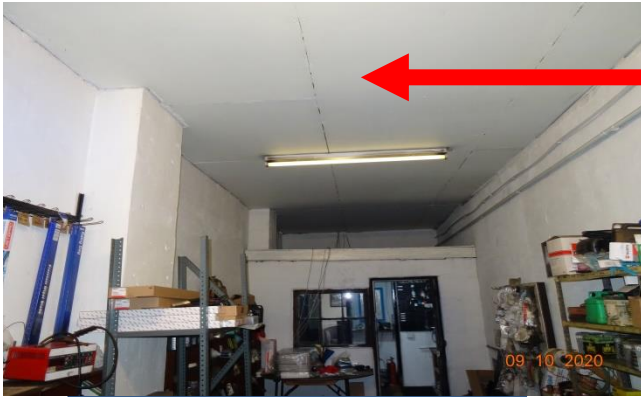
The bulk sample of the insulation board taken from the storeroom ceiling has proven positive to contain **Amosite (Brown Asbestos)**.

Location Ref 6: Sample TAG/A/S-07- Storeroom - **ASBESTOS DETECTED AMOSITE (BROWN ASBESTOS).**

| Loc/<br>ref | Location Description | Sample No / Element Inspected | Type of Asbestos<br>Detected | Notes |
|---|---|---|---|---|
| 6 | STOREROOM | SAMPLE TAG/A/S-07 INSULATION<br>BOARDS TO CEILING | <b>ASBESTOS DETECTED<br/>AMOSITE (BROWN<br/>ASBESTOS)</b> | See Location<br>Ref:18 Void to Floor |

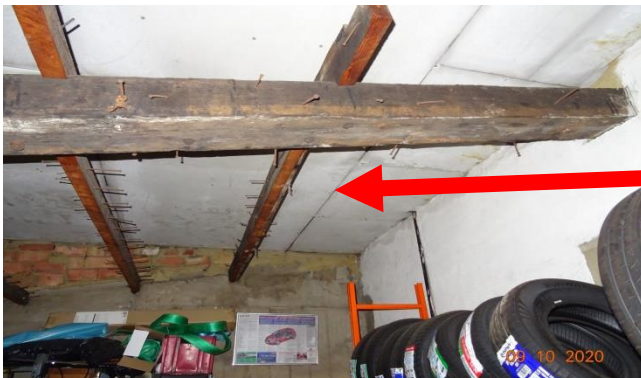
Location Ref 10: Sample TAG/A/S-07- Tyre Storeroom - **ASBESTOS DETECTED AMOSITE (BROWN ASBESTOS).**

| Loc/<br>ref | Location Description | Sample No / Element Inspected | Type of Asbestos<br>Detected | Notes |
|---|---|---|---|---|
| 10 | TYRE STOREROOM | CONSISTENT WITH SAMPLE<br>TAG/A/S-07 INSULATION BOARDS<br>TO OLD CEILING | <b>ASBESTOS DETECTED<br/>AMOSITE (BROWN<br/>ASBESTOS)</b> | See Location<br>Ref:18 Void to Floor |

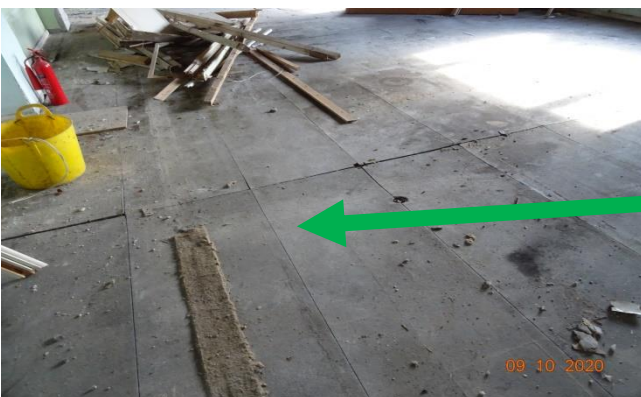
The bulk sample of the tiles and adhesive taken from the floor has proven negative to contain asbestos. **No Asbestos Detected**. Therefore, no further action is required for this material.

Location Ref 17: Sample TAG/A/S-08- Open Plan Floor - **NO ASBESTOS DETECTED.**

| Loc/<br>ref | Location Description | Sample No / Element Inspected | Type of Asbestos<br>Detected | Notes |
|---|---|---|---|---|
| 17 | OPEN PLAN FLOOR | SAMPLE TAG/A/S-08 TILES TO FLOOR | <b>NO ASBESTOS DETECTED</b> | n/a |

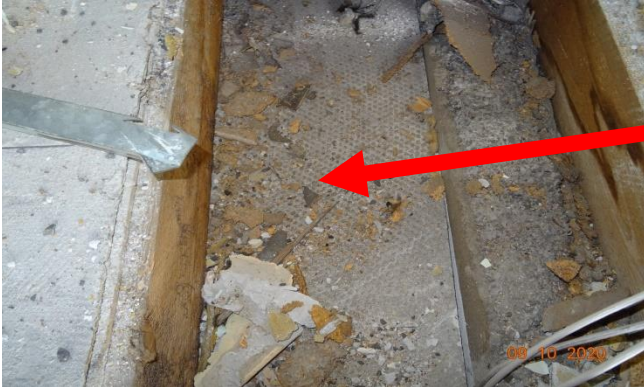
Location Ref 18: Sample TAG/A/S-07- Void To Floor - **ASBESTOS DETECTED CHRYSOTILE (WHITE ASBESTOS).**

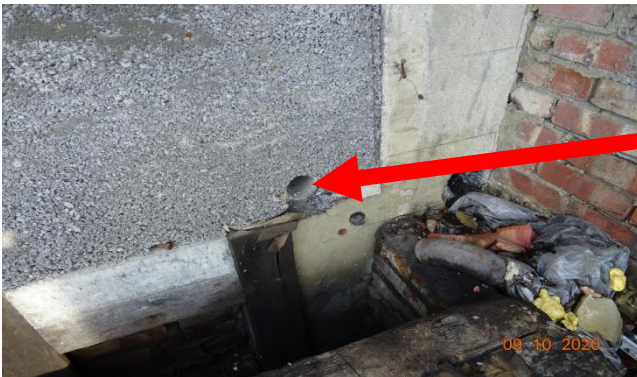
The bulk sample of the cement taken from the flue pipe has proven positive to contain **Chrysotile (White Asbestos)**.

Location Ref 20: Sample TAG/A/S-01- Flue Pipe - **ASBESTOS DETECTED CHRYSOTILE (WHITE ASBESTOS).**

| Loc/<br>ref | Location Description | Sample No / Element Inspected | Type of Asbestos<br>Detected | Notes |
|---|---|---|---|---|
| 20 | FLUE PIPE | SAMPLE TAG/A/S-01 CEMENT PRODUCT TO FLUE PIPE | | Approx. 1m <sup>2</sup><br>Material must be removed prior to refurbishment |

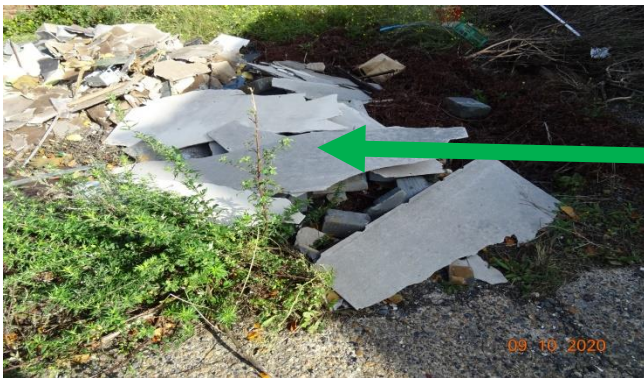
The bulk sample of the debris taken from the rear of the building has proven negative to contain asbestos. **No Asbestos Detected**. Therefore, no further action is required for this material.

Location Ref 21: Sample TAG/A/S-05- Debris - **NO ASBESTOS DETECTED.**

| Loc/<br>ref | Location Description | Sample No / Element Inspected | Type of Asbestos<br>Detected | Notes |
|---|---|---|---|---|
| 21 | DEBRIS | SAMPLE TAG/A/S-05 LOOSE DEBRIS<br>TO REAR OF BUILDING | <b>NO ASBESTOS DETECTED</b> | n/a |
