24<sup>th</sup> August 2022

**Our Ref:** 4768 22 08 24 Ltr Rpt 02 Rev A AS SP

**SITE: Former St Johns Ambulance HQ, Armoury Drive, Gravesend, DA12 1NB**  
**SERVICE: Supplementary Geo-Environmental Site Investigation**

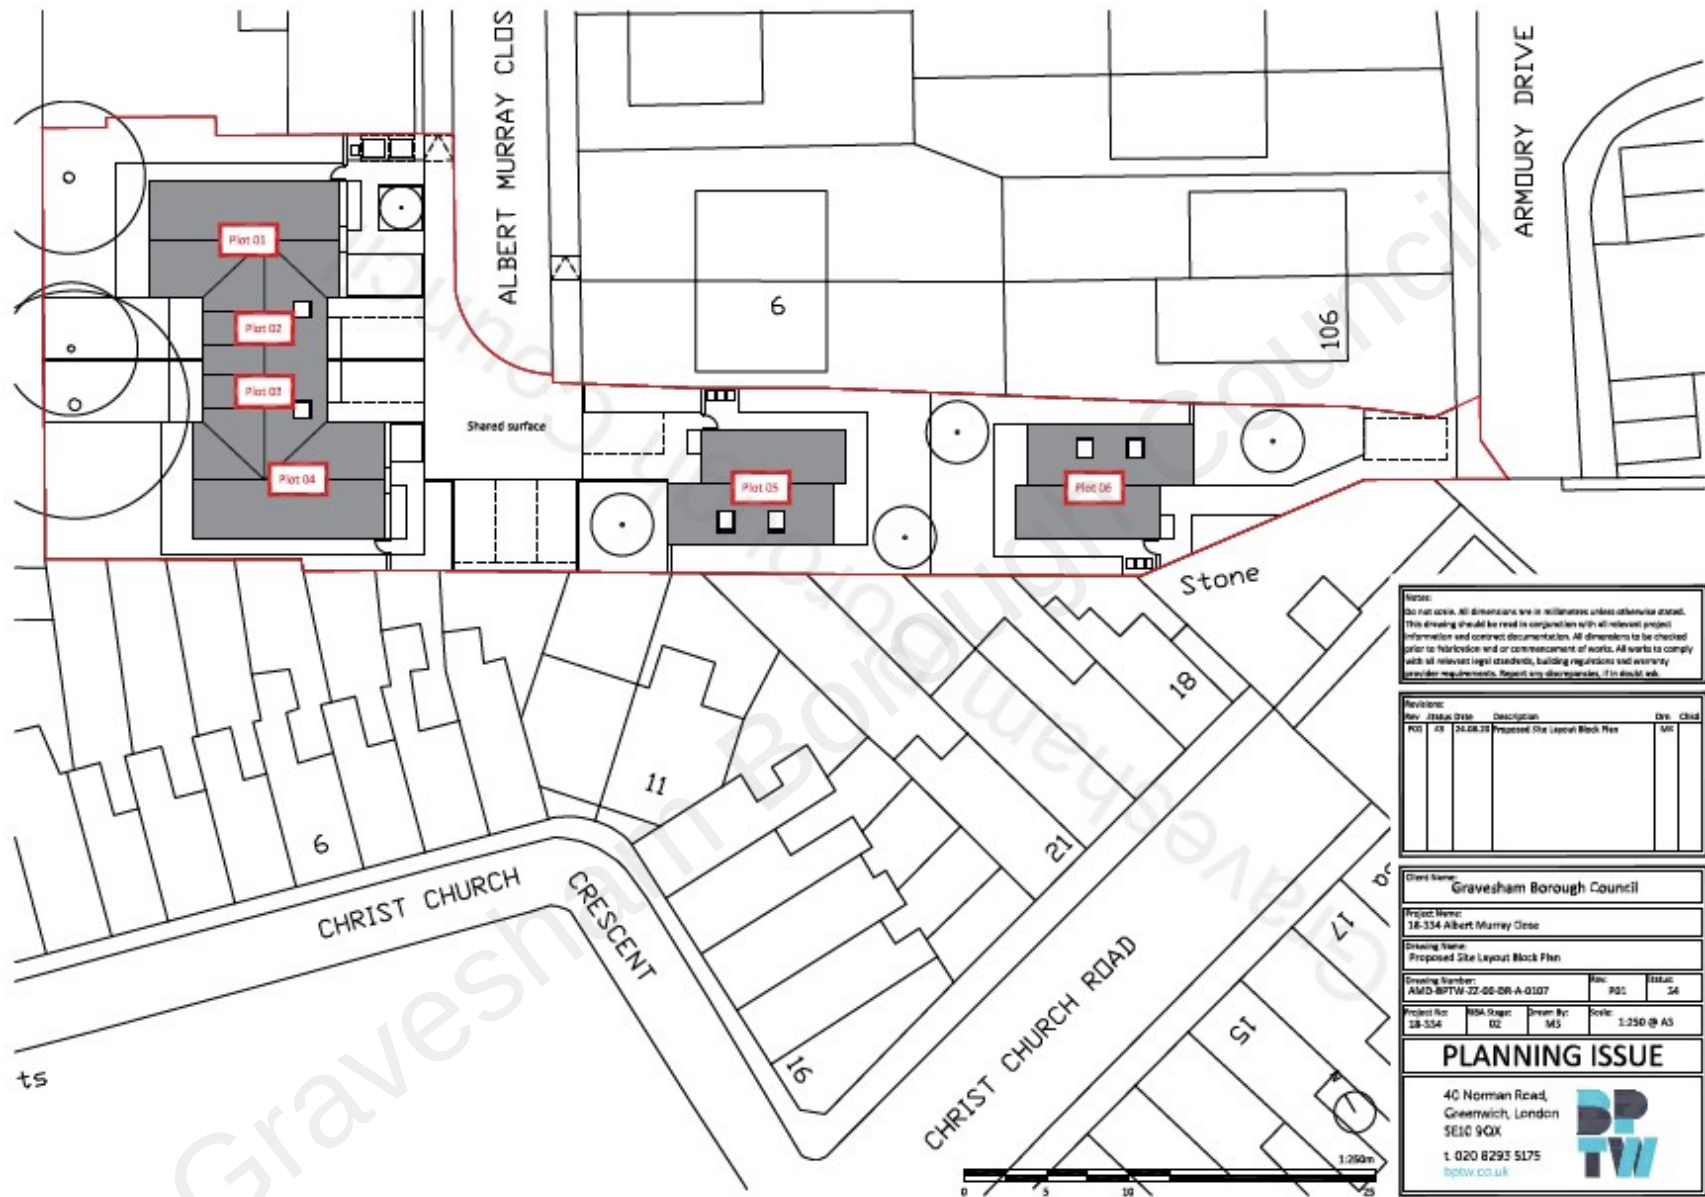
**FIGURE TITLE:** Proposed Site Layout Plan

The proposed re-development is understood to involve the demolition of existing buildings and construction of 1no. 2-storey block of flats and 2 no. detached bungalows (See Appendix A Figure 3 – Proposed Development Plan).
