Land East of Wrotham Road, Meopham
Phase I Geo-Environmental Desk Study
September 2025

Report Ref: 29473-GEO-0401

CLIENT: Richborough

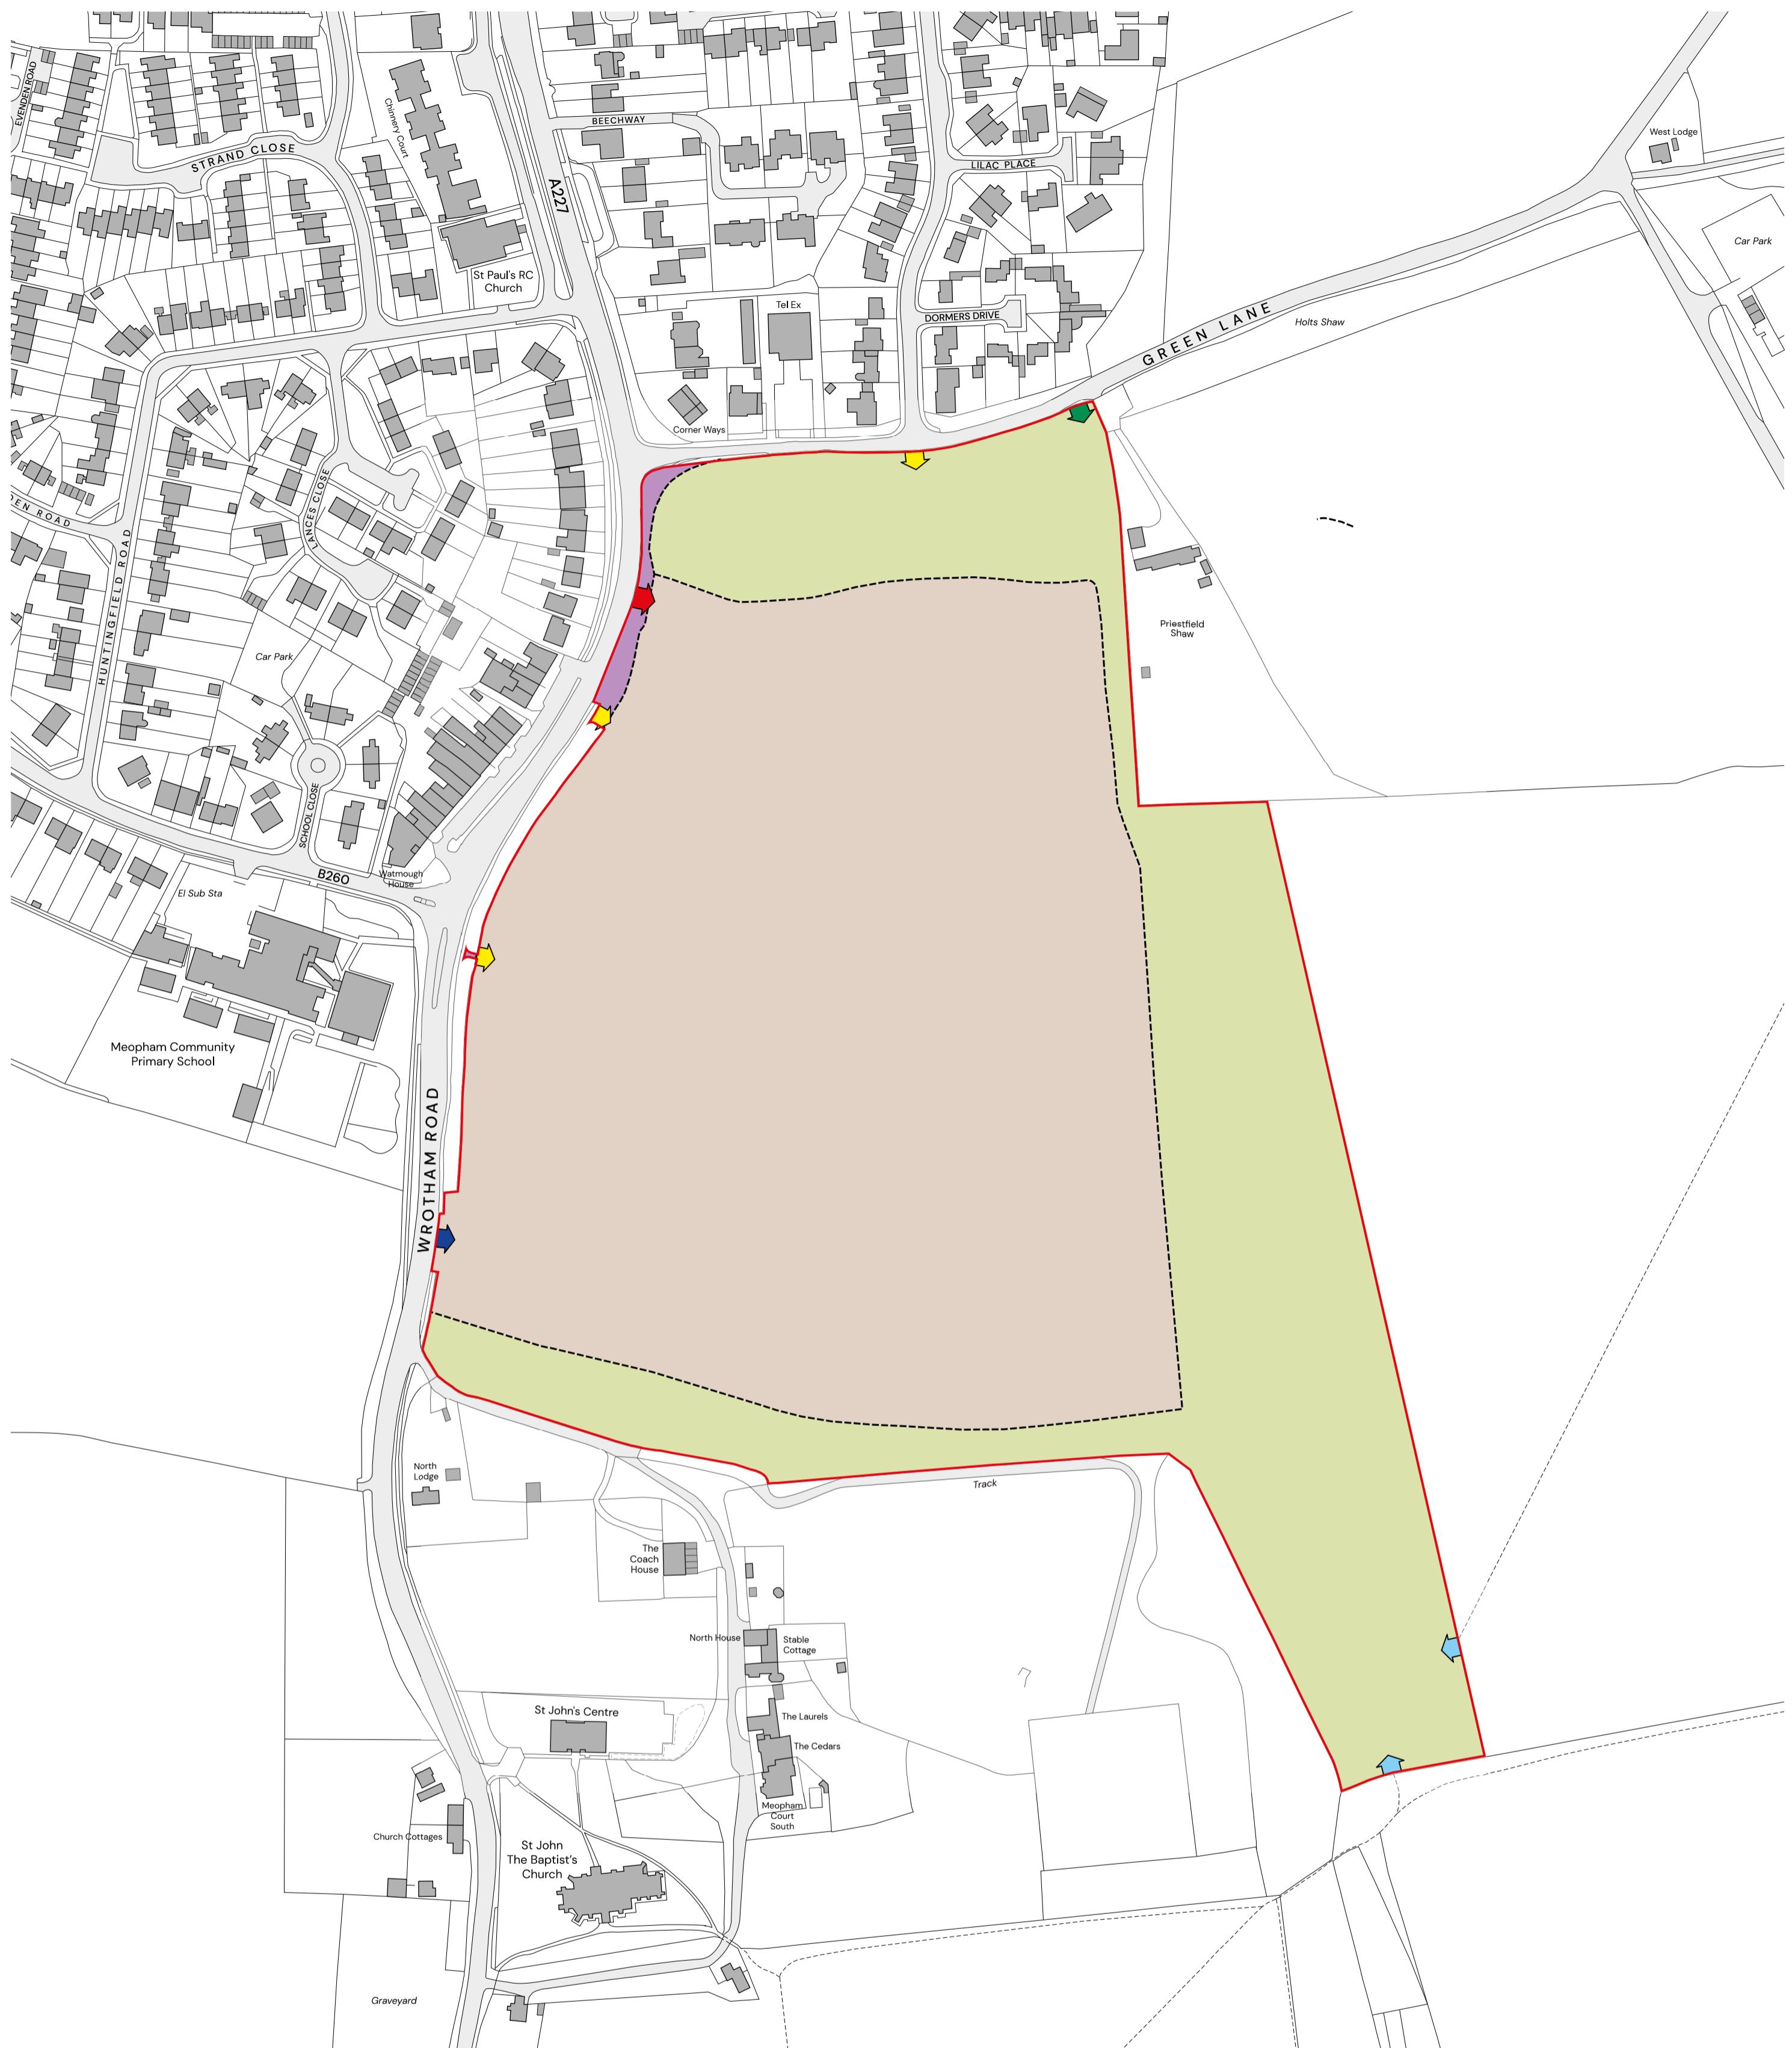
TEAM/DRAWN BY: CM | APPROVED BY: JW | DATE: 27/08/2025 | SCALE: 1:2000 @ A2 | DRAWING REF: P25-0485_DE_1006 | SHEET: 1 | REV: C | CLIENT: RICHBOROUGH

Site boundary
LAND USE PARAMETERS	
	Indicative area of land required for the proposed access, not within the residential land use (subject to detailed design)
	Proposed residential development (Use Class C3) including roads, footpaths, private drives, amenity and incidental open space and other associated infrastructure, subject to detailed design
	Proposed open space including roads, footpaths, children's play provision, allotments, orchard, landscaping, footpaths, drainage and other associated infrastructure, subject to detailed design
ACCESS PARAMETERS	
➡	Proposed access/egress for all modes (subject to detailed design)
➡	Existing public right of way access retained
➡	Potential access/egress for cyclists and pedestrians only (subject to detailed design)
➡	Potential emergency access for emergency vehicles and access/egress for cyclists and pedestrians (subject to detailed design)
➡	Potential access/egress for pedestrians only (subject to detailed design)

Note: All features and areas are subject to detailed design and to a tolerance of 10m.

1.3 A parameter plan is included in **Appendix A**.

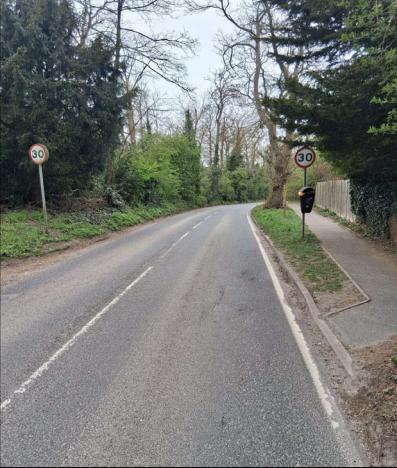
<p>Site Name: Land East of Wrotham Road, Meopham</p> <p>Project No.: 29473</p> <p>Client: Richborough</p> <p>Site Walkover Date: 10.04.2025</p>
Photo 1: View west along Green Lane, from site entrance.	Photo 2: View east along Green Lane, from site entrance.

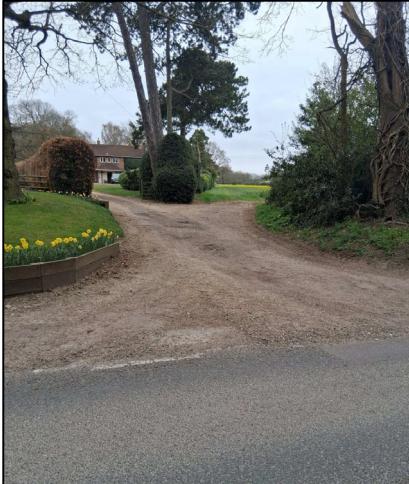
Photo 3: Site entrance off Green Lane.	Photo 4: View south-west across the western field.

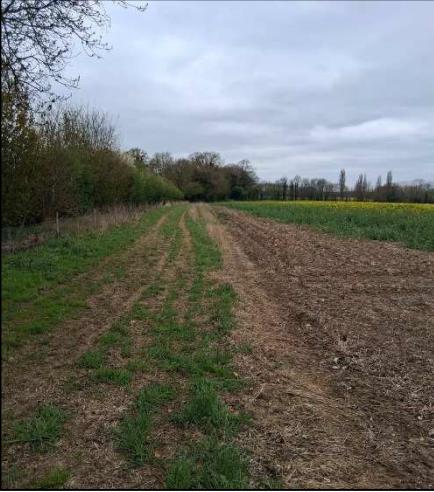
<p>Site Name: Land East of Wrotham Road, Meopham</p> <p>Project No.: 29473</p> <p>Client: Richborough</p> <p>Site Walkover Date: 10.04.2025</p>
Photo 9: View west along the southern boundary.	Photo 10: View west along the northern boundary.
