Project Name	Wrotham Road East, Meopham
Client	MEC Consulting Group
Site Address	Wrotham Road, Meopham, DA13 0JW
Report Reference	PA21698-00
Date	21 st March 2025
Author	AL
Quality Assurance	AT

Scheme Land East of Wrotham Road, Meopham
Client Richborough
Job ref. 29473

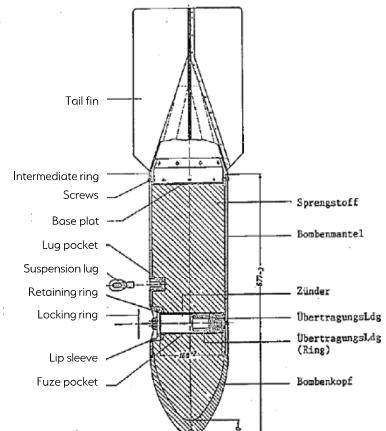
**SC 250kg High Explosive Bomb**

Bomb Weight	245-256kg (540-564lb)
Explosive Weight	125-130kg (276-287lb)
Fuze Type	Electrical impact/mechanical time delay fuze
Bomb Dimensions	1640 x 512mm (64.57 x 20.16in)
Body Diameter	368mm (14.5in)
Use	Against railway installations, embankments, flyovers, underpasses, large buildings and below-ground installations.
Remarks	It could be carried by almost all German bomber aircraft and was used to notable effect by the Junkers Ju-87 Stuka (<i>Sturzkampfflugzeug</i> , or dive-bomber).

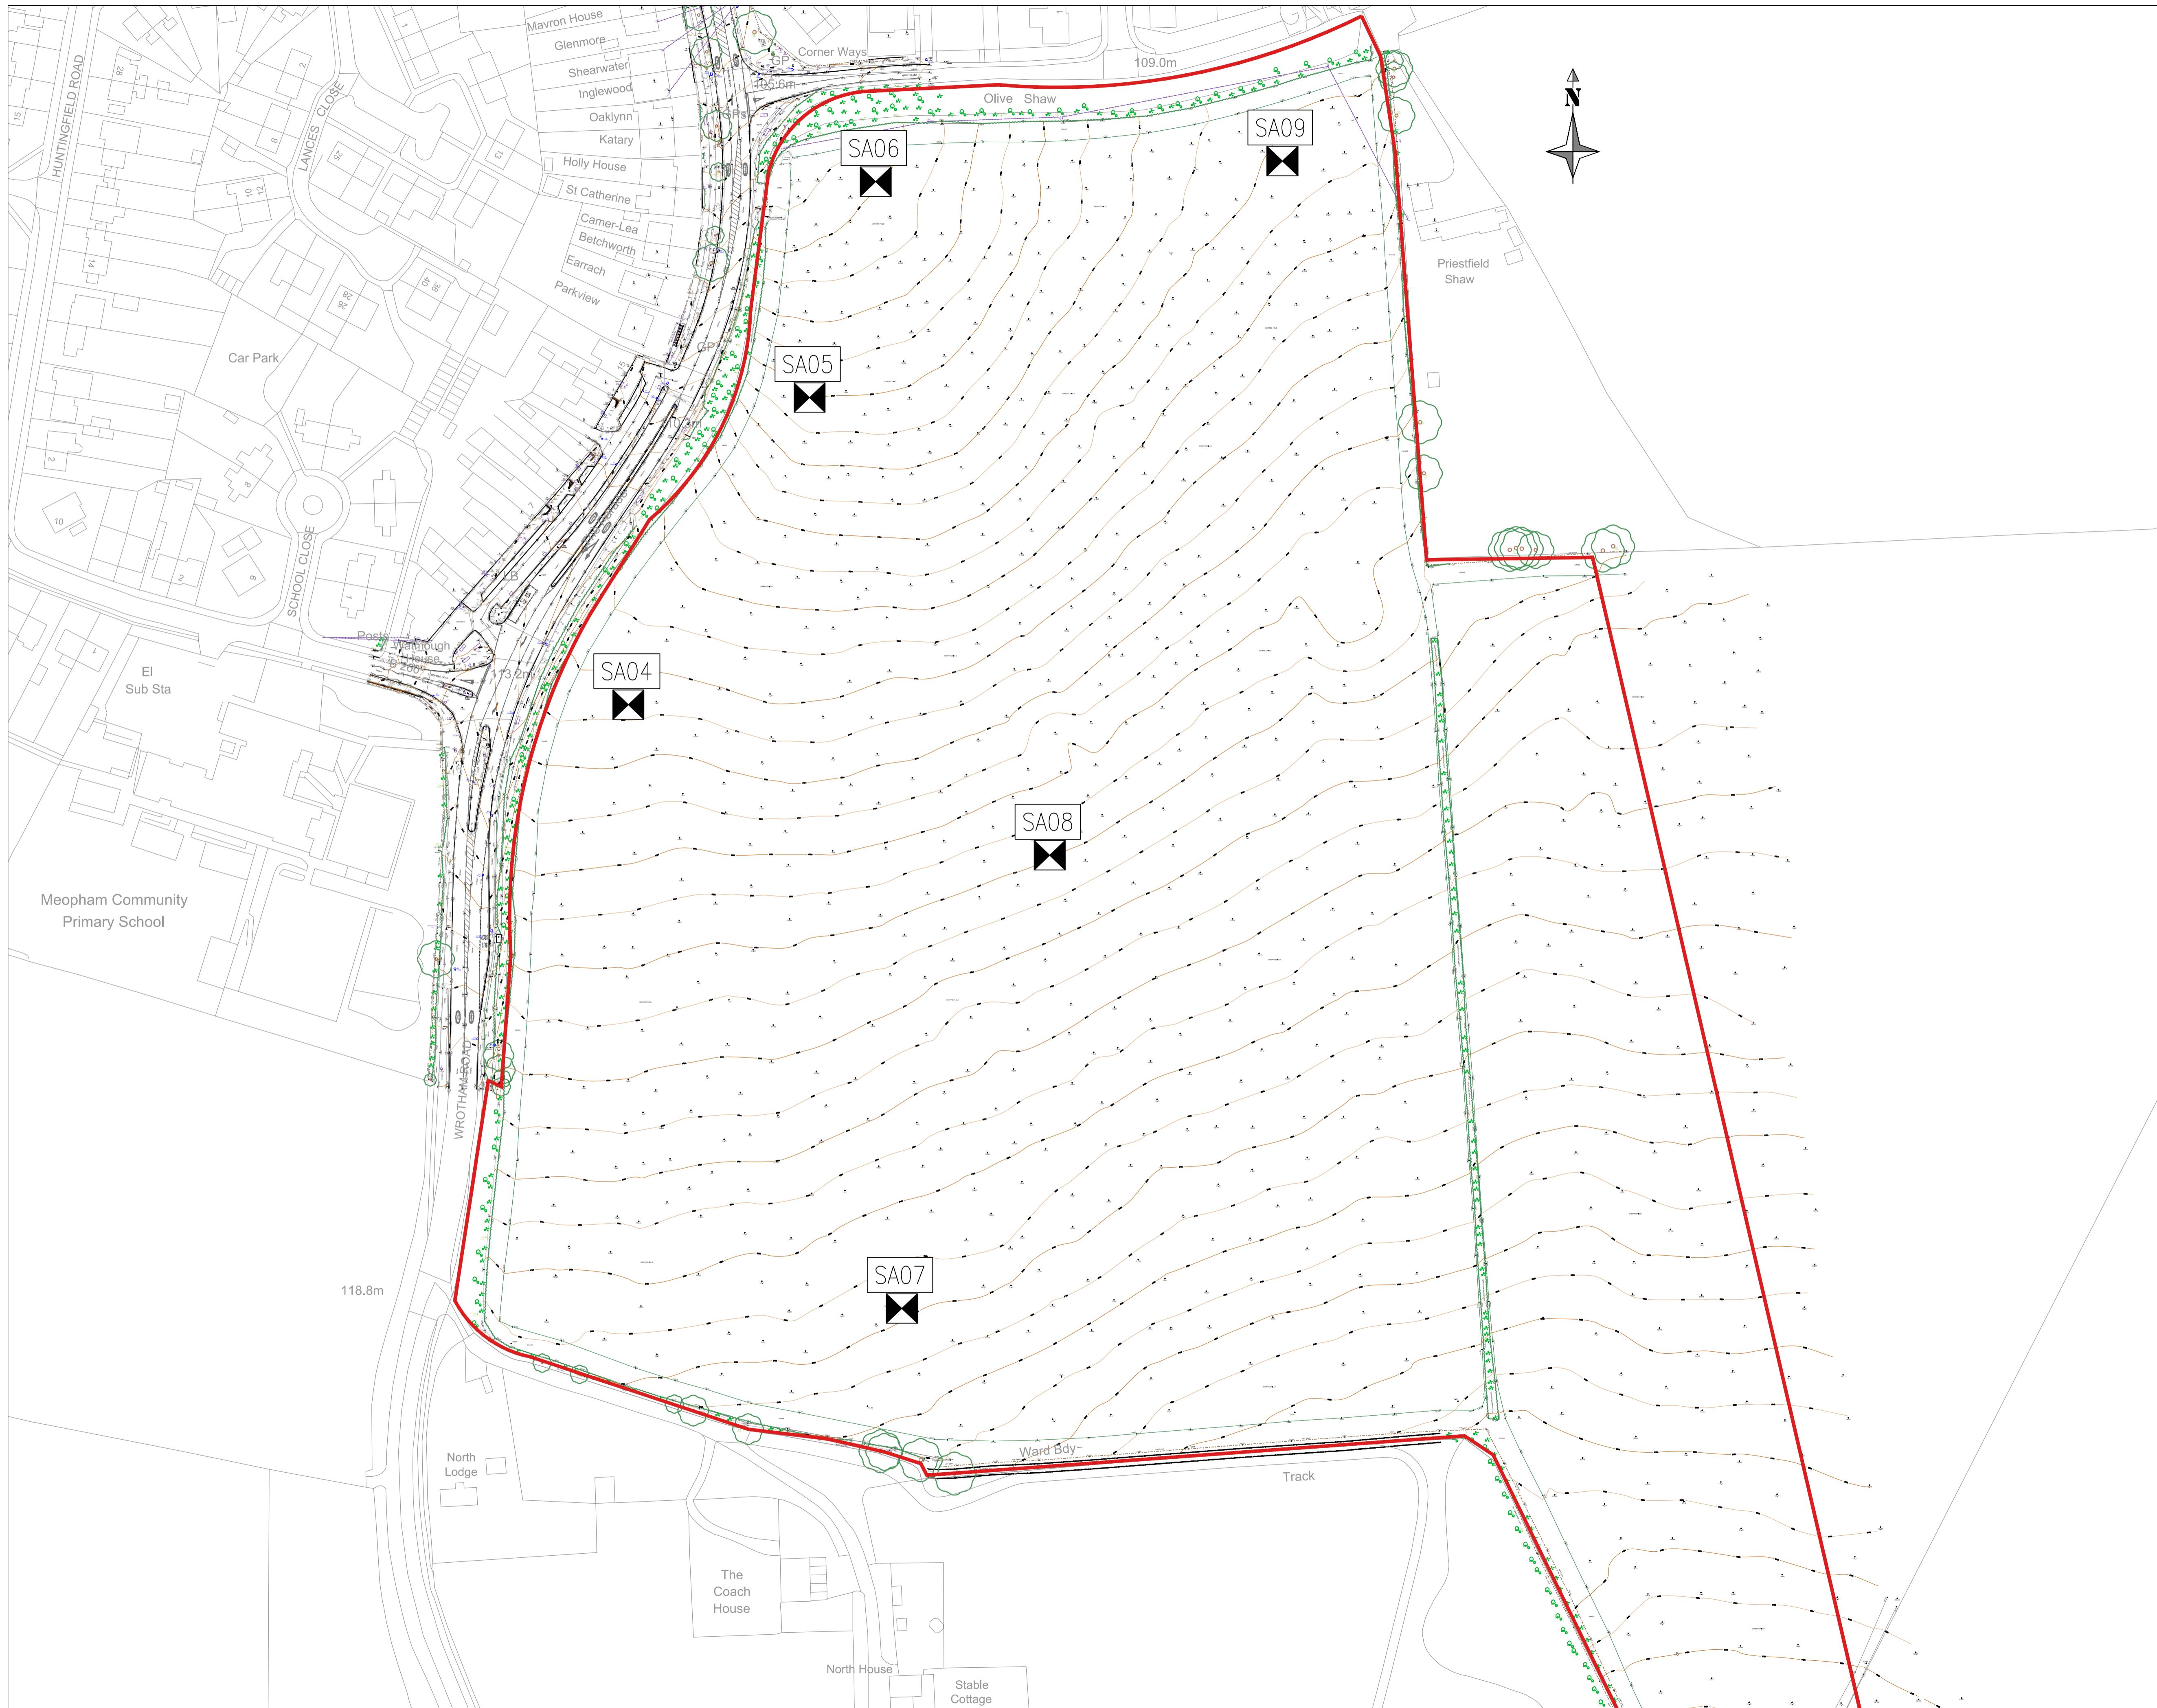
FIRST ISSUE	JM	CW	DT	08/04/25
REV: AMENDMENTS:	DRN	CHK	APP:	DATE:
PROJECT: LAND EAST OF WROTHAM ROAD MEOPHAM				
DRAWING TITLE: EXPLORATORY HOLE LOCATION PLAN				
CLIENT: RICHBOROUGH ESTATES LTD				
DRAWING NUMBER: 29473_04_140_01.1				
REVISION: -	SHEET SIZE: A1		SCALE: 1 : 1000	
STATUS: FOR INFORMATION / APPROVAL				
MEC Consulting Group		Telephone: 01530 264 753 Email: group@m-ec.co.uk Website: www.m-ec.co.uk ORDNANCE SURVEY © CROWN COPYRIGHT 2015. ALL RIGHTS RESERVED. LICENCE NUMBER 100055865.

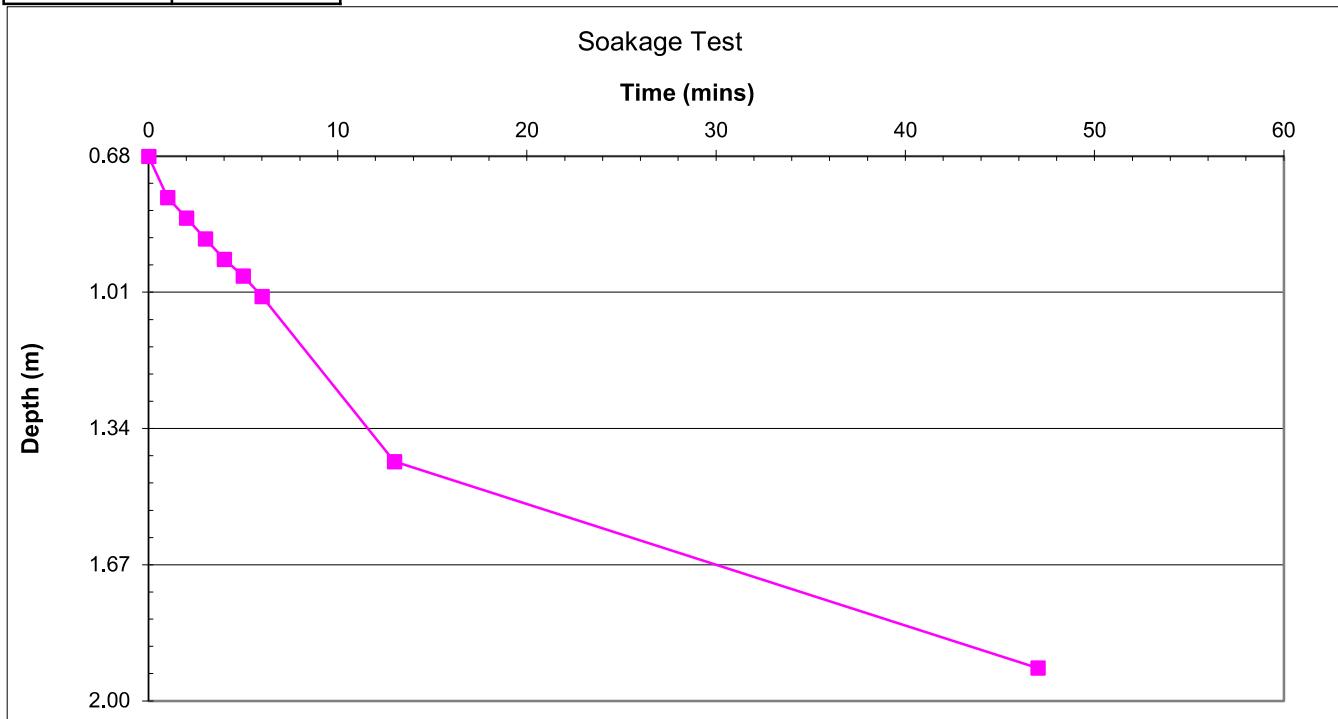
SOIL INFILTRATION RATE = 3.89E-05 m/s

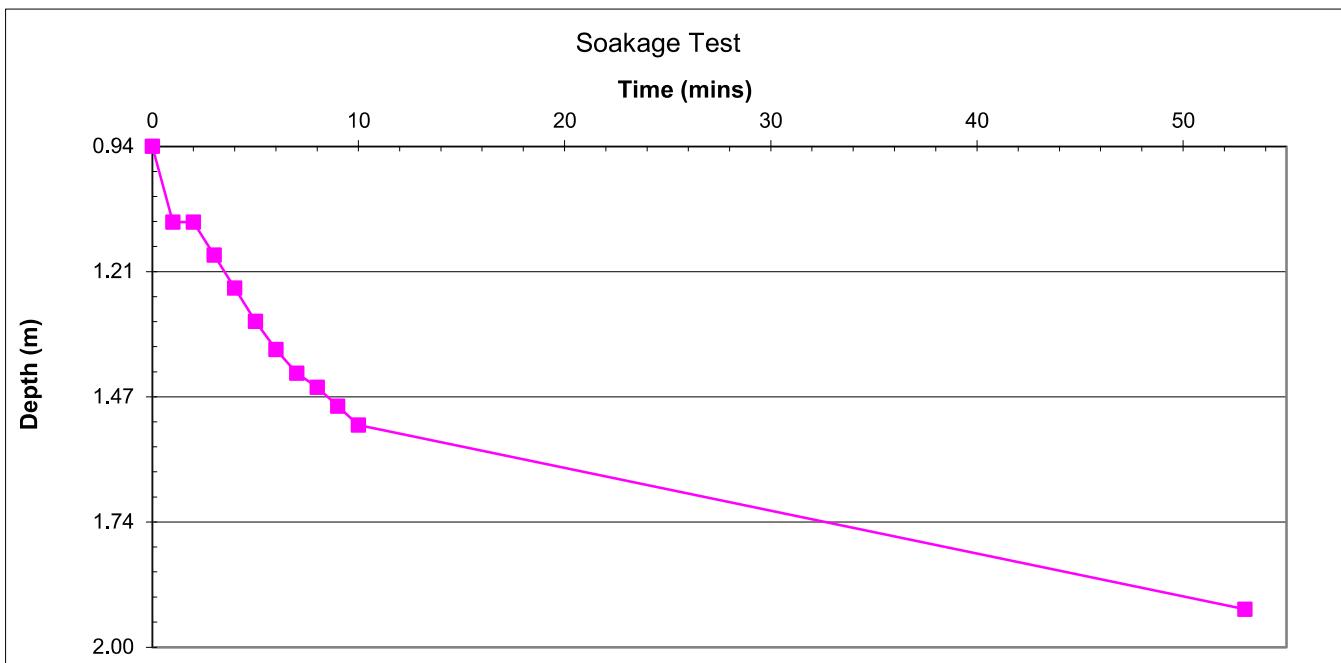
SOIL INFILTRATION RATE = 3.12E-05 m/s

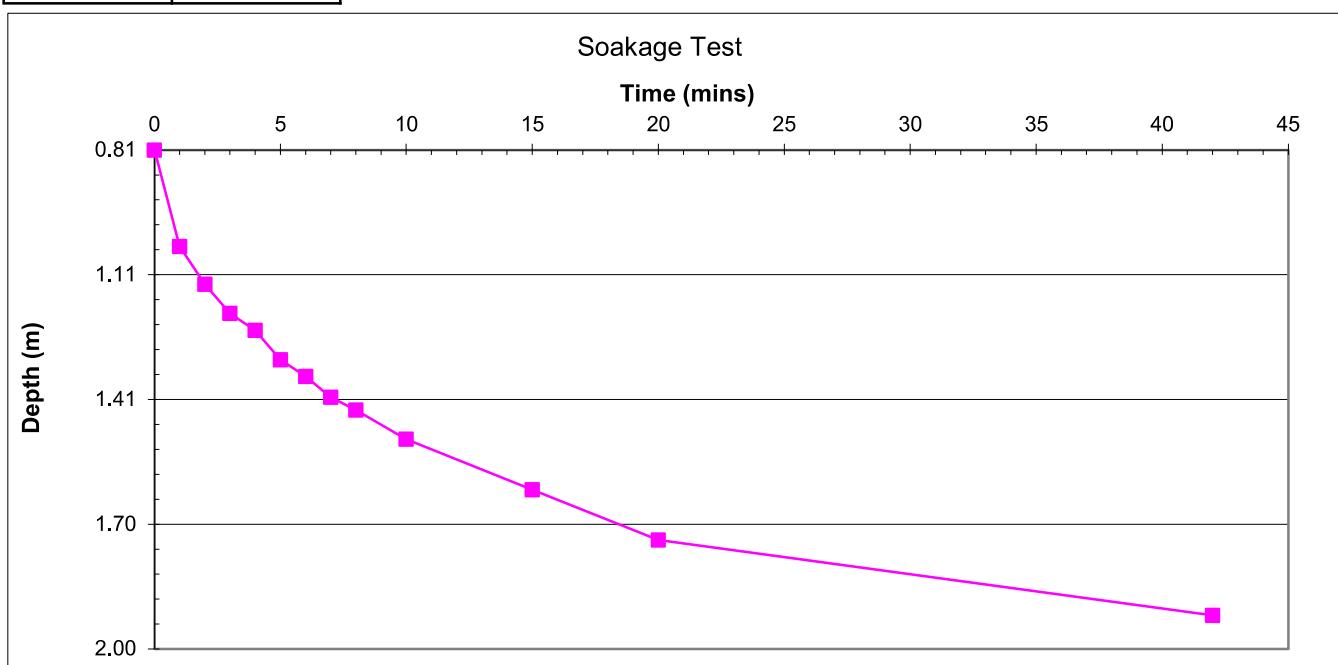
SOIL INFILTRATION RATE = 5.57E-05 m/s

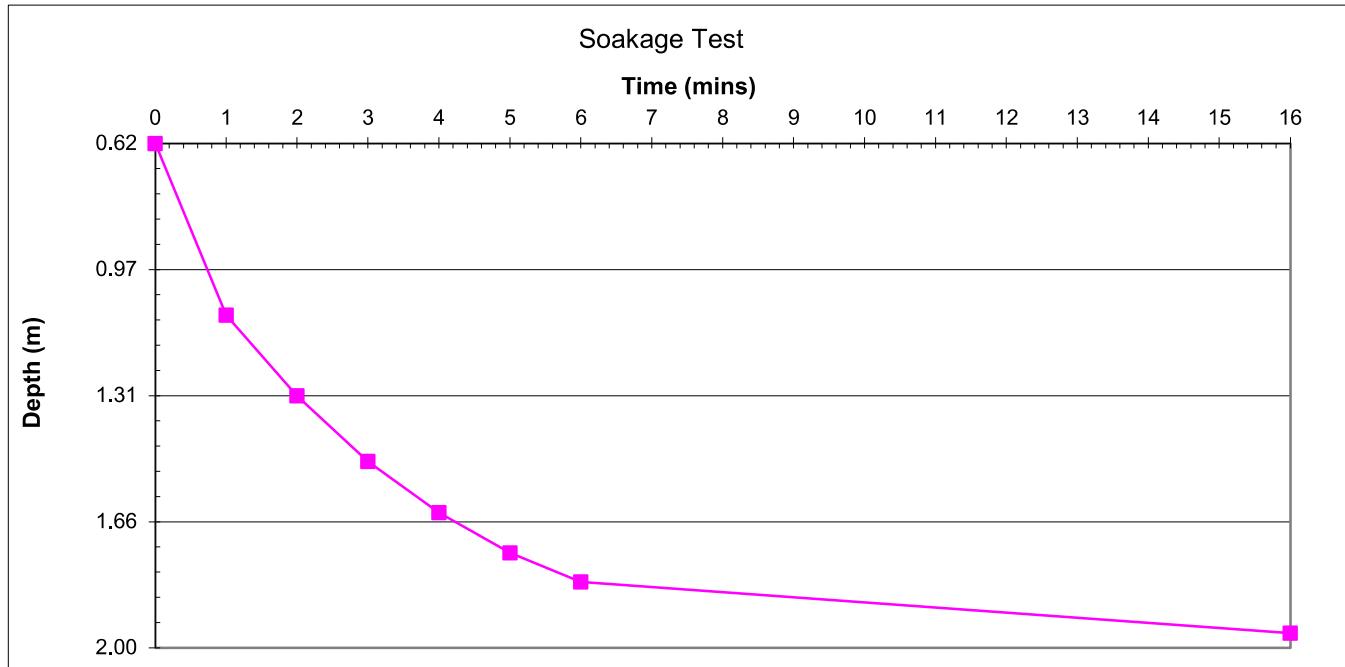
$$\text{SOIL INFILTRATION RATE} = 2.82 \text{E-04 m/s}$$

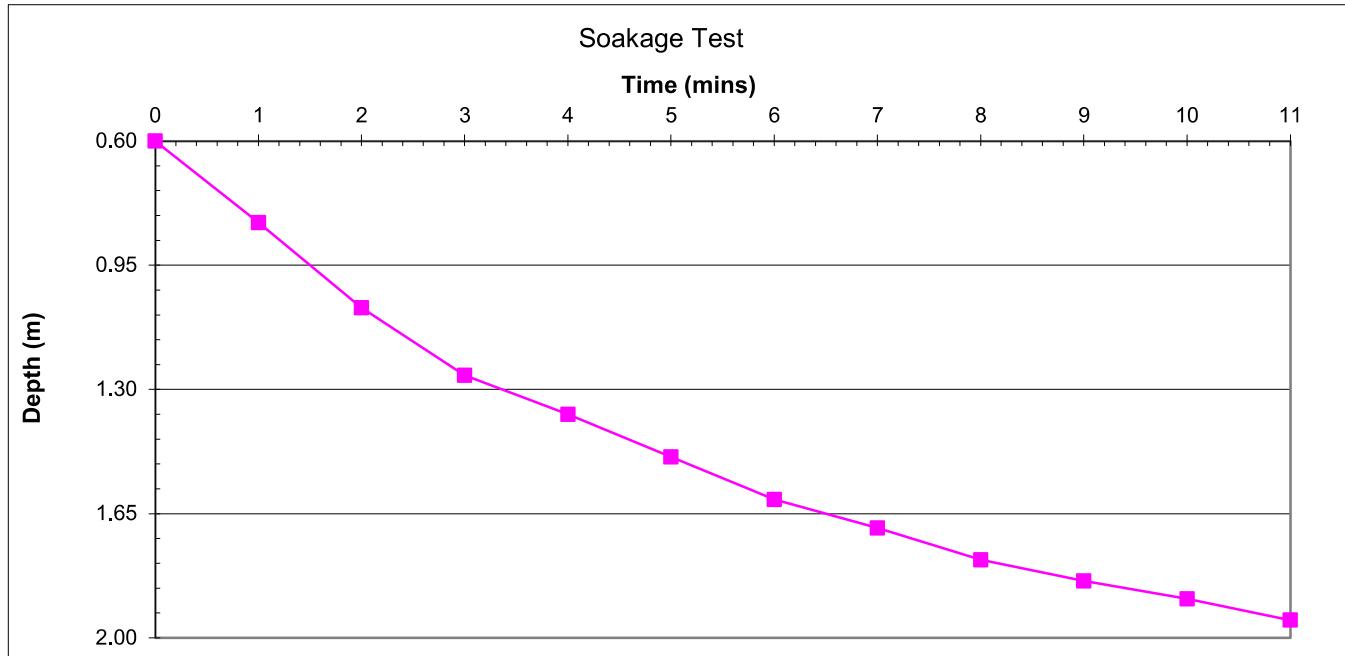
SOIL INFILTRATION RATE = 1.97E-04 m/s

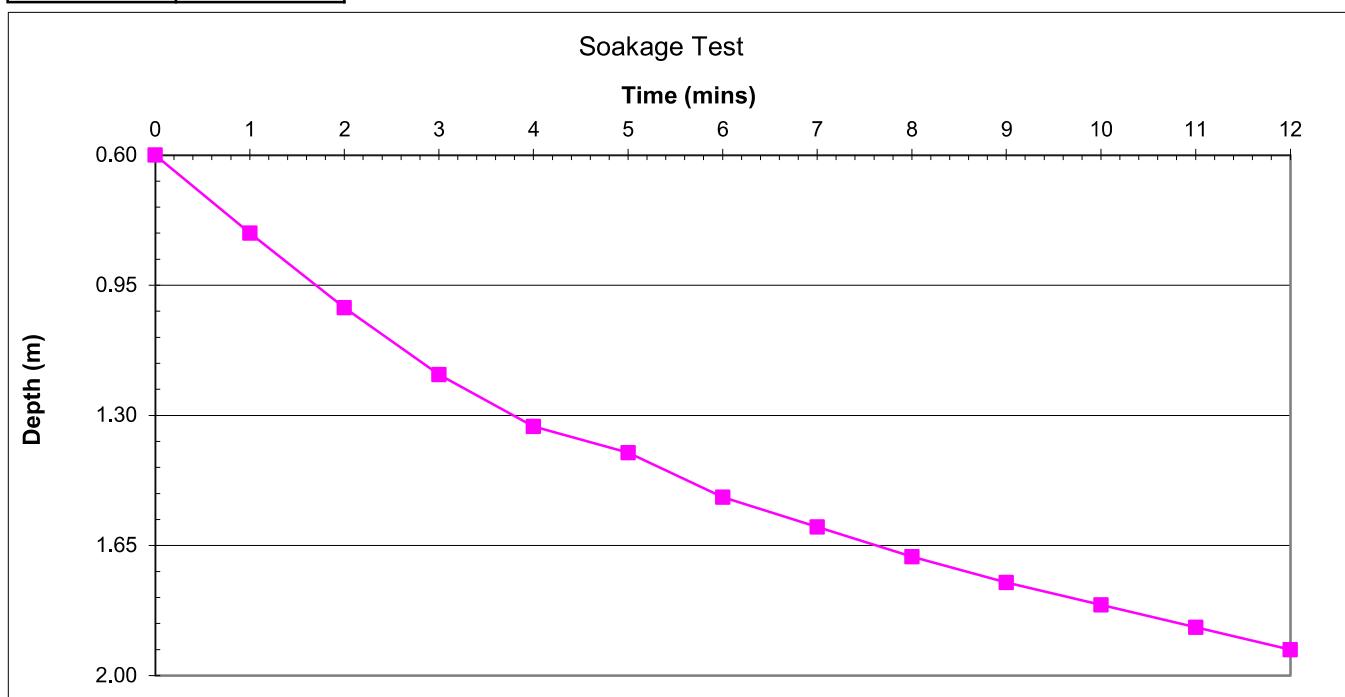
SOIL INFILTRATION RATE = 1.65E-04 m/s

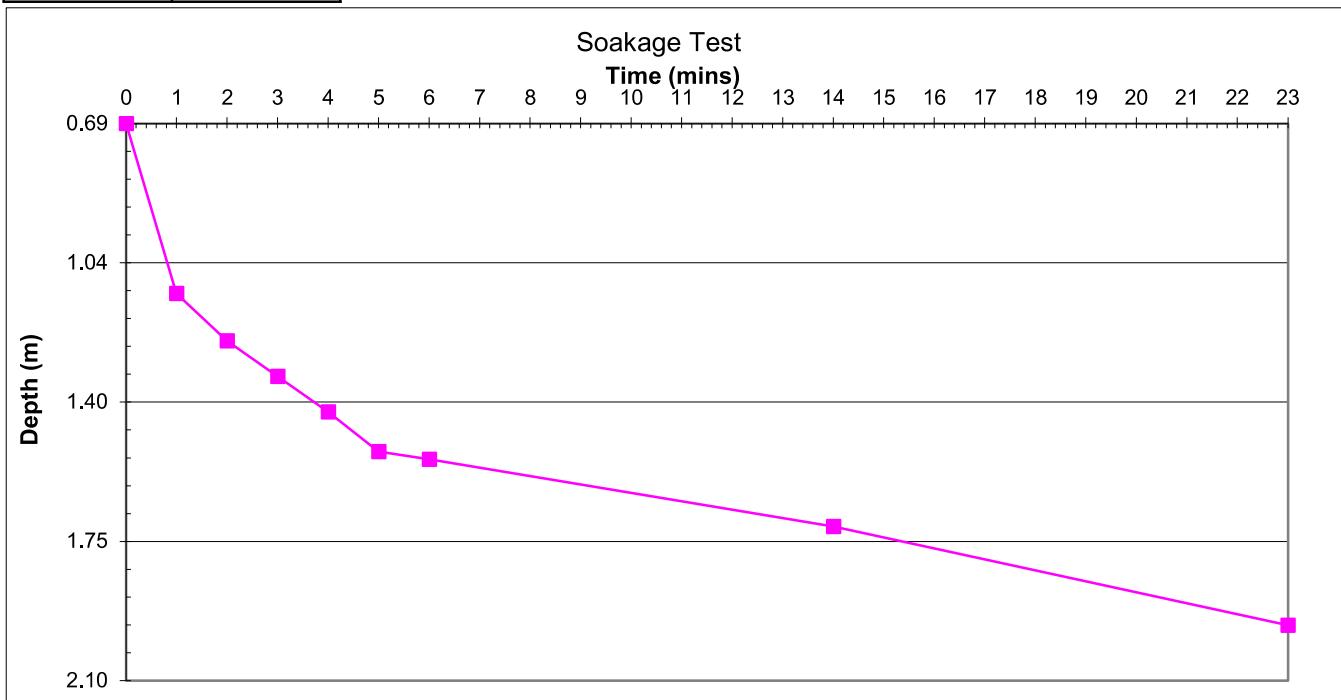
SOIL INFILTRATION RATE = 6.76E-05 m/s

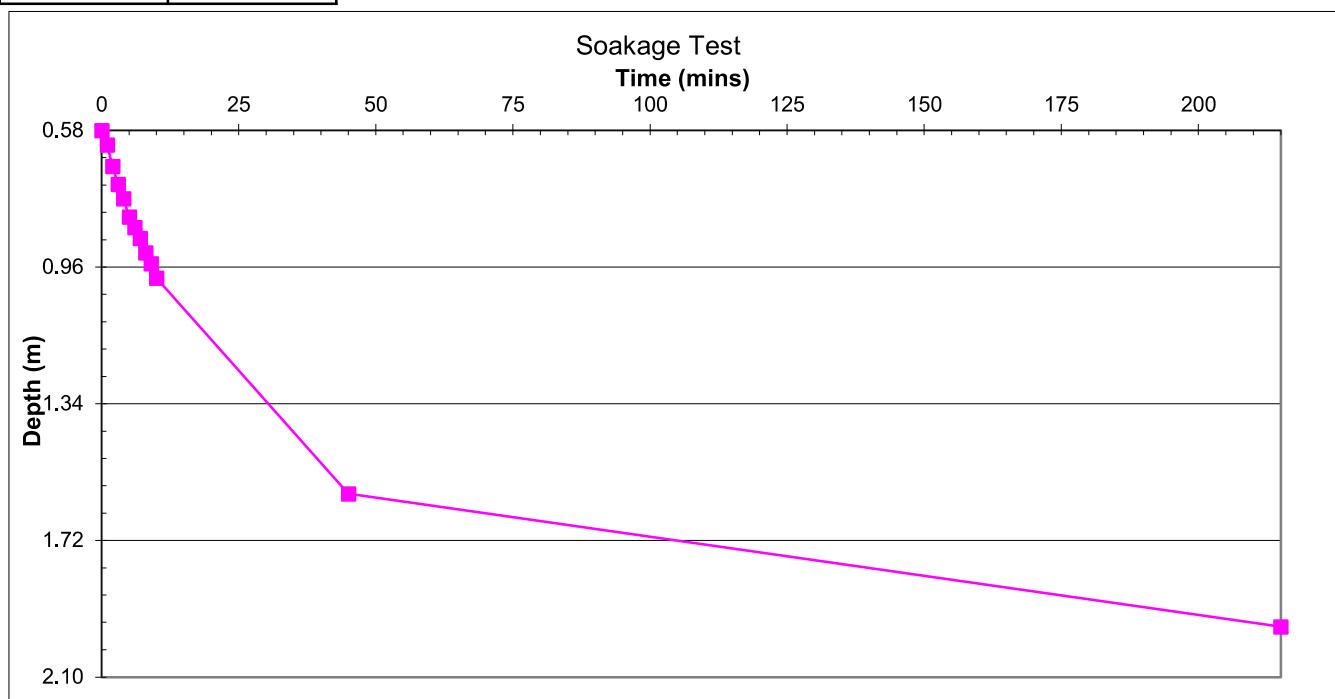
SOIL INFILTRATION RATE = 1.04E-05 m/s

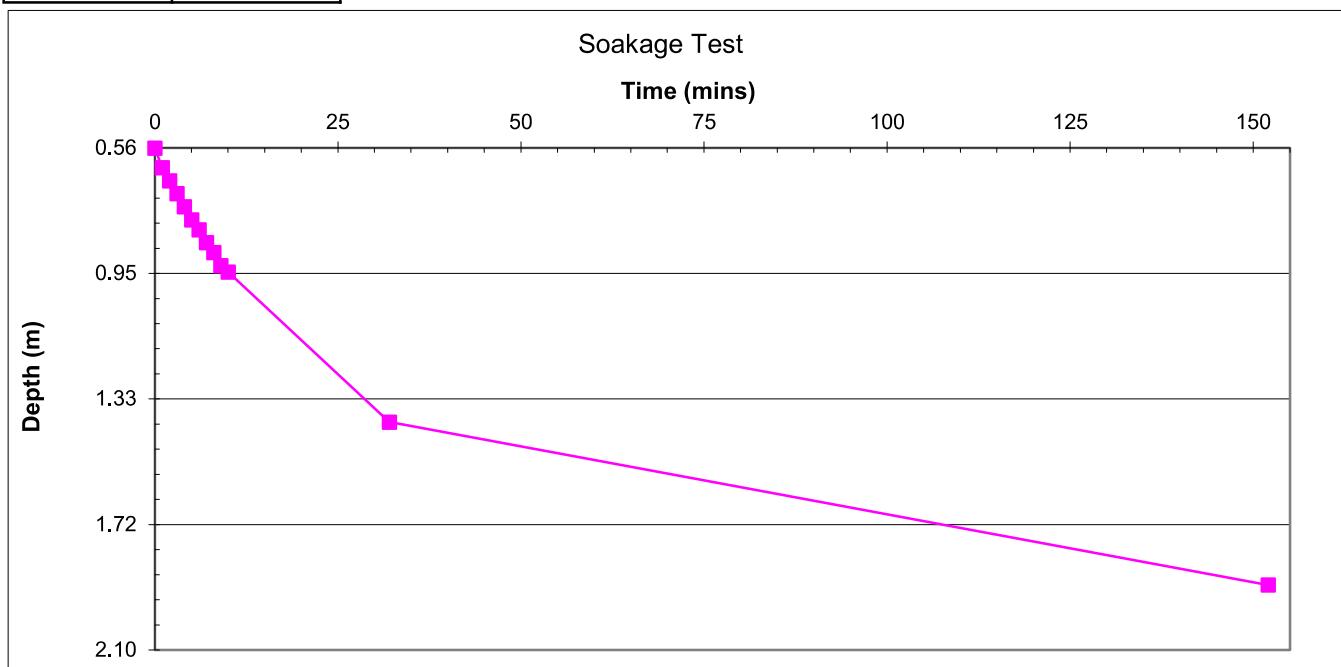
SOIL INFILTRATION RATE = 1.02E-05 m/s

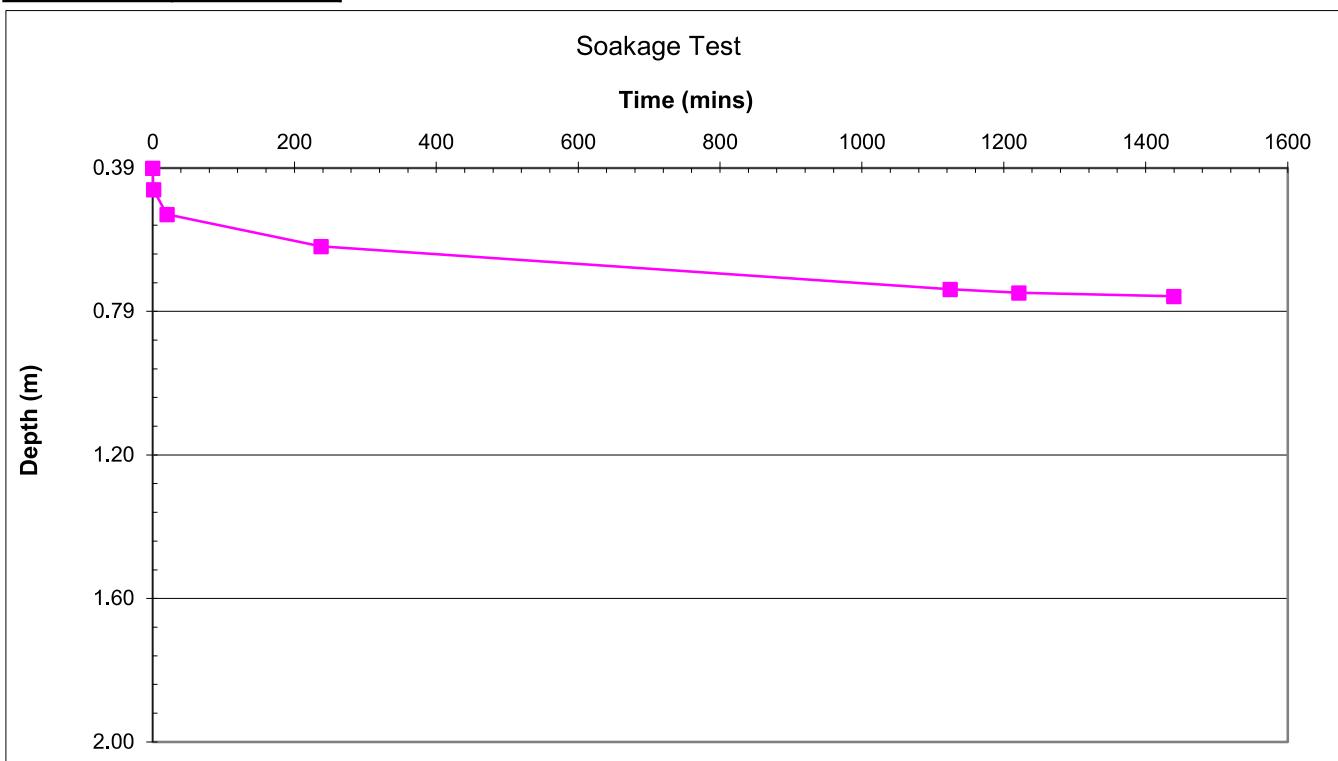
Insufficient soakage to derive an infiltration rate.

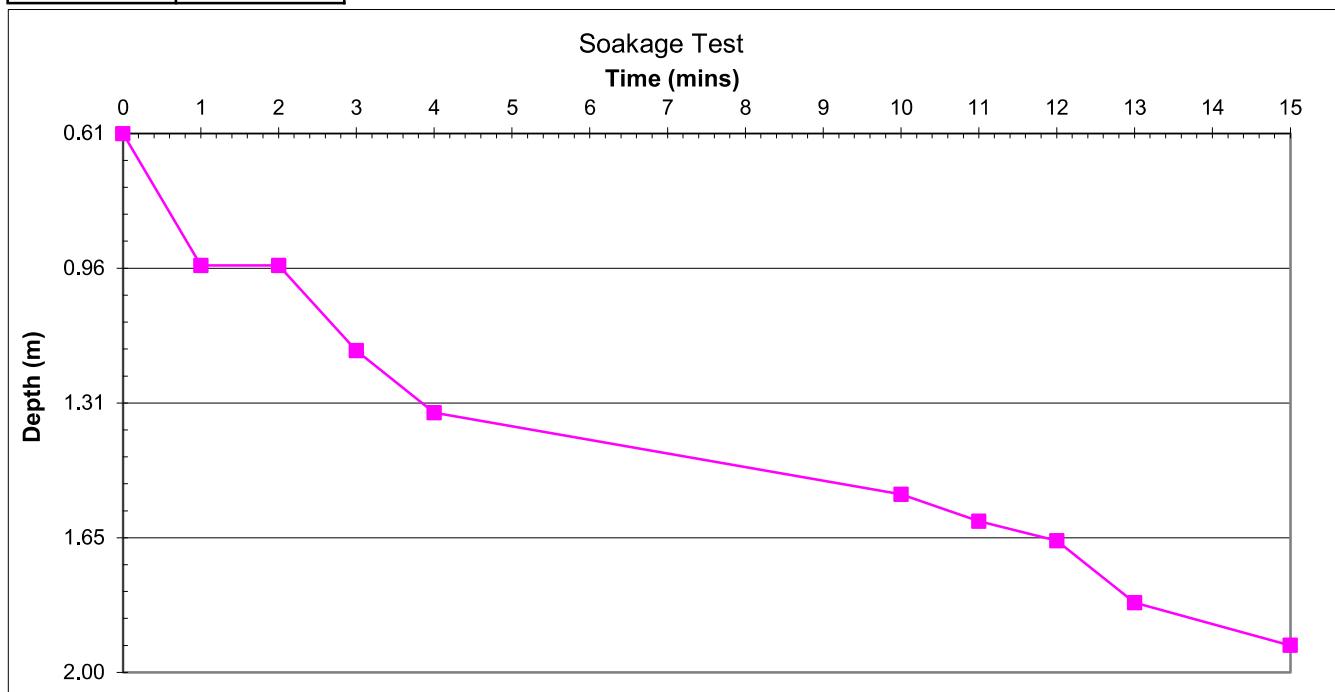
SOIL INFILTRATION RATE = 9.92E-05 m/s

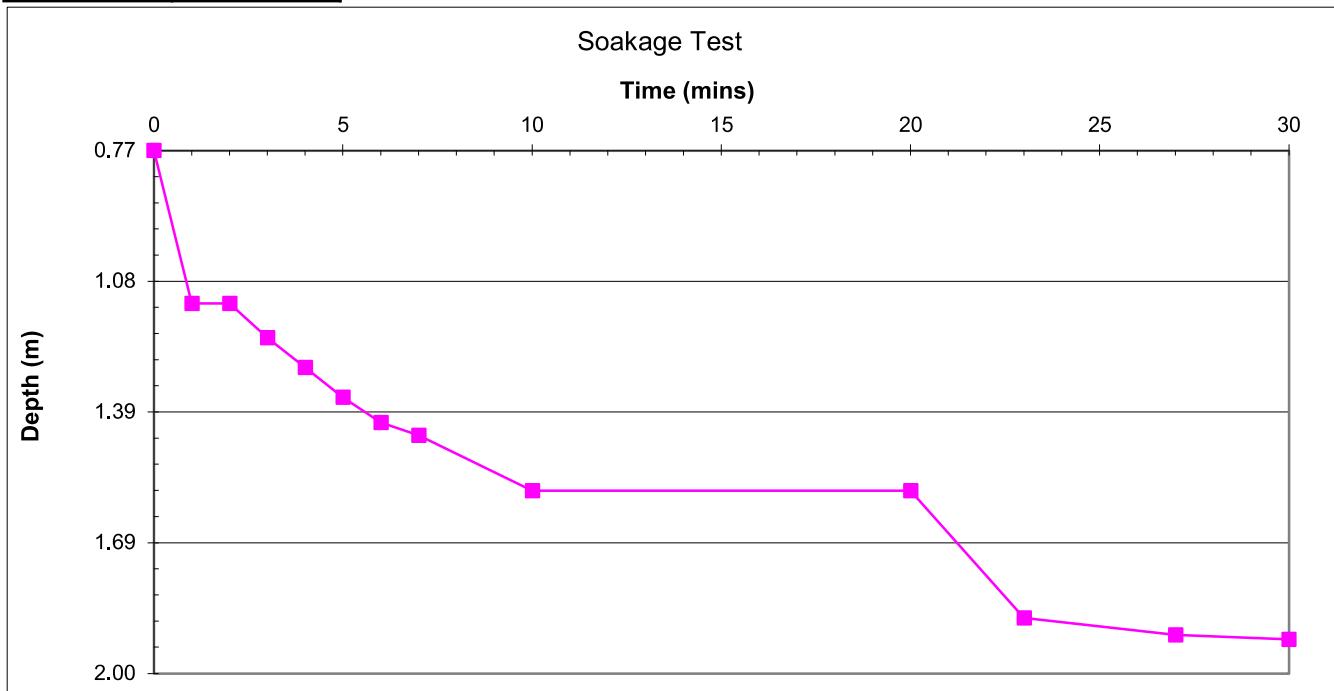
SOIL INFILTRATION RATE = 4.61E-05 m/s

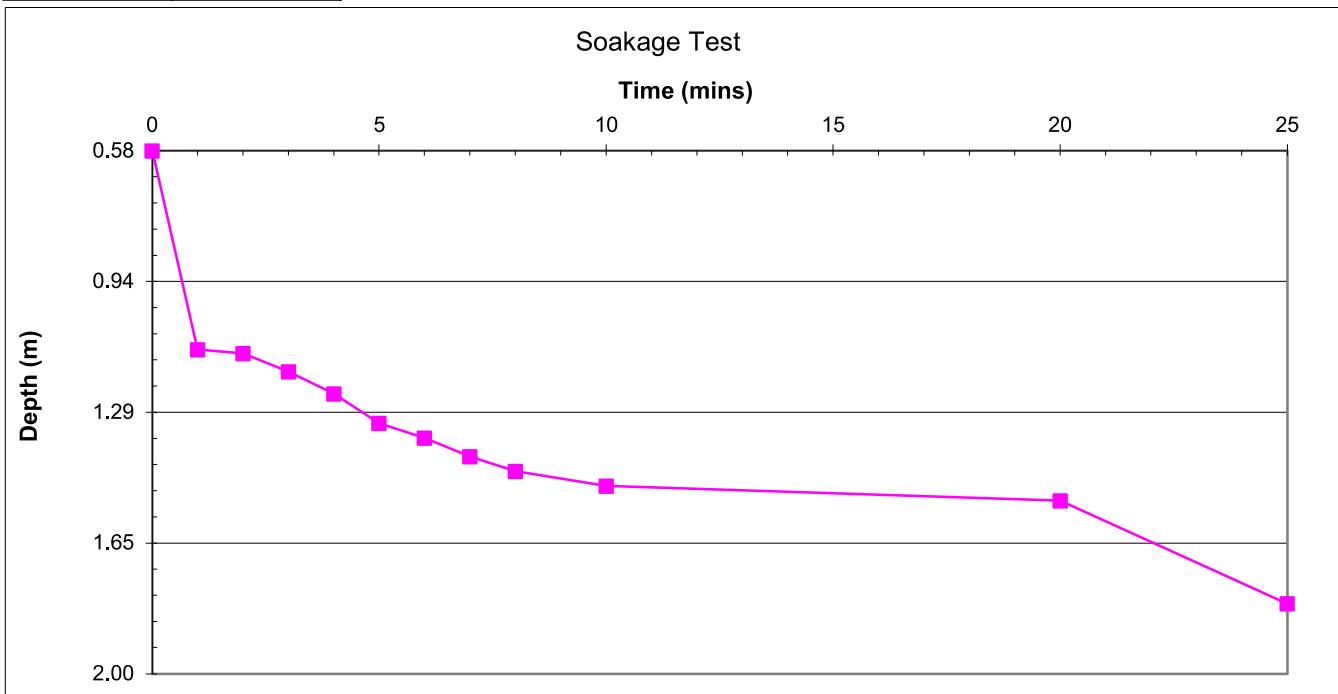
SOIL INFILTRATION RATE = 4.47E-05 m/s

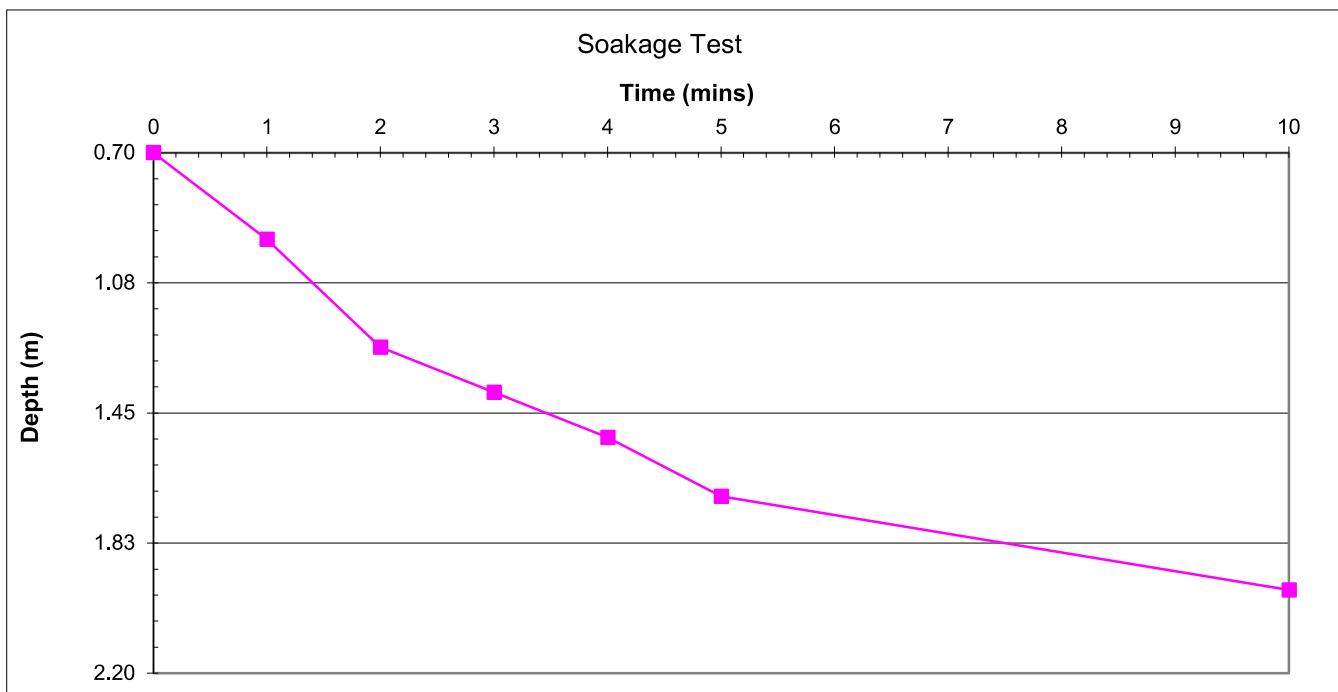
SOIL INFILTRATION RATE = 1.63E-04 m/s

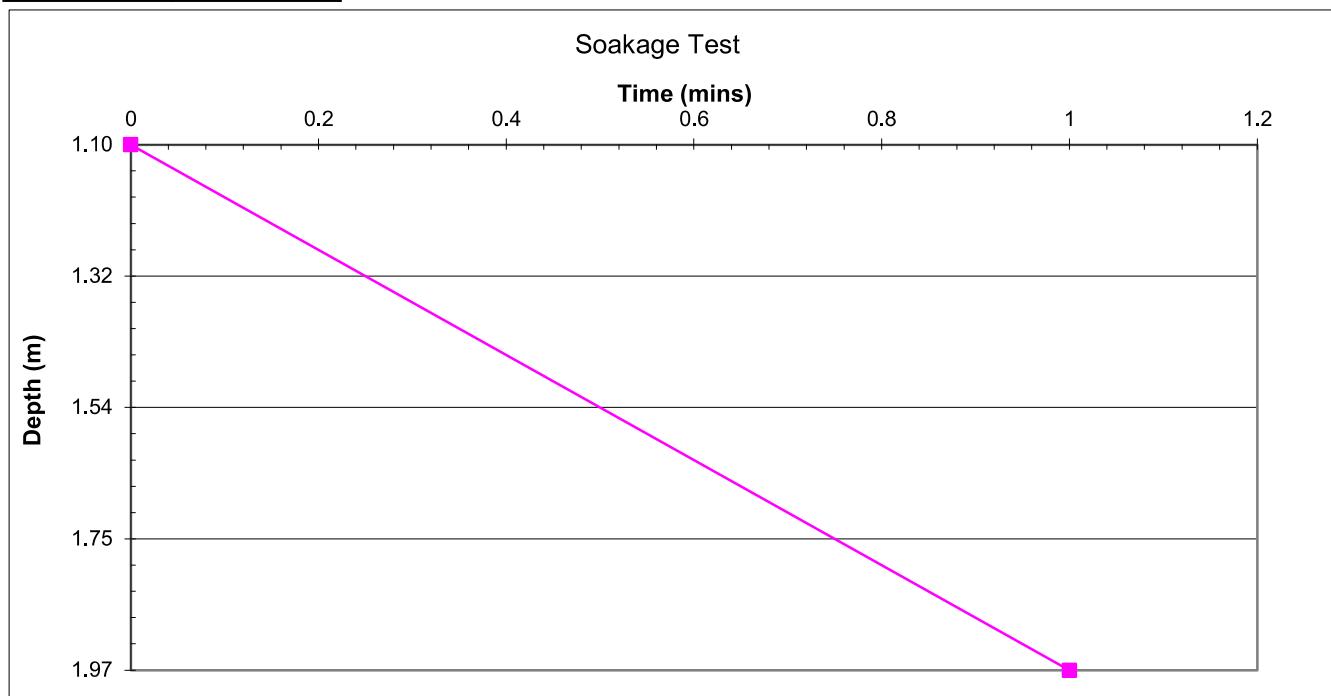
SOIL INFILTRATION RATE = 1.72E-03 m/s

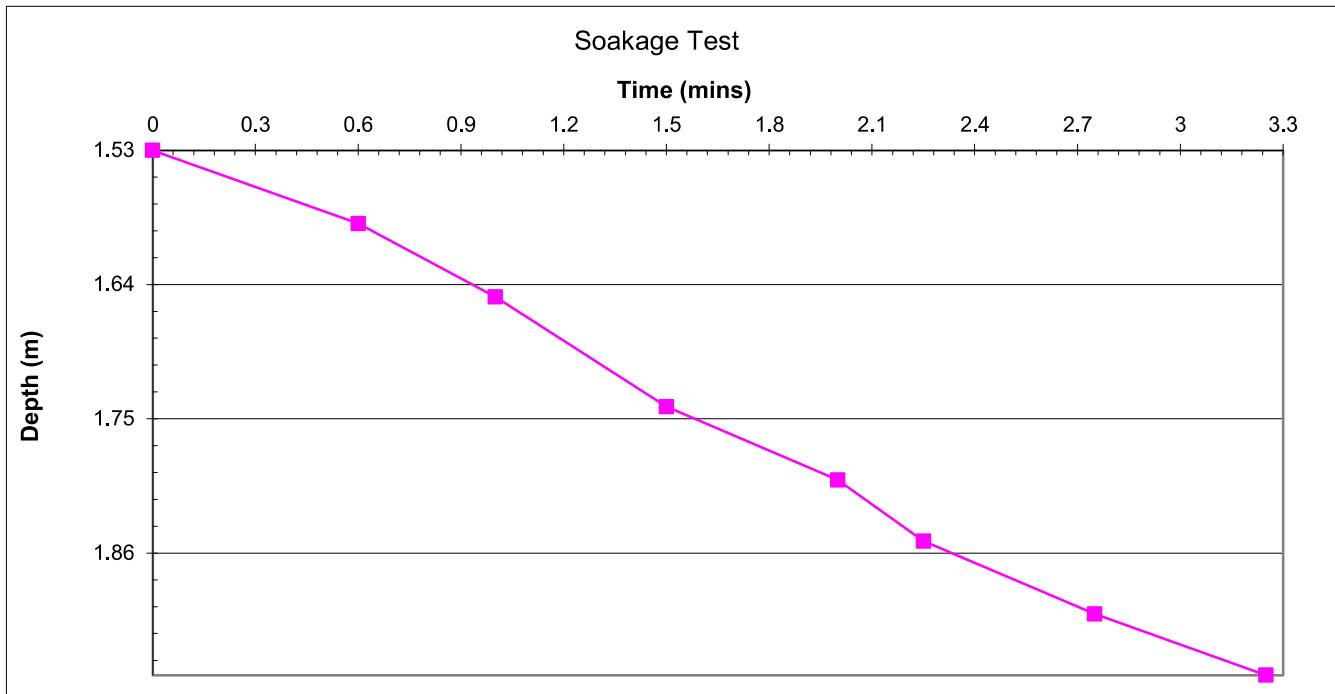
SOIL INFILTRATION RATE = 4.77E-04 m/s
