| rev. | description | | date | chkd. |
|---|---|---|---|---|
| project : 79-80 High Street<br>Gravesend | | | | |
| drawing title :<br>Typical Section Detail of<br>Secondary Glazing | | | | |
| proj no : 1961 | drg no: 03 | rev no: A | | |

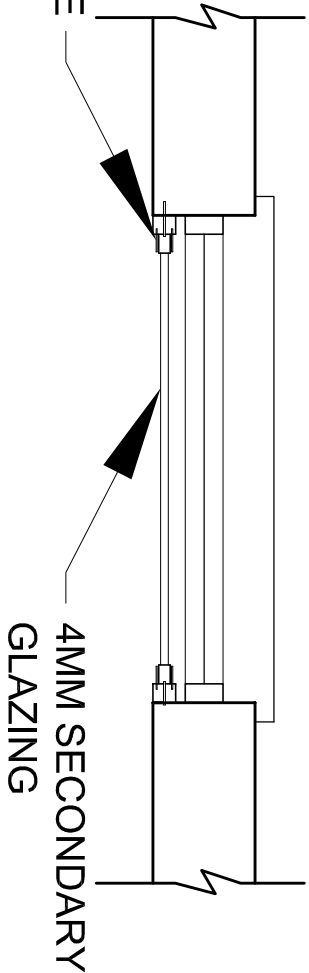
TYPICAL SECTION DETAIL  
OF SECONDARY GLAZING

SCREW DRILLED TO THE  
NEW TIMBER FRAME  
CONNECTED TO THE  
EXISTING WALL

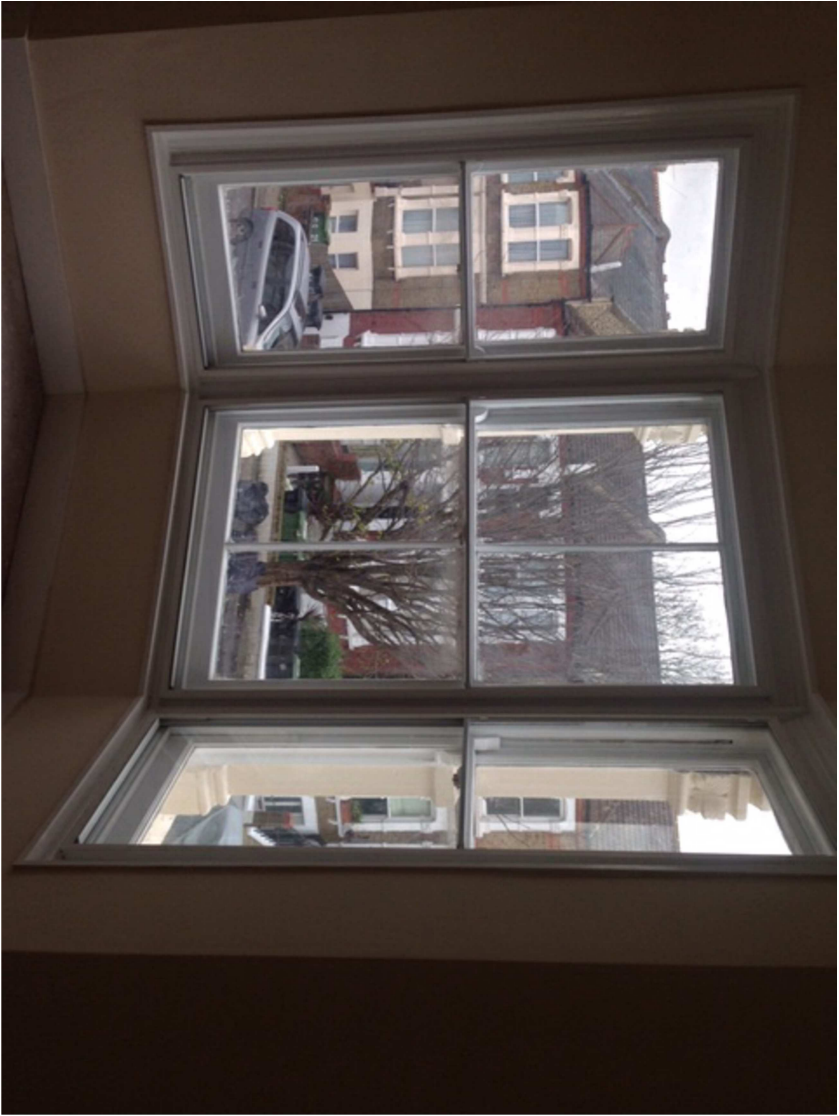
REFERENCE IMAGE OF WINDOW (NOT  
FROM THE APPLICATION SITE) SHOWING  
TYPICAL SECONDARY GLAZING WITH  
TRICKLE VENTS

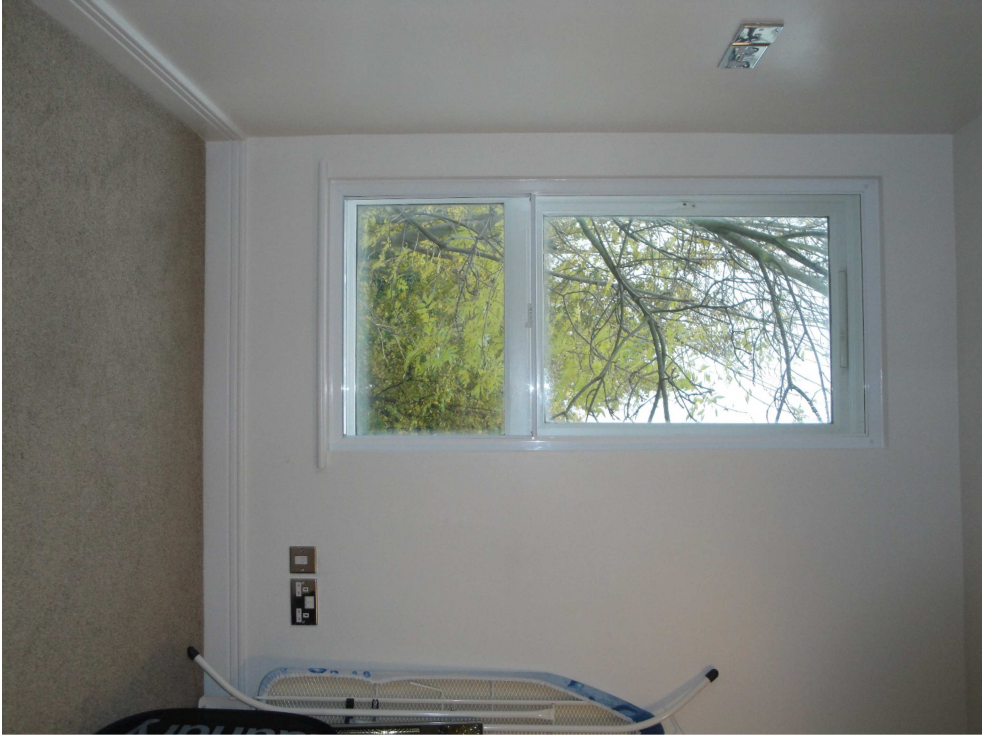
REFERENCE IMAGE OF WINDOW (NOT  
FROM THE APPLICATION SITE) SHOWING  
TYPICAL SECONDARY GLAZING WITH  
TRICKLE VENTS
