## Detailed Unexploded Ordnance (UXO) Risk Assessment

| <b>Project Name</b> | RSPB Higham Marshes |
| <b>Report Reference</b> | DA15134-00 |
| <b>Date</b> | 10/03/2022 |

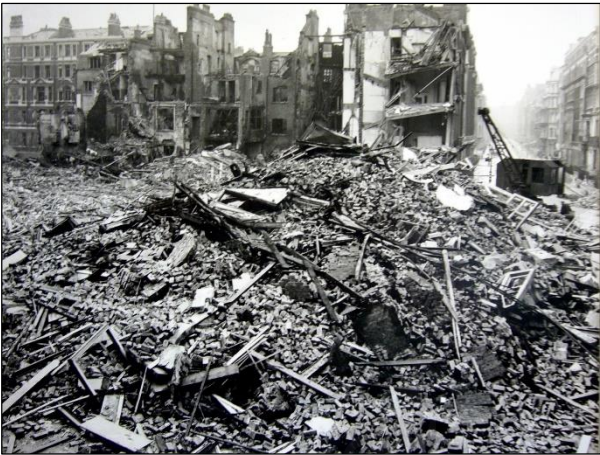
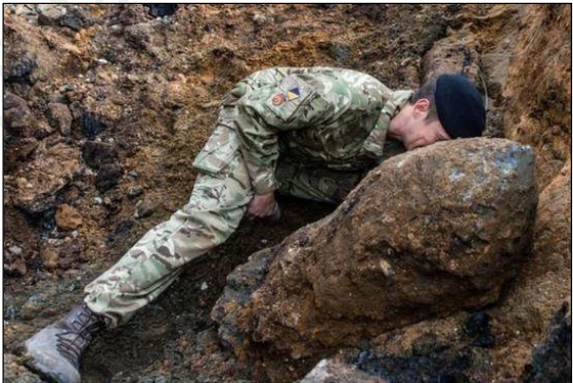
**Top:** J-curve Effect - Due to angle of entry, unexploded bombs would often end their trajectory at a lateral offset from point of entry, often ending up beneath adjacent extant structures/sites. The photograph above shows 250kg bomb found in Bermondsey pointing upwards, demonstrating 'J-curve'

J-curve is the term used to describe the characteristic curve commonly followed by an aerial delivered bomb dropped from height after it penetrates the ground. Typically, as the bomb is slowed by its passage through underlying soils, its trajectory curves towards the surface. Many UXBs are found with their nose cone pointing upwards as a result of this effect. More importantly, however, is the resulting horizontal offset from the point of entry. This is typically a distance of about one third of the bomb's penetration depth, but can be higher in certain conditions (see **Annex E**).

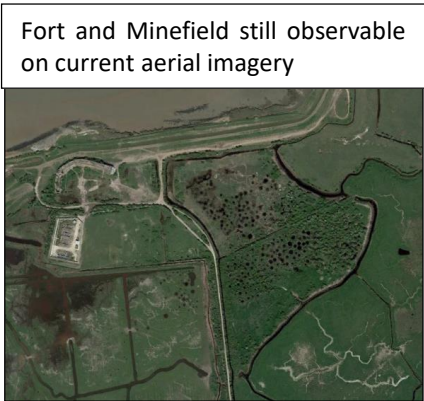
Markings confirmed to be bomb craters by the online resource *Heritage Gateway*

- Post-war aerial imagery of the site shows areas of discolouration/potential cratering in the north, central, and southern section of the site. Furthermore, according to the online resource *Heritage Gateway*, there are two WWII craters located on site. Grid references provided for these entries plot them in the centre of the site. It should be noted that the nature of the ground within the site could result in indicators of damage being obscured. This is because areas of marshland

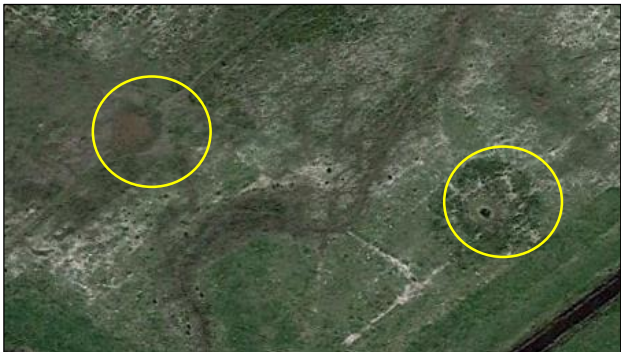
Cratering still visible in current aerial imagery

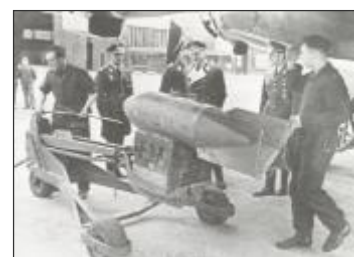
## SC 500kg

| Bomb Weight | 480-520kg (1,058-1,146lb) |

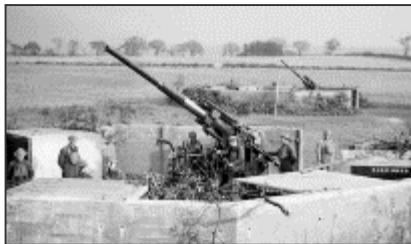
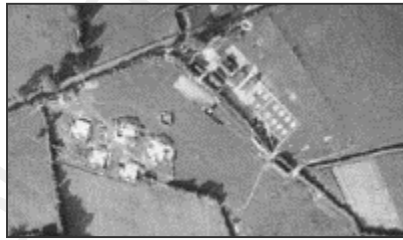
40mm Bofors Projectile

| Projectile Weight | 1.96lb (0.86kg) |
| Projectile Dimensions | 40mm x 310mm (1.6in x 12.2in) |
| Ceiling | 23,000ft (7000m ) |

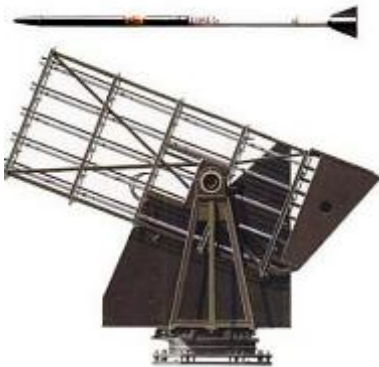
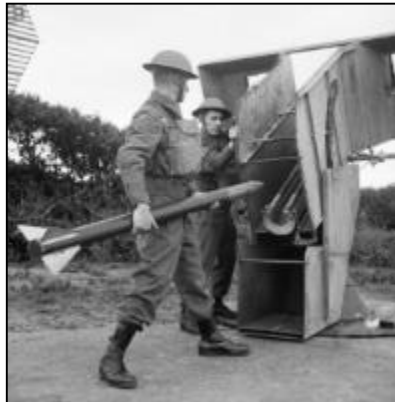
Unrotated Projectile (UP) – Z Battery

| Projectile Weight | 84lb (24.5kg) |
| Dimensions | 1930mm x 82.6mm (76 x 3.25in) |
| Use | As a short range rocket-firing anti-aircraft weapon developed for the Royal Navy. It was used extensively by British ships during the early days of World War II. The UP was also used in ground-based single and 128-round launchers known as Z Batteries. |
