# Phase 1 Desk Study

The Lion - Gravesend

| Report Type | Phase 1 Desk Study |
| Report Ref | R348-PH1-01.0_5318_RevA |

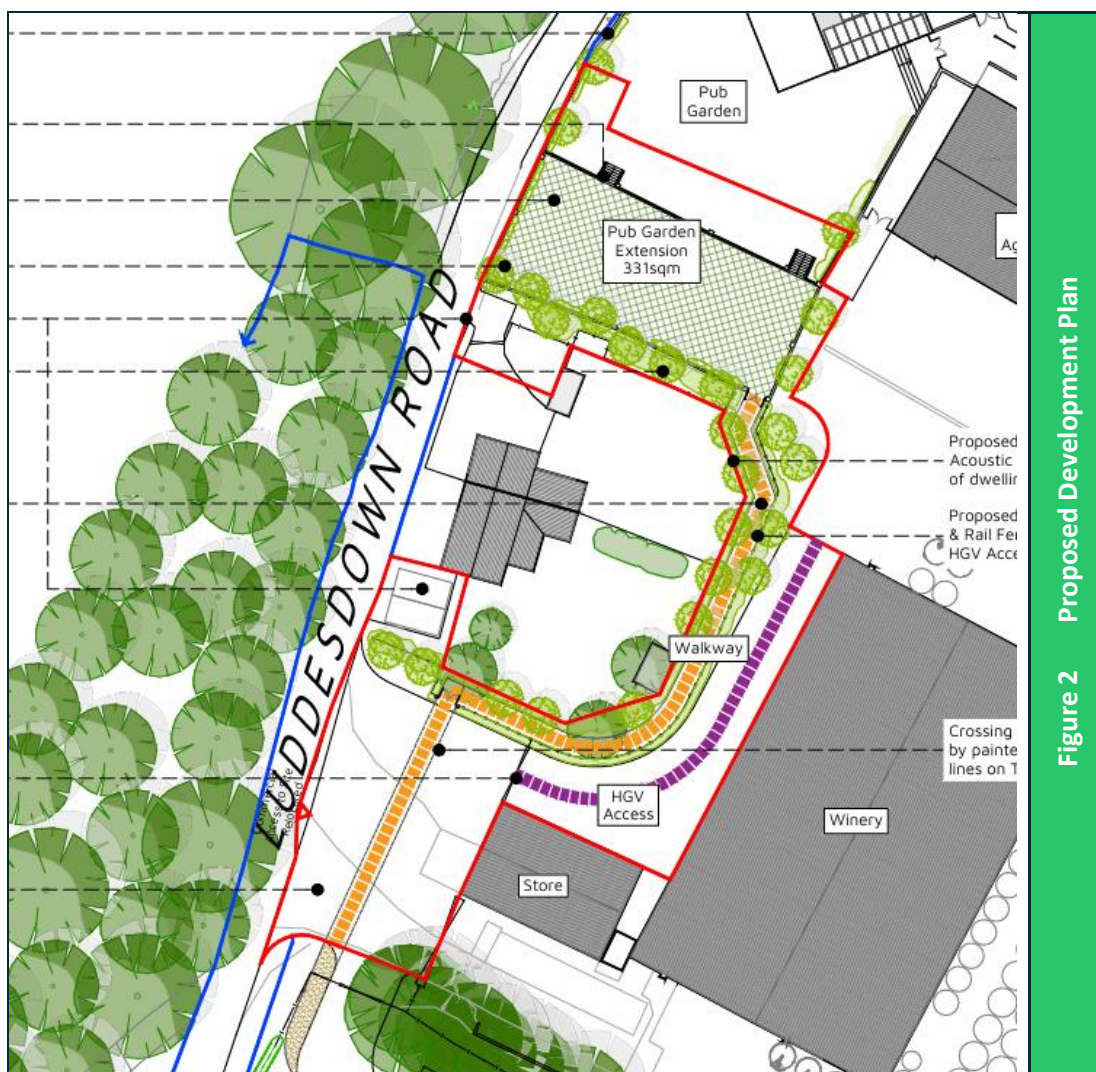
- 1.6 It is understood that the site is proposed to be redeveloped to provide an **extended pub garden** for The Lion and **alter access ways** to the adjacent pub and **farmyard (Court and Brookers Farm)**, as illustrated in Figure 2.

on either side. Alongside the pedestrian walkway will be a vehicular access track for HGVs leading to Brookers Farm. The south-western access point will therefore become the main access point for the overflow car park (beyond south of site) and Court and Brookers Farm adjacent to the east of the site.

- 1.9 No buildings are proposed on site with external areas comprising communal open space in the form of a pub garden, soft verges, and hardstanding access ways. There are no underground structures anticipated with below ground features limited to foundations and buried services.
- 1.10 Enabling works to permit the development are understood to involve the partial clearance of the site. It is understood that site levels will remain relatively similar to that present.

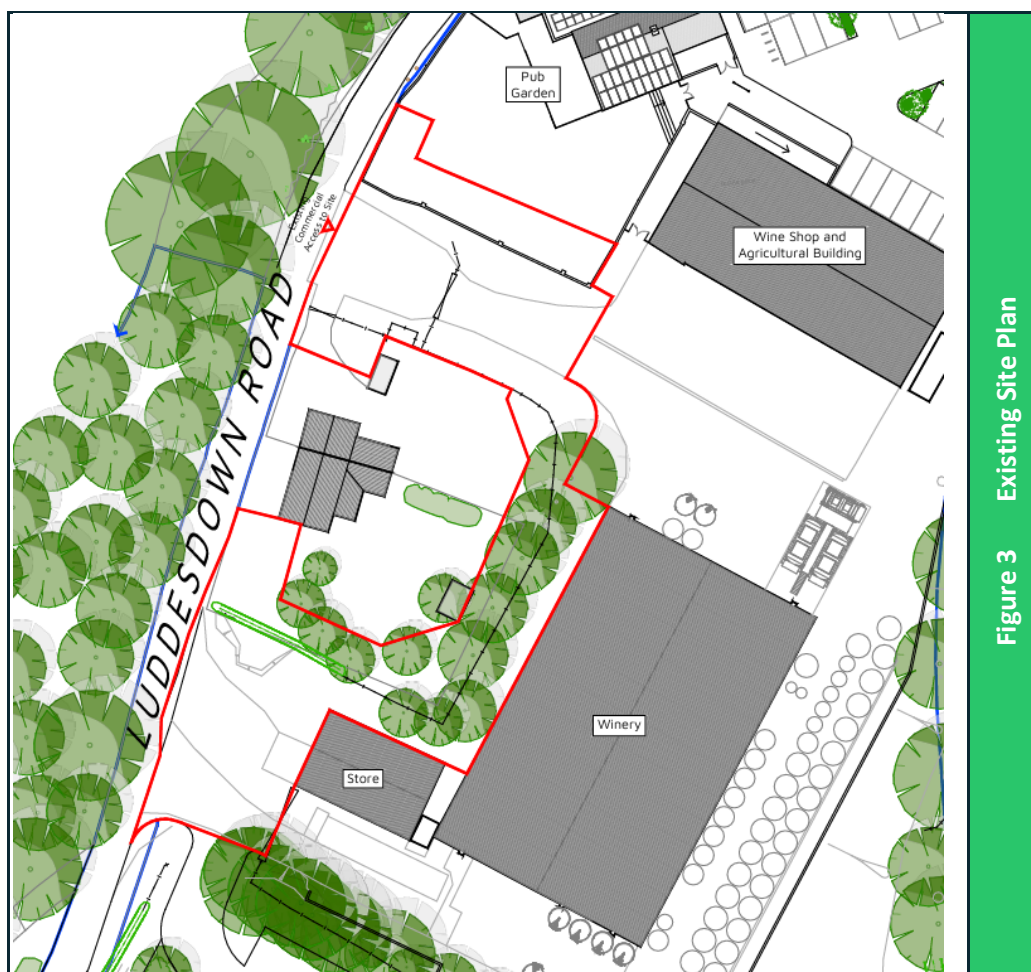
Figure 3 Existing Site Plan

- 2.2 A site walkover was undertaken by a qualified consultant from Lustre on 29<sup>th</sup> May 2025. The majority of the site was accessed, however the gardens of the adjacent residential properties and the green shipping container observed on site were not accessible.

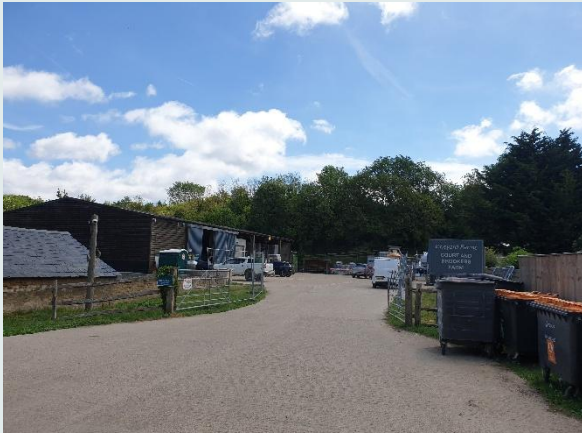
Northern site access

- 2.3 The northern portion of the site formed **access** to a yard area associated with **Court and Brookers Farm** (Vineyard Farms Ltd) adjacent to the east of the site. This portion comprised a concrete track with soft grassed verges on either side. Several large commercial bins were observed along the southern side of the track, likely associated with the adjacent agricultural activities. The pub garden of The Lion bound the site to the north.

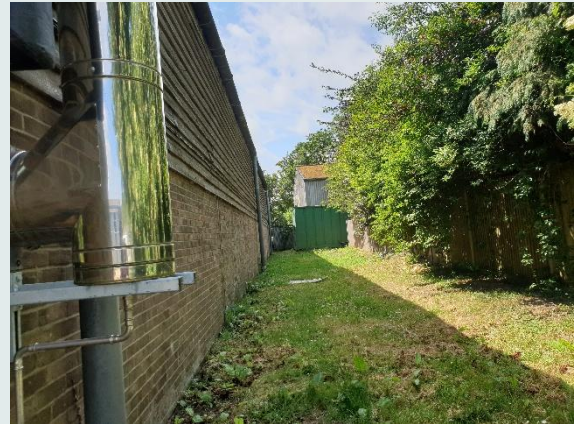
Proposed walkway area from north

commercial yard. The walkway opened into the southern portion of the site, to the west of the green shipping container and small off-site warehouse. Within this northern area of the southern portion, there was an area overgrown with vegetation, where an **excavator and stockpile of aggregate** was being stored at the time of the walkover. The southern-most point of the site formed the entrance of a **large car park** that appeared to be under construction at the time of the walkover.

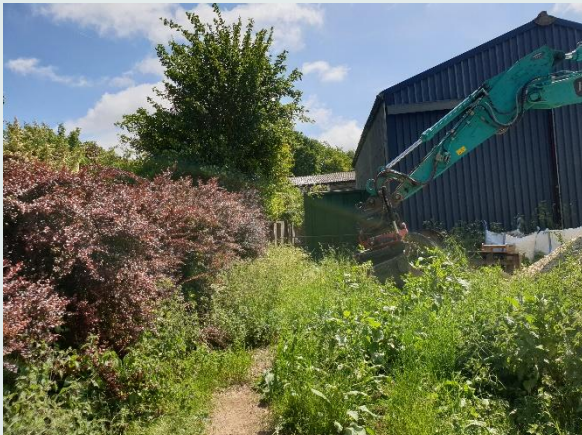
- 2.6 The southern portion of the site mainly formed another hardstanding access route to Court and Brookers Farm beyond the east of the site. A small farm building was present along the south-eastern boundary of the site (off-site), separating the proposed walkway area from the adjacent off-site

Overgrown area in south of site

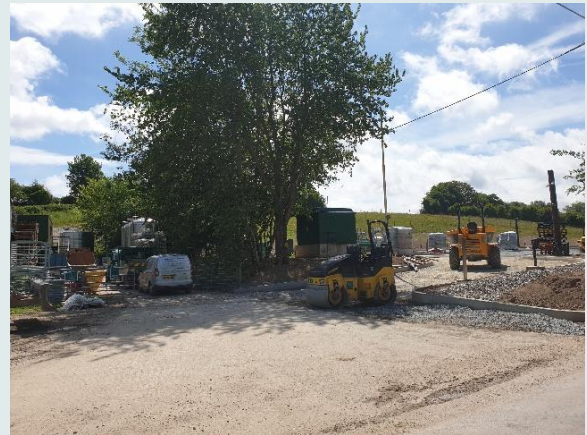
Southern-most area of site

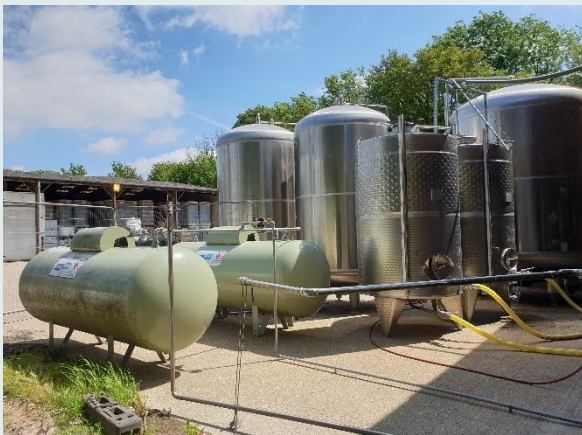
- 2.12 Along the northern boundary of the site was the **pub garden of The Lion**, with two shed-like structures backing onto the site. The pub garden is approximately 2m lower than the site, with a **retaining wall** along the northern boundary of the site.
- 2.13 As mentioned previously, **two residential properties** are located along the western boundary of the site, with the site overlapping the eastern-most area of the associated private gardens. Farm buildings used for wine making are situated along the eastern boundary of the site.

**Winery plant adjacent to site boundary**

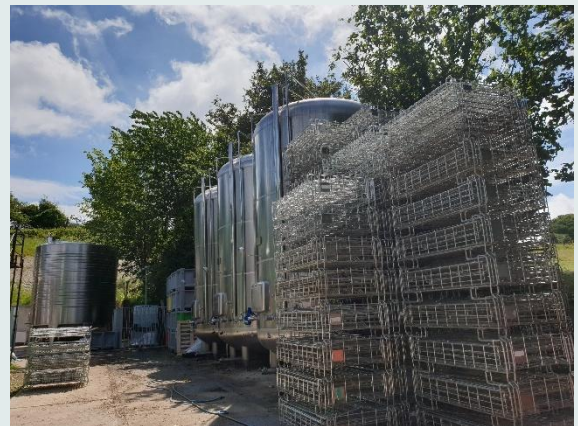
**Off-site winery plant**
