## Bat Emergence and Re-Entry Surveys (BERS)

**Survey site:** Hopehill Scout Campsite, South Street, Wrotham Road, Meopham, Kent, DA13 0QJ

**Project:** This report is prepared to inform a planning application with the Gravesham Borough Council. The proposal is described as:  
The side extension of a toilet block.

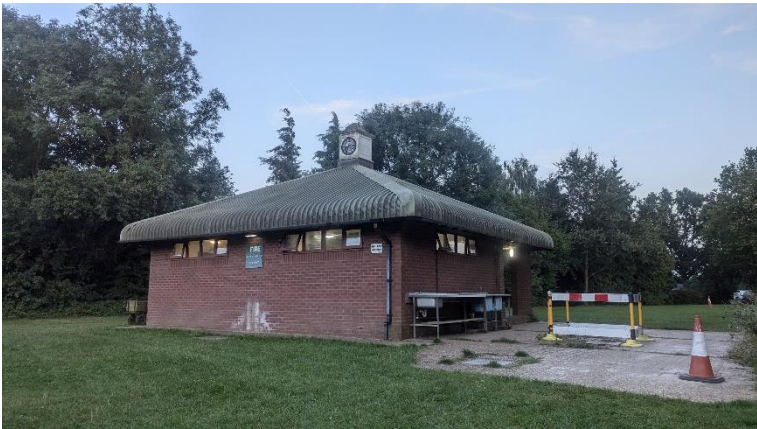
| <i>Surveyor 1</i> | <b>No emergencies.</b> The first bat was a common pipistrelle seen at 21:13 which passed north to south along the eastern elevation of B1. At 21:17 a common pipistrelle was seen passing down the west of B1. Common pipistrelles were seen flying over the building at 21:21 and 21:33. Additionally, common pipistrelles were seen foraging in front of the building at 21:33 and 21:36. Common pipistrelles were heard throughout the survey. At 22:26, a brown long eared bat was heard but not seen. | |

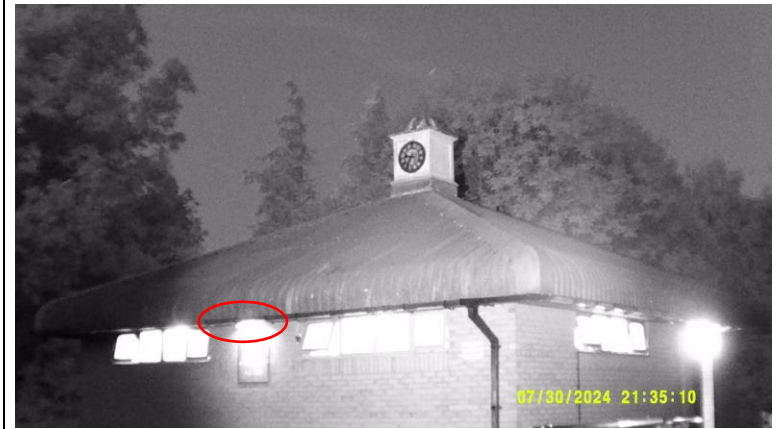
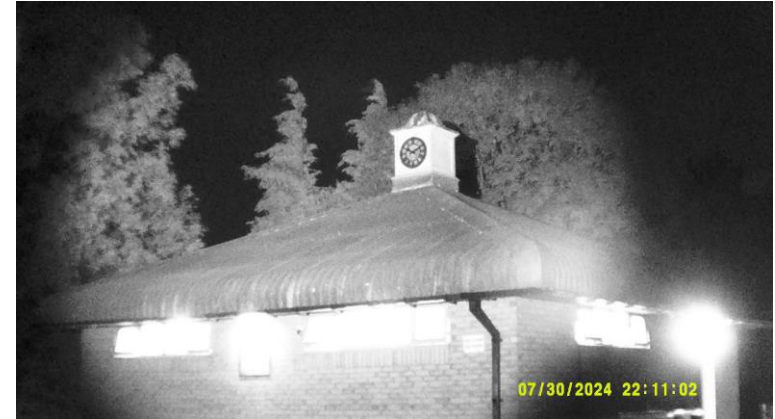
*IR position 1*

**Emergence seen.** Review of the IR video revealed a common pipistrelle emergence from the eaves of the building.

Emergence circled in red.

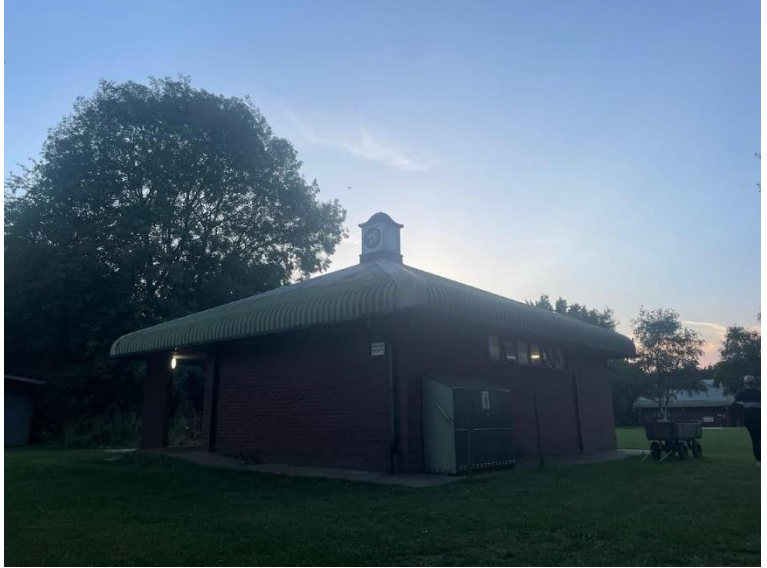
| <i>Surveyor 2</i> | <b>No emergencies.</b> Common pipistrelle activity throughout the survey. The first bat was a noctule at 20:58 which was heard but not seen. Common pipistrelles were seen passing from south to north along the east of B1, and common pipistrelles were seen passing along the east and south elevations, The first bat was seen at 21:21 and the last seen at 22:26. A brown long eared bat was heard but not seen at 22:26. | |

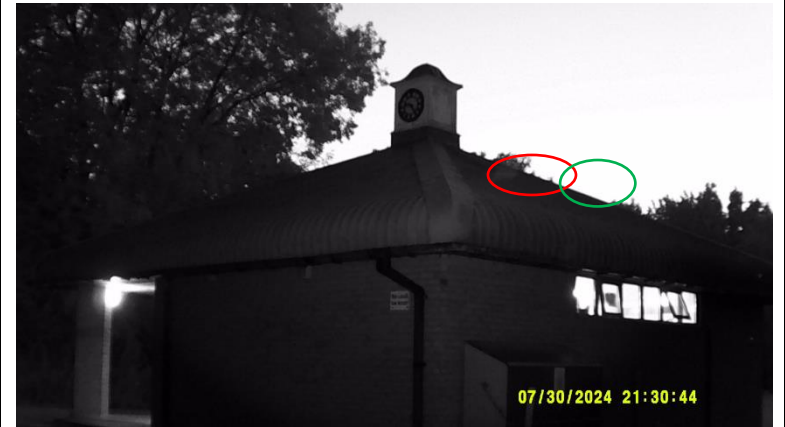
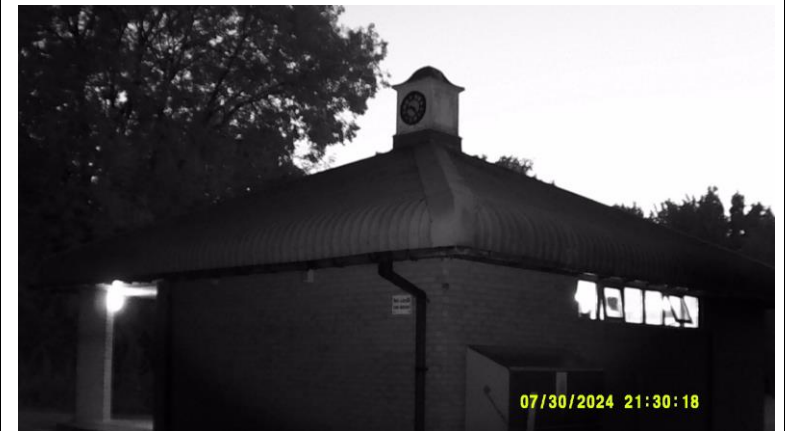
*IR position 2***Emergence seen.** Review of the IR video revealed a common pipistrelle emergence from the ridge of B1 at 21:30 ???

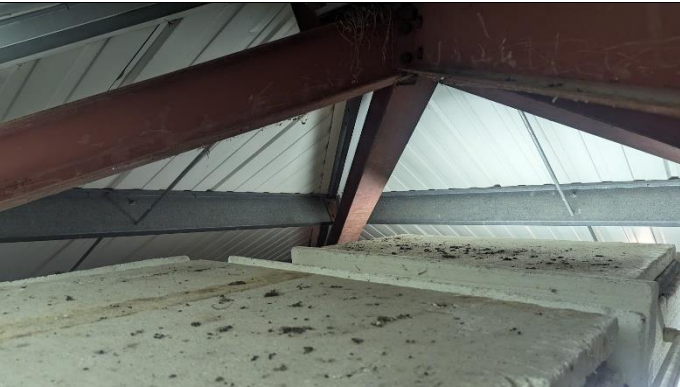
| Dusk Emergence Survey 2 | | | | | |
|---|---|---|---|---|---|
| Interior inspection | | An internal inspection was undertaken during this survey. Hundreds of droppings were still present under the ridge beam, and no new areas of droppings were identified. | | | |

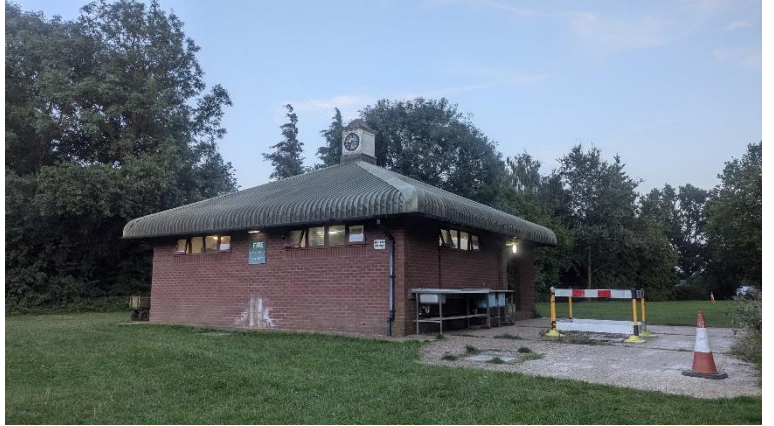
| <i>Surveyor 1</i> | | <b>No emergences.</b> The first bat was seen at 20:26 which was a common pipistrelle passing along the north of B1. Common pipistrelle bats were seen foraging 20:33, 20:43, 20:58, and 21:01. Common pipistrelles passed along the western elevation at 20:37, 20:56, 20:57, 21:09, and 21:10. Bats were seen passing along the east elevation at 20:49, 20:53, and 20:55. At 21:01, a common pipistrelle was seen circling B1 until 21:14. | | | |

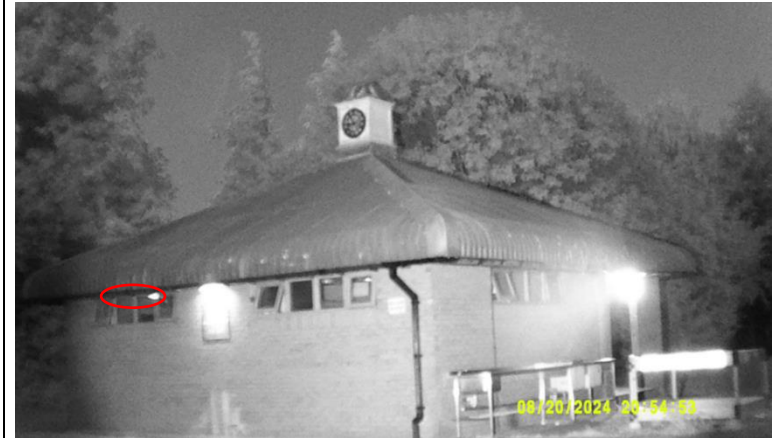
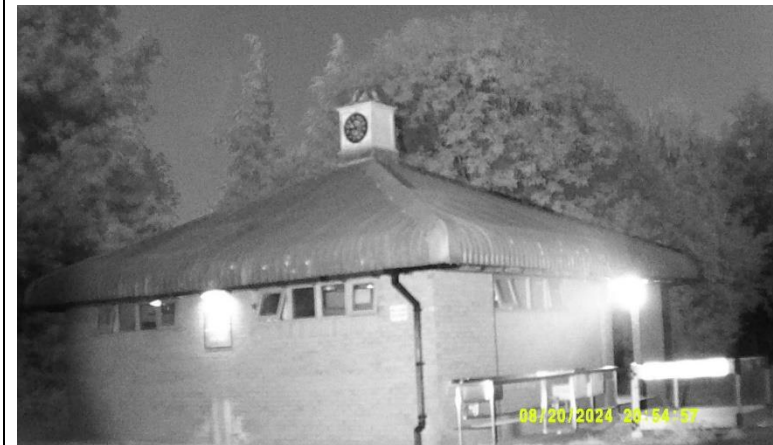
*IR position 1*

**Emergences seen.** At 20:54, two common pipistrelles emerged from the eaves. Emergence point in red.

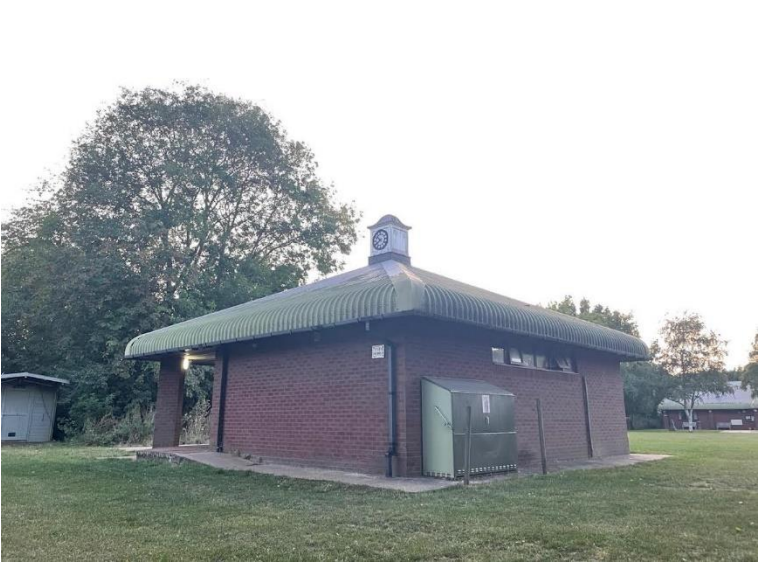
| <i>Surveyor 2</i> | <b>No emergencies seen.</b> The first activity was a common pipistrelle passing from the northwest elevation west towards the surveyor, and then turning to fly towards the southwest at 20:26. A noctule was heard but not seen at 20:27. At 20:27, a common pipistrelle passed southwest to north. At 20:30, a common pipistrelle was foraging over the surveyor. There was activity which was heard not seen from common pipistrelles from 20:33 to 20:40. At 20:38, a common pipistrelle was foraging in front of the building. At 20:40, a common pipistrelle passed northwest to east along the northeast elevation. Between 20:45 and 21:15, there was constant common pipistrelle activity along the south and west elevation. | |

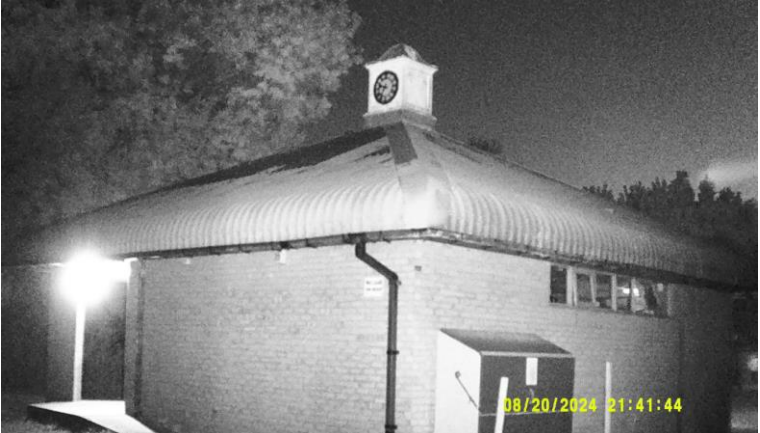
| <i>IR position 2</i> | <b>No emergencies seen.</b> The IR footage reflected the surveyors findings. | |

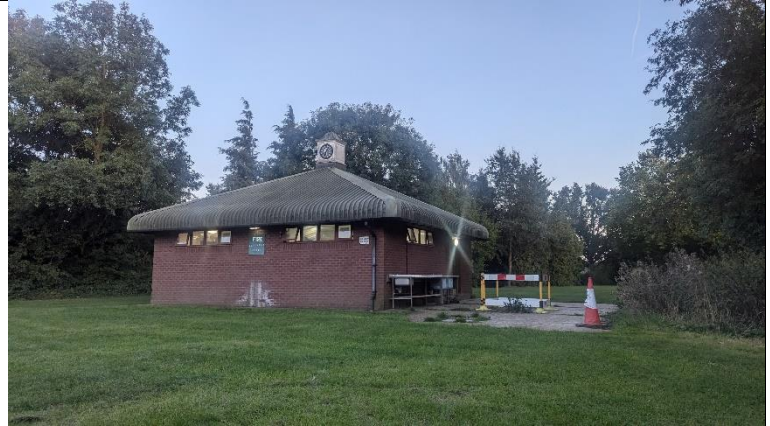
| <i>Surveyor 1</i> | <b>No emergences.</b> The first bat was seen at 19:16 which was a common pipistrelle which passed along the northern elevation of B1. Common pipistrelles were seen foraging to the north of B1 at 19:23. Common pipistrelles passed down the eastern elevation of B1 at 19:22, 19:30, and 19:54. From 19:37 to 19:42, a common pipistrelle was circling the building. | |

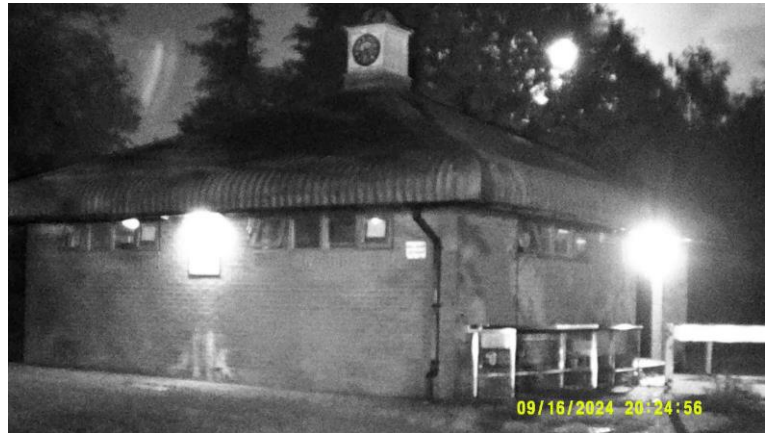
| <i>IR position 1</i> | <b>No emergences.</b> IR footage reflects the view of the surveyor. | |

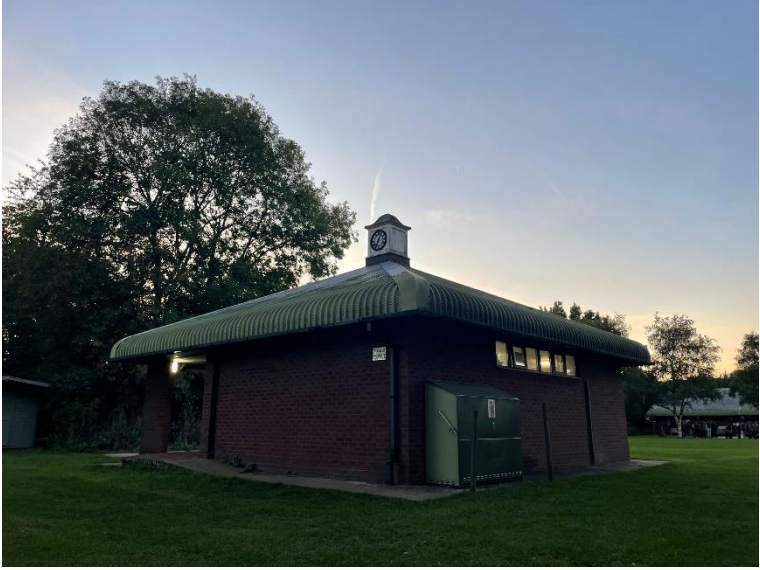
| <i>Surveyor 2</i> | <b>No emergences.</b> The first activity was a common pipistrelle which was heard not seen at 19:22. At 19:31 a common pipistrelle passed southwest to northeast over the southeast elevation. A common pipistrelle passed at 19:40 from east to northwest. At 19: 36 21:44 there was constant activity of common pipistrelles flying around the building. This occurred again at 19: 53 and 20: 00. The last activity was a common pipistrelle which was heard not seen at 20: 49. | |

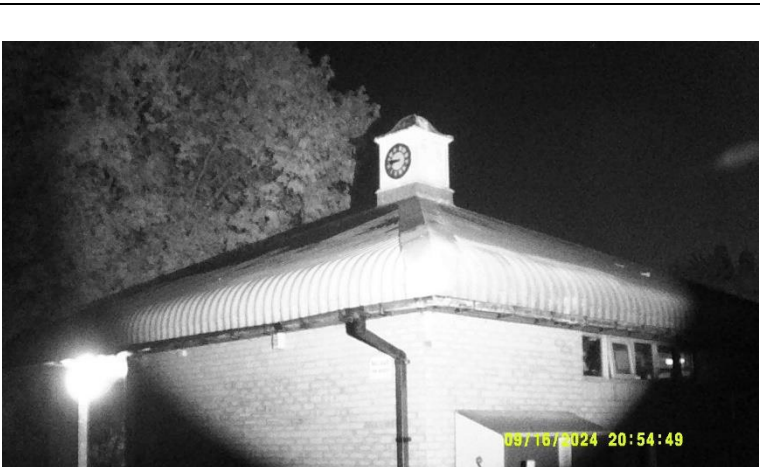
| <i>IR position 2</i> | <b>No emergences.</b> IR footage reflects the view of the surveyor. | |
