## 4.0 HERITAGE & SIGNIFICANCE STATEMENT

### 4.1 Appraisal of Historic Maps

The conservation area appraisal and heritage listing note adjoining buildings 195 & 196 Parrock Street were brick constructed under slate hipped roof in the early 1800's.

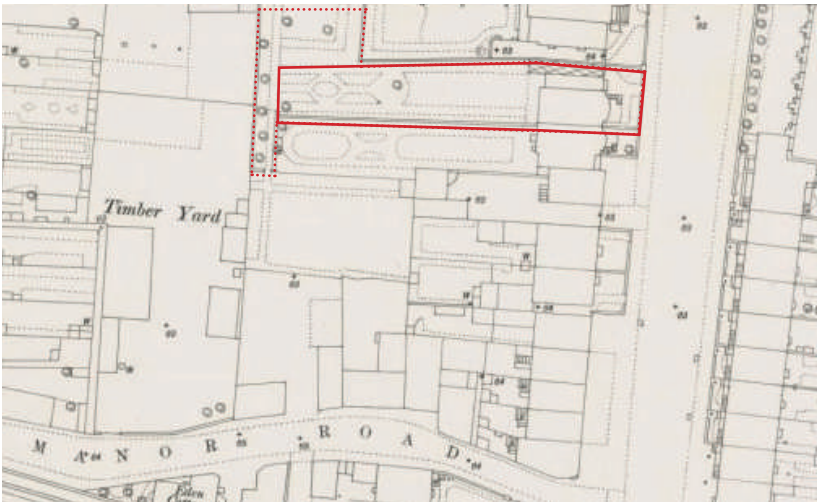
Fig 10: 1866 Site Location Map - Map source: <https://maps.nls.uk/>

OS Map dated 1866

Evidencing:

- Formal domestic front and rear gardens denote residential use
- Access path and openness to rear of site
- Original main dwelling house extends with bay to front
- North side wing, slightly set back
- A further thin north wing with hatch depicting a glazed roof
- Front light-well and steps down
- No. 196 attached to 197

The earliest historic map resourced is dated 1866 (See *Fig 10*) and displays the building as a residential dwelling house with landscaped garden. There is historic evidence on site today of the garden being ornamentally landscaped: remnants of historic tiles depict a garden room, since been removed.

A side wing extension was introduced during the early C19th running east to west along the boundary wall with no. 194, protruding to the rear. A hatch on the 1866 map depicts this as originally being under glass roof.

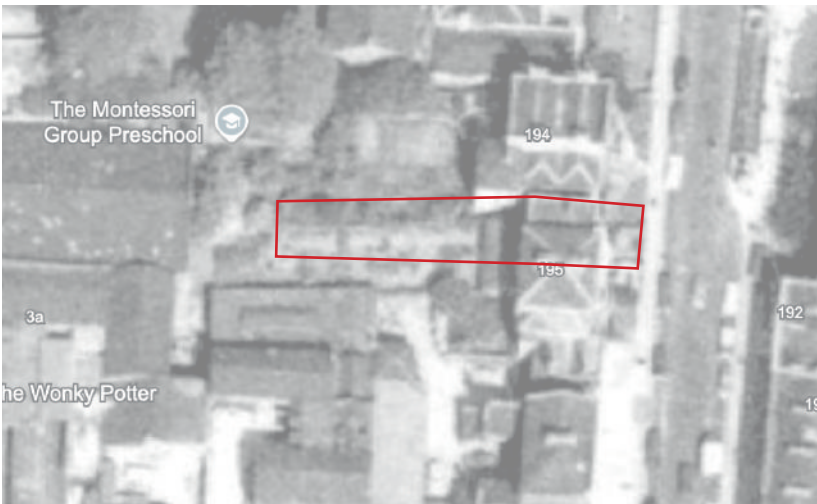
Fig 11: 1907 Site Location Map - Map source: Google Earth

1907 (pre heritage listing)

Evidencing:

- Flat roof extension to the rear
- Aforementioned glass roof element replaced with flat roof
- Chimney still evident within flat roof

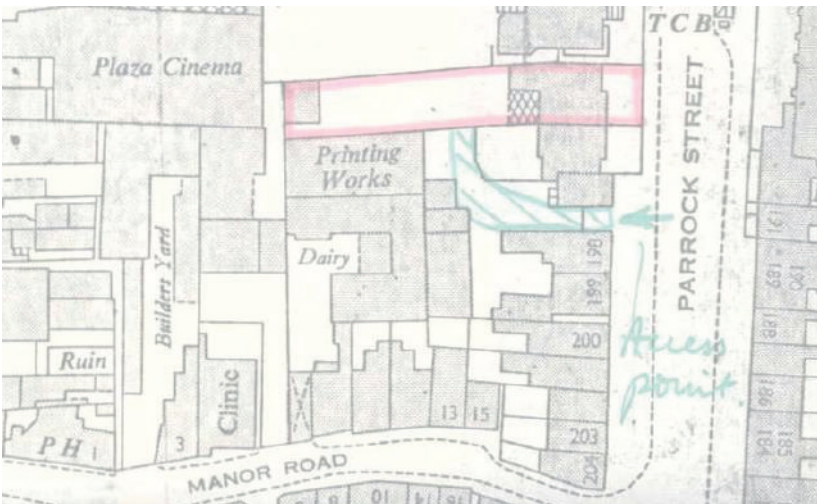
Fig 12: 1977 Site Location Map - Map source: Gravesham Planning app. 19763070

1977 (post heritage listing)

Evidencing:

- Changed office use - portable building evident in yard approved for temp bank use whilst awaiting new premises
- Hatch denotes different construction, assumedly the flat roof to the rear
- Plan depicts designated rear site access via underpass of no. 199 to south
- 196 rear residential building previously Printing Works

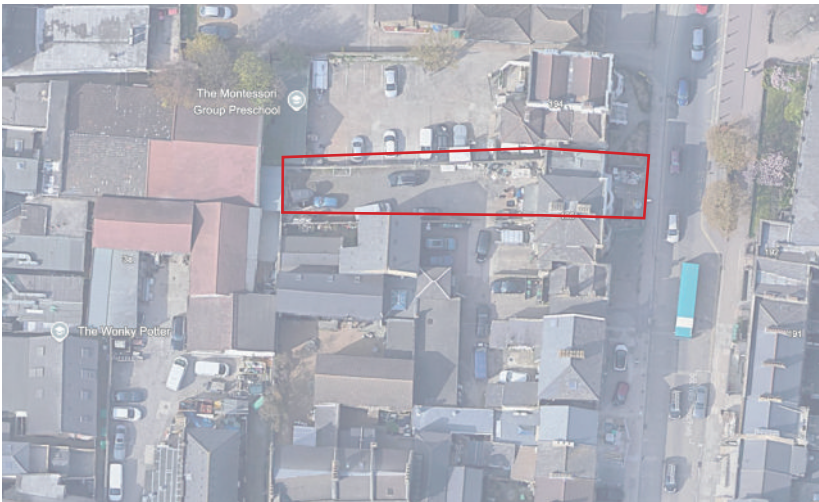
Fig 13: 2021 Site Location Map - Map source: Google Earth

Map dated 2021

Evidencing:

- Continued office use - rear yard being used for parking
- Flat roof rear extension
- Flat roof over later north side wing extension - parapet wall surround
- Roof trap hatch
- Later chimney (defined by orthogonal orientation to original building)
- 197A reconstructed to rear of 196 as a residential use block

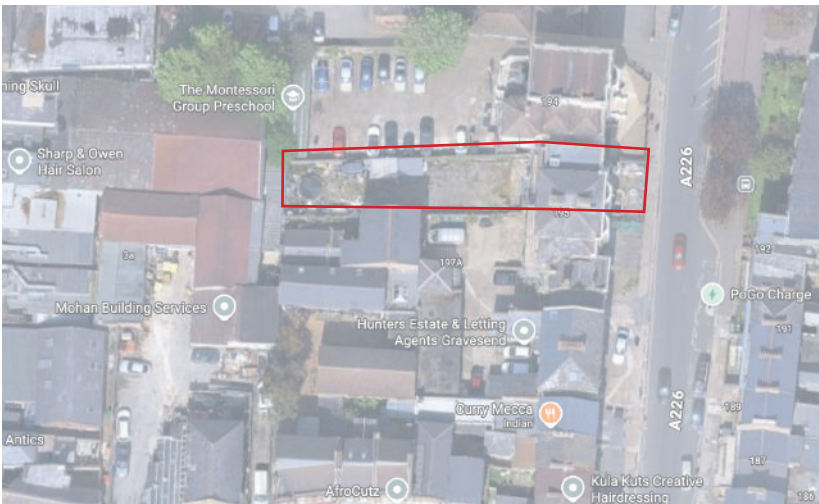
Fig 14: 2025 Most Recent Site Location Map - Map source: Google Earth

Map dated 2025

Evidencing:

- Redundant use - no cars in yard
- AOV installed within hipped slate side wing roof
- Chimney to flat roof removed
- Roof trap hatch removed
- Boundary wall vehicular access in-filled

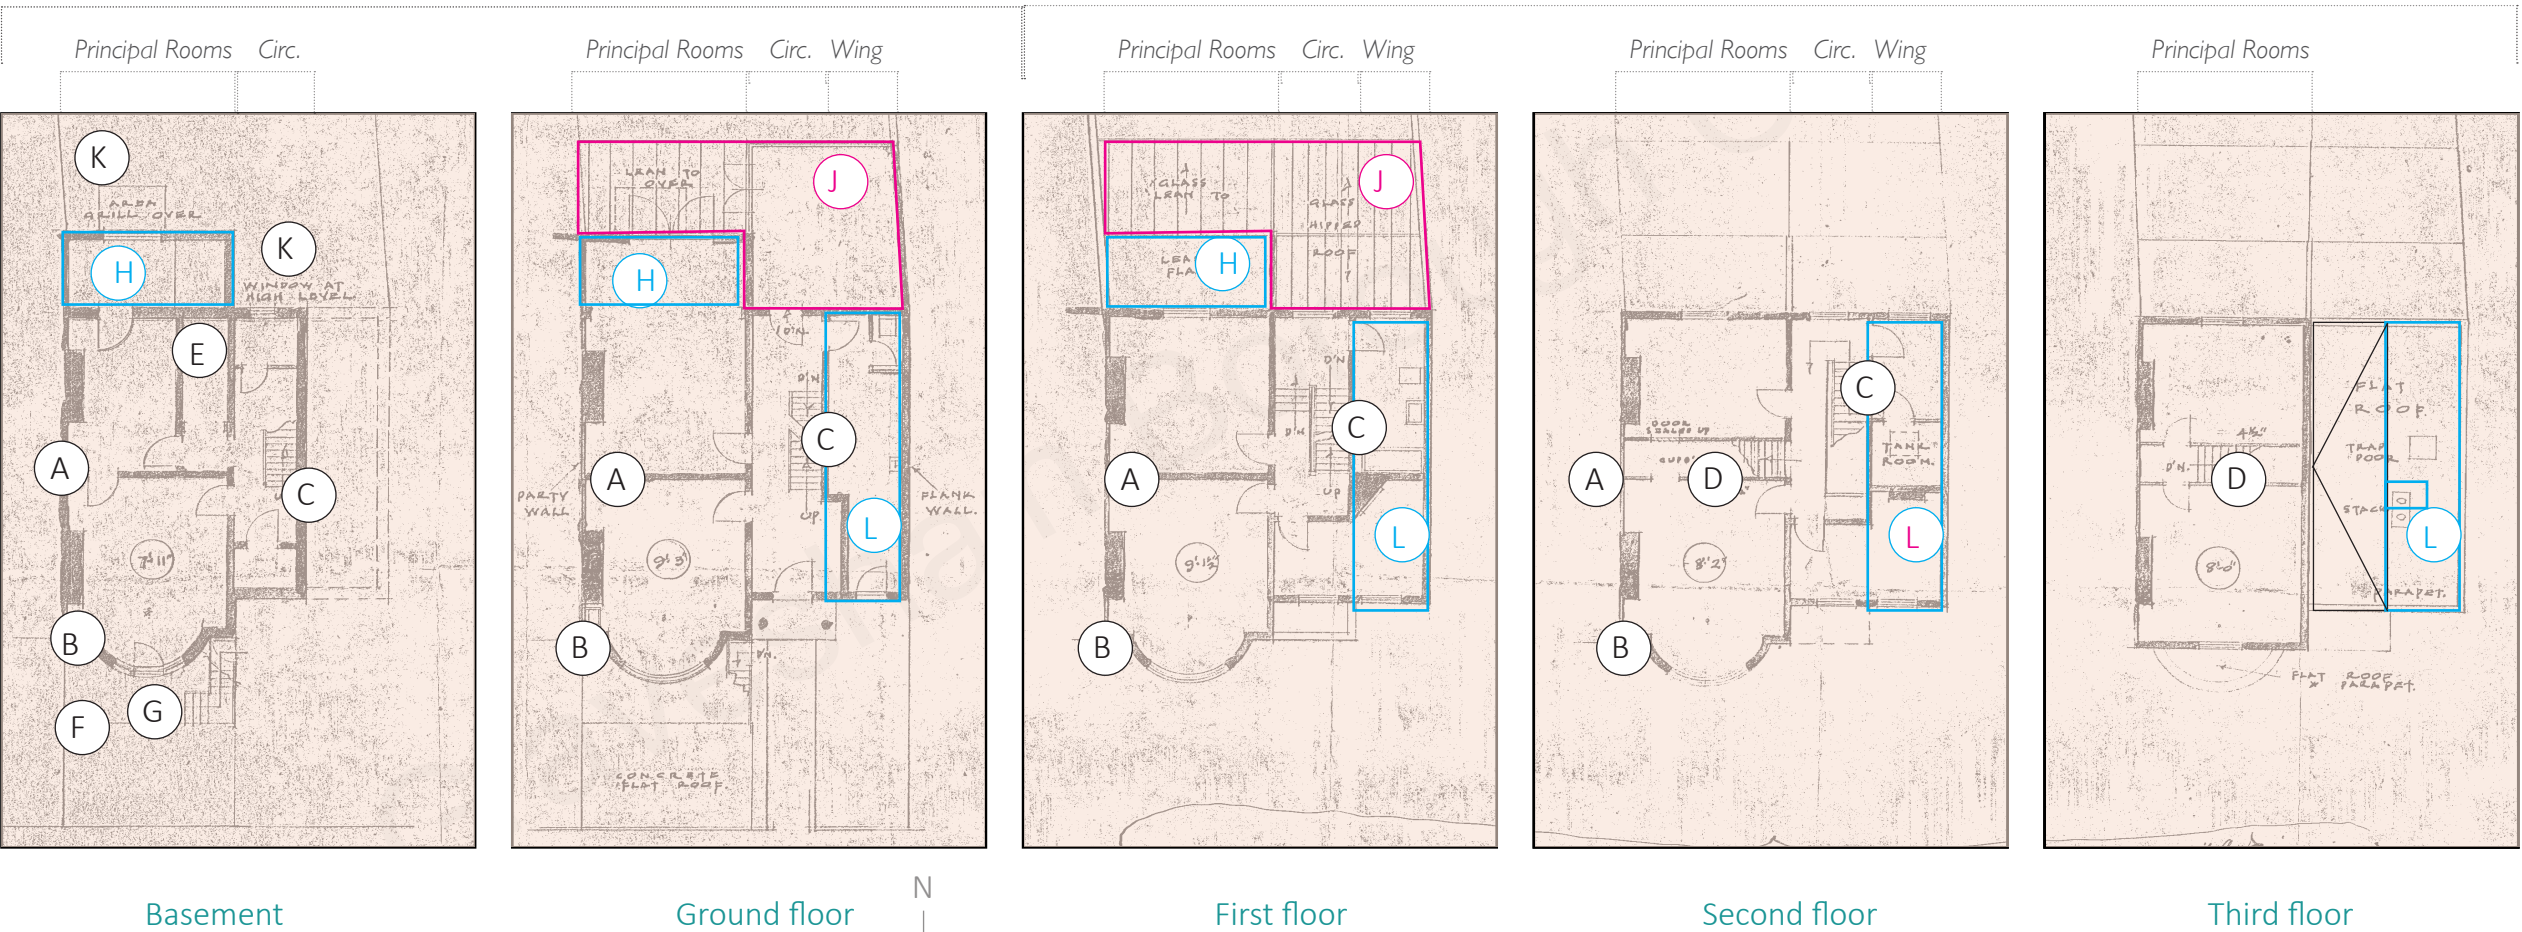
Above: 1866 Site Location Map - Map source: <https://maps.nls.uk/>  
Below: Fig 10 (above): Floor Plans Drawing No. 1296 by George B. Clay and Partners

### 4.2.1 1967 - Earliest Floor Plan Record- As Found

#### Evidencing:

A - partition dividing front and rear reception rooms; front & rear chimneys to all floors

B - bay window to front

C - central staircase & corridor circulation

D - staircase dividing front and rear rooms between second and third floor

E - dividing corridor to rear room in basement

F - bunker under concrete slab and steps down to front lightwell

G - central door in front basement bay

H - 2 storey lgf/gr flat roof extension with gf french doors and lightwell grill over basement to rear- assumedly late c.19

J - hipped/lean-to glazed roof rear additions installed over lightwell grill(h) - assumedly early c20th

K - rear lgf window

L - side wing extension under parapet roof with bathroom to 1f and wc to gf assumedly late c.19 - \*note incorrect orientation of chimney to satellite evidence\*

These plans evidence of the original historic plan form layout. The application solely for change of use, with additions nor adjustments apparent. The plans depicts 19th/early 20th Century additions not depicted in the 1866 map, including:

- removal of an elongated glazed roof side extension, replaced with a 3 storey flat roof parapet extension over ground, first and second floors for service rooms, chimney within and trap door providing access to the flat roof;
- rear flat roof extension with French doors at ground floor;
- light-well grill over lower ground floor aperture and glazed roof additions to the rear and side (assumedly added past aforementioned flat roof rear extension) with rear lean-to extending to glass hipped roof return, (all since removed).

Evidence of the later side extension is revealed today in the change of yellow London Stock brick to the front elevation and a render to the rear and side, distinguished by a weaker stucco line to the main building and the location of the removed hipped glazed roof is marked in the plasterwork to the rear flat roof extension. Black and white floor tiles remain in situ.

1967 plan drawings (to follow) indicate the glazed side element replaced with a 3 storey side extension (over ground first and second floors) under parapet flat roof, which was continued around the hipped slate wing roof as depicted in 1907 map (See *Fig 16*). Although no longer evident, a 3rd chimney was formed within the extension. (recently removed - acceptance of its removal in planning terms acknowledged in the NMA)

At, or around the same time a rear extension was also introduced to the rear principal room from basement to ground floor under flat roof with side parapet walls. French doors with fixed side panels were inserted at ground floor; a window set within a new rear light well under grill formed, all evidenced in the 1967 plans. (See *Section 4.2.1*)

1967 planning drawings also depict a wrap around glazed rear extension, assumedly added during building mixed use as a dentist which operated within the ground and basement floors; a 3 storey flat occupying the first, second and third floors.

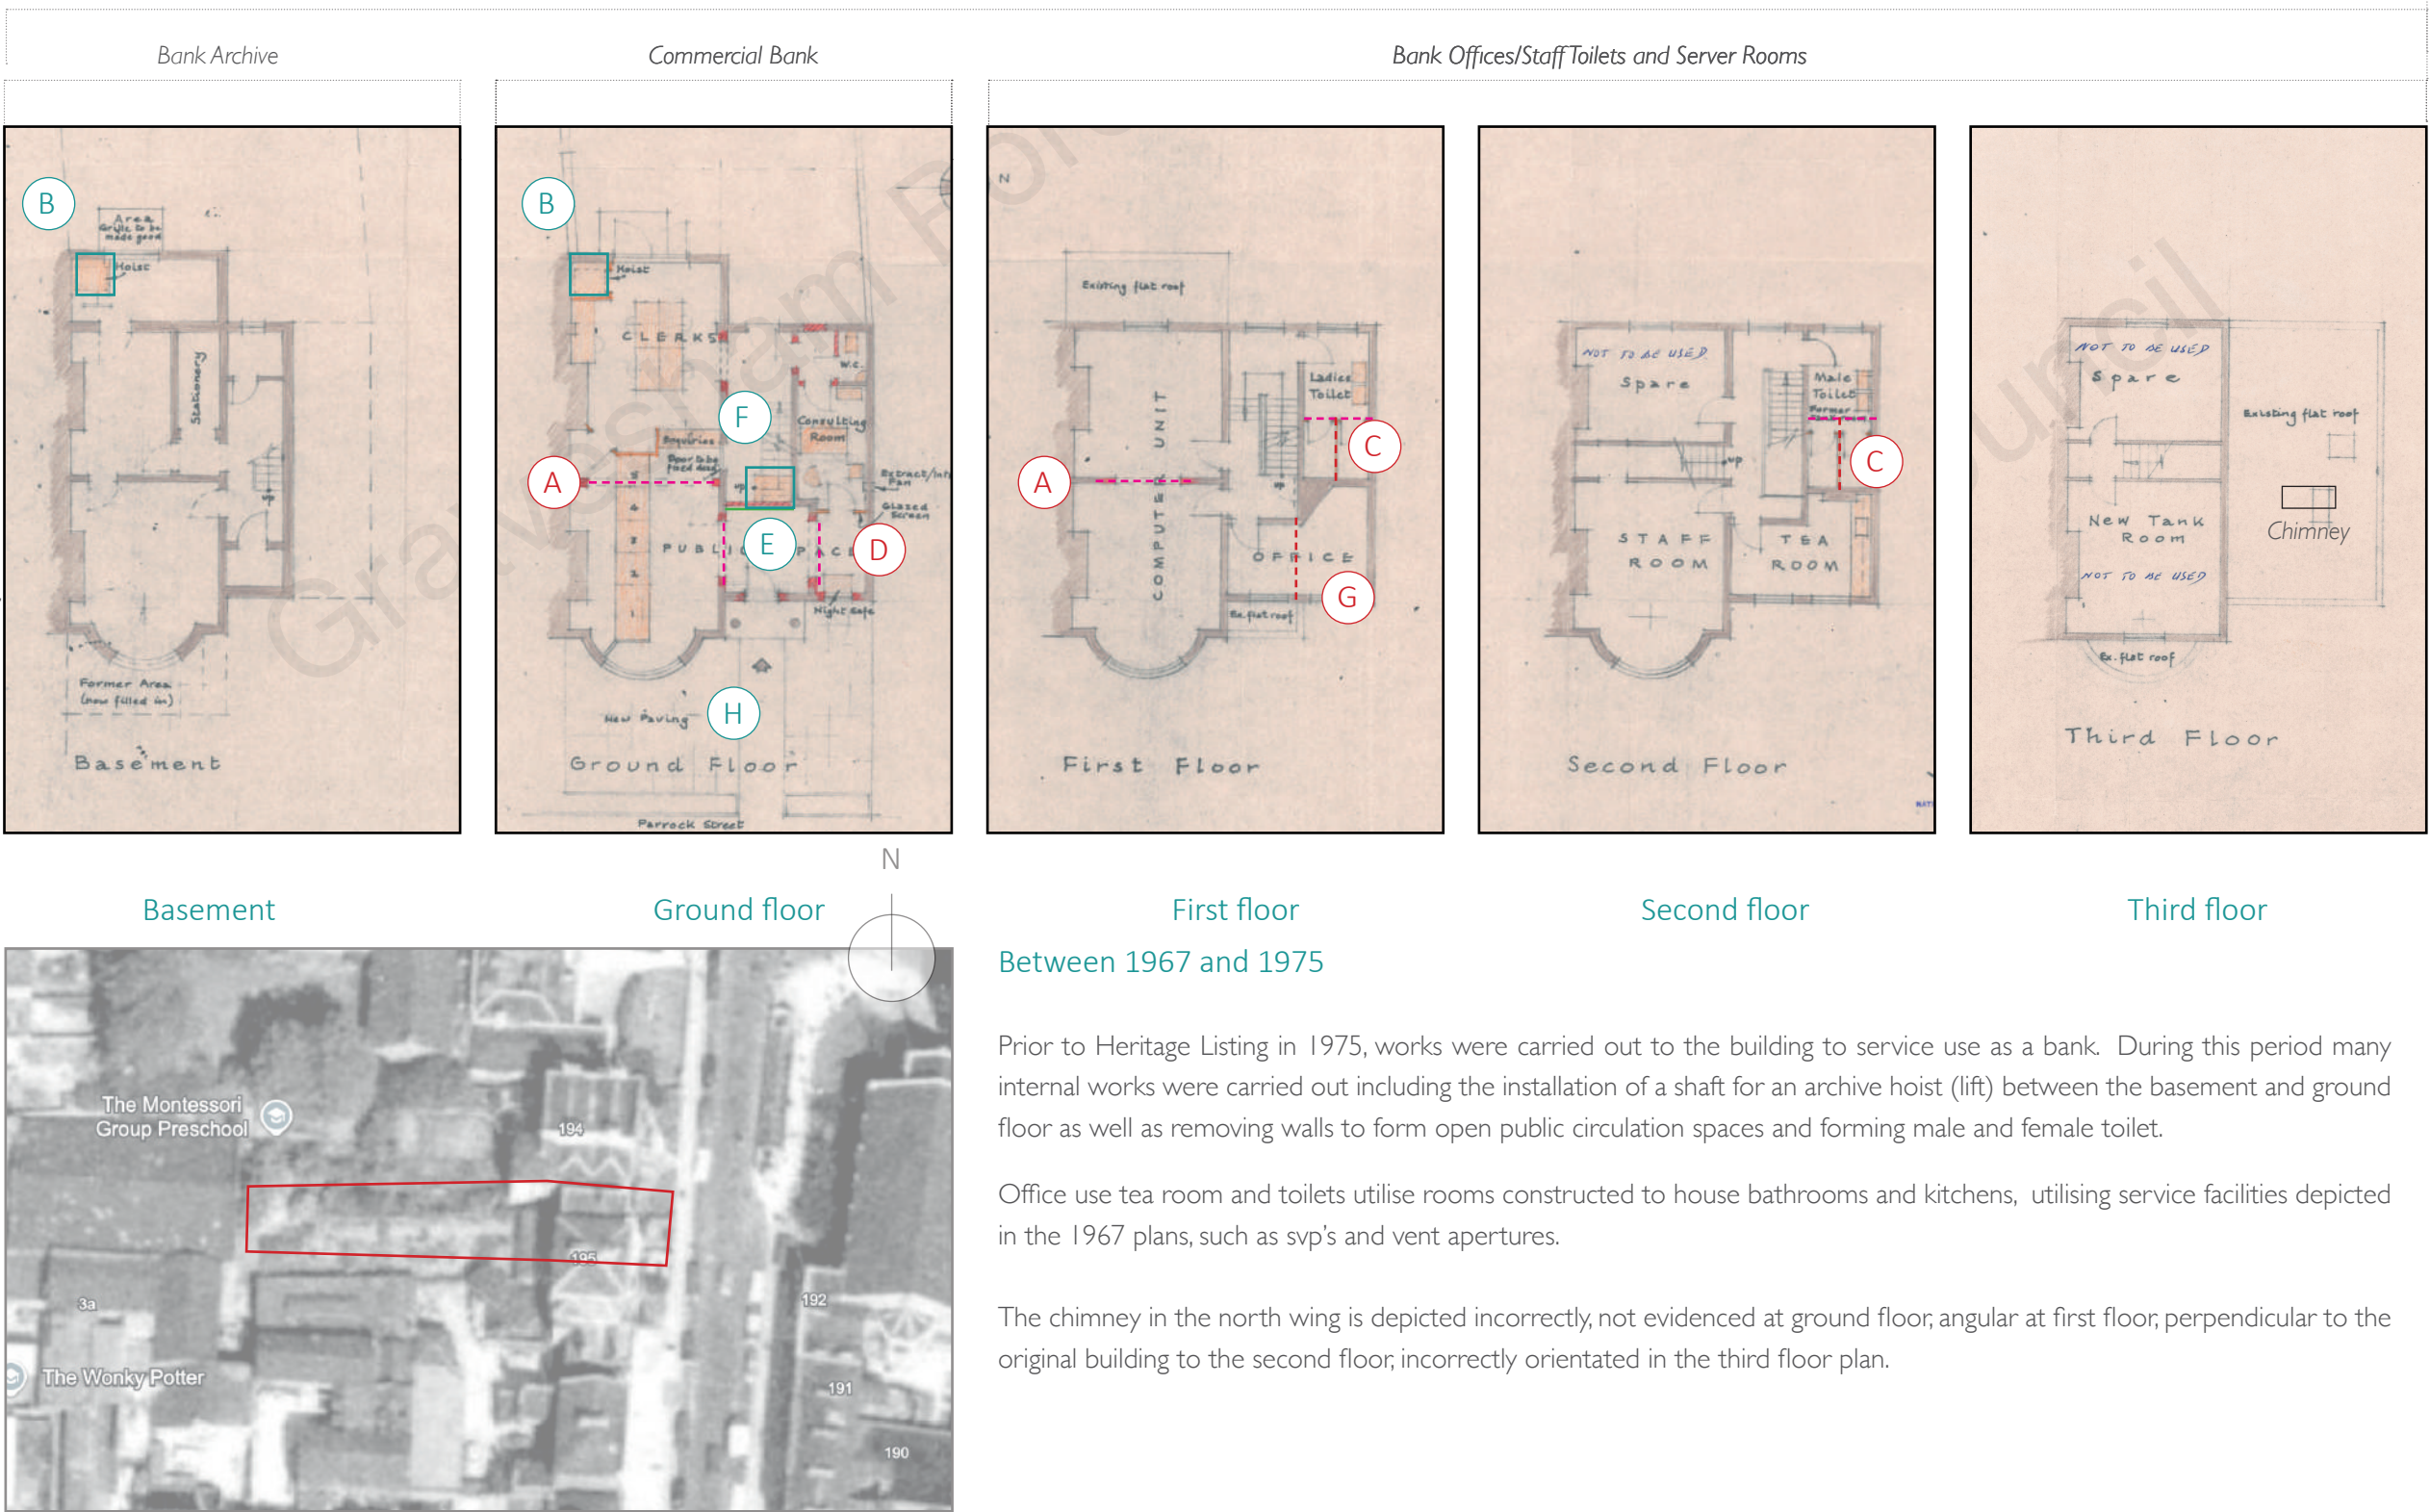
Above: 1907 Site Location Map - Map source: Google Earth  
Below: Fig 11 (above): Floor Plans Drawing No. 46/11 by F. Norman James Architects

4.2.2 1968 Pre Heritage Listing - As Found  
Change of Use Dental and Living to Bank  
Approved Planning Application 19671070

- 4.2.1
- Evidencing:
- A - part-removal of dividing wall at ground and first floors
  - B - hoist shaft formed between basement and ground floor
  - C\* - division side wing rooms to form staff toilets
  - D\* - part removal of original wing wall to circulation space into later wing addition to form public foyer
  - E - partition formed dividing circulation space from foyer
  - F - staircase re-orientated at first floor forming 1/4 landing
  - G\* - removal of original wing wall into later wing addition
  - H - new square cementeous pavers (which remain today)
- \*some partitions may have been removed prior to occupancy by the bank.

Prior to Heritage Listing in 1975, works were carried out to the building to service use as a bank. During this period many internal works were carried out including the installation of a shaft for an archive hoist (lift) between the basement and ground floor as well as removing walls to form open public circulation spaces and forming male and female toilet.

Office use tea room and toilets utilise rooms constructed to house bathrooms and kitchens, utilising service facilities depicted in the 1967 plans, such as svp's and vent apertures.

The chimney in the north wing is depicted incorrectly, not evidenced at ground floor; angular at first floor; perpendicular to the original building to the second floor; incorrectly orientated in the third floor plan.

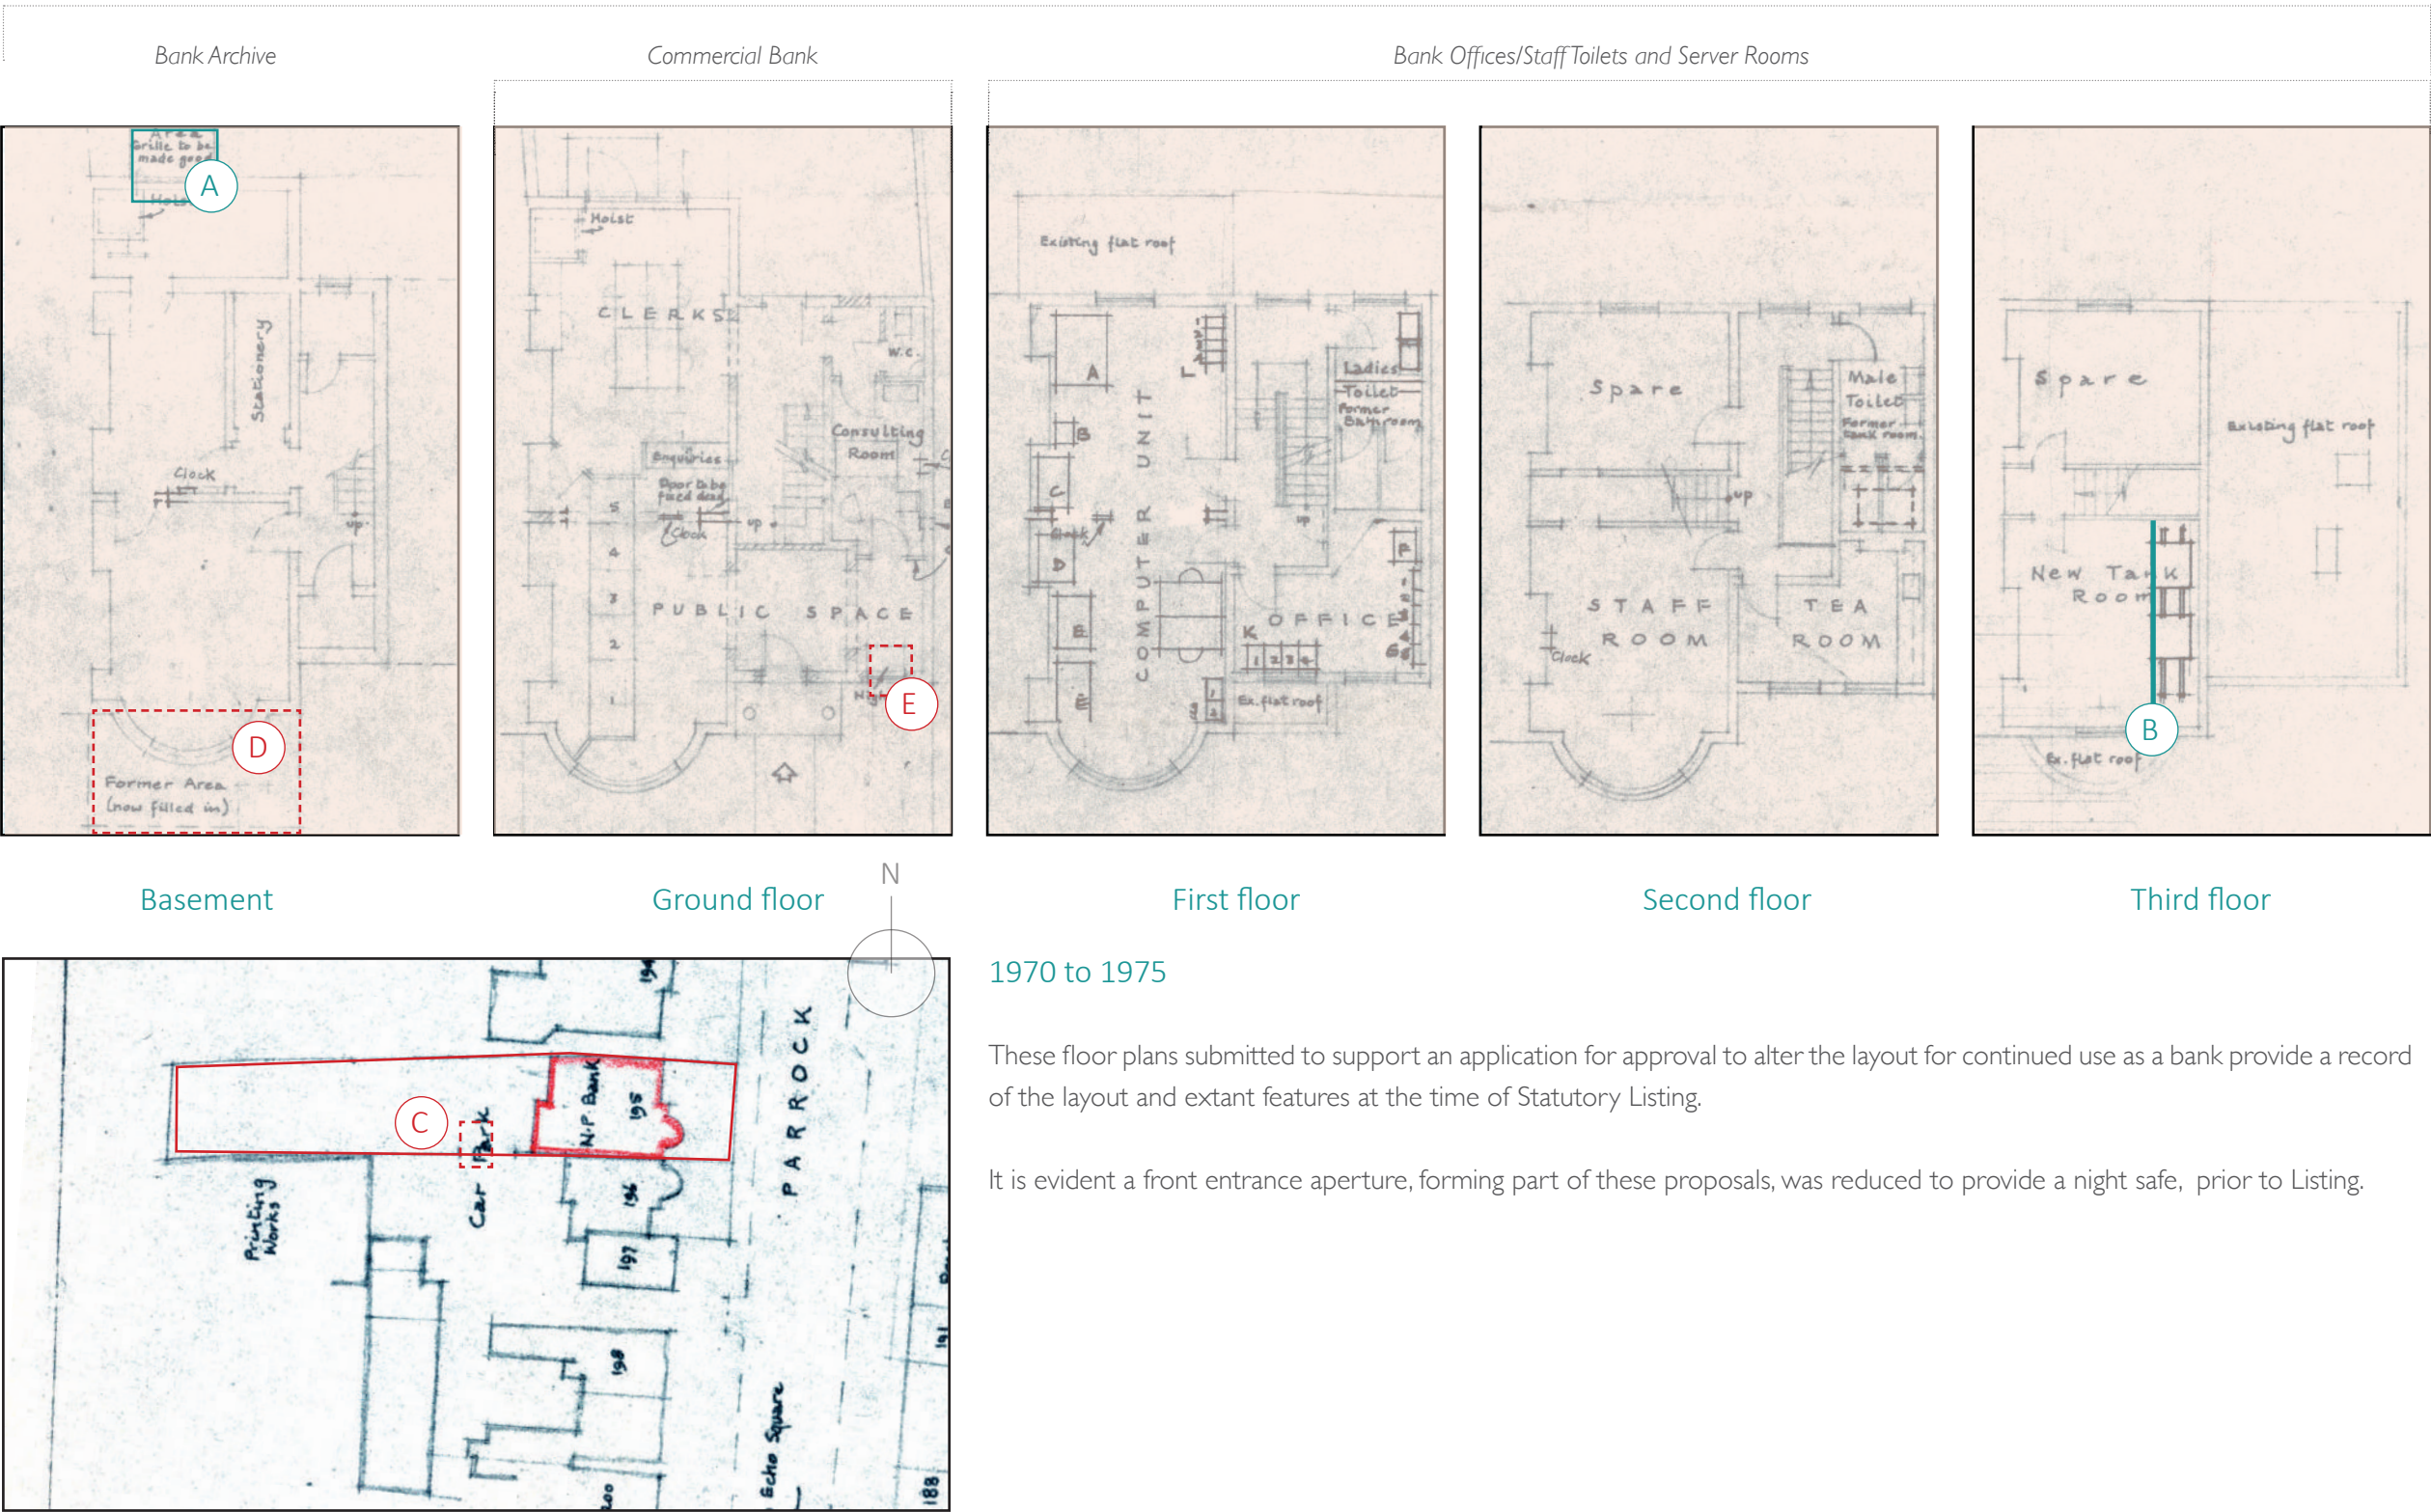
Above: Planning Floor Plans by F Norman James

4.2.3 1970 Heritage Listing- As Found

Evidencing:

A - grill made good over lightwell window lw02

B - 3rd floor front 'tank' room formed

C - part of wall removed to provide car access to rear parking

D - area filled in

E - night safe formed in door aperture

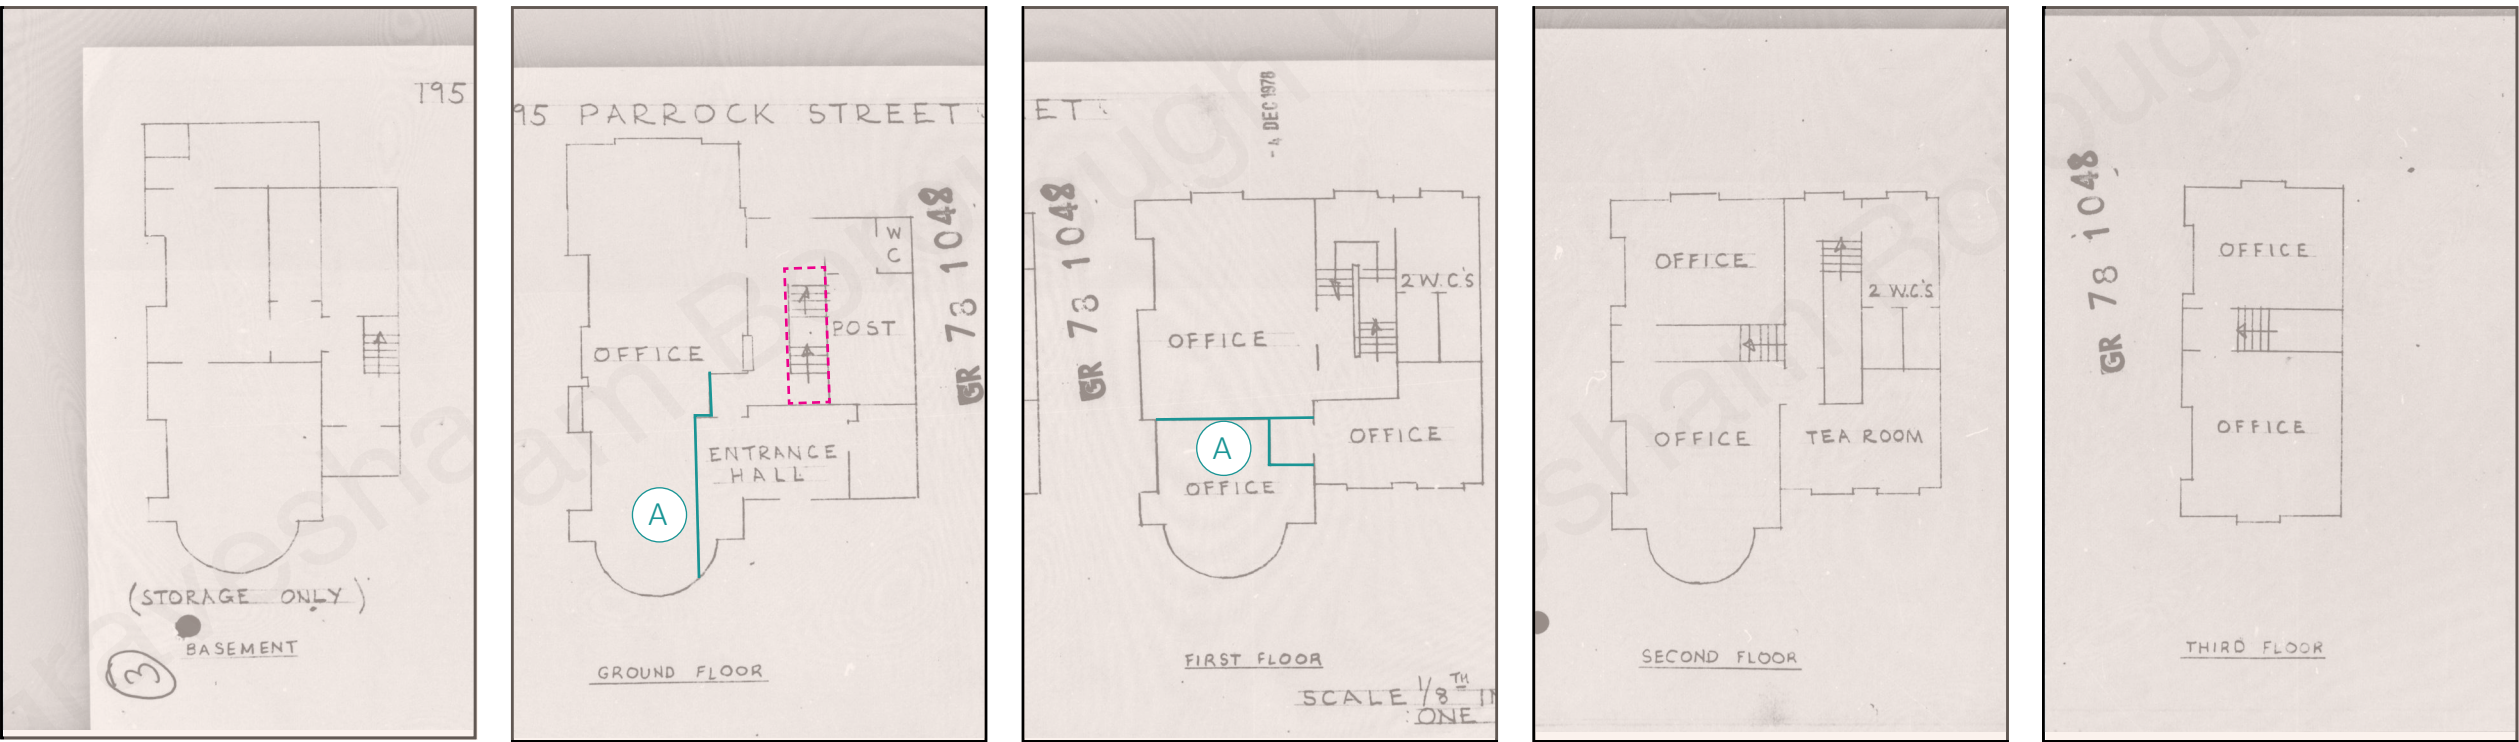
Above: Floor Plans Drawing from local authority portal - source unknown  
Below: Fig 16 1977 Site Location Map - Map source: Gravesham Planning app. 19763070

4.2.4 1978 Post Heritage Listing- As Found  
Continued (permanent) Office Use  
Approved Planning Application 19781048

Evidencing:

A - partition divisions to front ground and first floor principal rooms - as approved

B - ground floor staircase returned to straight flight

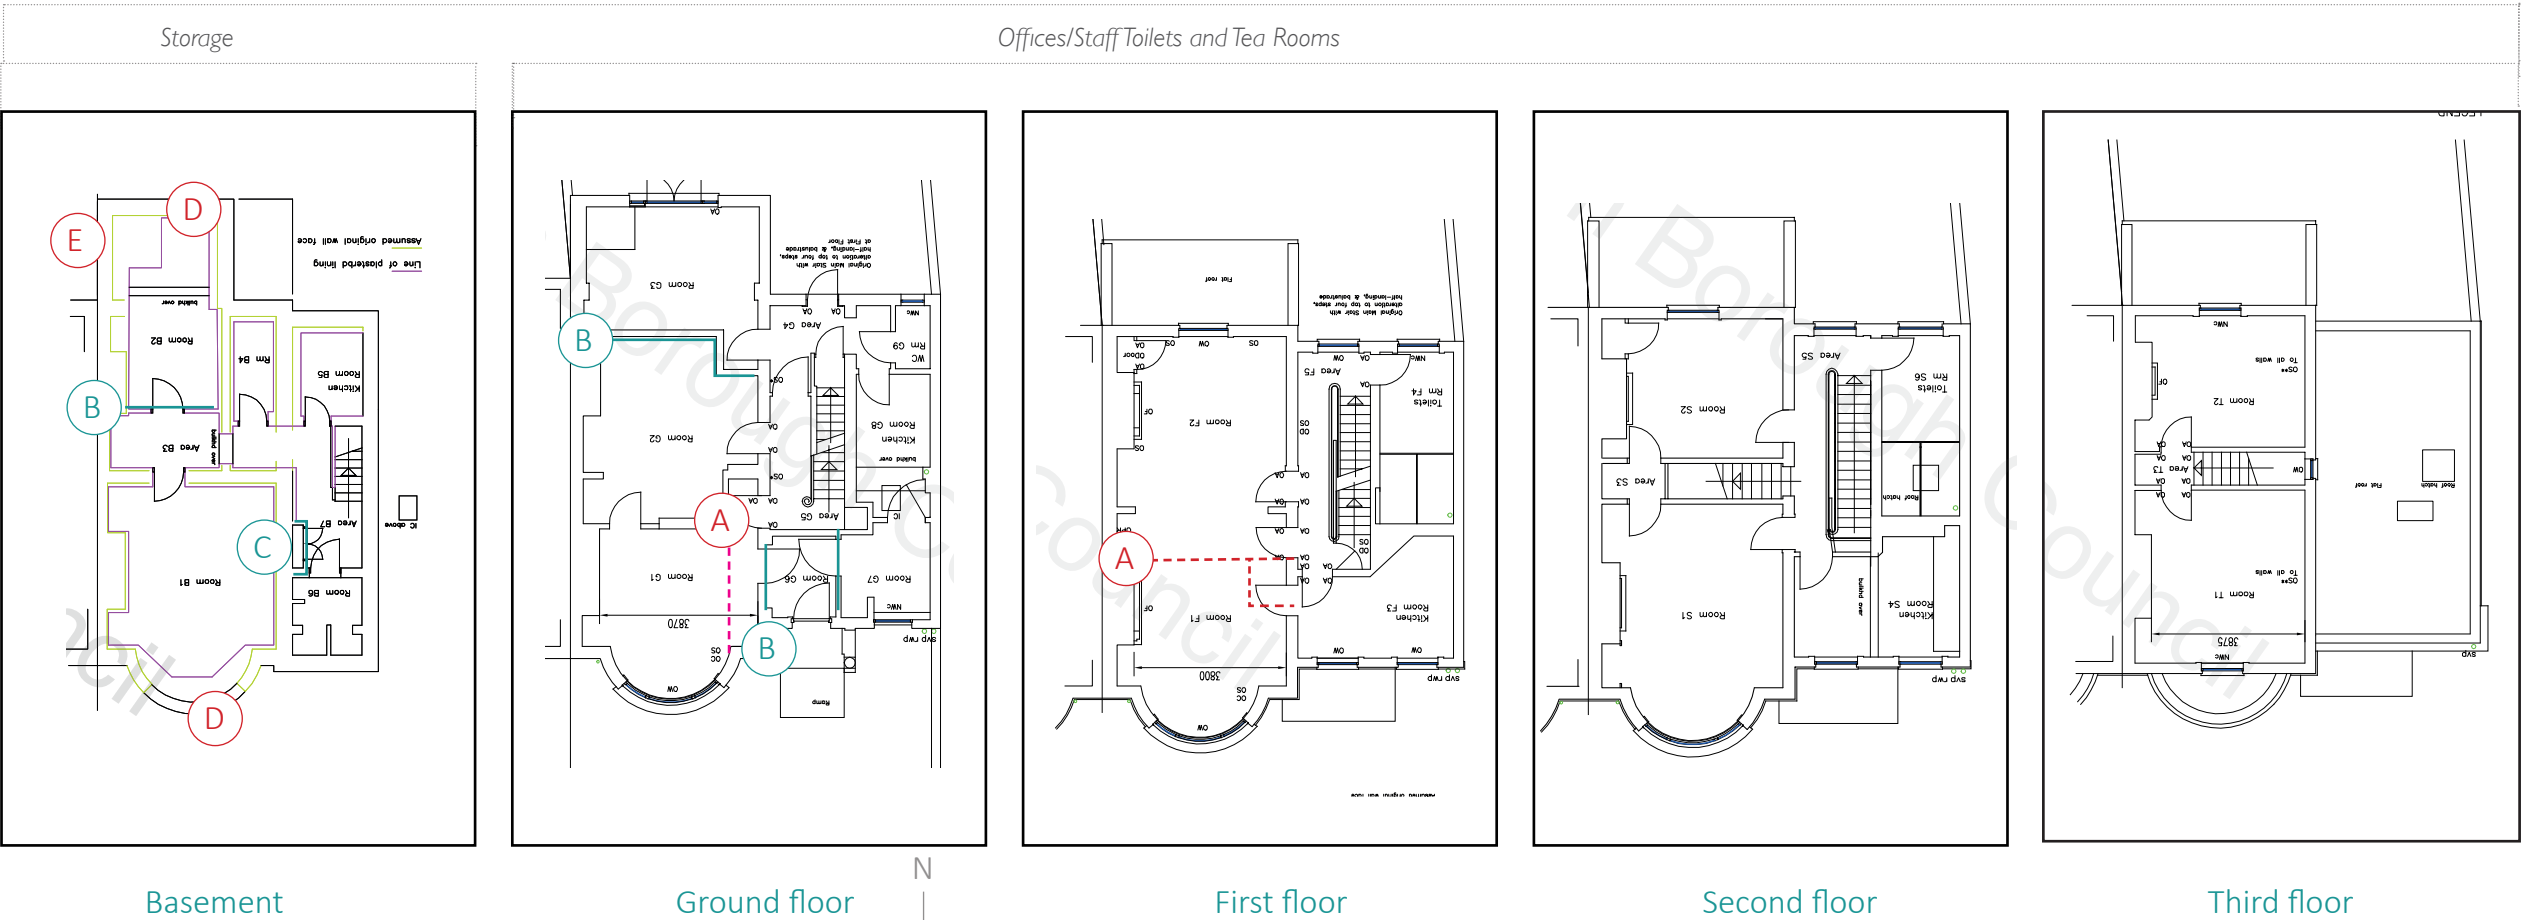
Above: As Existing Conservation Floor Plans Drawing No. 016 by John N Woods Architect  
Below; Fig 13: 2021 Site Location Map - Map source: Google Earth

4.2.5 2015 Historic Fabric- As Intact  
Change of Use & Conversion Office to Residential  
As Existing Floor Plans

- Evidencing:
- A - 1978 partition removed
  - B - partitions formed
  - C - service cup. formed
  - D - front & rear lightwell fenestration lost
  - E - hoist removed, shaft apparent

At the time of heritage listing the front light-well was in-filled with pavers the area since opened up.

Works were carried out in 2022/3 to convert the building to flats. There is no photographic evidence to record the works and the impact on the historic fabric of the building. However, as part of the approved application, conservation drawings by JNW Architects in 2015 (See *Section 4.2.5*) reference original details, materials and finishes such as doors, frames, mouldings, architraves and skirtings.

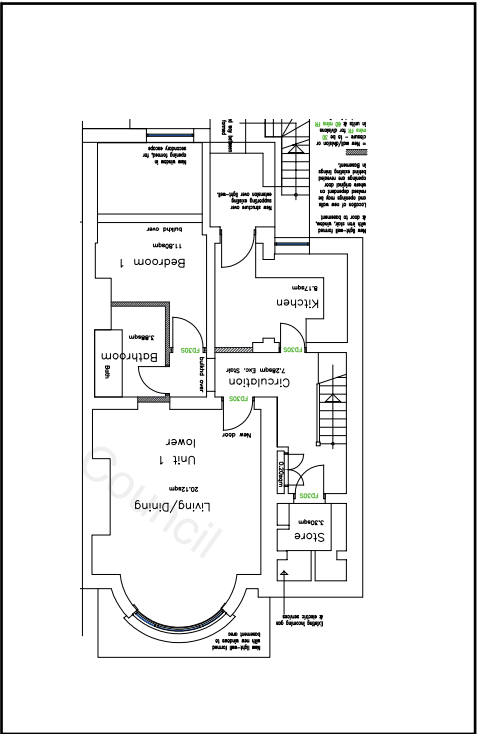
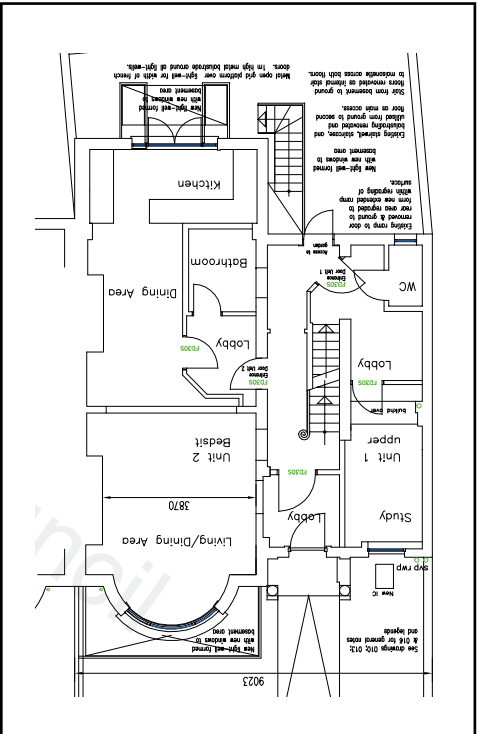
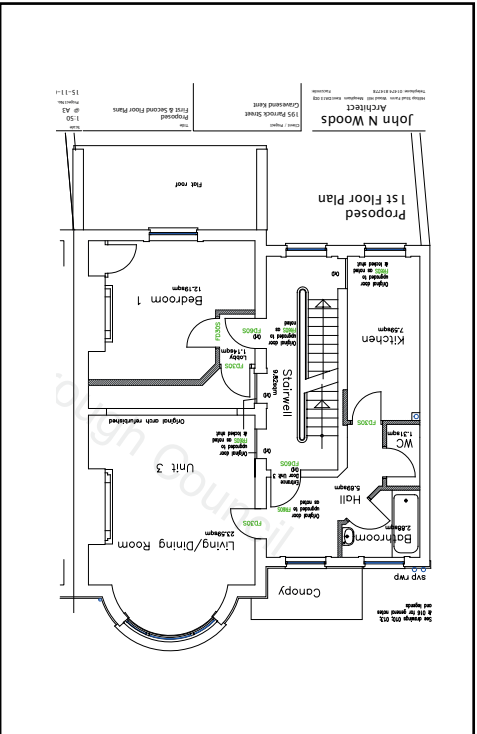
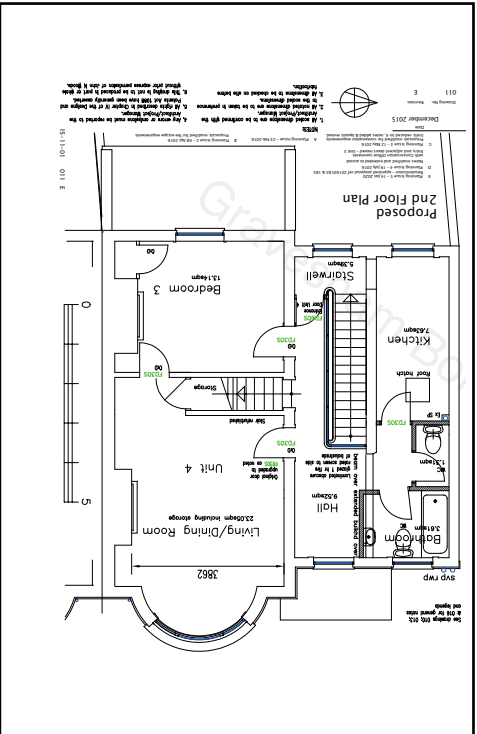
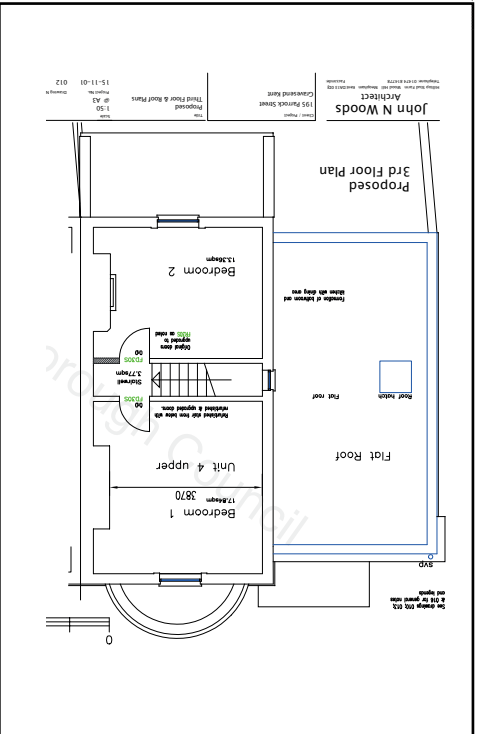
Above: As Proposed floor plans by John N. Woods Architect dated 4th May 2020  
Below: Fig 14: 2025 Most Recent Site Location Map - Map source: Google Earth

4.2.6 2020 As Approved Scheme (not realised)

Design intent.

Whilst this scheme was not initiated, it should be noted that approval granted the change of use and installation of partitions to form flats to each floor reliant on associated utilities and fire strategies.
