## Supporting Photographs - Existing Ceiling Condition

| <b>Site</b> | Jeskyns Court, Jeskyns Road, Cobham, Gravesend, DA12 3AL |
| <b>Application</b> | Listed Building Consent - ceiling removal and like-for-like reinstatement |
| <b>Reference</b> | PP-15254293 / DSS 72232236 |

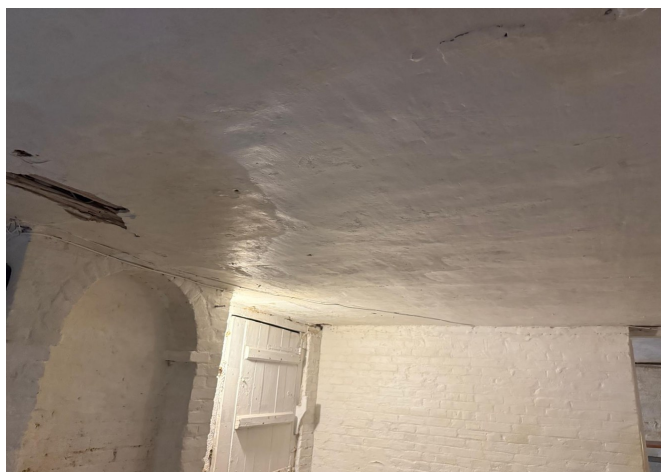
Photograph 1: Existing condition of the water-damaged lath and plaster ceiling at Jeskyns Court. Photographs show areas of cracking, plaster loss and exposed laths.

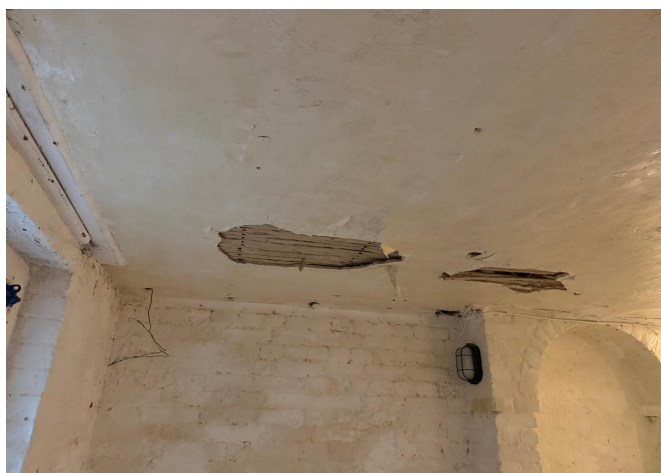
Photograph 2: Existing condition of the water-damaged lath and plaster ceiling at Jeskyns Court. Photographs show areas of cracking, plaster loss and exposed laths.

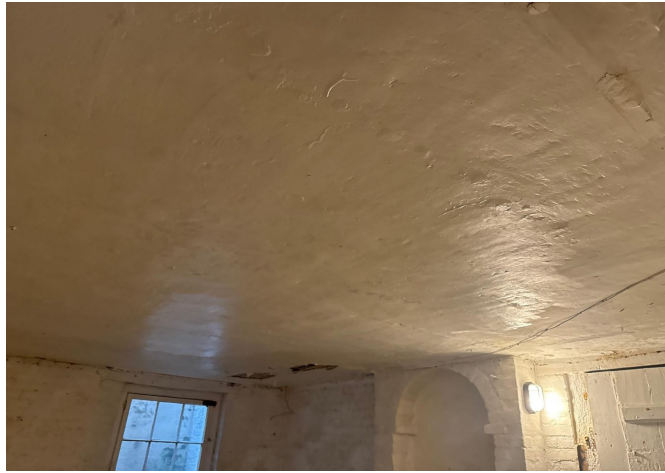
Photograph 3: Existing condition of the water-damaged lath and plaster ceiling at Jeskyns Court. Photographs show areas of cracking, plaster loss and exposed laths.

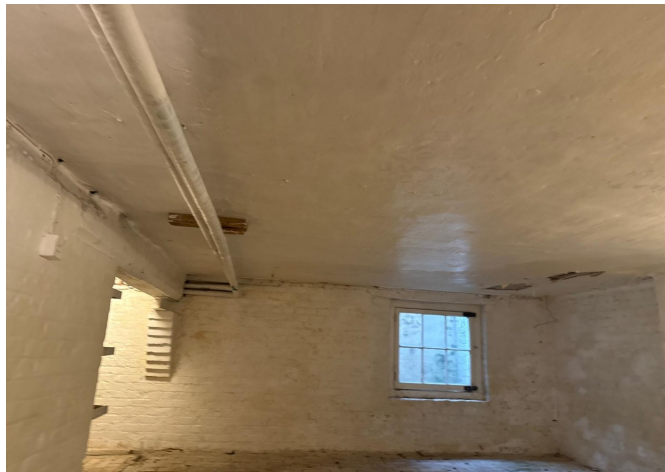
Photograph 4: Existing condition of the water-damaged lath and plaster ceiling at Jeskyns Court. Photographs show areas of cracking, plaster loss and exposed laths.

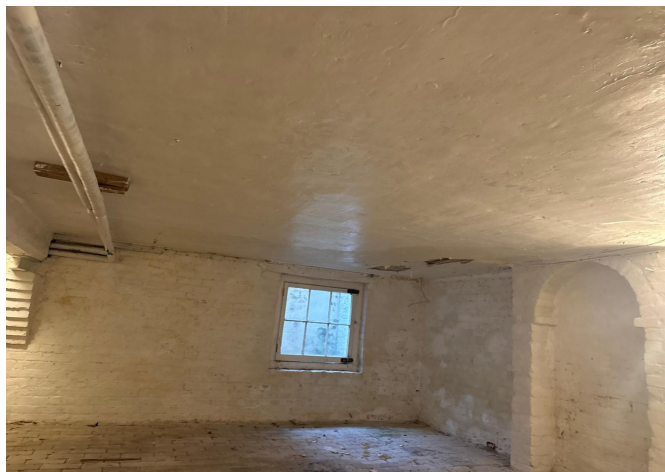
Photograph 5: Existing condition of the water-damaged lath and plaster ceiling at Jeskyns Court. Photographs show areas of cracking, plaster loss and exposed laths.

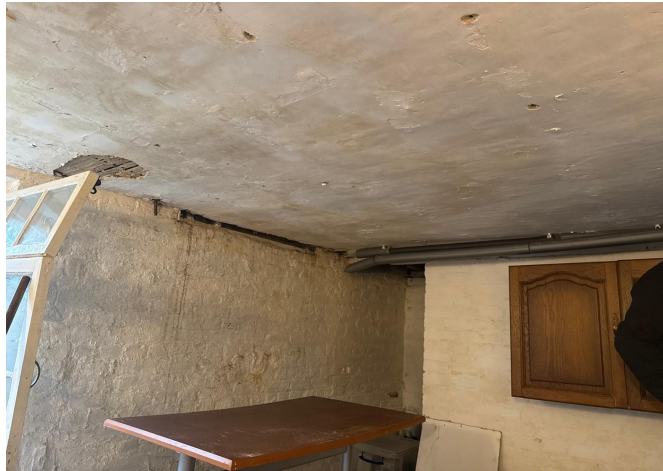
Photograph 6: Existing condition of the water-damaged lath and plaster ceiling at Jeskyns Court. Photographs show areas of cracking, plaster loss and exposed laths.

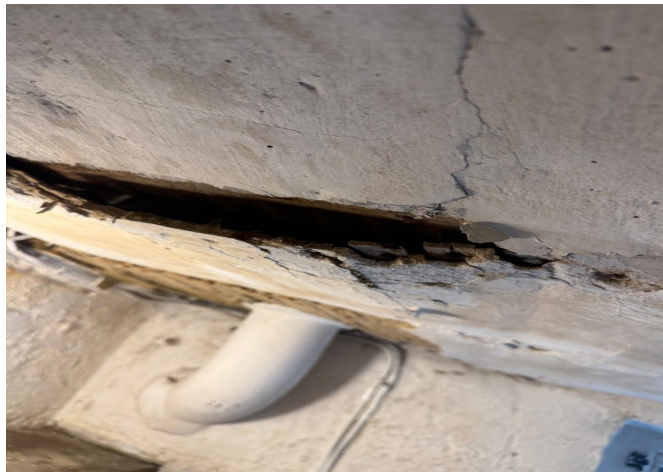
Photograph 7: Existing condition of the water-damaged lath and plaster ceiling at Jeskyns Court. Photographs show areas of cracking, plaster loss and exposed laths.

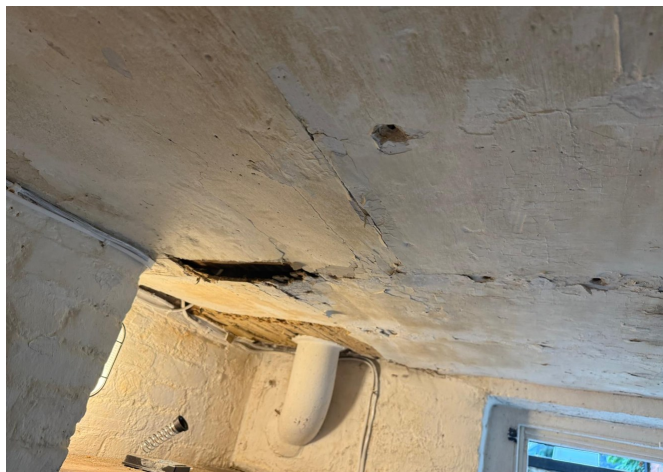
Photograph 8: Existing condition of the water-damaged lath and plaster ceiling at Jeskyns Court. Photographs show areas of cracking, plaster loss and exposed laths.

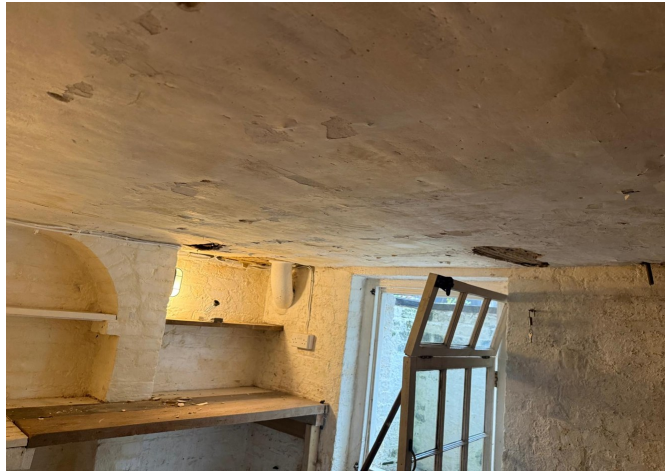
Photograph 9: Existing condition of the water-damaged lath and plaster ceiling at Jeskyns Court. Photographs show areas of cracking, plaster loss and exposed laths.

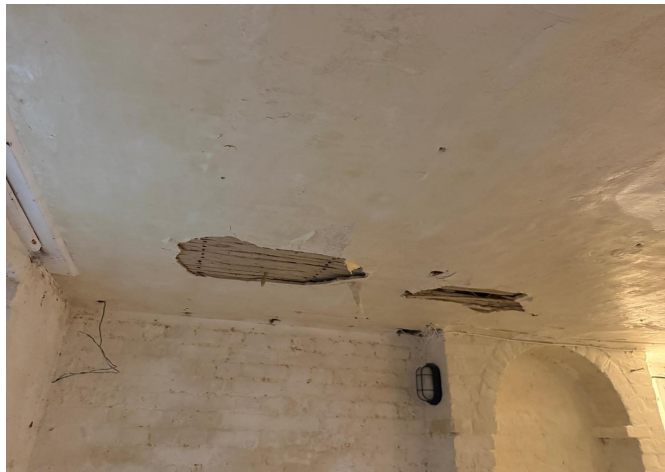
Photograph 10: Existing condition of the water-damaged lath and plaster ceiling at Jeskyns Court. Photographs show areas of cracking, plaster loss and exposed laths.
