# Heritage Statement

## 20 Stone Street, Gravesend, Kent DA11 0NP

**Date:** 02 April 2025

**Ref:** 01093

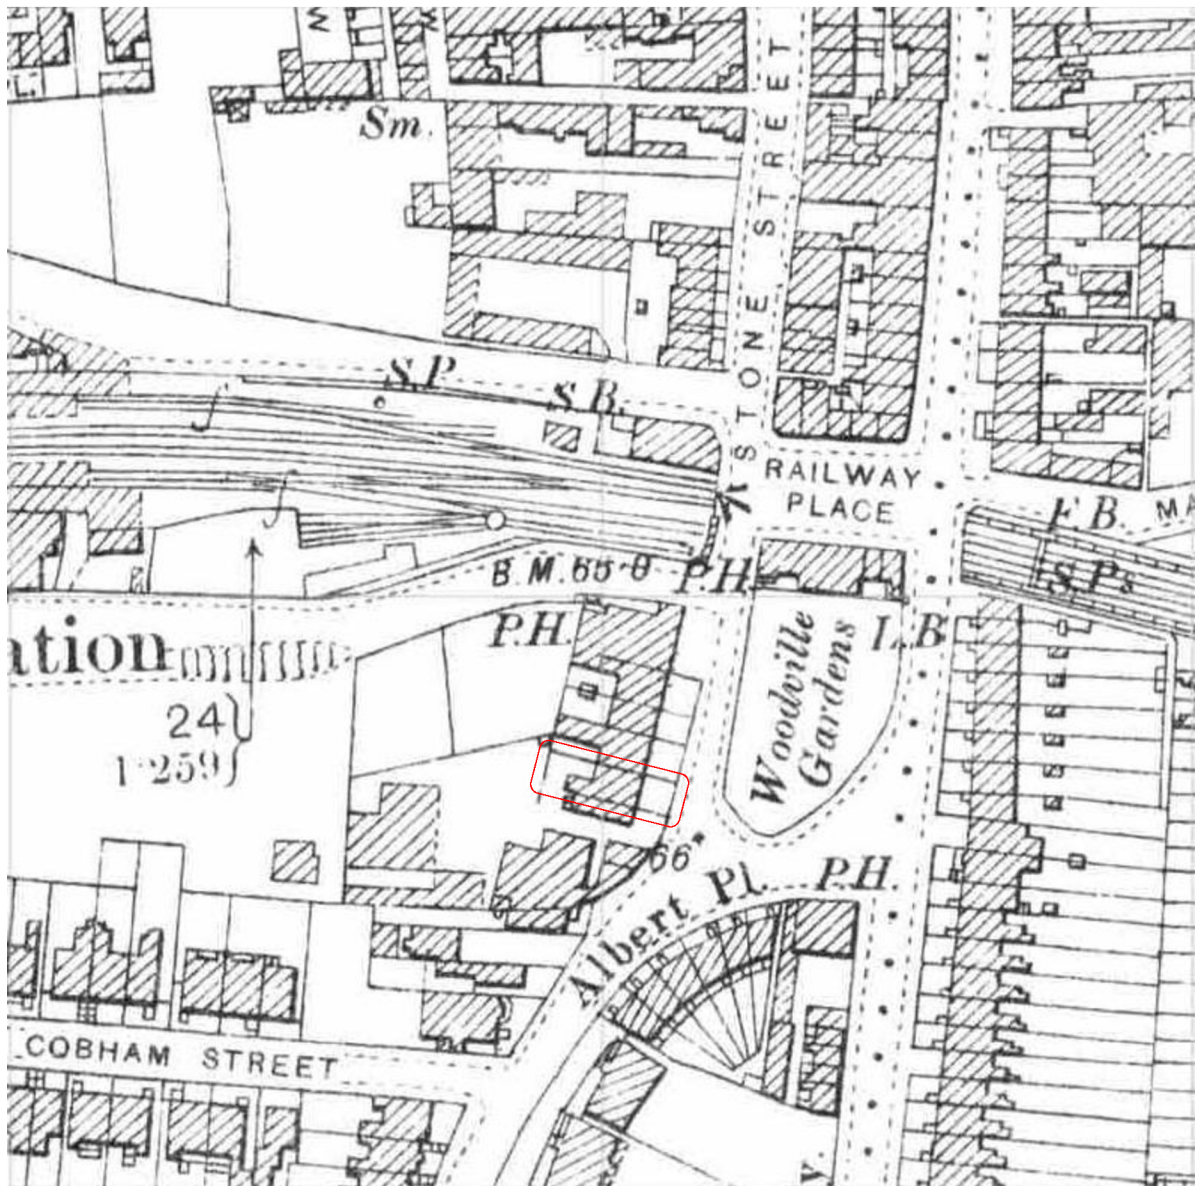
**Fig 3:** An extract of the 1896 Ordnance Survey map, showing the subject property in red.

- 2.6 The 1897 large scale Ordnance Survey map (**Fig 3**) records a similar arrangement in terms of 20 Stone Street, although the timber yard to the south (now unlabelled) had expanded. This includes a building that abutted 20 Stone Street on the south.

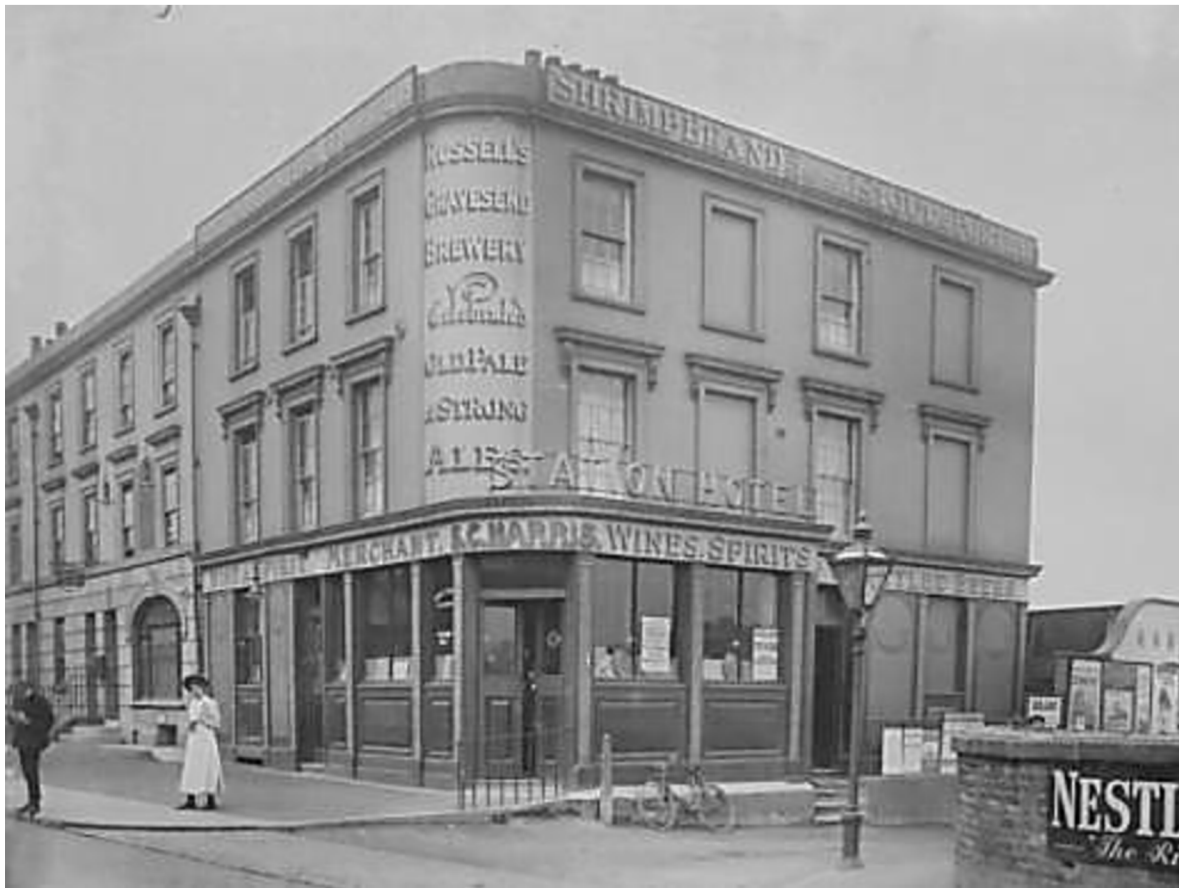
**Fig 5:** An extract of an undated, early C20 photo of the corner pub.

2.8 An undated, early C20 photo shows the corner pub and part of the terrace (**Fig 5**), but unfortunately 20 Stone Street itself is not visible in the image.

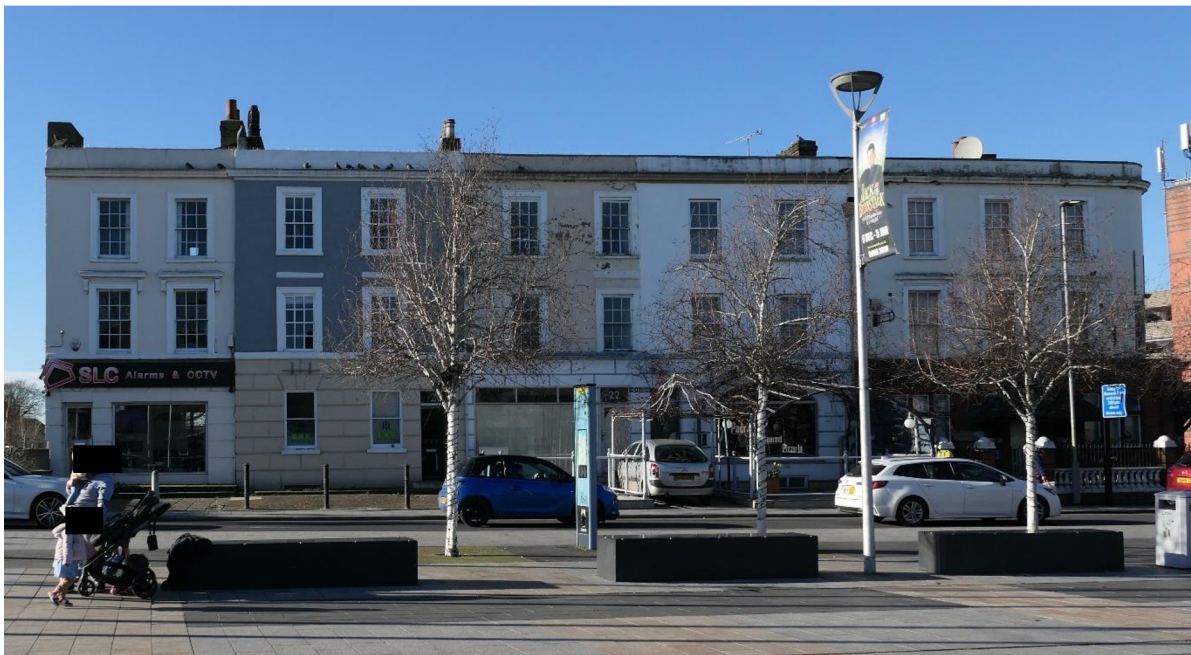
2.12 It appears from the list entry that the building was not internally inspected at the time of listing, as was common practice at the time. The house would have been listed instead on the basis of its age, and its group value with the rest of the terrace, as stated in the list entry. The group value of the terrace, with its coherent frontage to Stone Street, is plain to see from **Photo 1**.

**Photo 1:** A frontal view of the terrace at 20-24 Stone Street.

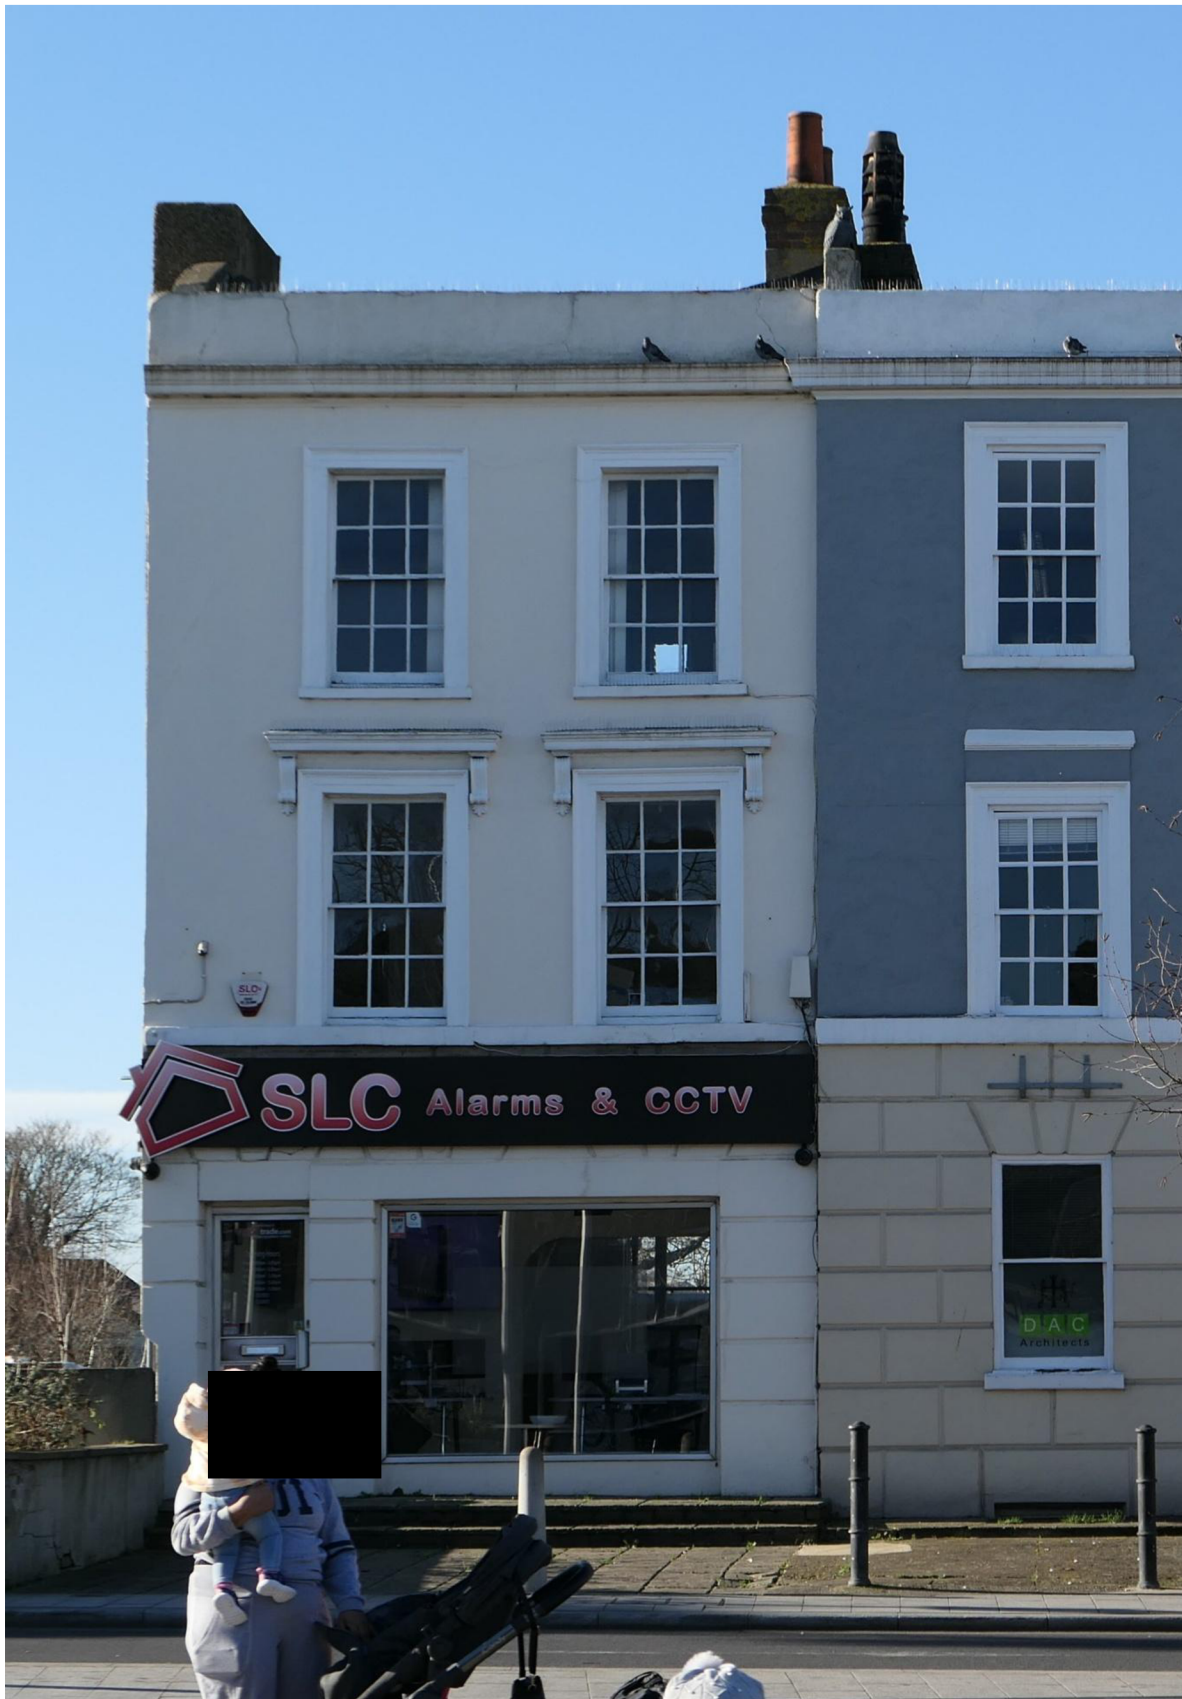
2.13 **Photo 2** shows the facade of 20 Stone Street, which reflects the architectural style of the time and is a good example of a relatively modest mid C19 terraced house (though in reality it was added to the pre-existing building, which was modified to create the semblance of a terrace). The slight step in the façade marks the distinction between the former workhouse at 21 Stone Street and the purpose-built house at 20 Stone Street, albeit in a subtle way. There is also a slight misalignment in the windows of 20 Stone Street and its neighbour, but again this is relatively subtle. The glazed entrance door and plate glass shopfront, together with the somewhat garish fascia sign, are at odds with the façade. The loss of the front light well is regrettable.

**Photo 2:** A view of the façade of the subject property.

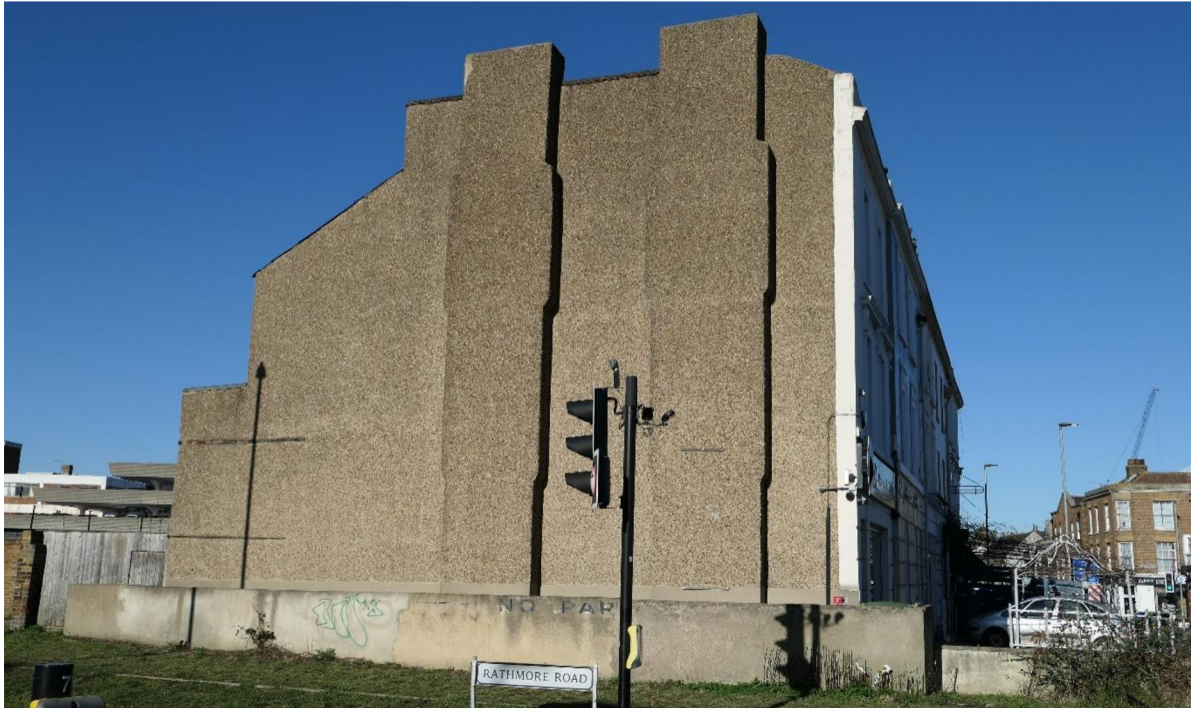
2.14 The southern, side elevation (**Photo 3**) is now completely covered in cementitious pebbledash. Because of the projecting chimneystacks (which notably do not relate to the plan form of 20 Stone Street, where the fireplaces are set in the northern

party wall), the elevation looks truncated, as though the terrace once continued southwards. However, that is not what the historic Ordnance Survey maps record. Nevertheless, there was a structure to the south of 20 Stone Street and this must have been what the now redundant chimneystacks related to. There are two horizontal steel straps visible on the left, which have been used to quite literally tie or strap the little closet wing addition at the end of the building to the mono-pitched stairwell projection.

**Photo 3:** A view of the southern, side elevation.

- 2.15 The pebbledash is an unfortunate, poor quality finish that obscures the brickwork, although it probably also conceals the scars of the previously abutting structure. It is non-breathable and has the potential to cause damage to the building's fabric. As can be seen from the photos, in particular the rear (**Photos 4 & 5**), it is in a poor state, with flaking having occurred. This unsightly, poor quality and inappropriate finish markedly detracts from the building (and the Upper Windmill Street Conservation Area), but potentially also poses risks to the building's fabric.

| Proposal | Assessment |
|---|---|
| Removal of the cementitious pebbledash render and replacement with lime render. | <p>This would aesthetically enhance the listed building by replacing an unsightly, inappropriate surface treatment with a more appropriate one.</p> <p>This would also:</p> <ol style="list-style-type: none"><li>i. sustain the significance of the listed building, and</li><li>ii. remove risks to it by replacing an impervious surface treatment with a breathable one.</li></ol> <p>Both of these are described as examples of 'heritage benefits' in the National Practice Guidance (Paragraph: 020 Reference ID: 18a-020-20190723).</p> |

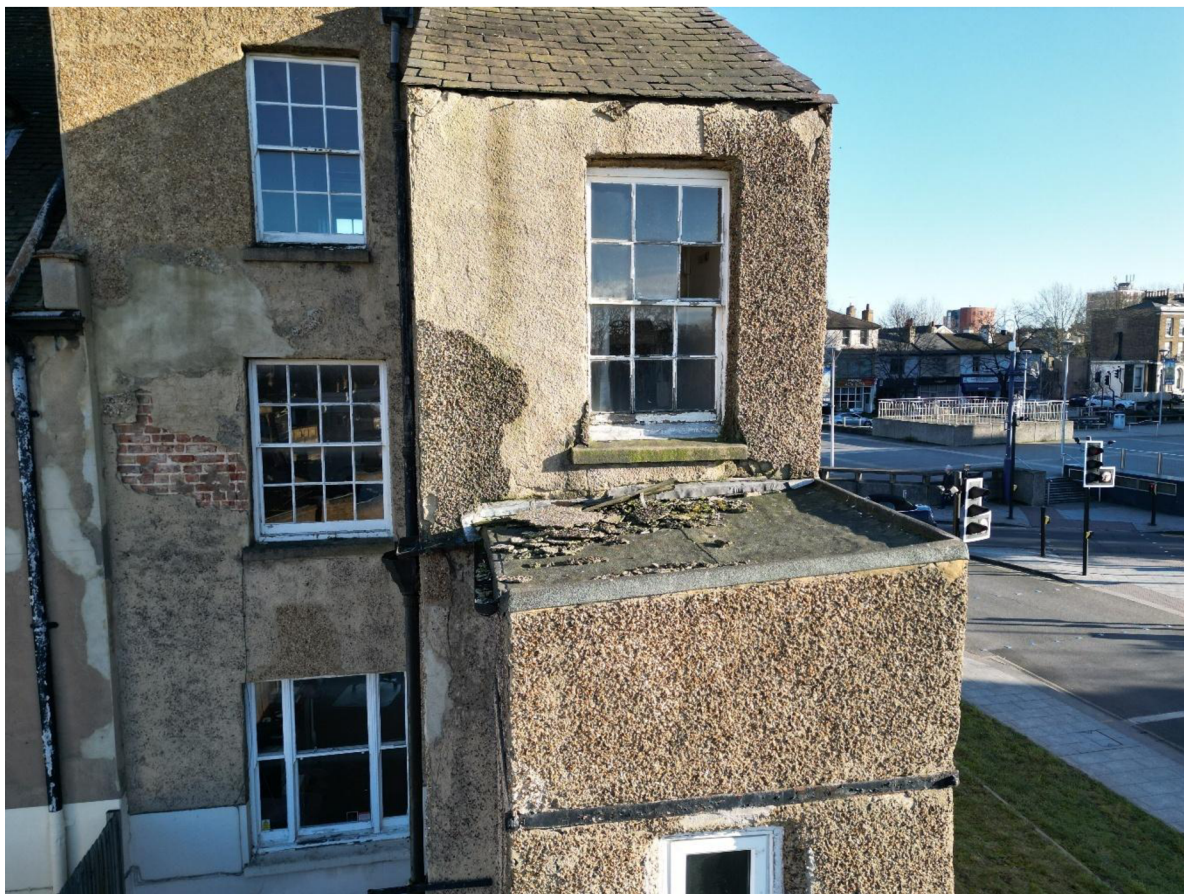
- 2.16 The high level view of the rear of 20 Stone Street (**Photo 4**) shows the sorry state of the elevation, and also the top strap of the added little closet wing. In contrast with the coherent frontage, the view of the back of the terrace (**Photo 5**) shows the very clear difference between the houses that were converted from the former workhouse, and the subject property, with its butterfly roof and projecting staircase, which was added at the end of the former workhouse. Unlike the façade, from here it is not difficult to distinguish the different phases.

**Photo 4:** An elevated view of the rear of 20 Stone Street.

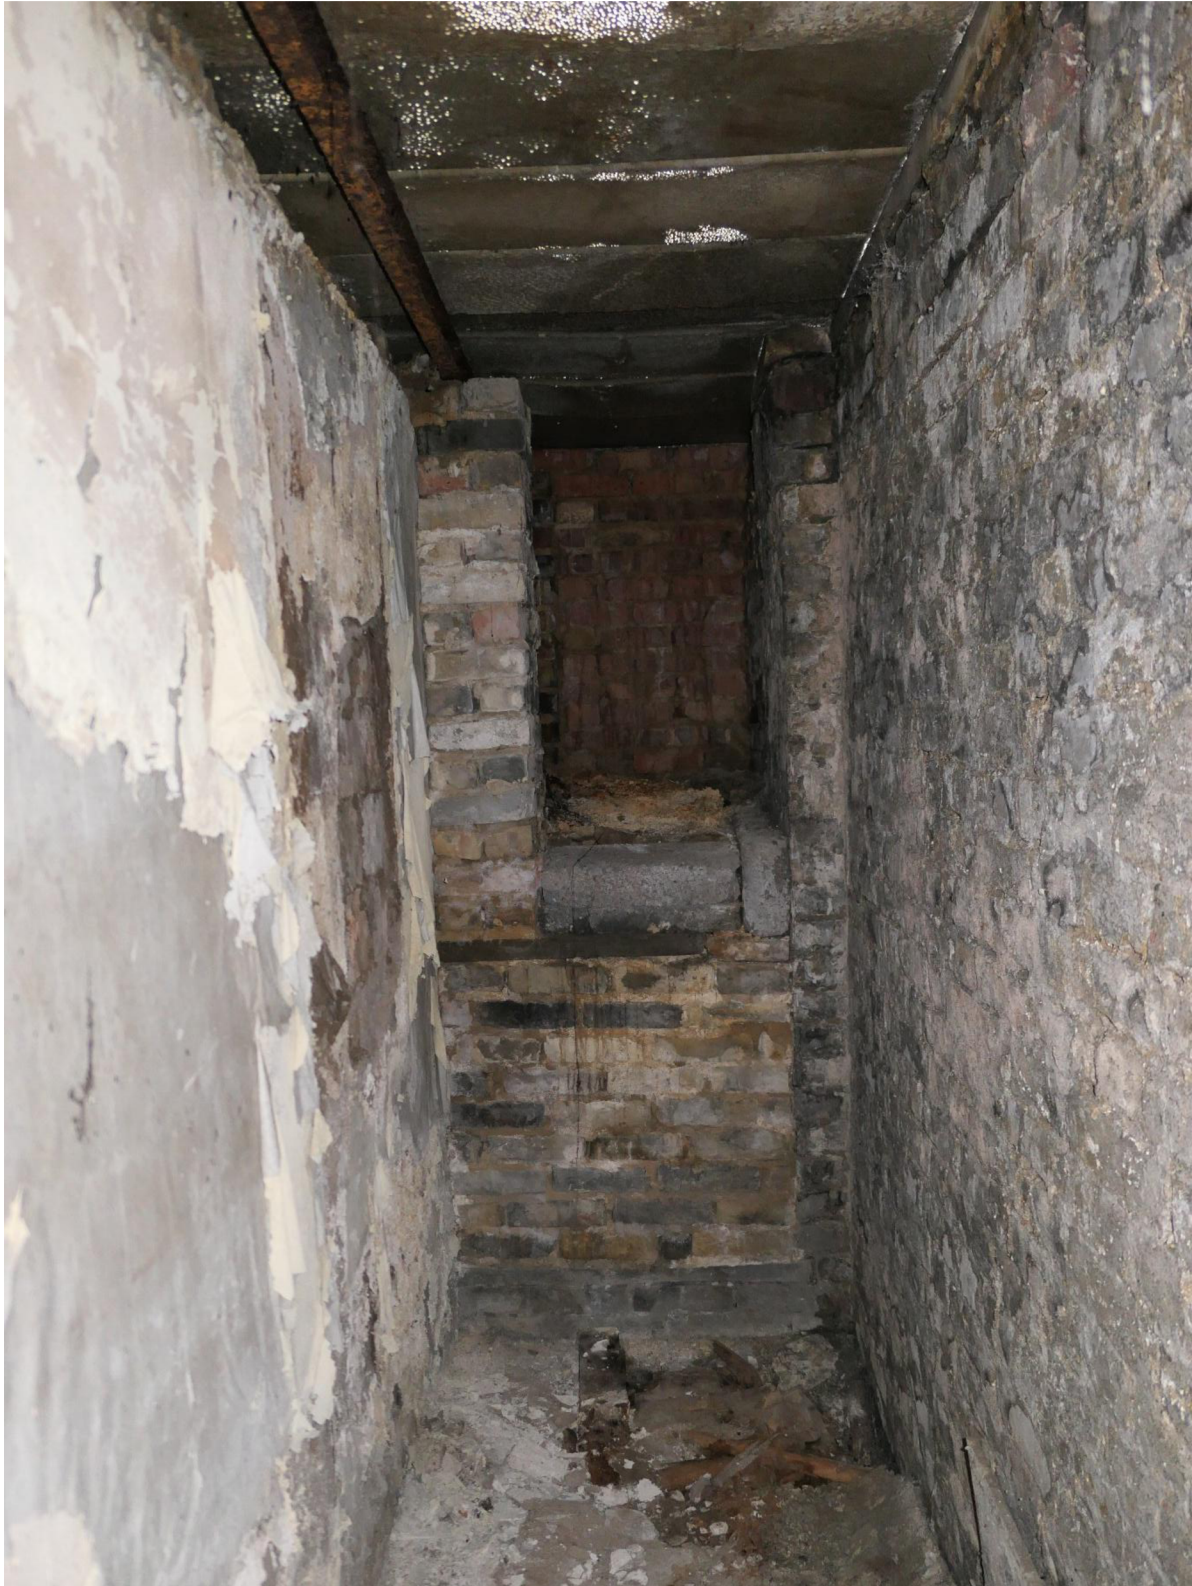
- 2.17 Turning to the interior, the front and back room arrangement, with a service passage between the stairs and the front light well, has survived in a legible way. The front basement light well has been covered/internalised, but survives in a fossilised way (**Photo 6**), with the front room's basement window now filled with blockwork.

**Photo 6:** the front basement light well has been covered, but survives in a fossilised way, with the front basement window filled with blockwork.

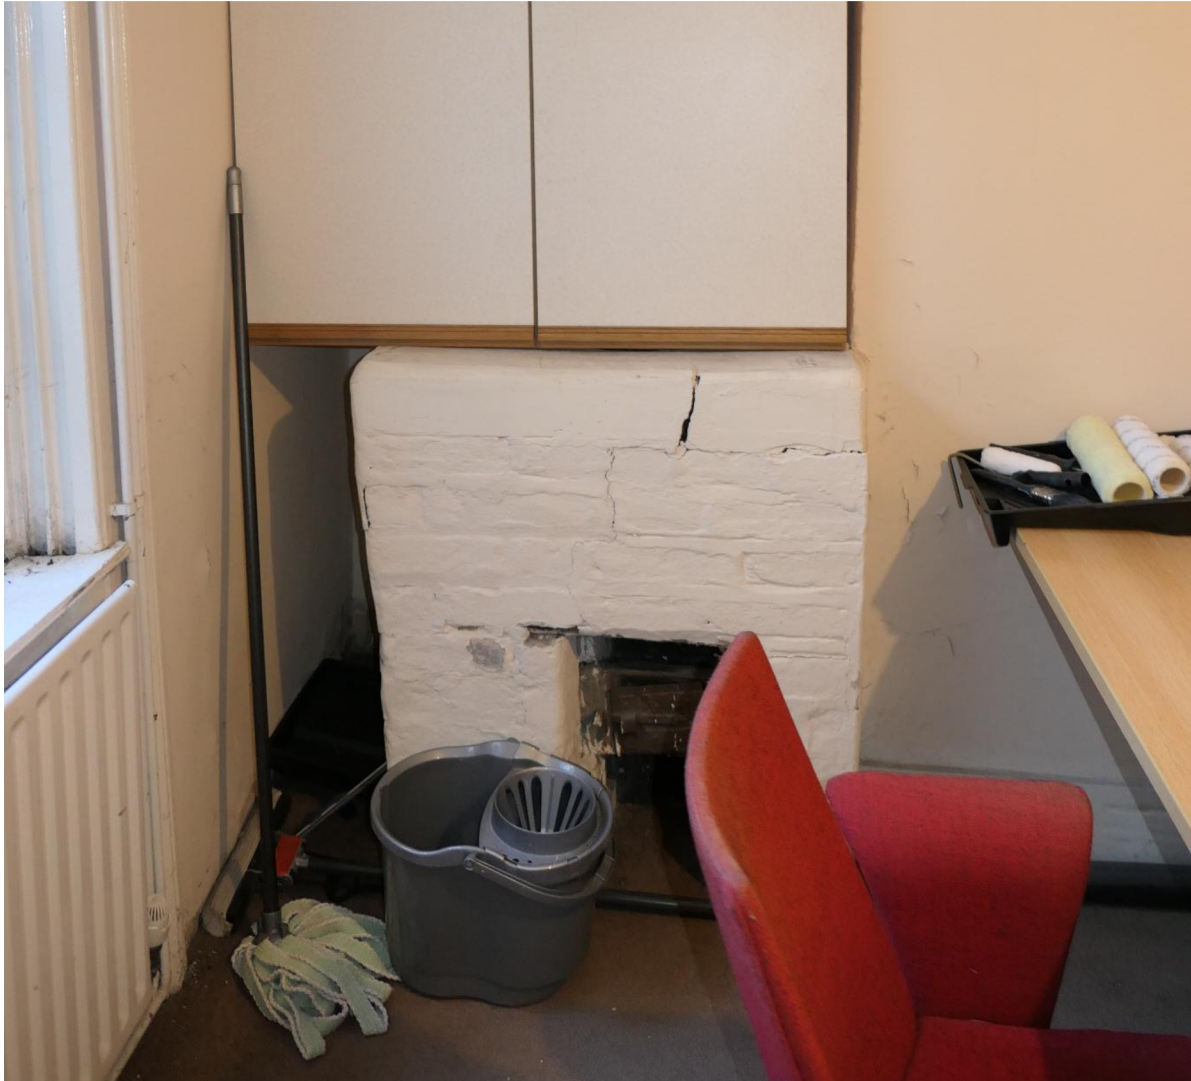
2.18 The front basement room has been converted to a strong room and it is without any features of note, perhaps aside from the heavy steel door. There are a few interesting surviving features in the rear room; there is a little brick oven or stove-like structure adjacent to the chimneybreast (**Photo 7**) and this was probably for a copper.

**Photo 7:** The little brick oven or stove-like structure adjacent to the chimneybreast in the rear basement room.

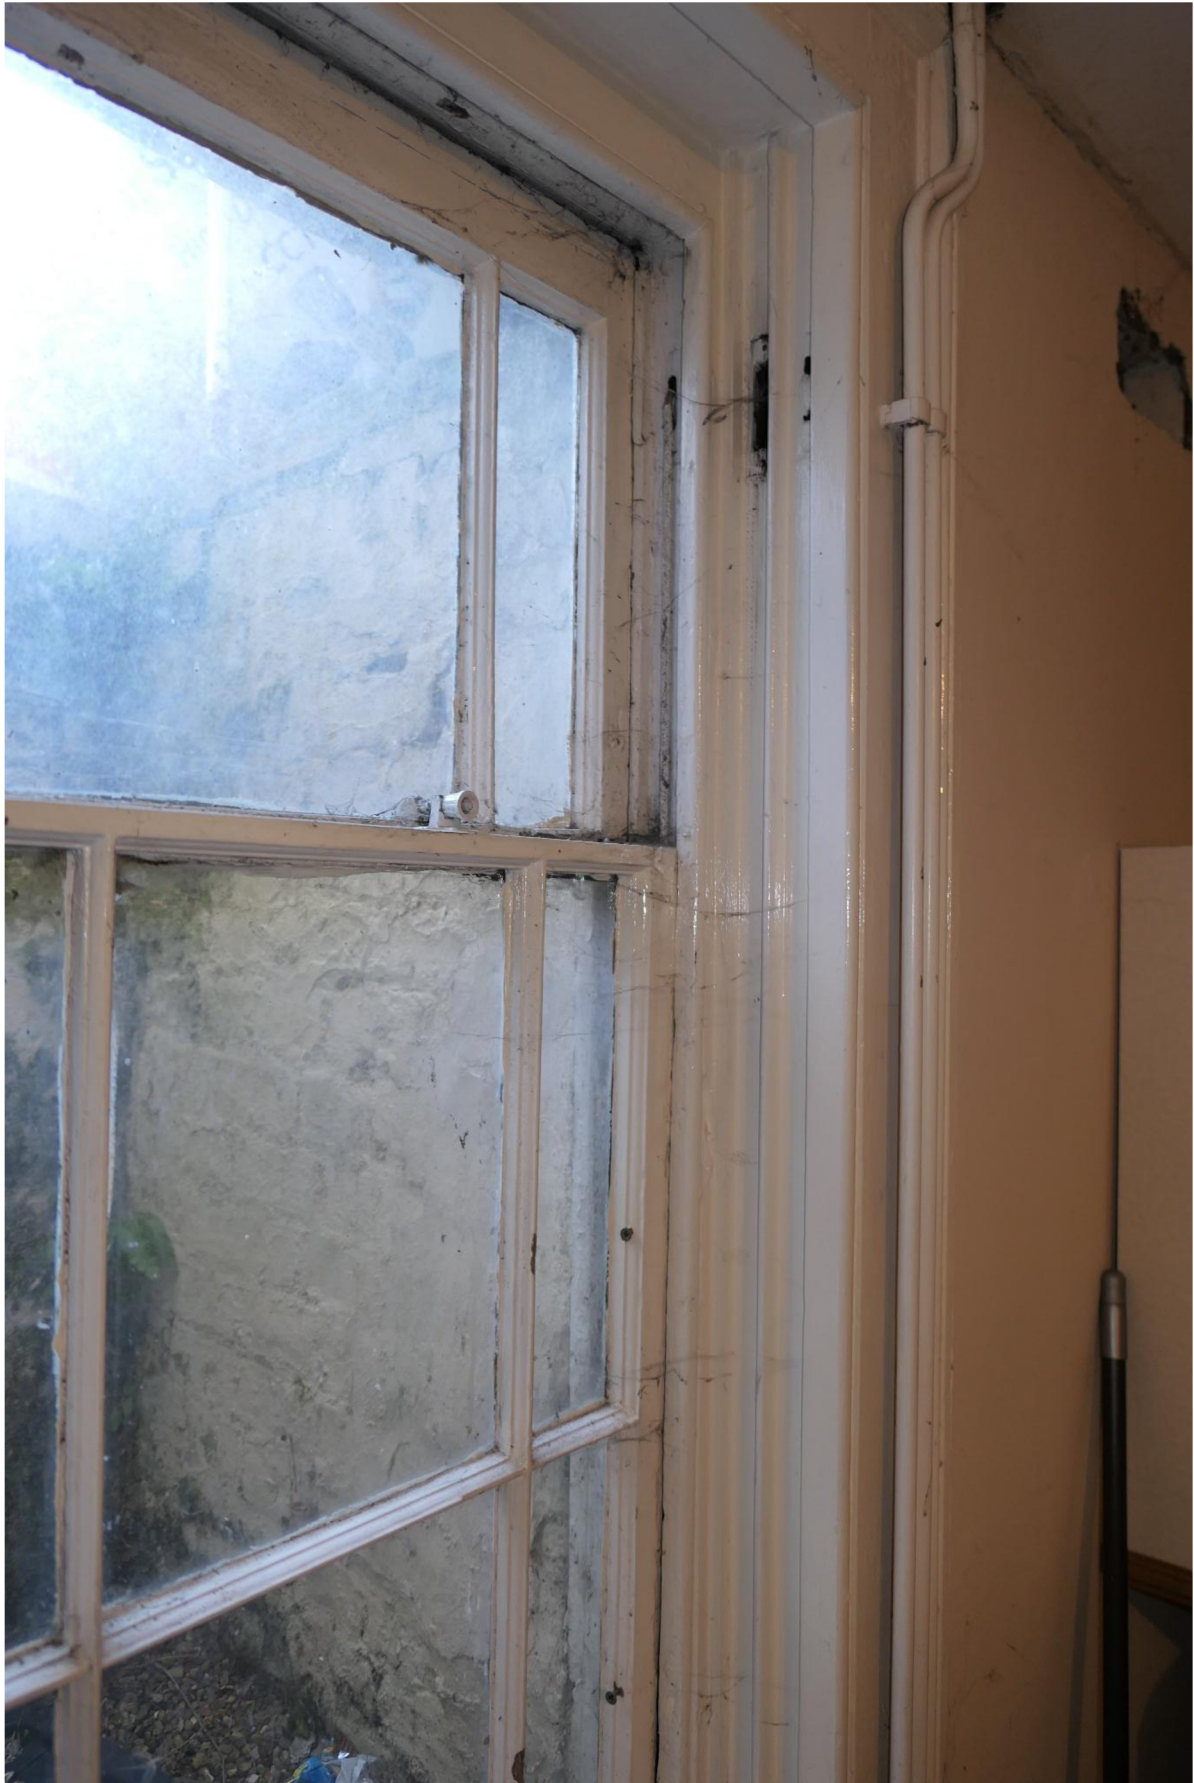
2.19 Another interesting feature in the rear basement room is the window reveal, which has a set of internal guide rails with pulleys, on the inside of the window reveal (**Photo 8**). These likely related to vertical sliding shutters that would have been contained in the box behind the radiator (see **Photo 7** above) and it is possible, though perhaps unlikely, that they are still *in situ*. The rear window looks to be original, although one of the glazing bars to the top sash has been removed. The visible components of the staircase at the basement have been replaced (**Photo 9**), possibly the result of decay from damp conditions at this level; this flight is of no intrinsic interest.

**Photo 8:** A detail of the window reveal at the rear basement room.

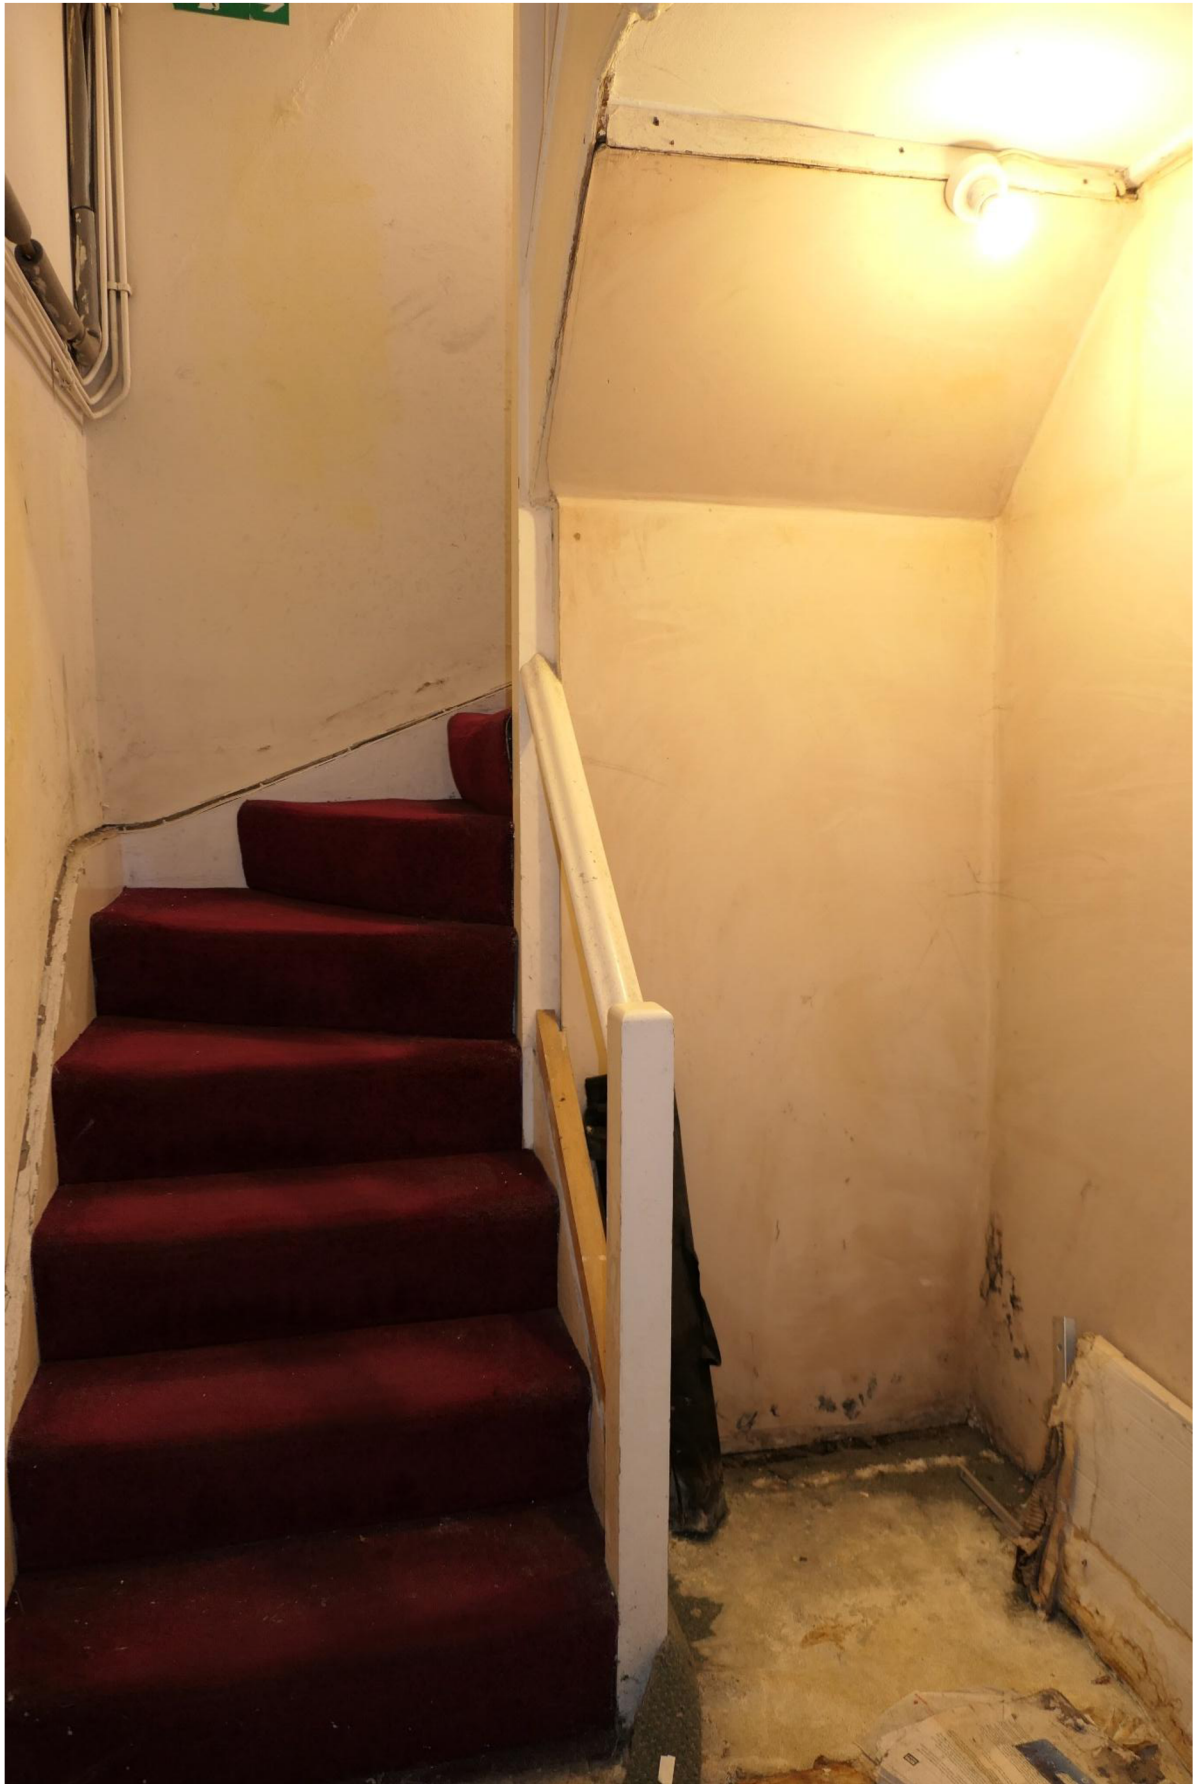
**Photo 9:** The basement stairs has been replaced.

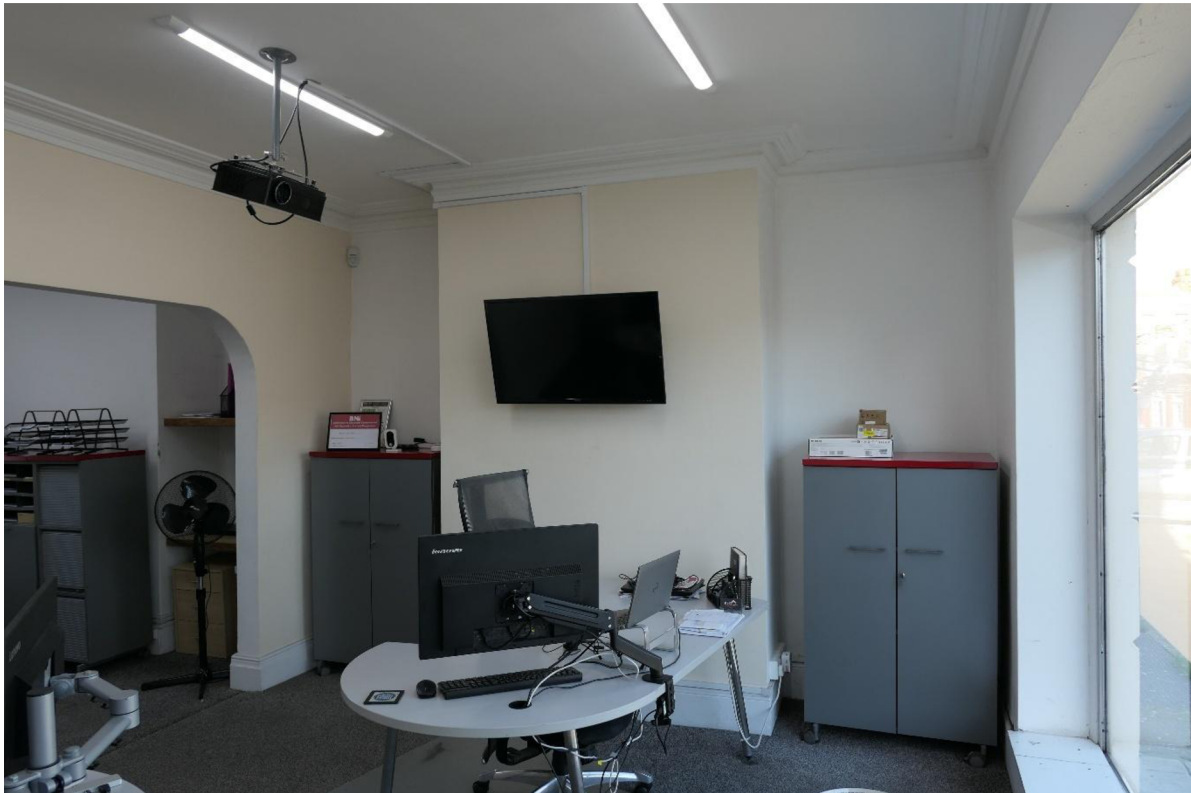
**Photo 10:** The front ground floor room.

2.20 The plan form at the ground floor is still broadly legible, although there must have been a passage between the entrance door and the rear staircase, which has been removed, and a large opening now connects the front and rear rooms (**Photo 10**). Although there is a cornice (**Photo 11**), this respects the current plan form and the crispness of the feature, along with the straight joints that can be seen in places, indicate this to be a modern replacement. The tripartite rear window is a replacement, and the opening was probably enlarged. The simple staircase with stick balusters and turned column newel (**Photo 12**) looks to be original.

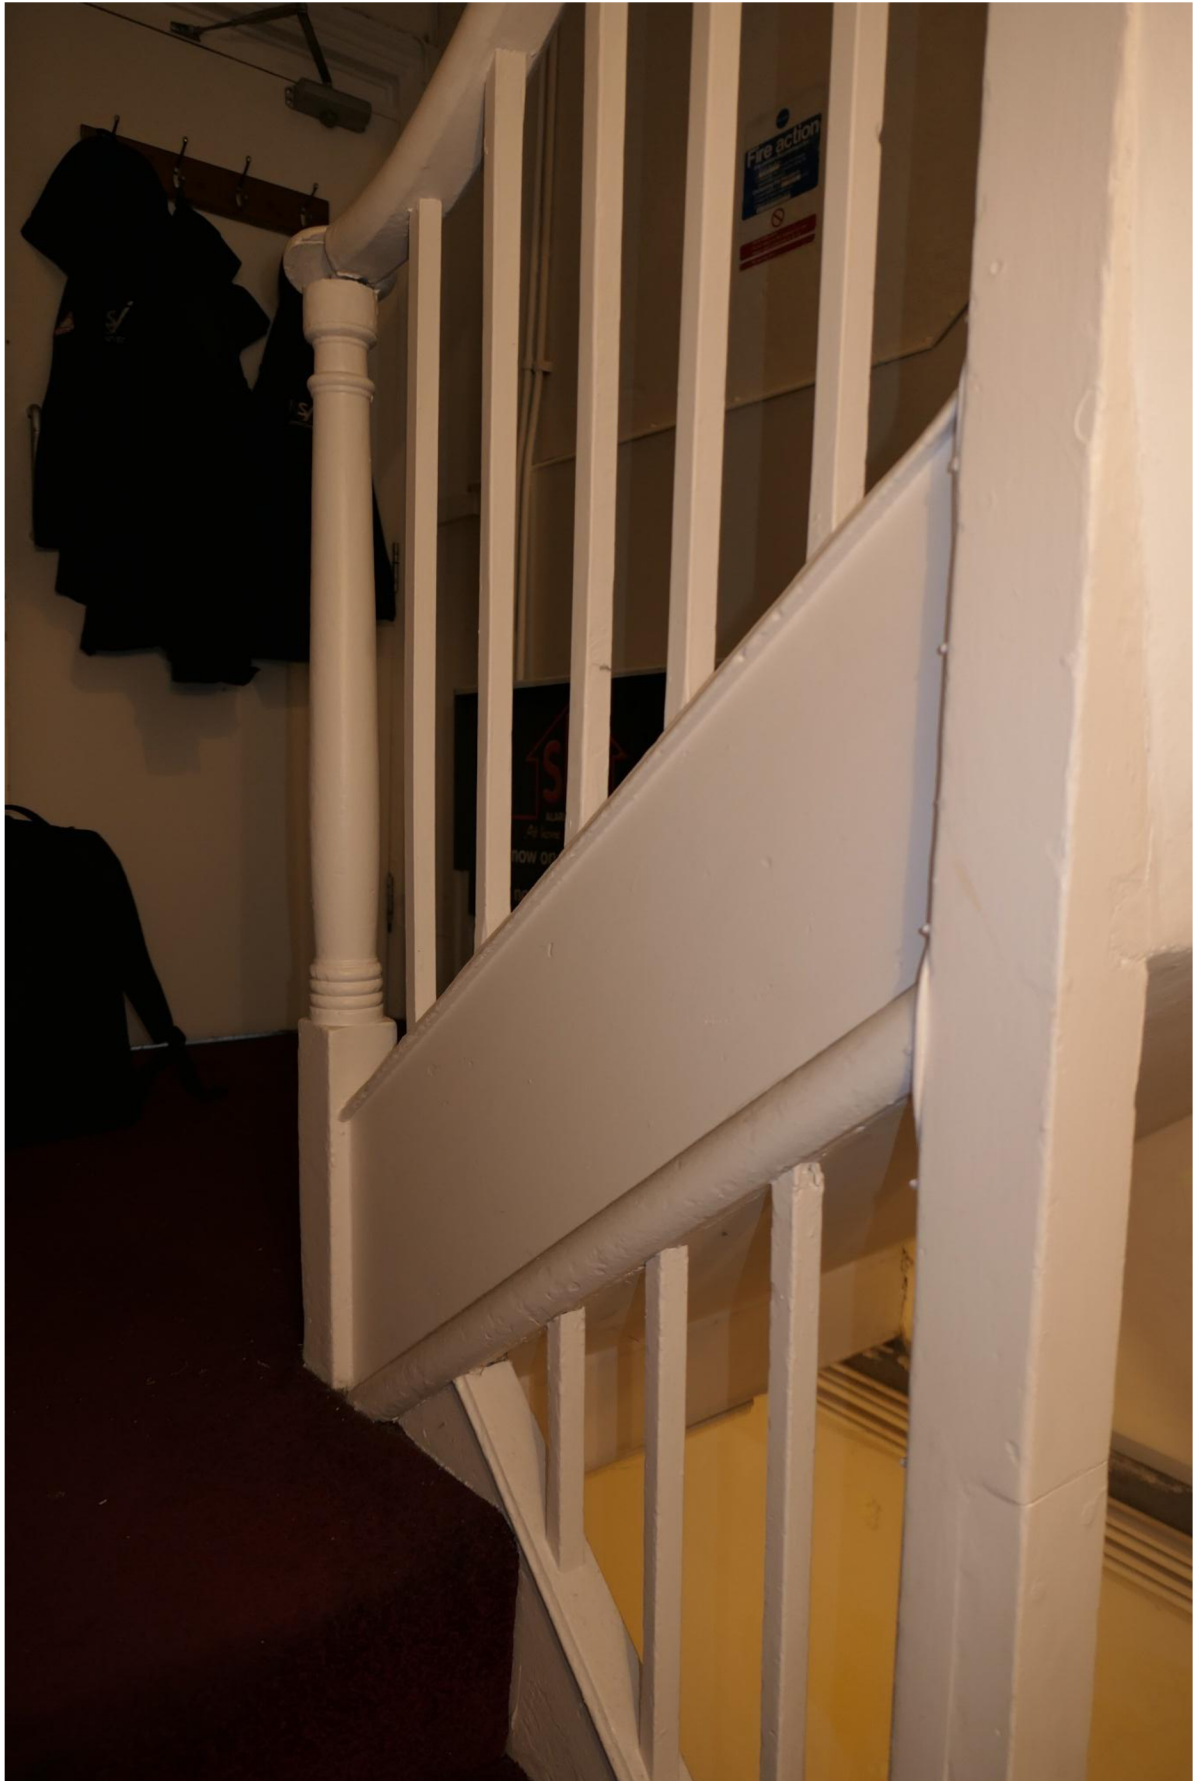
**Photo 12:** The staircase at the ground floor.

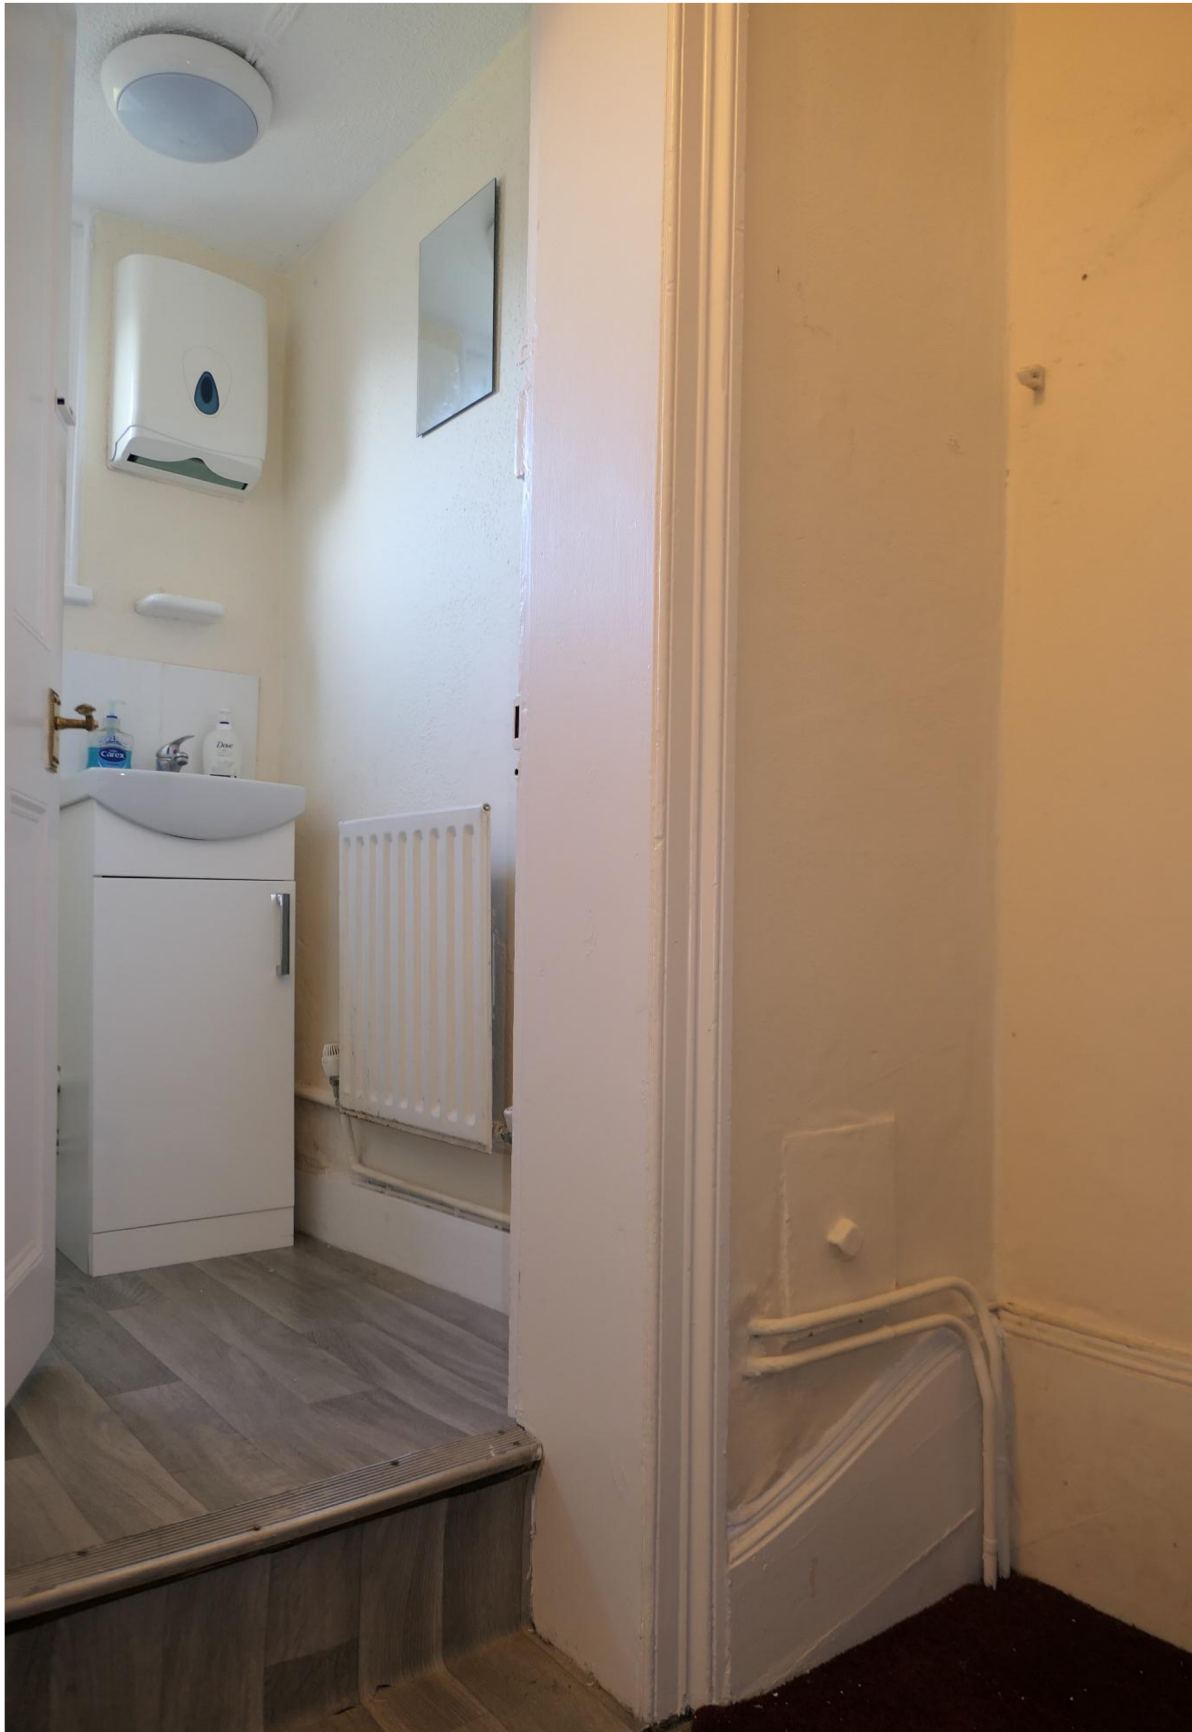
- 2.21 The rear closet wing at the half landing (**Photo 13**) is unsurprisingly featureless, although the bolt and tie plate of the external steel strap can be seen in the stairwell, where there is also a skirting board that looks to be original.

**Photo 13:** The rear closet wing at the half landing.

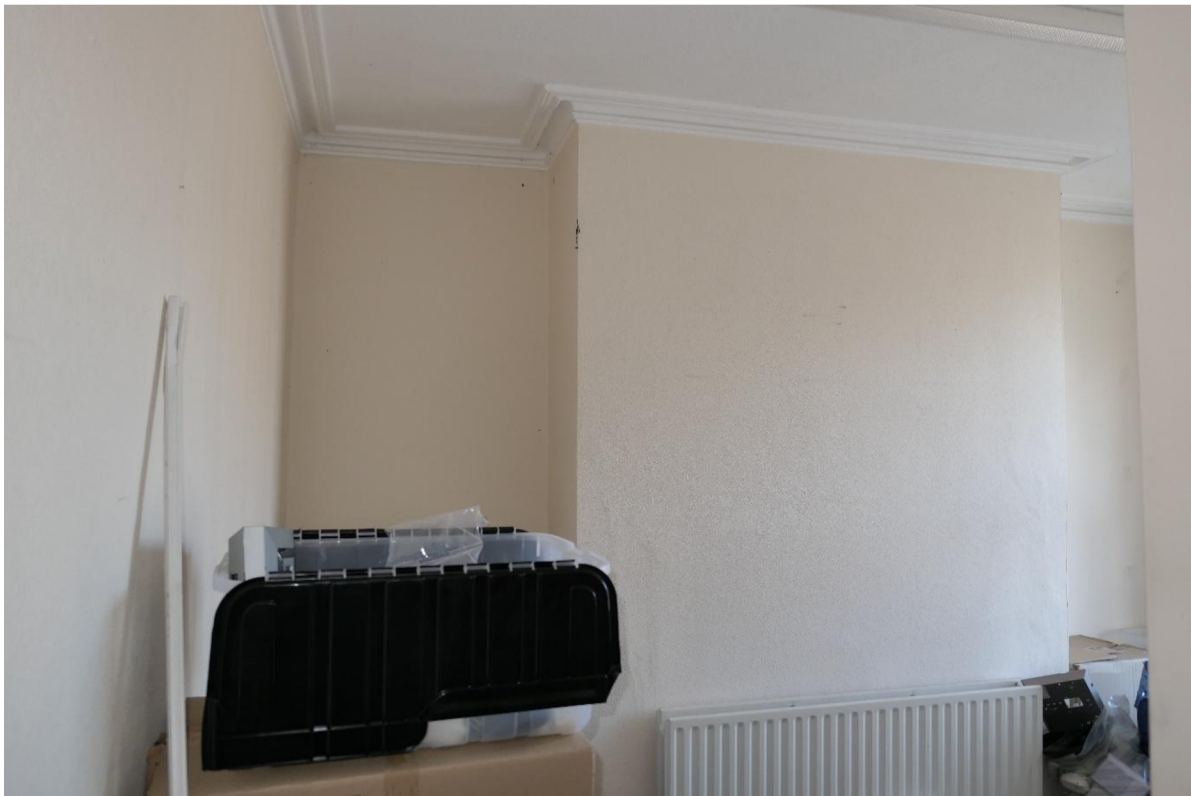
**Photo 14:** The front first floor room.

2.22 At the first floor, the plan form survives well at the rear of the building (the staircase, passage and rear room), but has been badly compromised at the front, where a small lobby and a room have been awkwardly inserted into the front room. There is an authentic-looking cornice that denotes the front room's proportions. The rear room is absent of a cornice, or any notable features. The windows (front and rear) look to be original, though in a poor state due to the effect of condensation sitting on the slim glazing bars and bottom rails. That is typical of windows of this age, but perhaps exacerbated here by the fact that the rooms look to be under-used and consequently they have perhaps not historically received the maintenance they might have otherwise. The crisp mouldings on the doorcases do not look to be of any great age, although it is possible that the frames are original. The two doors are both modern.
