# Heritage Statement

## 20 Stone Street, Gravesend, Kent DA11 0NP

**Date:** 02 April 2025

**Ref:** 01093

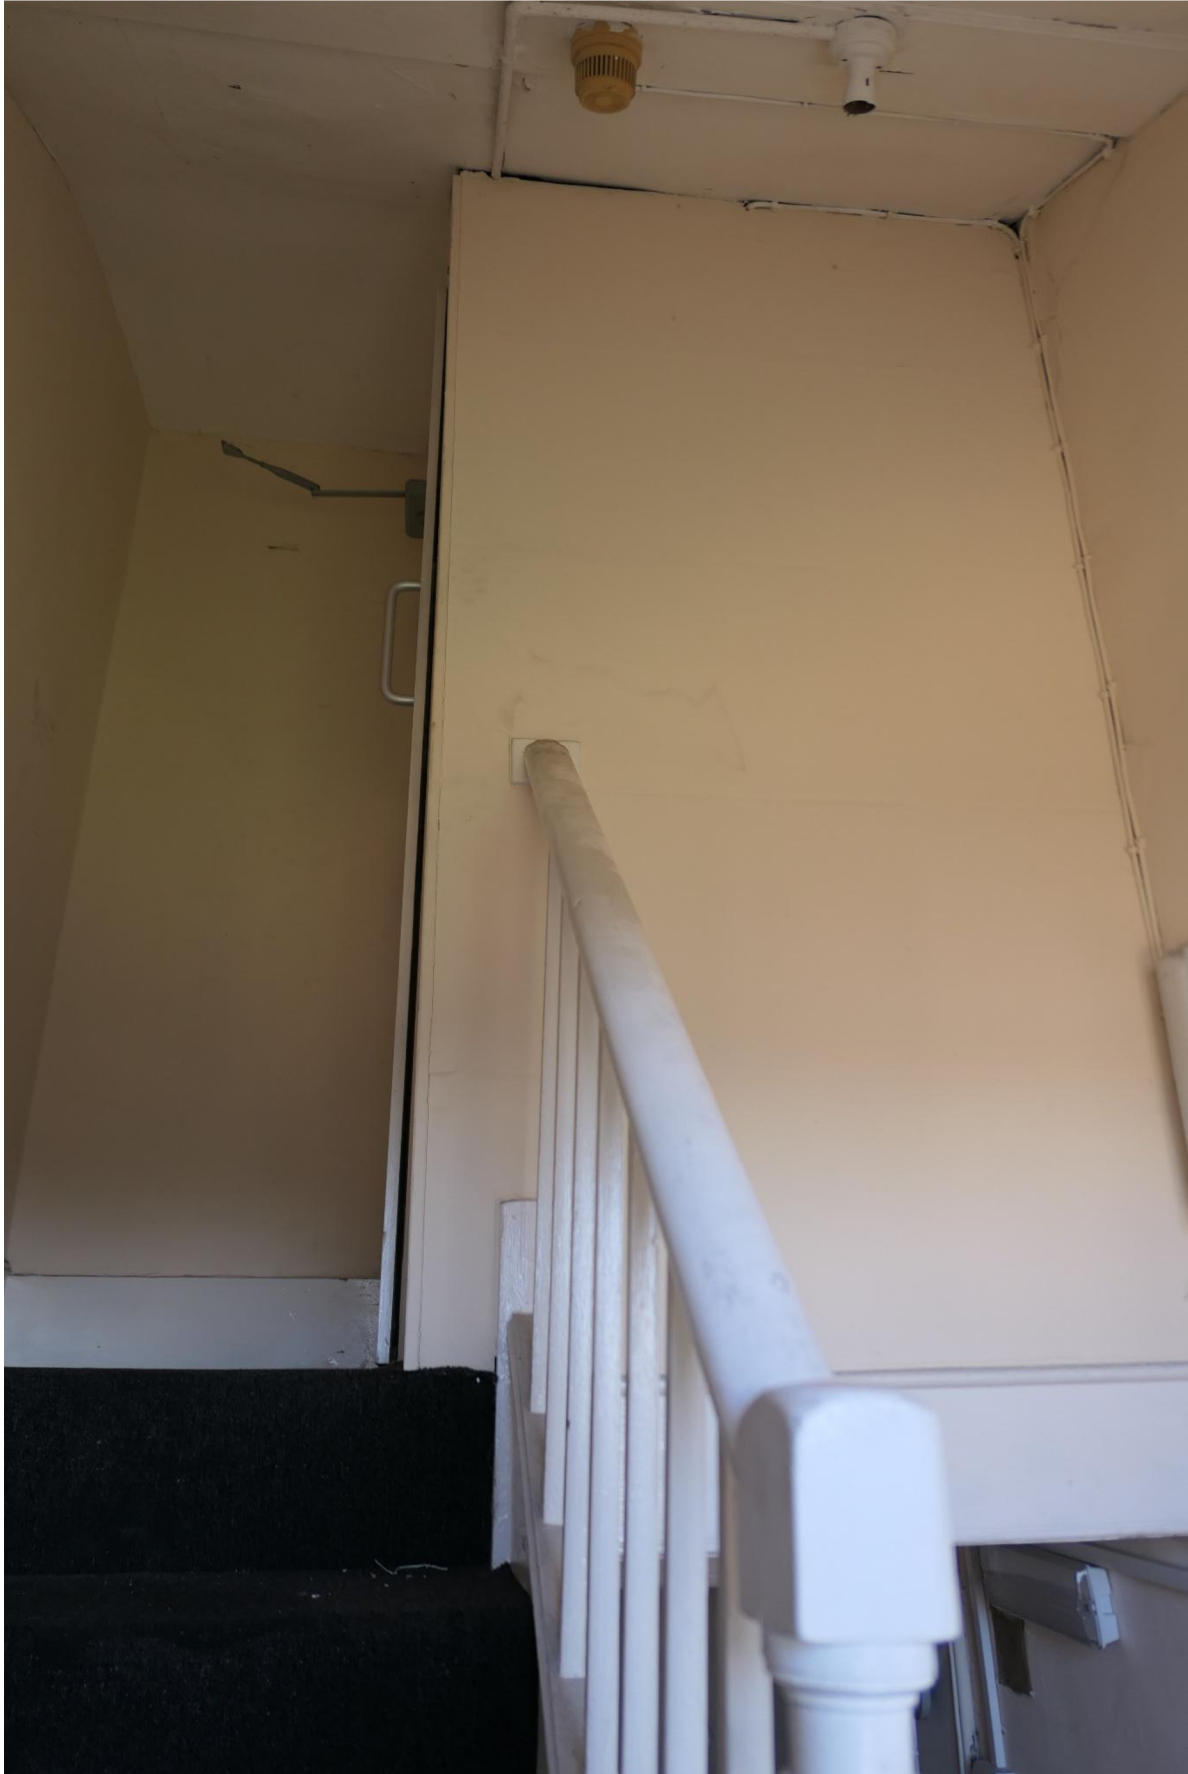
- 2.23 The staircase at the second floor has been truncated by a boxed lobby (**Photo 16**). The plan form at the rear has been compromised by removal of the passage, to create a larger rear room (**Photo 17**). A rooflight has been inserted in this area. The partition between the front and rear rooms has been replaced with a modern part-glazed partition, with a door. There is off-the-peg modern coved cornicing to both rooms. The lath & plaster ceiling in the front room (**Photo 18**) has come loose in a couple of places, possibly the result of damp deterioration because the upper floor is evidently under-used. While the front windows are original, they are self-evidently in a poor state. The rear window has been replaced, presumably due to having deteriorated beyond repair in the past.

**Photo 16:** The staircase at the second floor has been truncated by a boxed lobby.

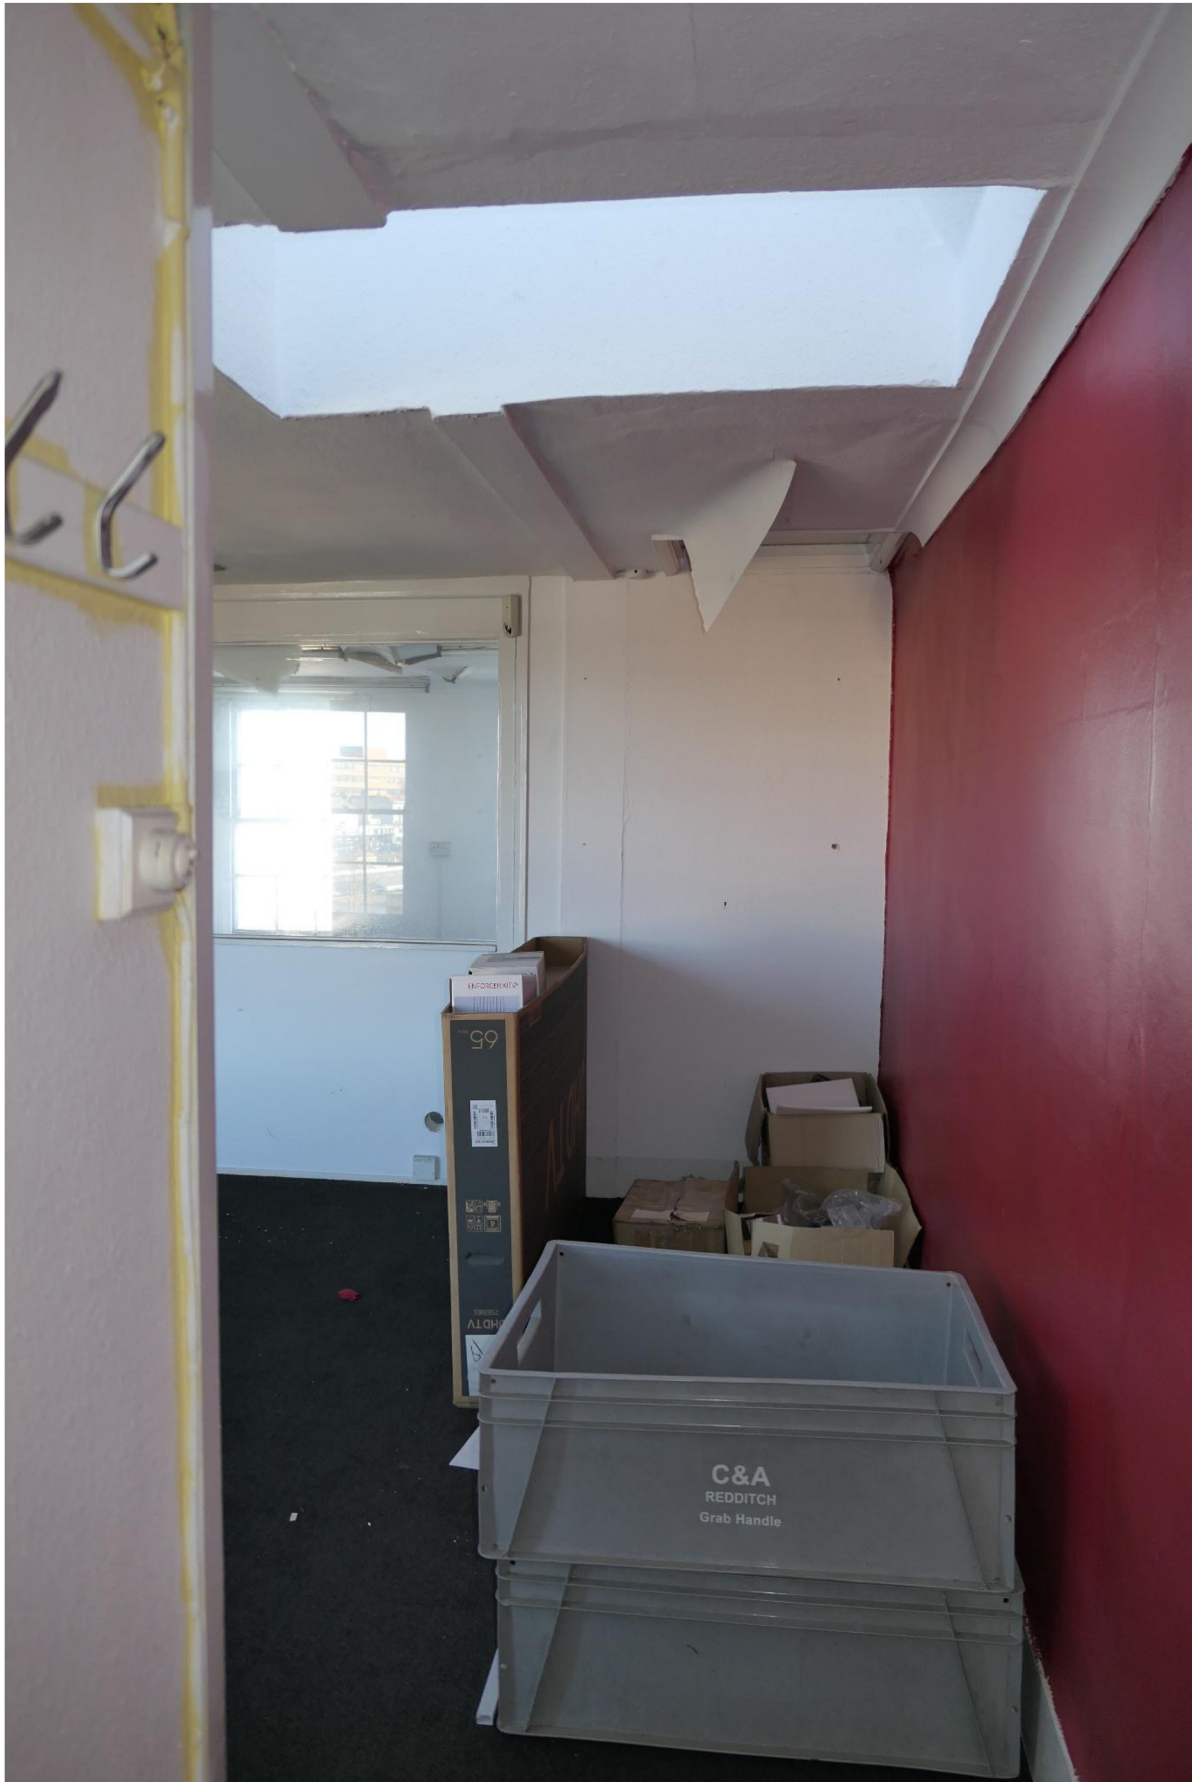
**Photo 17:** The plan form at the rear has been compromised by removal of the passage, to create a larger rear room.

| Proposal | Assessment |
|---|---|
| Insertion of a small bathroom at the second floor rear room, which reinstates the corridor. | On one hand, this would be harmful in the sense that there would be a bathroom within the rear room. On the other hand, this would reinstate a legibility of plan form on the second floor that does not presently exist, and which would be an enhancement. The assessment is undertaken on the basis that the overall effect of this intervention is neutral, when the harm of a bathroom in the rear room is balanced with the reinstatement of a plan form that would improve on the existing layout. |
