# **Milton Place, Gravesend**

Phase 2 Geo-Environmental Assessment

**Reference:** AW/CS/P23-2862/02 Rev A

**Date:** January 2024

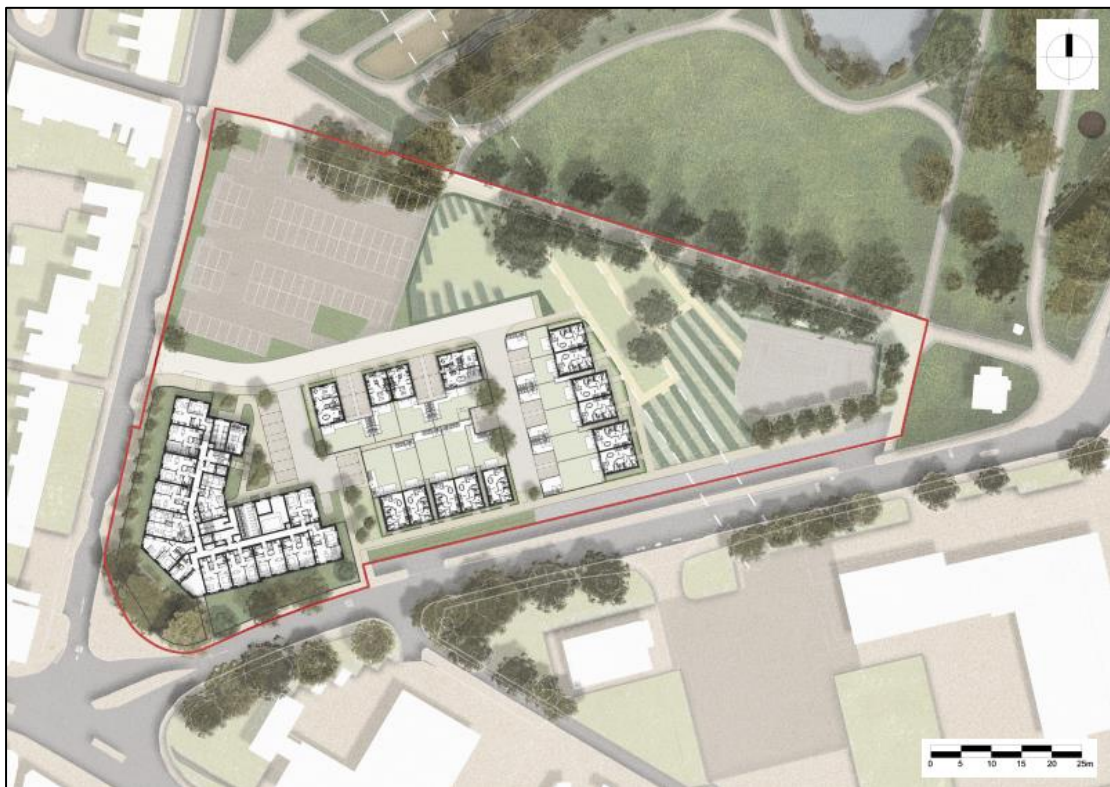
**Figure 1.1: Proposed Development Layout**

- 1.2 The Client plans to submit a planning application to Gravesham Borough Council for development of the Site with 76No. units comprising 61No. units within a 4-storey apartment block and 15No. 2/3 storey residential houses with private gardens, associated car parking and areas of soft landscaping.
- 1.3 The proposed development layout is illustrated in Figure 1.1, below:

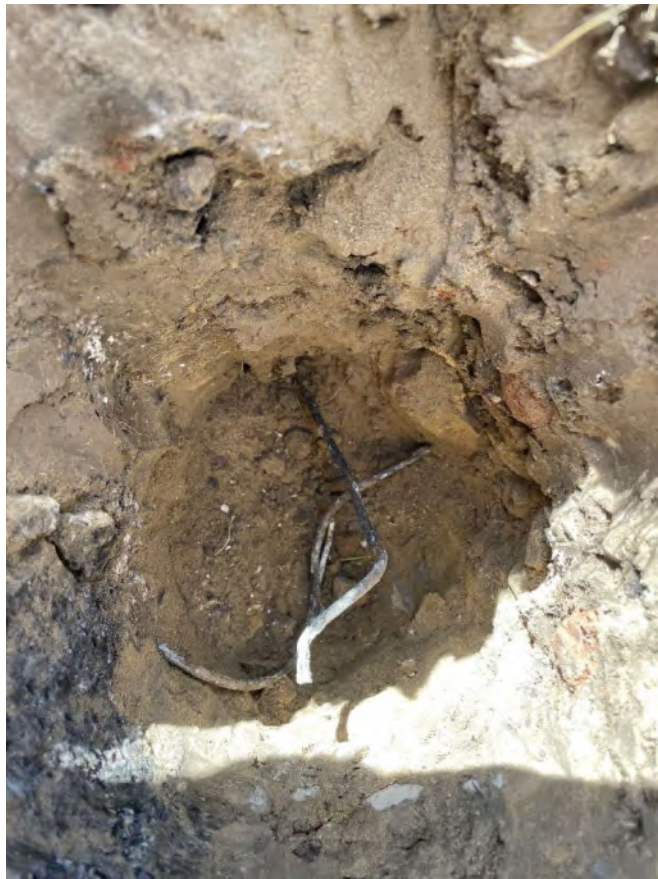
**Plate 1: WS01 – refusal on possible reinforced  
concrete wall of former swimming pool**
