**LUSTRE**  
CONSULTING

**2 VALE ROAD - NORTHFLEET**

**SUPPLEMENTARY PHASE 2 SITE INVESTIGATION**

| NON-TECHNICAL SUMMARY | |
|---|---|
| Site | Vale Road, Northfleet DA11 9RE |

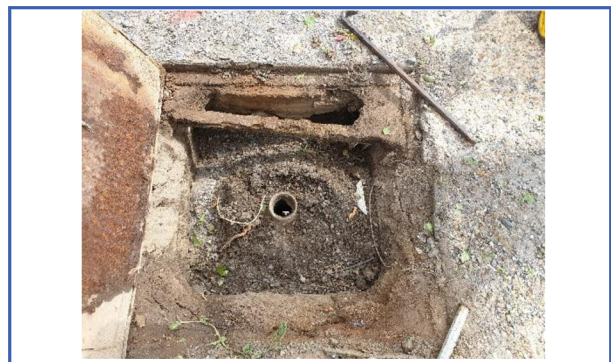
*Fill point infrastructure within manhole*

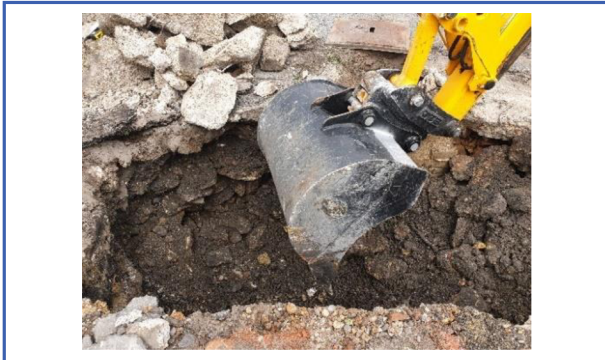
3.9 Within TP203 ground conditions beyond the concrete slab (logged as side A) were consistent with anthropogenic fill material to a depth of 3.3m bgl. This comprised silty sand gravel with moderate ash content. Gravel was recorded as chalk, brick, glass, slate, concrete and brick. At 3.3m bgl ground conditions were recorded as yellowish brown and greyish brown silty slightly gravelly SAND with gravels comprising flint and chalk. This layer remained unproven to base of the excavation at 3.8m bgl.

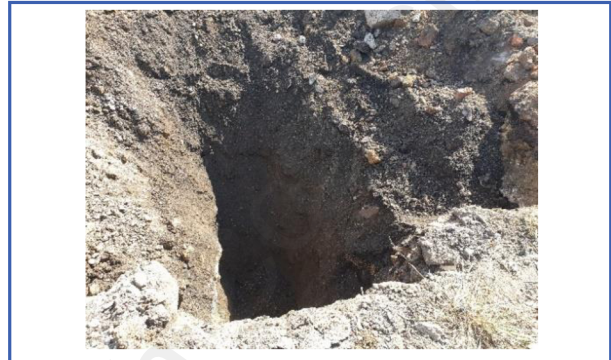
TP204

3.10 Within TP204, reworked natural soils broadly similar to those encountered in TP203 were identified from a depth of 1.3m bgl in the excavation undertaken adjacent to the concrete slab. The reworked natural soils were described as orangish brown sandy gravelly CLAY. Gravels comprised flint and chalk. This was underlain by natural soils comprising white structureless CHALK at depth of 2.5m to base of the excavation at 2.8m bgl.

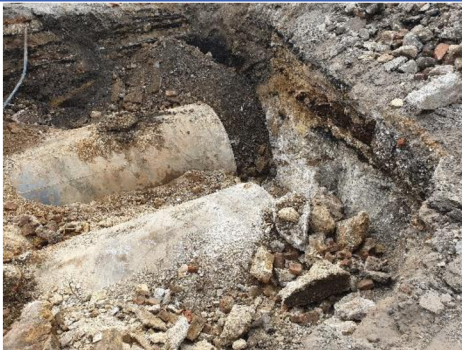
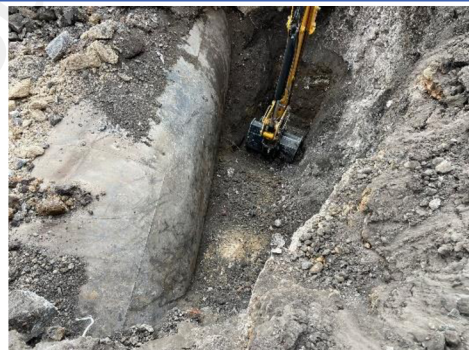
- 3.11 Further excavation was then undertaken through the concrete slab as this was suspected to be a protective cap above the USTs. Two cylindrical tanks were identified beneath the concrete. The fill point identified above related to the southern tank, with a second tank identified to the north which had a fill point at the opposite end of the tank. The excavation was progressed to expose the tanks on three sides (northern, southern and western); access constraints prevented the excavation from completely exposing eastern end of the tanks. Both tanks were orientated from east to west and measured approximately 1.8m in diameter and are estimated to be 10m in length. The depth to the top of the tank was estimated to be 1.7m bgl. It is noted that based on a 1.8m diameter, the base of the tanks would be at an approximately depth of 3.5m bgl. Excavations TP203 and TP204 would therefore have been deep enough to coincide with lower half of the tanks i.e. most likely area of soils to have been impacted by any leaks originating from tanks. Further excavation was then undertaken along the northern side of the tank (TP205). Ground conditions were consistent with reworked naturals encountered in TP204; however, these soils were identified to extend to the base of the hole at 4.6m bgl.

- 3.12 Both tanks appeared to be in good condition with **no evidence of corrosion, damage or loss of integrity**. No visual or olfactory evidence of hydrocarbon contamination associated with tanks was observed. However, a small area of staining (no odour or elevated PID readings) possibly representing a minor historical spill from surface was identified along the northern side of the tanks extending to a depth of approximately 2.4m bgl. As noted above the USTs are located immediately off-site, rather than within the planning boundary.
- 3.13 The excavation around the tanks has been temporarily re-instated pending arrangement of tank decommissioning and removal at a future date. This comprised backfilling with arisings and sealing of the surface with concrete to prevent infiltration of surface water.

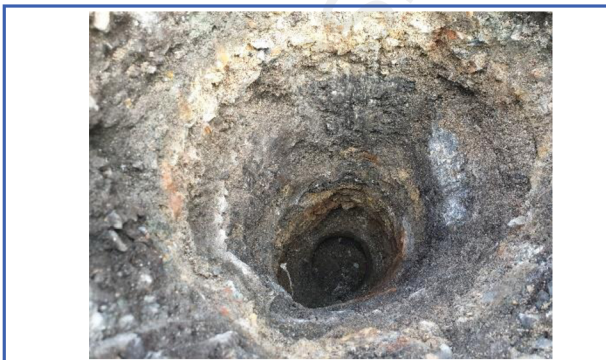
- 4.3 Made Ground was encountered from a depth of 0.15m bgl to a depth of 18.8m bgl and comprised a mixture of both granular and cohesive material.
- 4.4 Granular Made Ground was encountered to a depth of 2.7m bgl which was broadly similar to Made Ground encountered within trial pit excavations undertaken both in the former forecourt of the petrol filling station and offsite adjacent to the west of the former shop footprint. However, slight hydrocarbon odour was noted from 0.15 to 0.6m bgl likely associated with coal tar within bituminous materials.

*BH201 – hand pit*

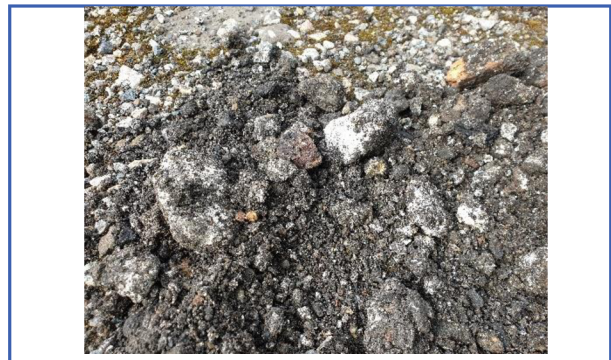
*BH201 arising to 2.7m bgl*

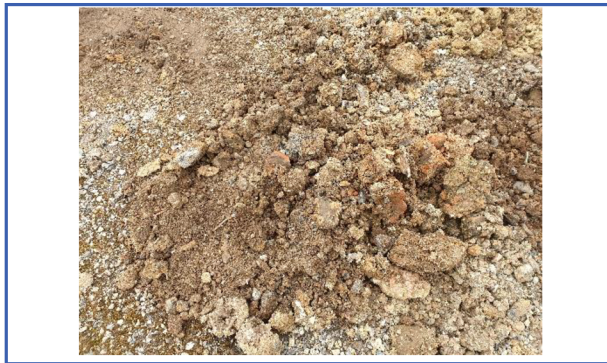
- 4.5 This was underlain by predominantly cohesive Made Ground to a depth of 10.3m bgl. Cohesive Made Ground comprised slightly sandy gravelly silty CLAY with varying amounts

and types of anthropogenic constituents. Localised high proportions of metal were encountered throughout the cohesive Made Ground as well as occasional coarse gravel size fragments of coal tar with an accompanying slight hydrocarbon odour. Suspected ACM cement was encountered from 4.7m to 6.5m bgl. Organic clay and inclusions of wood were encountered within cohesive Made Ground from 7.9m bgl to 9.3m bgl.

*BH201 representative arisings 2.7-6.5m*

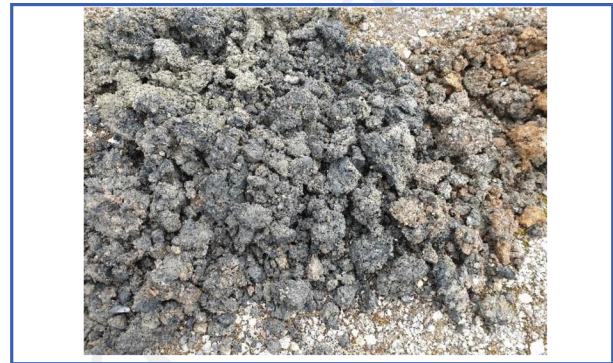
*BH201 representative arisings 7.9 – 9.3m bgl*

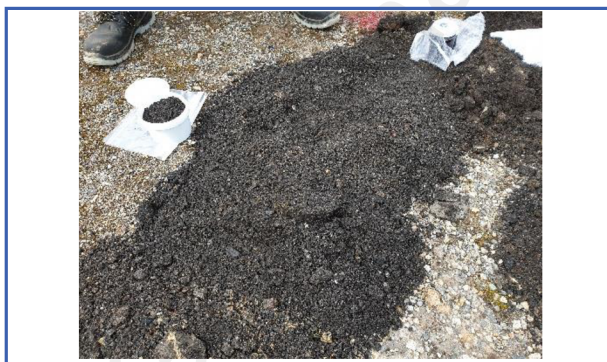
- 4.6 From a depth of 10.3m bgl to base of Made Ground at 18.8m bgl Made Ground was granular and predominantly comprised black silty sand GRAVEL with high ash content. This material was considered to be consistent with bottom ash. Other anthropogenic materials in minor quantities included metal, brick, wood and slate. Suspected ACM cement was encountered at a depth of 11m bgl. From 18m to 18.8m bgl materials appeared to comprise demolition rubble and included degraded coal tar likely from felt roofing as well as brick, slate and concrete.

*BH201 – representative arisings 10.3-18m bgl*

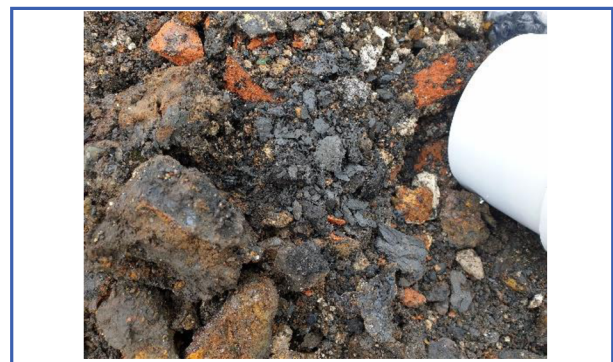
*BH201 – representative arisings 18-18.8m bgl*

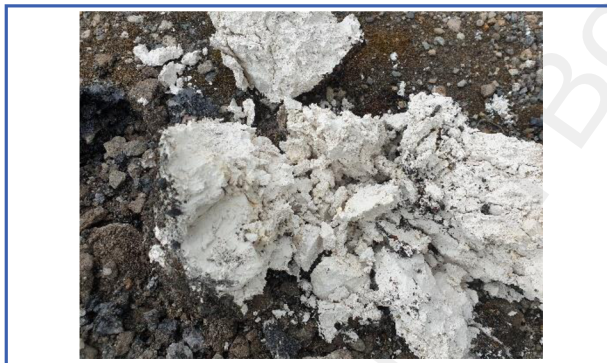
- 4.8 Chalk arisings were encountered from a depth of 18.8m bgl. These became damp from approximately 20m bgl and were recovered as silty water from below the water strike at 21m bgl. A band of flint was encountered from 25 to 25.3m bgl.
- 4.9 It appears from early recovery of arisings that chalk is likely structured at this depth, however, recovery was limited and became structureless in appearance when damp. Chalk arisings were therefore described as structureless chalk composed of cream slightly gravelly SILT. Gravel is medium density and white with rare inclusions of flint gravel.
- 4.10 No visual or olfactory evidence of hydrocarbon or solvent contamination was identified. No elevated concentrations were identified from in-situ PID headspace readings.

BH201 – Chalk arisings 18.8 to 20m bgl

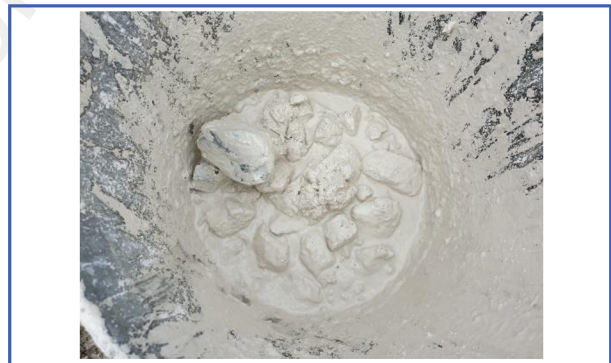
BH201 – chalk arisings circa 25m bgl
