# TOLLGATE, GRAVESEND, KENT

## Bat Survey Report

SLR Ref: 425.064460.00001  
Version No: Final  
November 2022

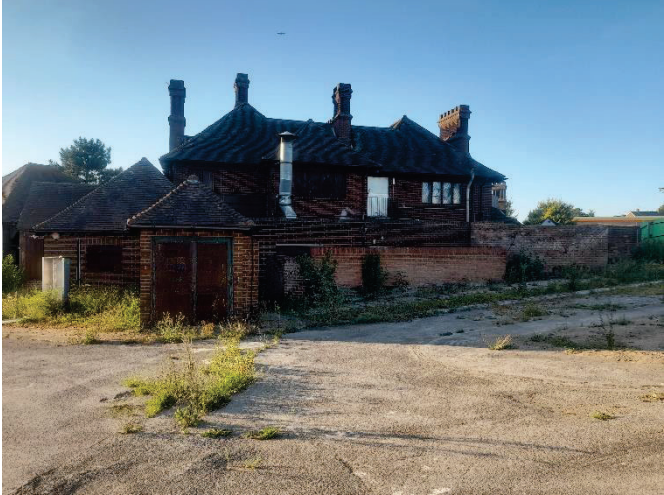
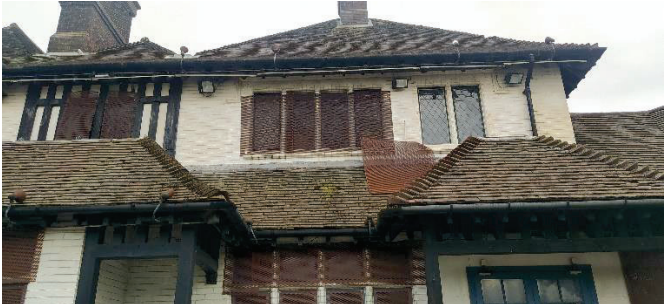
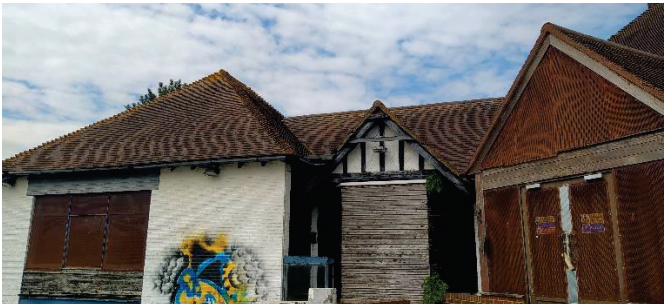
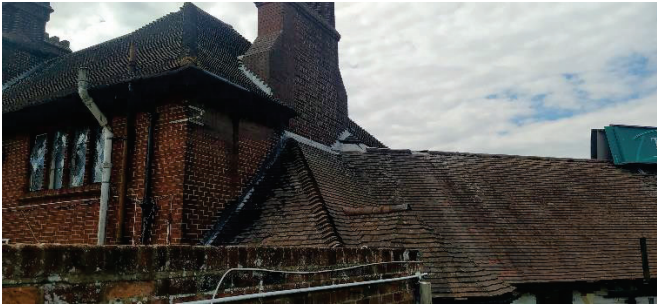
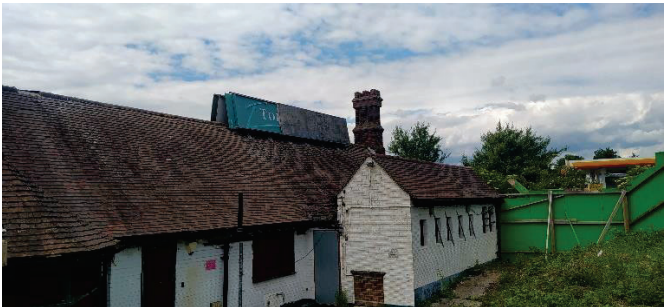
| Building Photo | Notes |
|---|---|
| <p>Building 1 – northwest aspect</p> <p>Building 1 – northern aspect, western end</p> <p>Building 1 southwest aspect</p> | <p><b>Moderate Potential</b> for roosting bats. No internal access gained. Building 1 was a large complex shaped with a two-storey central section and three single storey wings (two located at the south-eastern end and one at the north-western end). The majority of the building was constructed of red brick. There were a few holes within the brickwork. All roofs were pitched with clay tiles, including all dormers and ground-floor bay windows and porches. Many tiles were either missing or damaged. There were multiple windows and doors, which were singled glazed. Many of which were severally damaged and/or covered with security wire mesh. There was also sections of wooden tongue and grove panelling with damaged areas.</p> |

| Building Photo | Notes |
|---|---|
| <p>Building 1 – eastern aspect</p> <p>Building 1 – southeast aspect</p> | |

| Building Name | Description | Access gained? | Roosting potential |
|---|---|---|---|
| B1 | Derelict public house. Large, complex shaped building over two-storeys and single storey wings. Broken windows, missing wooden cladding, missing/broken roof tiles and holes in brickwork. | N | Moderate |

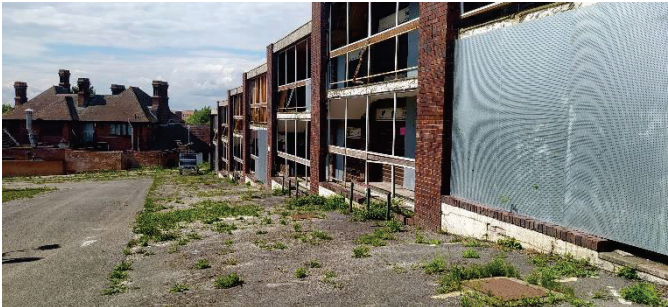
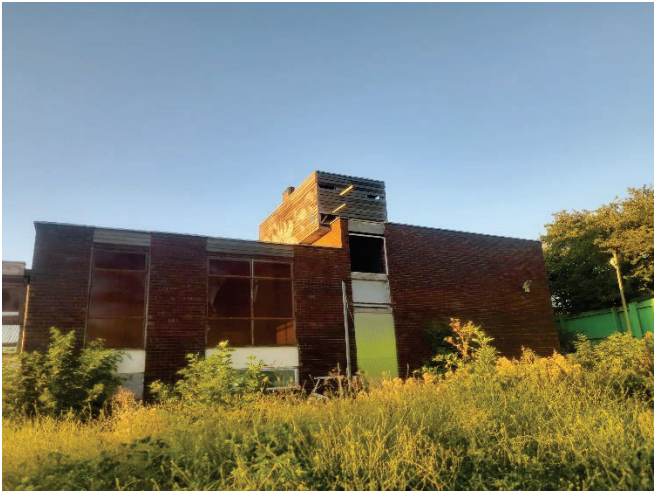
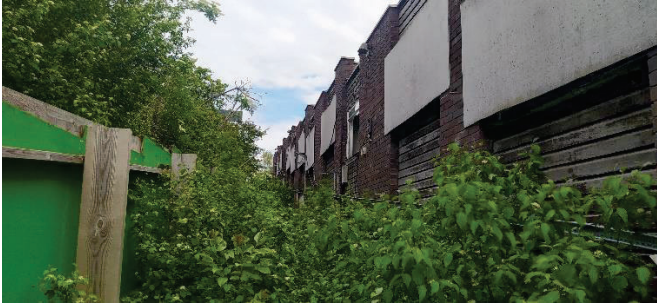
| Building Photo | Notes |
|---|---|
| <p>Building 2 – southwest aspect, northern section</p> <p>Building 2 – southwest aspect, northern section, under covered walkway</p> | <p><b>Moderate potential</b> for roosting bats. No internal access gained. Building 2 comprised two long and narrow, two-storey sections, which were joined in the middle. Each level had a covered walkway which was part of the building construction. The main building material was red brick. The roof was flat throughout. Most of the windows and doors were boarded up and not visible. The windows which were visible were single-glazed and damaged. There were large sections of wooden tongued and grooved panelling. Some wood was missing and/or damaged.</p> |

| Building Photo | Notes |
|---|---|
| <p>Building 2 – southern aspect</p> <p>Building 2 – northeast aspect, northern end</p> | |

| Building Name | Description | Access gained? | Roosting potential |
|---|---|---|---|
| B2 | Derelict motel. Long, narrow building with sections. Two-storey and flat roof. Broken windows and missing wooden cladding. | N | Moderate |

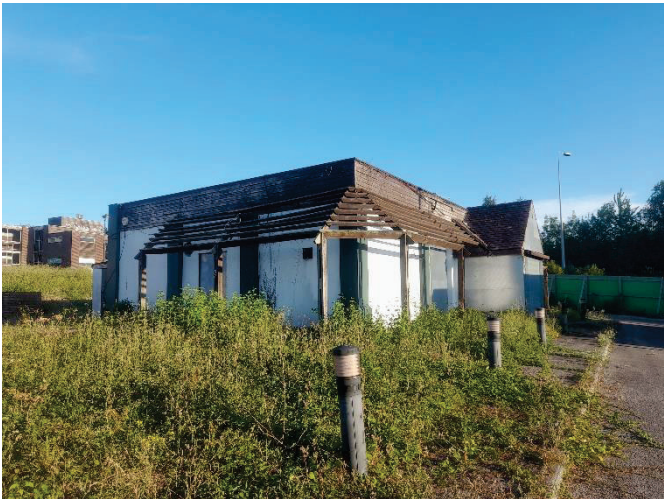
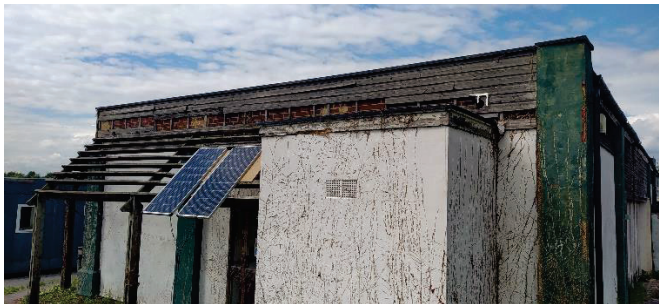
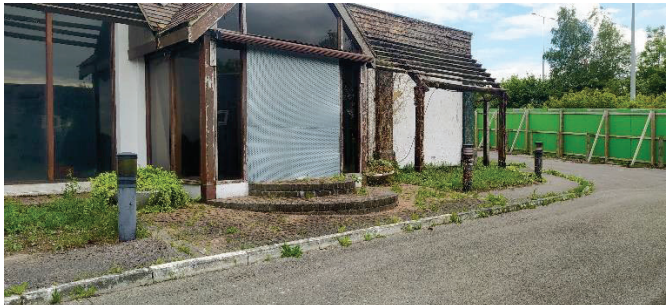
| Building Photo | Notes |
|---|---|
| <p>Building 3 – northwest corner</p> | <p><b>Moderate potential</b> for roosting bats. No internal access gained. Building 3 was a small, single storey, flat roofed building. The main construction was red brick, which was rendered over the majority of the surface with wooded tongue and groove cladding over the upper areas. Some of the wood was missing and/or damaged and there was at least one hole present in the brickwork. The main entrance had a pitched roof porch section, which had clay tiles. Some tiles were missing. The northwest aspect (main frontage) has large, single-glazed windows.</p> |

| Building Photo | Notes |
|---|---|
| <p>Building 3 – southeast aspect</p> <p>Building 3 – northwest aspect</p> | |

| Building Name | Description | Access gained? | Roosting potential |
|---|---|---|---|
| B3 | Derelict shop. Small single storey building with damaged wooden cladding, missing roof tiles and holes in brickwork. | N | Moderate |

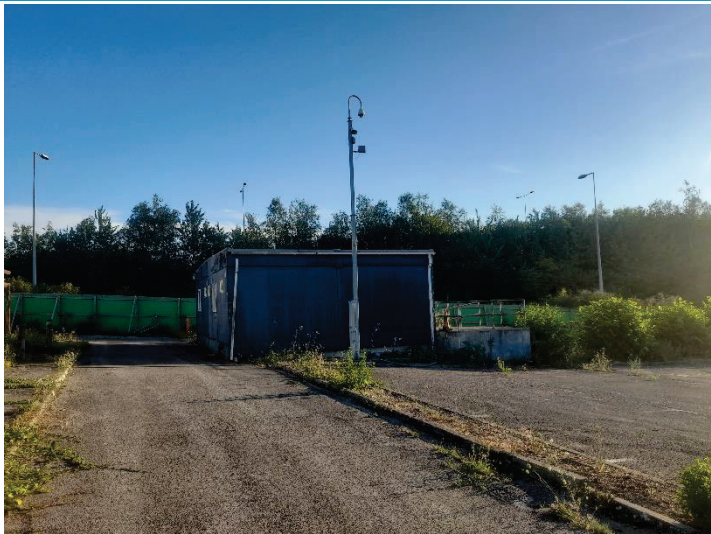
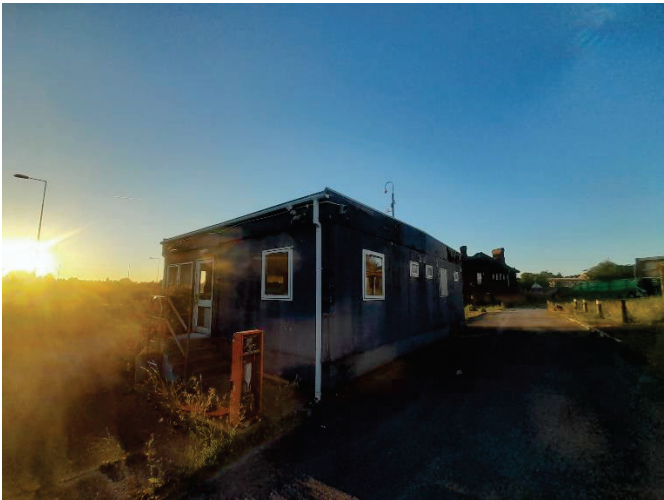
| Building Photo | Notes |
|---|---|
| <p>Building 4 – northeast aspect</p> | <p><b>Negligible potential</b> for roosting bats. No internal access gained. Building 4 was a small, single storey prefab building with a flat roof. The construction materials were mainly plywood panelling with a rendered finish, which had small amounts of damage. There were several double-glazed uPVC windows and two doors, which were in good condition.</p> |

| Building Photo | Notes |
|---|---|
| <p>Building 4 – southeast corner</p> | |

| Building Name | Description | Access gained? | Roosting potential |
|---|---|---|---|
| B4 | Derelict office. Small, single storey prefab building with minor damage to plywood panelling. | N | Negligible |
