## GEO-ENVIRONMENTAL INVESTIGATION REPORT

**Tolgate,  
A2, Gravesend, Kent**

Report No: 12954 CL 002

Client: BP Oil UK Ltd

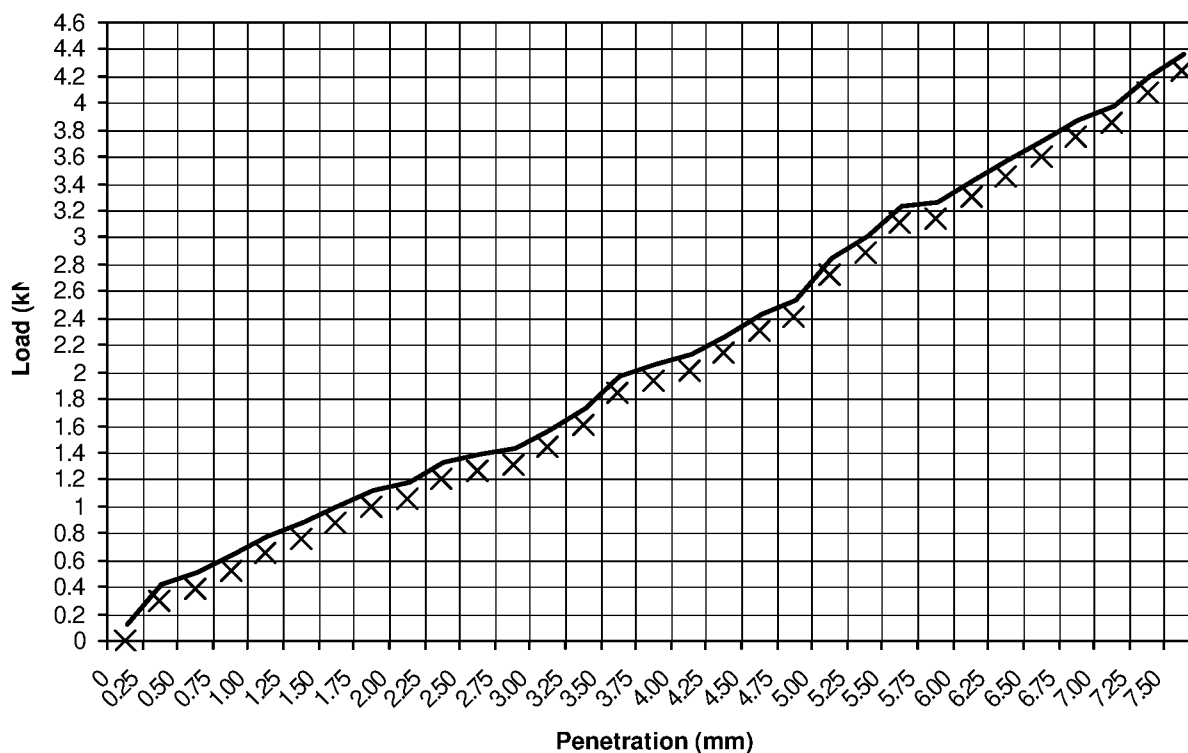
### Graphical Representation

## CBR Test Location: Four
